Utility Assessment and Site Feasibility Study

Sunrise State Park East Haddam, Connecticut

December 2010

Project No. 2010 0950 A10

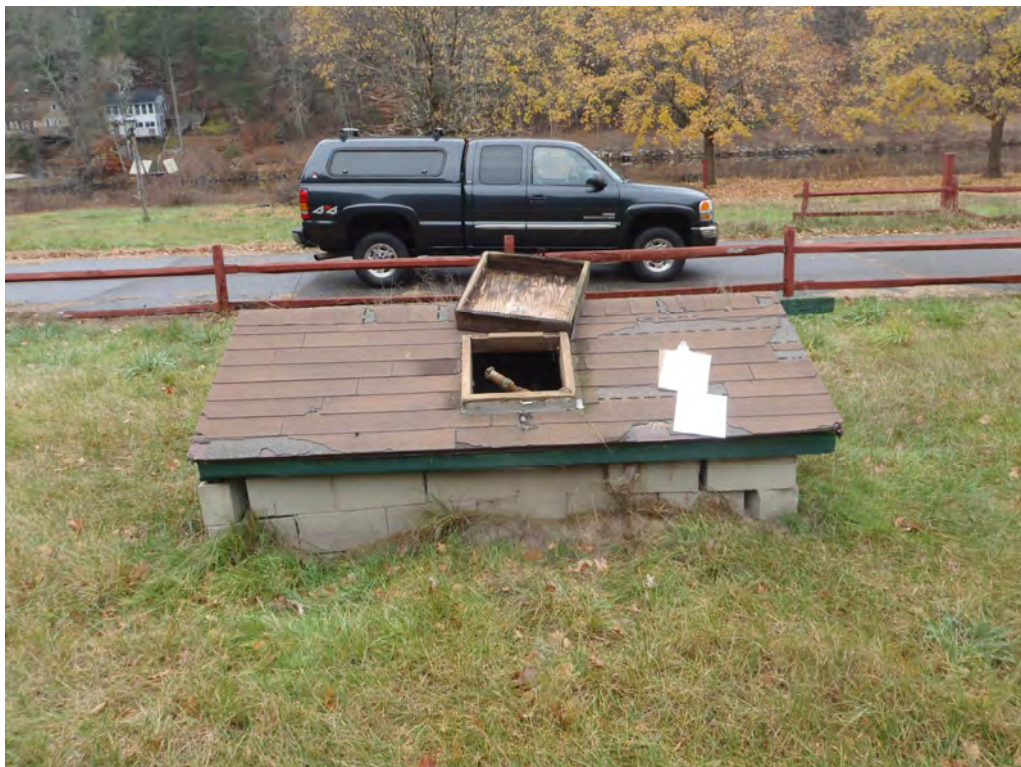
Photo 3-7 – Septic Pumping Wetwell

- The Waterfront Pavilion Area drained to a central wetwell west of the open-air seating area adjacent to the Main Dining Hall (*Appendix A*, Photo 3-7). Effluent from this wetwell was pumped uphill to a drywell behind the Maintenance Building in Arthur's Paradise. (*Appendix A*, Photo 3-8) This wetwell was observed to contain debris, with the pump itself disconnected and removed from its mounting.

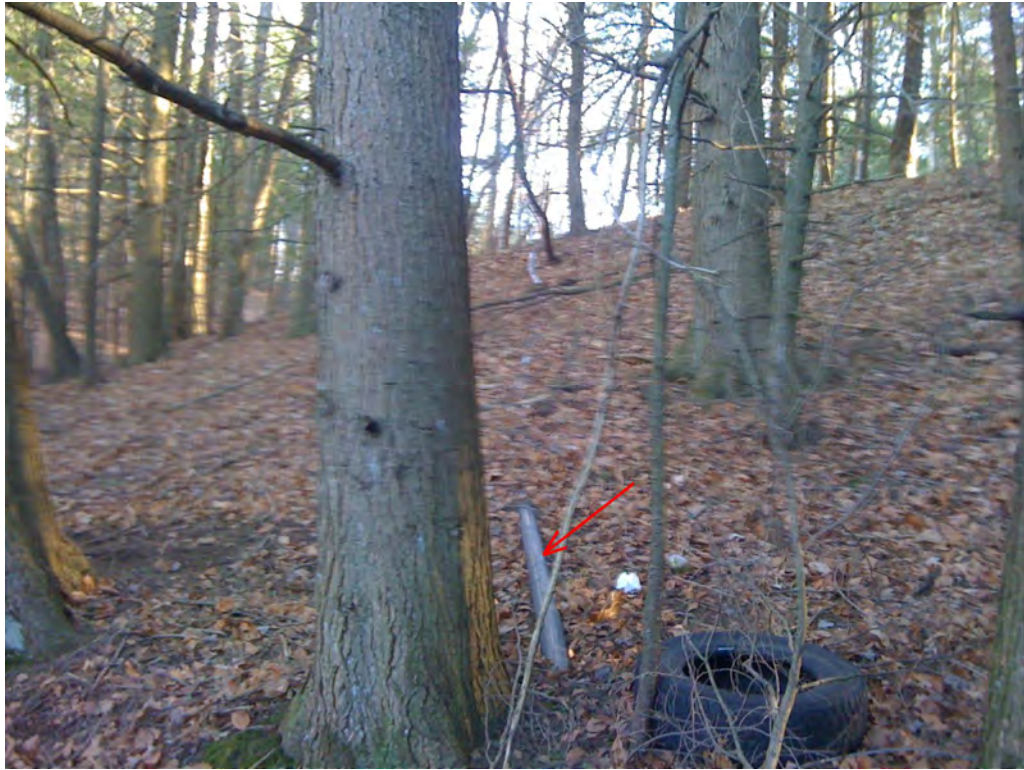
Photo 3-8 – Exposed Septic Forcemain

Additionally, septic force-mains or gravity drain lines on or just below the existing ground surface may not meet public health codes for coverage requirements. A specific example observed is the 4" PVC force main discharging effluent from the wetwell in the Waterfront Pavilion Area to the drywell(s) in Arthur's Paradise.

Due to the nature of construction, reuse of existing drywells serving individual cabins or buildings may be impractical. Excavation efforts and costs to exhume, inspect, and test these systems may exceed those required to directly replace or upgrade these systems with larger, more centralized leaching fields. Therefore, reuse of subsurface septic systems in the Single Cabin/Double Cabin Area and the Waterfront Cottage Area may not be practical.

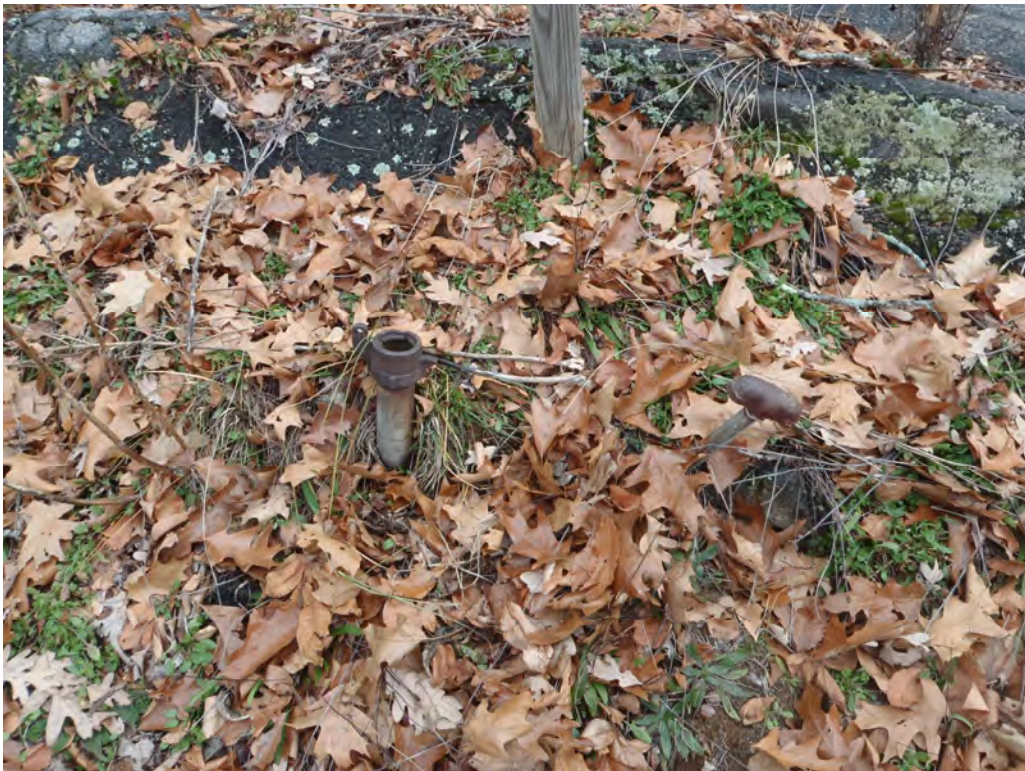
Photo 4-3 – AOC-04 (Suspected UST Vent Pipe)

For AOCs identified as suspected UST areas (AOC-03, AOC-04, AOC-05, AOC-06) we recommend that a ground-penetrating radar survey (GPR) be completed to confirm that a UST is present. The ages of the USTs are unknown and the tanks may be beyond their expected life capacity. We recommend that identified USTs be removed and properly disposed of off-site. Confirmatory sampling of the tank graves should be performed in accordance with the Connecticut Underground Storage Tank Closure Guidance Document published by CTDEP.

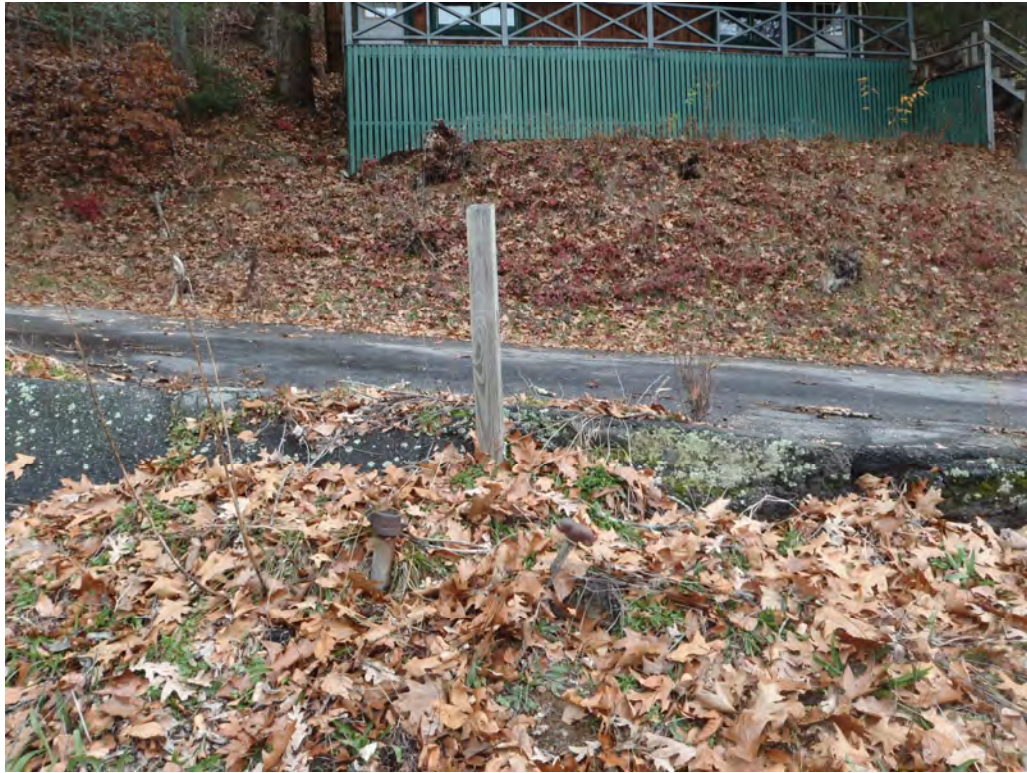
Photo 4-4 - AOC-05 (Suspected UST Vent Pipe)

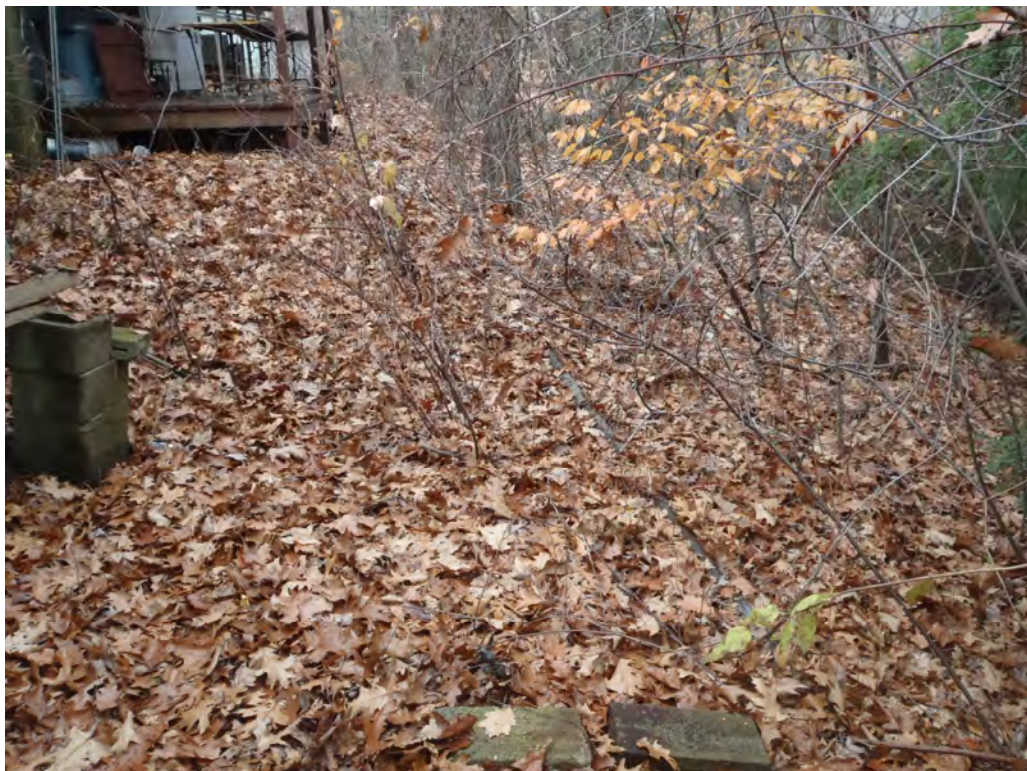
Photo 4-5 - AOC-06 (Suspected UST)

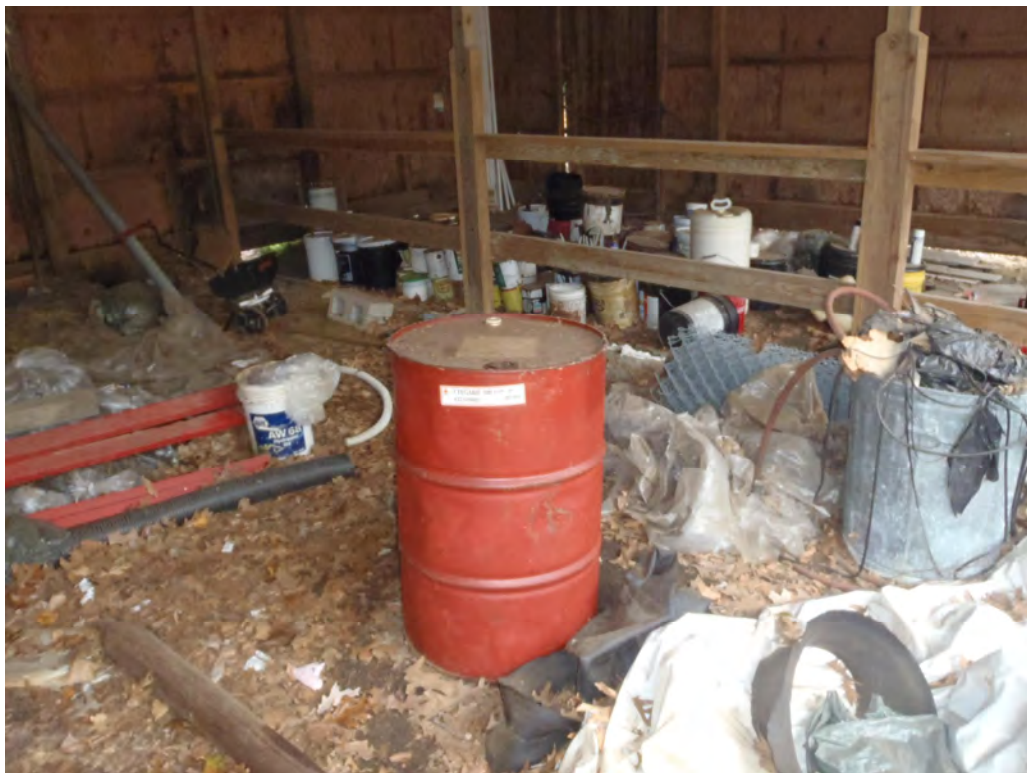
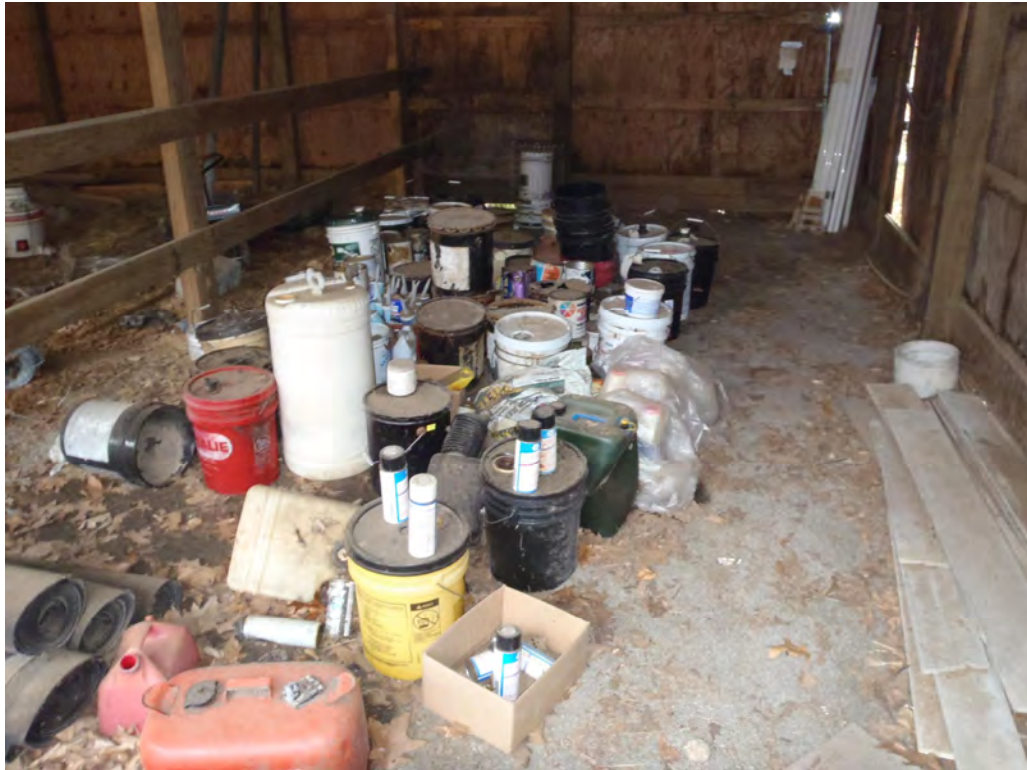
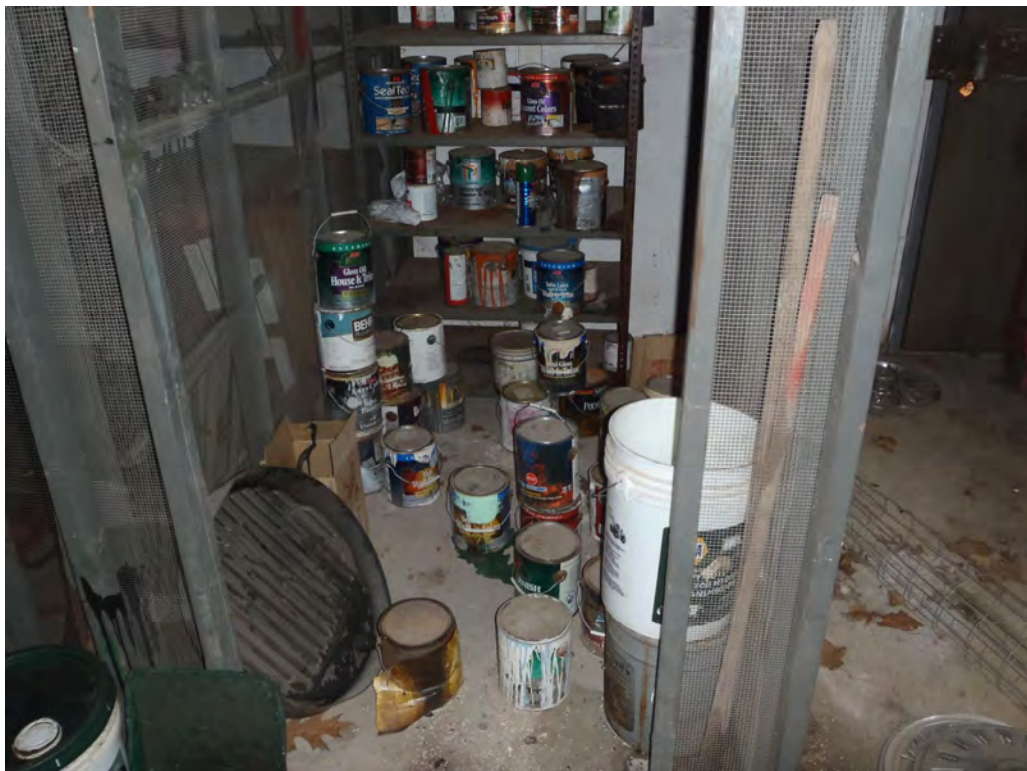
The maintenance garage (AOC-08) is the highest priority AOC that was identified at the Site. In addition, to the COCs identified above, the garage COCs consist of pesticides/herbicides, lead from acid batteries, semi-volatile organic compounds, and polychlorinated biphenyl's. As further described in *Table 4-2*, numerous containers and drums containing potentially hazardous materials are present at this AOC. Several of the containers are in poor condition. Staining is present on the ground surface in the vicinity of the containers.

Photo 4-7 - AOC-08 (Maintenance Garage)

Photo 4-8 - AOC-08 (Maintenance Garage)

Photo 4-9 - AOC-08 (Maintenance Garage)

We recommend that the containers and drums of the chemicals at the maintenance garage be removed and properly disposed of at a permitted facility. Due to the poor condition of some of the containers, over pack of the contents may need to be performed by the contractor. Some of the material may be required to be disposed of as a hazardous waste. If material is disposed of as a hazardous waste, waste manifests will be submitted and filed at CTDEP by the Generator.

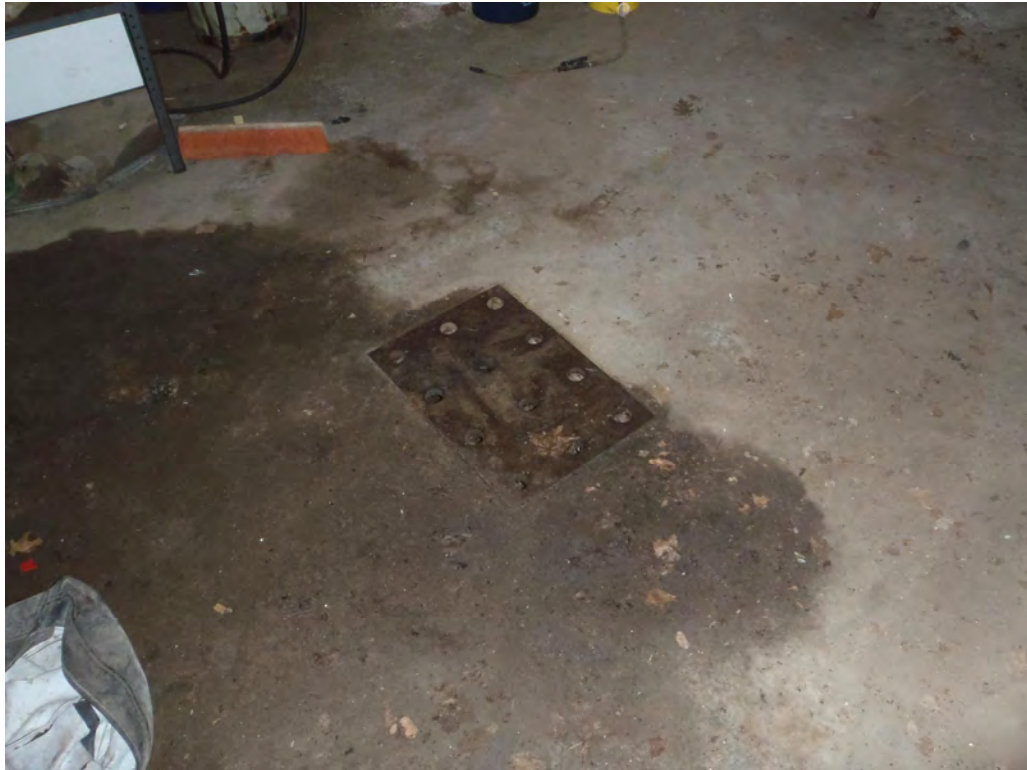
Photo 4-10 - AOC-08 (Maintenance Garage Floor Drain)
