Reach Level Assessment

SURVEY REACH ID: <u>NR-4</u>		WTRSHD/SUBSHD:		DATE: <u>11/23/09</u>		ASSESSED BY: <u>SG+CM</u>	
START TIME: <u>10:15</u> AM/PM	LMK: <u>FORMATION</u>	END TIME: <u>11:45</u> AM/PM	LMK: <u>ARMY</u>	GPS ID:			
LAT <u>41° 43' 04"</u> LONG <u>72° 43' 24"</u>		LAT <u>41° 48' 18"</u> LONG <u>72° 43' 34"</u>		DESCRIPTION:

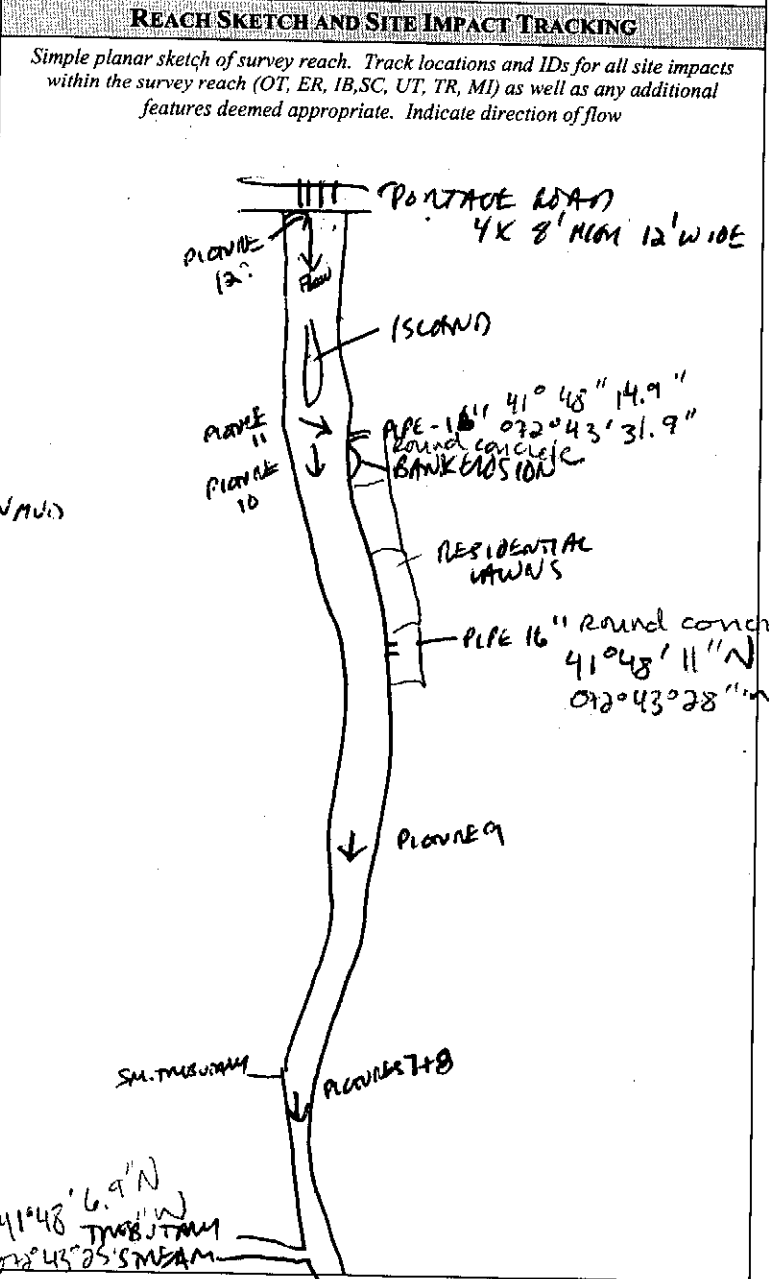
NOTES: (biggest problem you see in survey reach)

IMPACTED BUFFER - RESIDENTIAL LAWNS

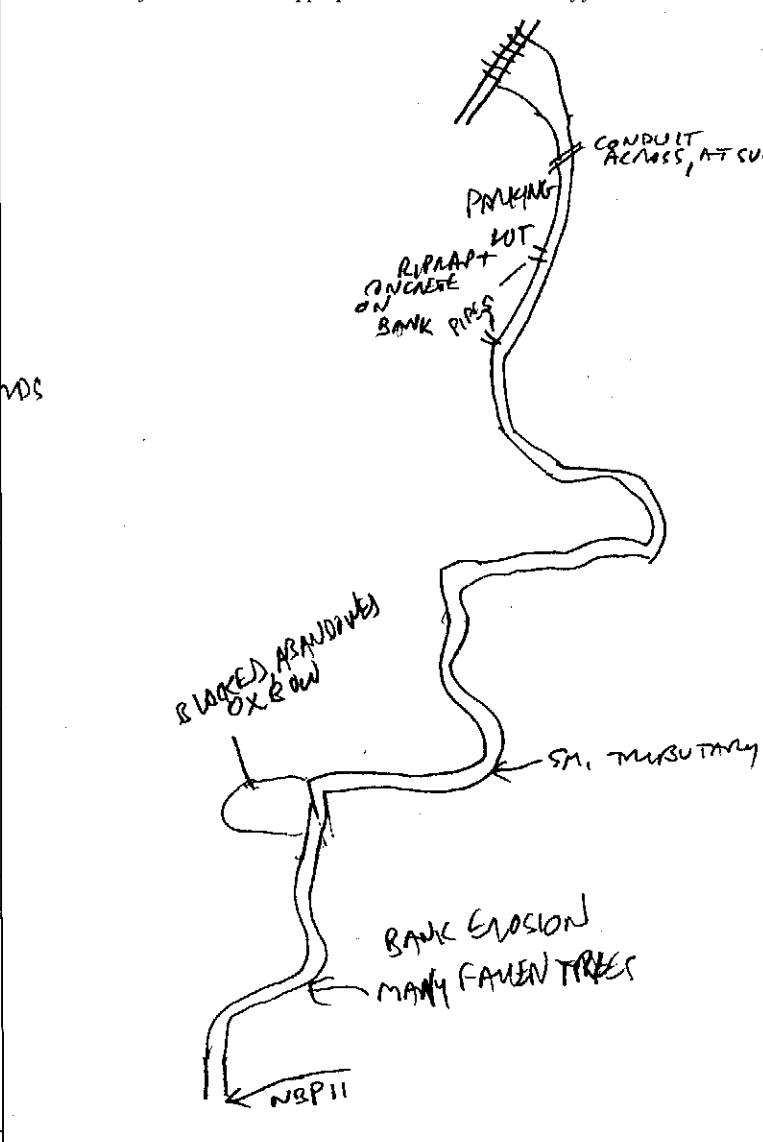
Simple planar sketch of survey reach. Track locations and IDs for all site impacts within the survey reach (OT, ER, IB, SC, UT, TR, MI) as well as any additional features deemed appropriate. Indicate direction of flow

NOTES: (biggest problem you see in survey reach) Impacted Buffer adjacent to parking lot along Right Bank

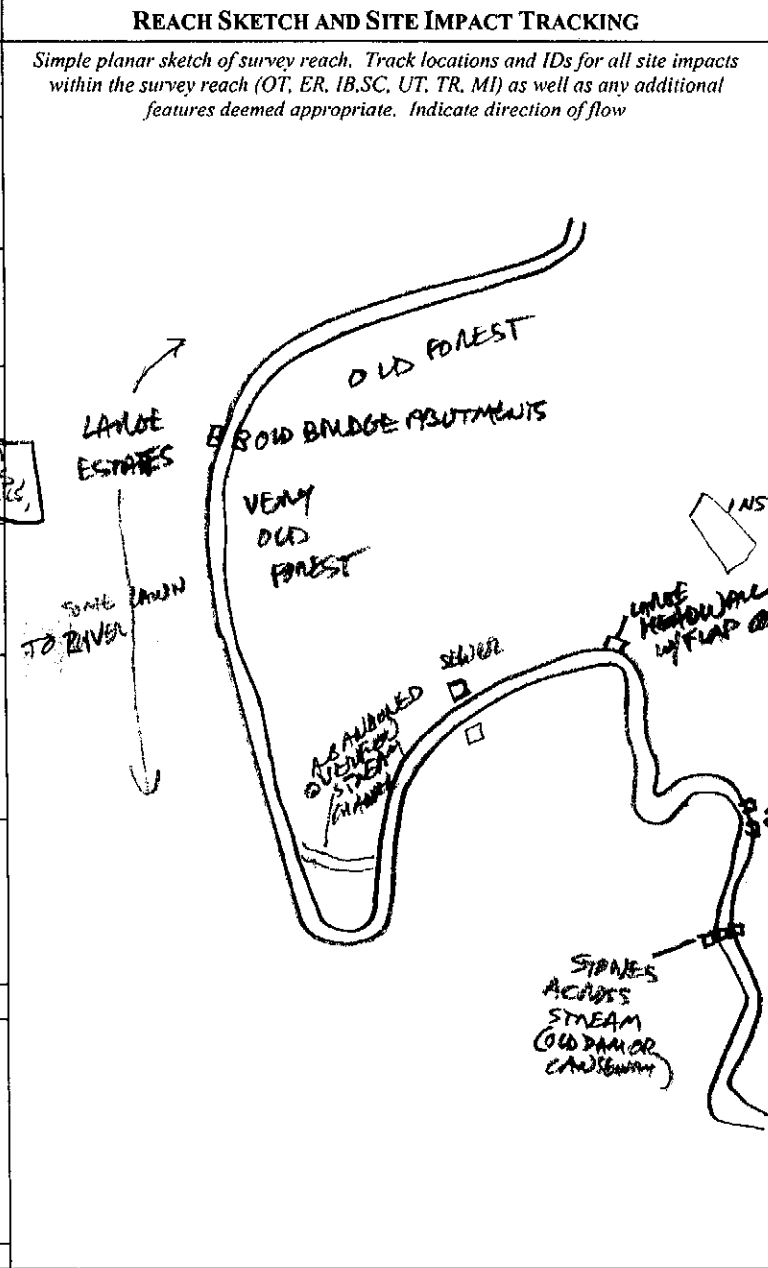
NOTES: (biggest problem you see in survey reach) TRASH in water (i.e., styrofoam cups + plates), plastic bottles, some invasive plants, but overall there is wide forested buffer - particularly along the left bank there is mature floodplain forest with many trees DBH > 30" + excellent riparian wildlife habitat.

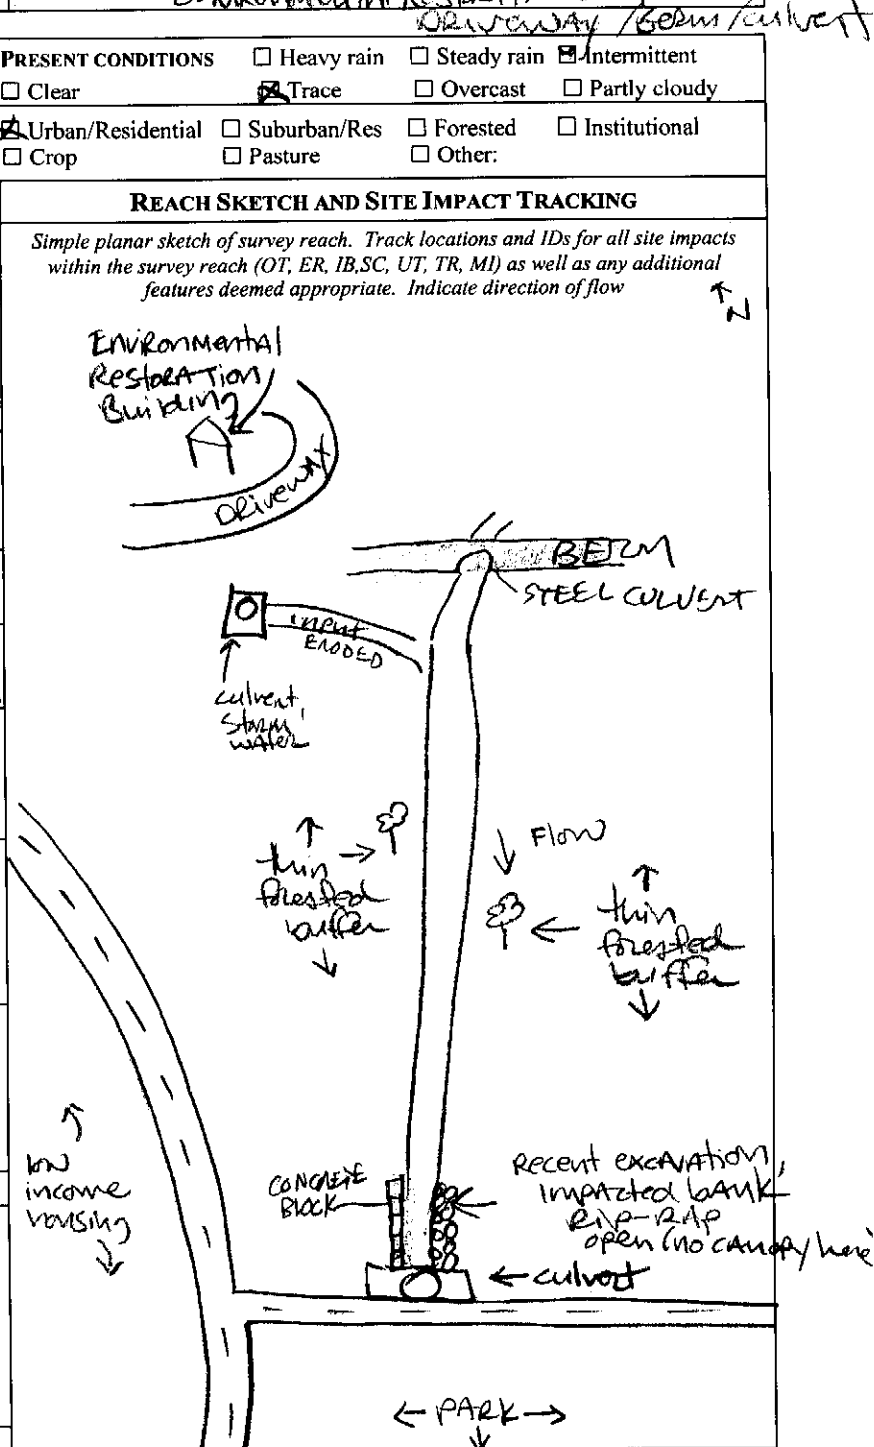
NOTES: (biggest problem you see in survey reach)
 Impacted bank @ southern end upstream of culvert. The underlying tunnel that carries water downstream must be very long - it is not located on the other side of the street - or it is closed.

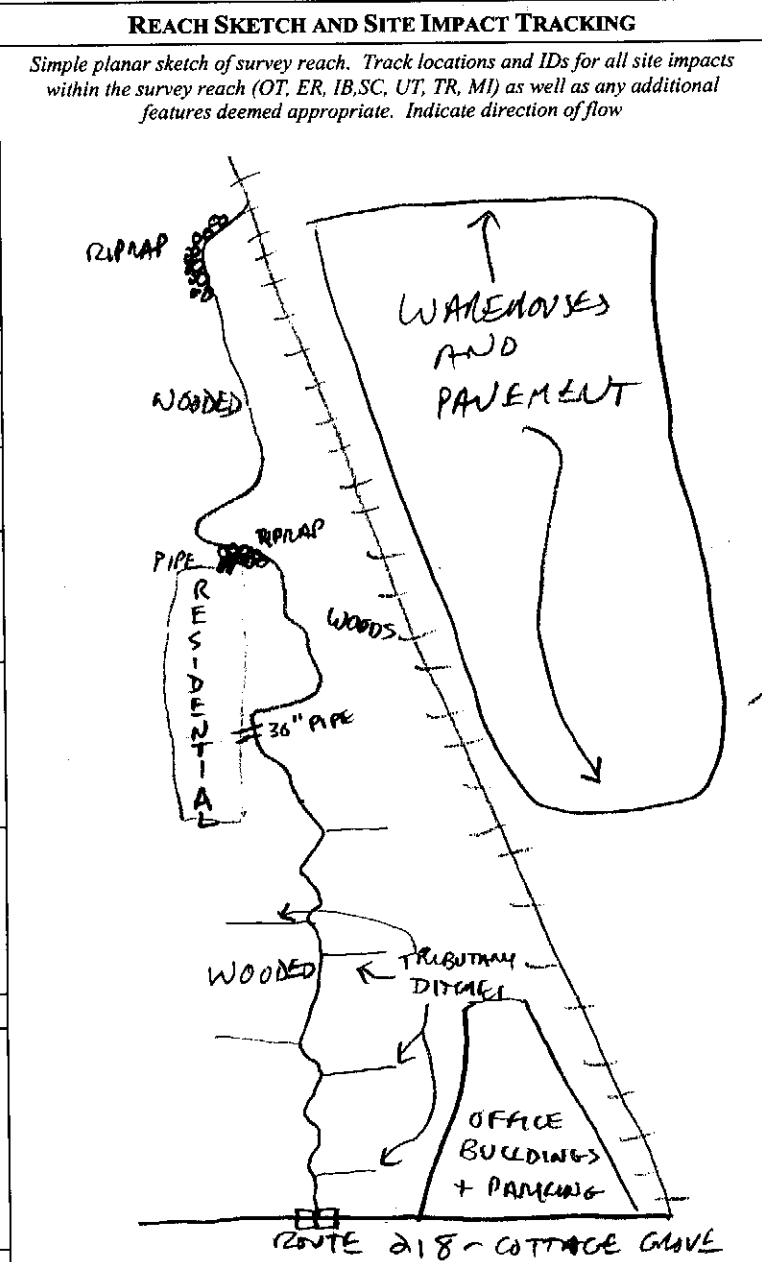
NOTES: (biggest problem you see in survey reach) Impacted buffers: AREAS OF EROSION, INVASIVE PLANTS, lots of stormwater inputs/runoffs, AREAS OF RIP-RAP (Right bank) behind residential neighborhood.

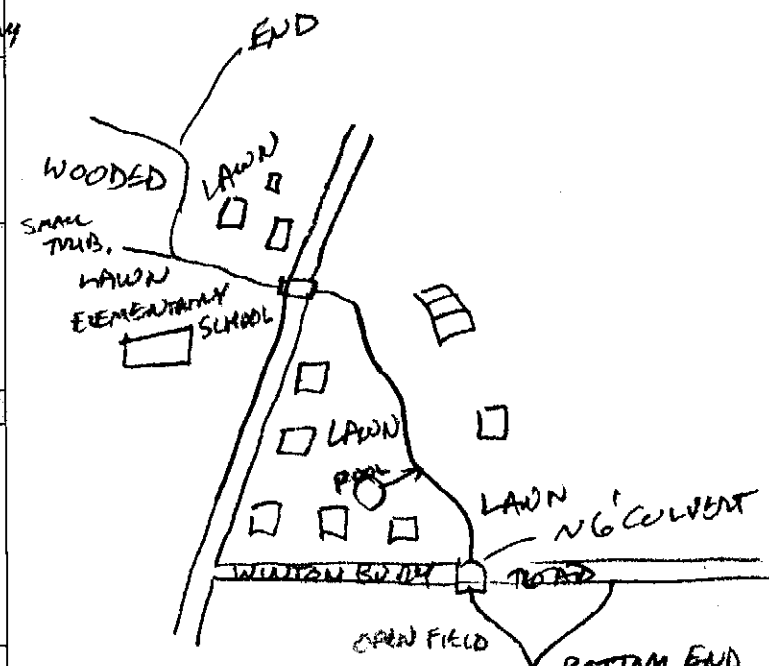
NOTES: (biggest problem you see in survey reach) **SUBURBANIA: MOWN LAWNS, DUMPING OF YARD WASTE, DRAINING OF POOL TO STREAM**

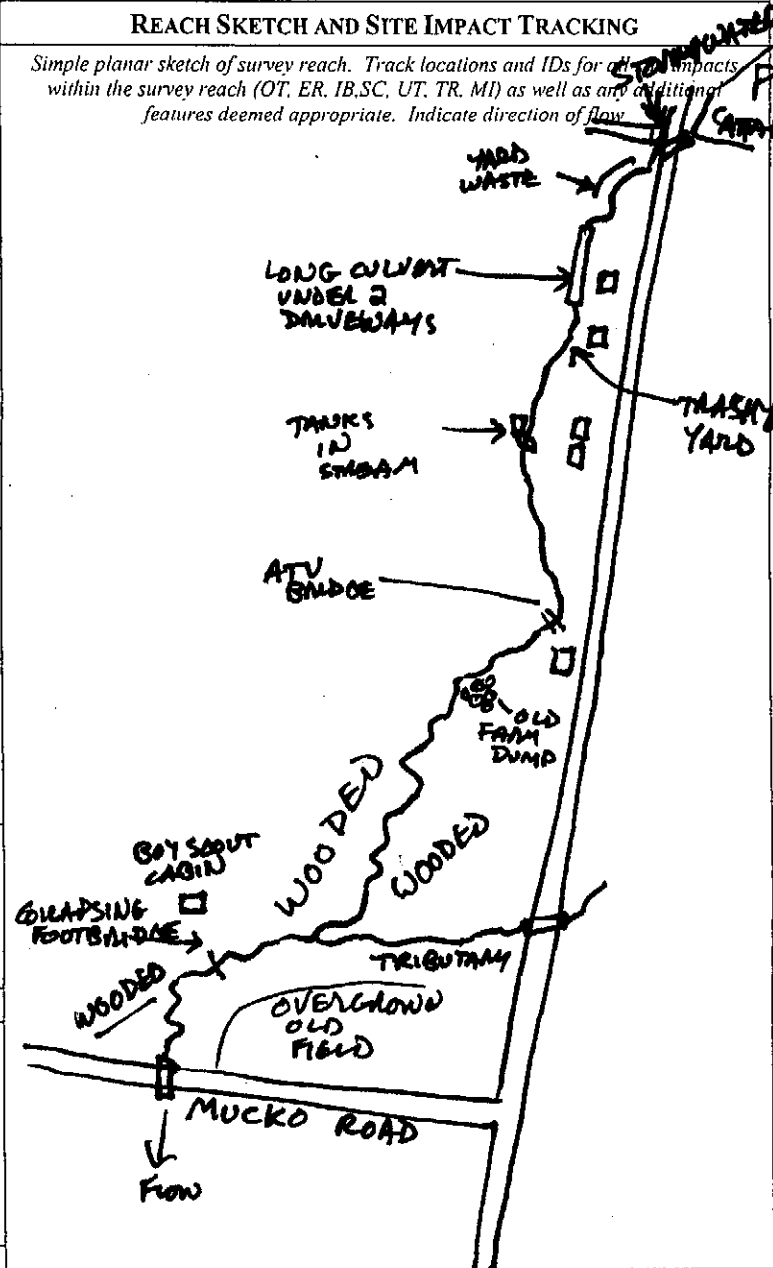
NOTES: (biggest problem you see in survey reach) **very long culvert + trash-dumping on left bank**
 (includes trees, old car, stone, old foundations, broken pipe. Another dump area at Woodland Ave
 (includes plastic bottles etc). REPORTED TO AUTHORITIES YES NO

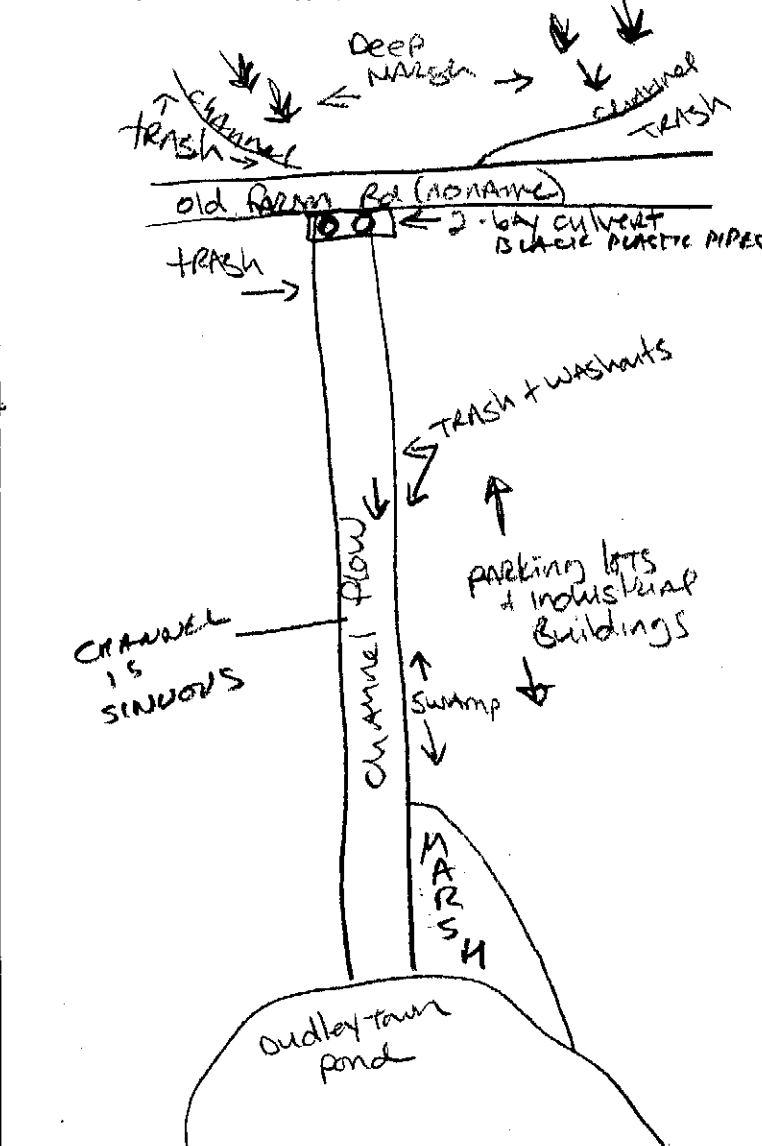
Simple planar sketch of survey reach. Track locations and IDs for all site impacts within the survey reach (OT, ER, IB, SC, UT, TR, MI) as well as any additional features deemed appropriate. Indicate direction of flow.

NOTES: (biggest problem you see in survey reach)
 + TRASH + dumping (car parts, plastic bottles, plastic buckets, vinyl siding, garbage cans, etc.)
 + PARKING LOT RUNOFF FROM INDUSTRIAL BUILDINGS (VEHICLE WASHING?)
 REPORTED TO AUTHORITIES YES NO

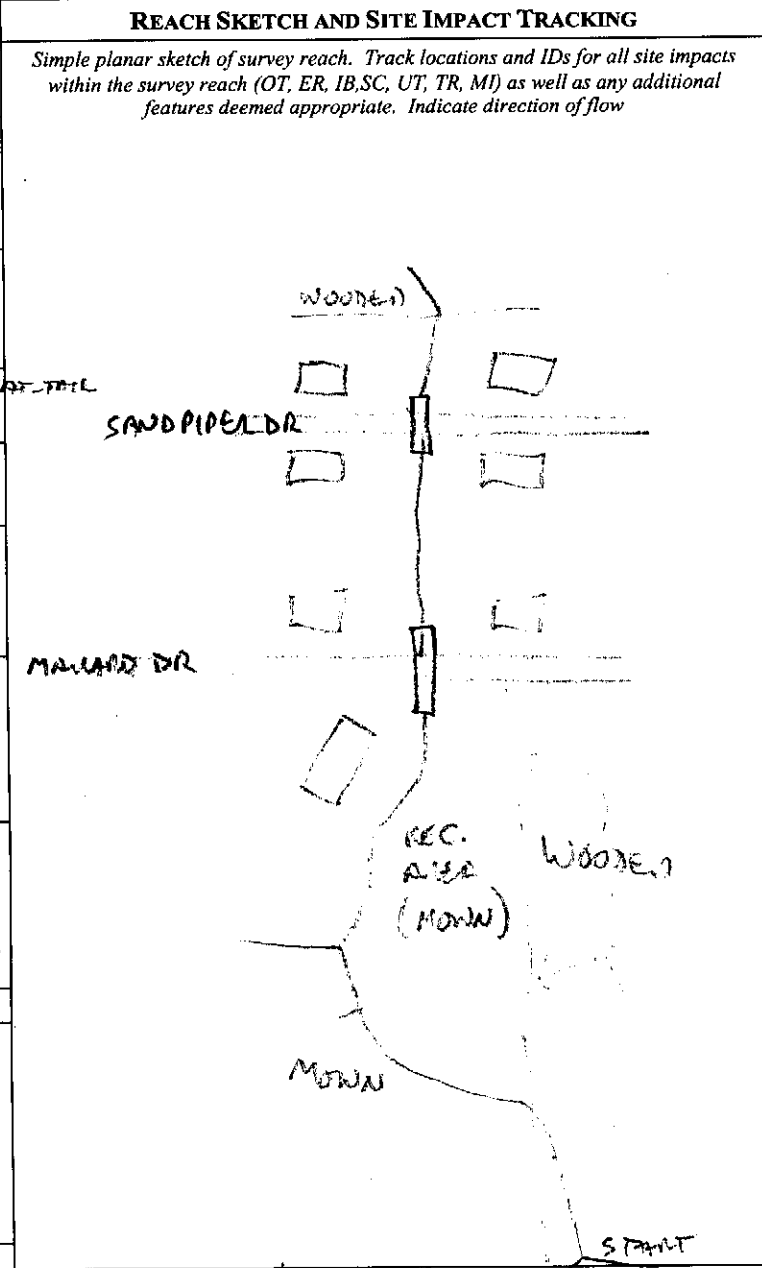
NOTES: (biggest problem you see in survey reach) **Impacted over adjacent to athletic fields**

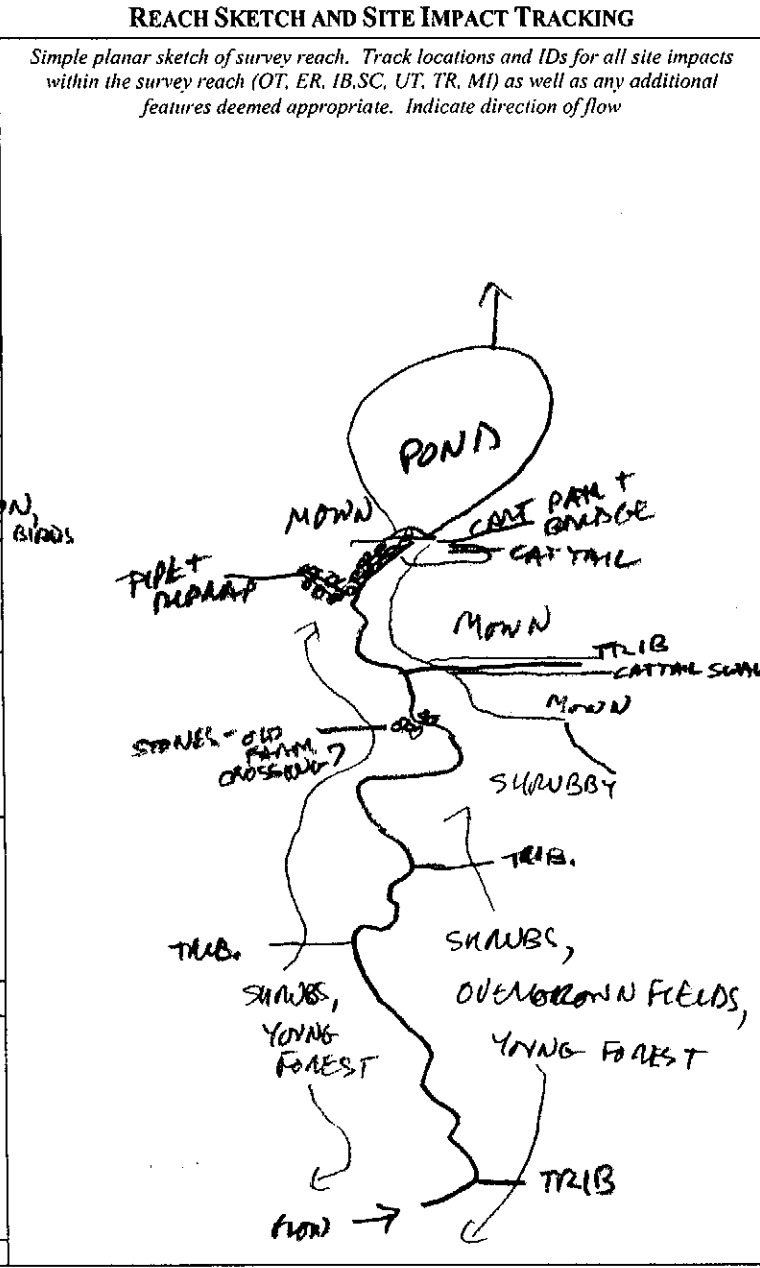
NOTES: (biggest problem you see in survey reach) GOLF COURSE RUNOFF + RIPRAP
