Health Consultation

COS COB POWER STATION
GREENWICH, FAIRFIELD COUNTY, CONNECTICUT

JULY 21, 1999

HEALTH CONSULTATION

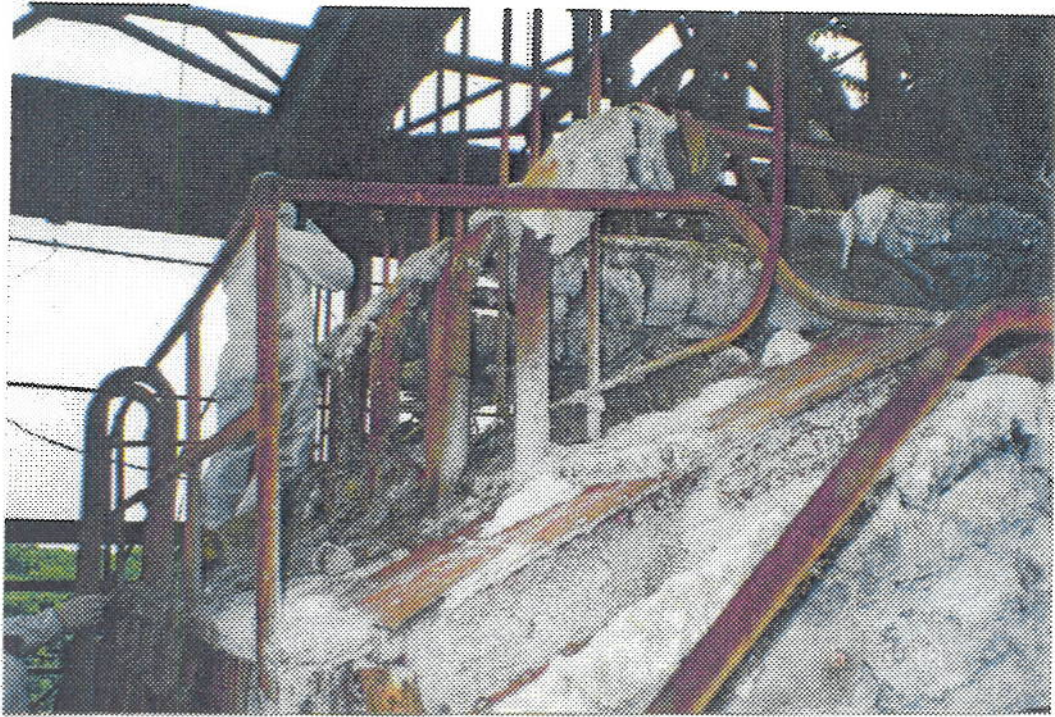
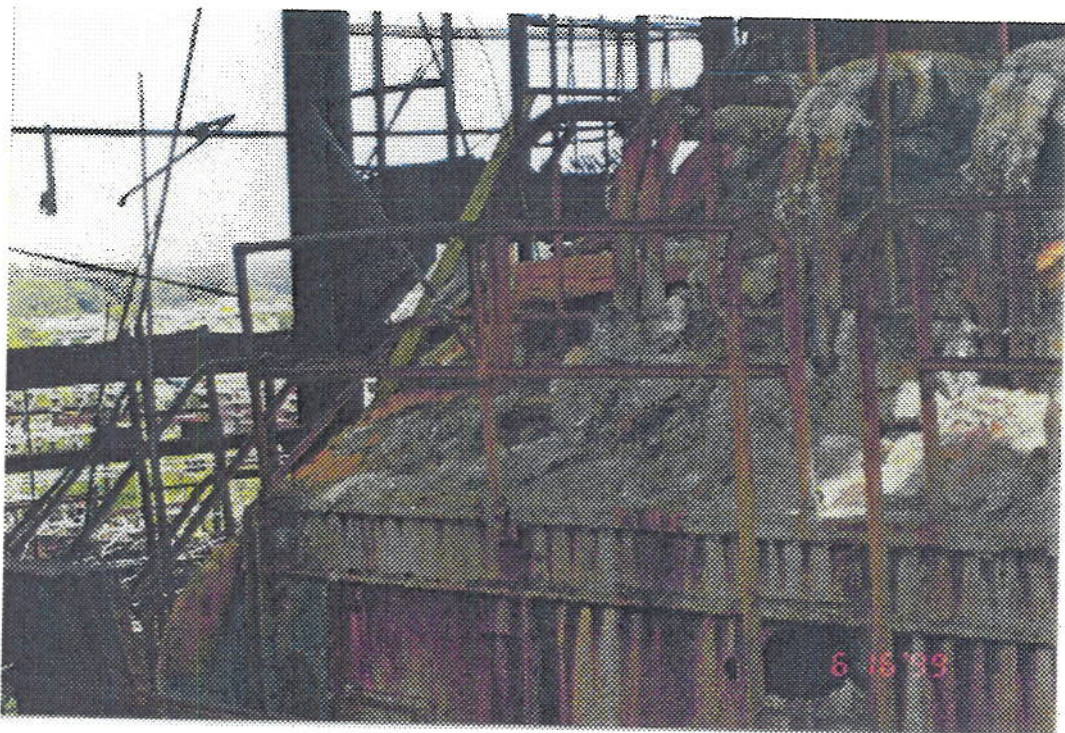
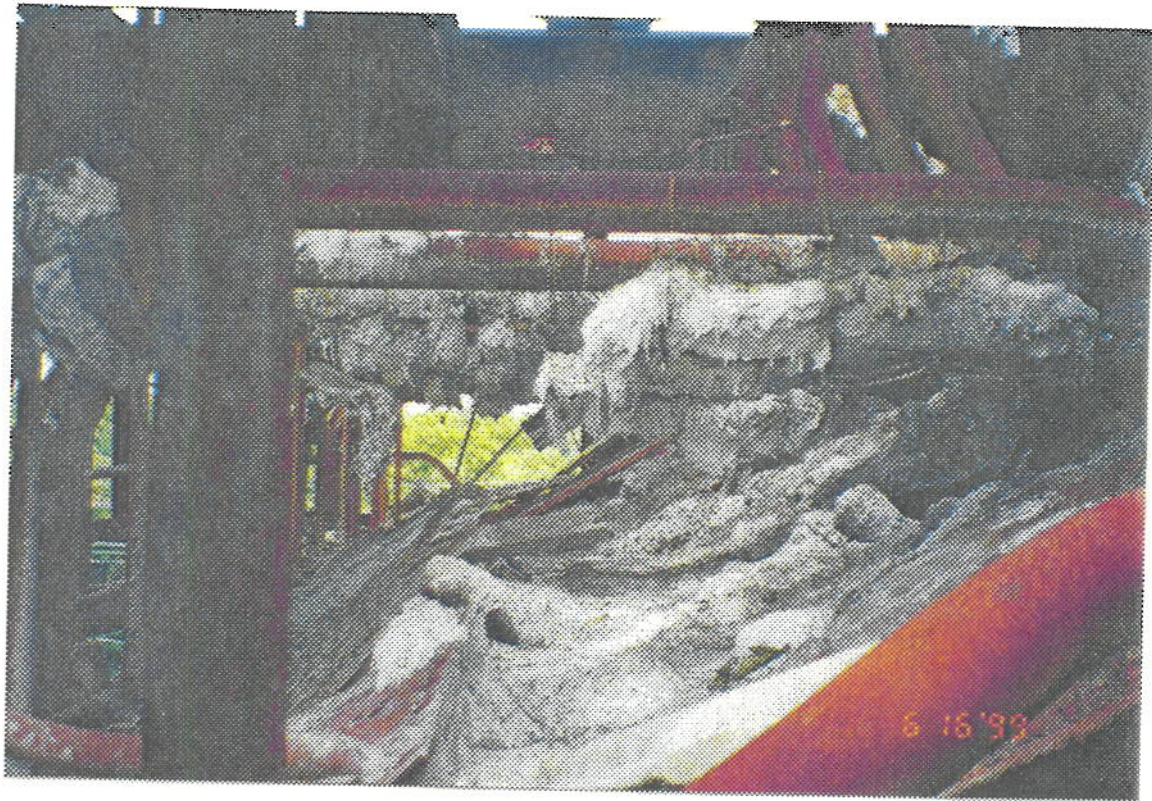
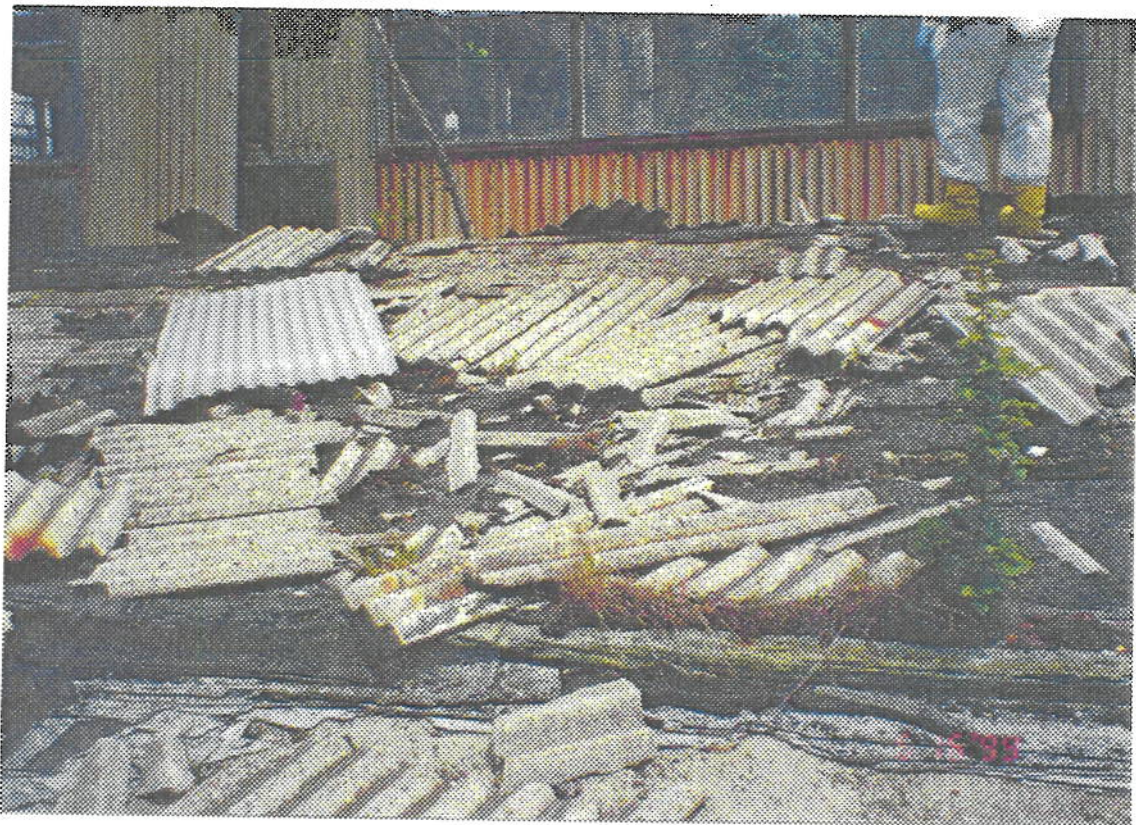
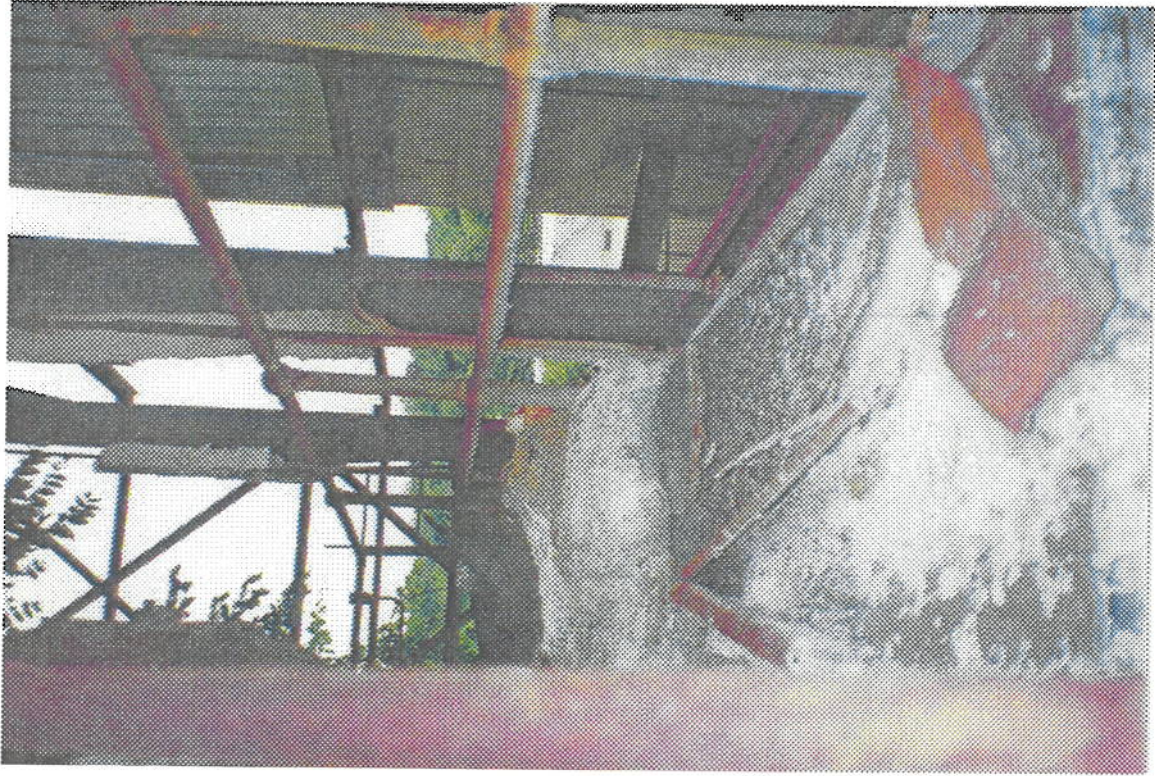
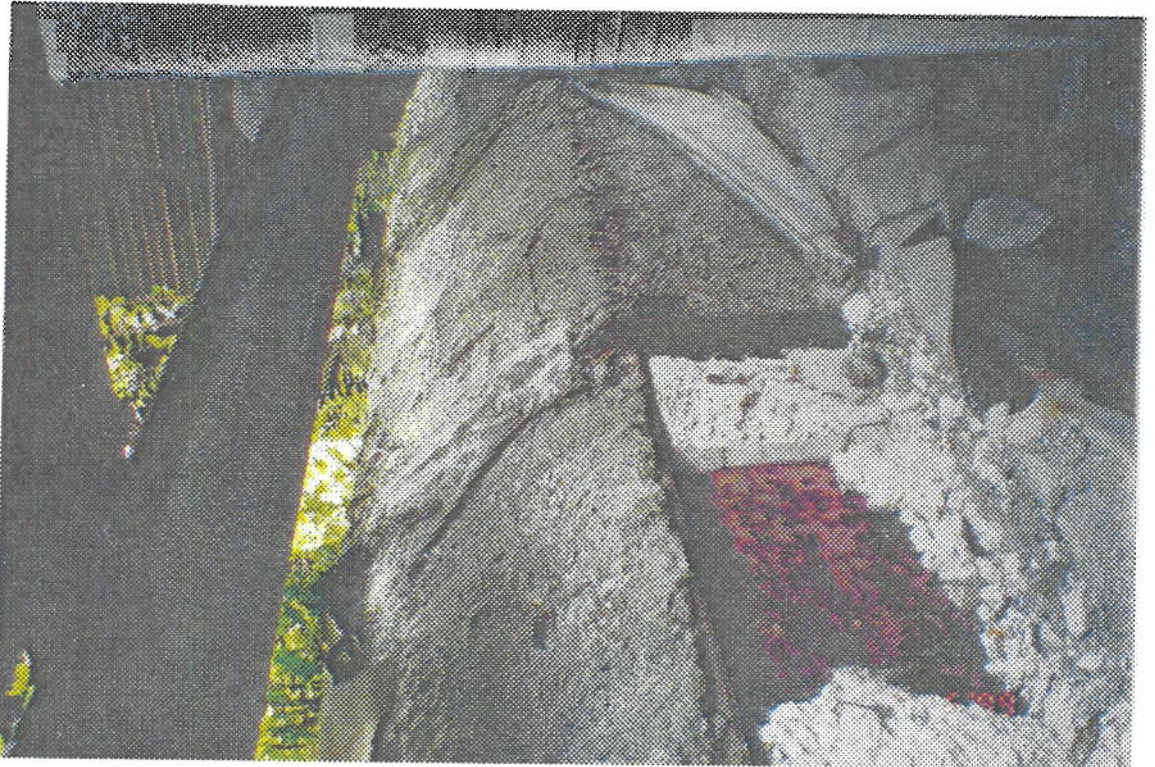
APPENDIX B
Site Visit Photographs

It is obvious that the building has not been maintained and significant damage to the building and its contents have occurred as a result of aging, weathering and vandalism. Throughout the site visit, we observed evidence of wall and roofing failure, including missing sections of roof and cement and roofing materials on floors. Many windows

Evidence of water infiltration and saturation of thermal insulation materials was observed throughout the building, but particularly in the west boiler room where the tops of the boilers are open to the environment. In the west boiler room, six boilers that originally had been coated with trowelled-on insulation have received extensive weather damage and the insulation material is falling off these surfaces onto catwalks, stairs and floors below. It is obvious that this material is in a friable condition and in some areas is many inches thick. A similar condition was observed in the basement. Insulated pipes have become water damaged and insulating material is falling onto floor surfaces. During heavy rain events, materials are washed from first and second floors to the basement area as evidenced by the insulation dripping from stairwells. Trenches exist in the building that were used for cooling water intake and outflow from the Mianus River. These trenches now contain asbestos-containing material which can be released into the River.

Asbestos-containing tar paper, shingles and corrugated transite were observed in various states of deterioration on the roof of the facility. In one area, this deteriorated material, in the form of a fine powdery-like substance, has collected along the edge of the roof. We observed trees that had seeded themselves and were actually growing out of asbestos containing insulation materials on the roof.

The asbestos-containing materials need to be removed in a controlled manner that prevents the release of asbestos to surrounding residential and business areas. This removal needs to occur as soon as possible. There may be on-going, sporadic releases of asbestos currently taking place. In addition, no one can predict when a weather condition, fire, building collapse or other event may liberate and disperse the friable asbestos into the surrounding community. Physical hazards need to be fully evaluated and addressed.
