**Summary Report
Condition Reassessment and
Post Tension Strand Evaluation
25 Sigourney Street
Hartford, Connecticut**

**DCS Project No. BI-2B-034A
Architects Project No. 206063**

13 October 2011

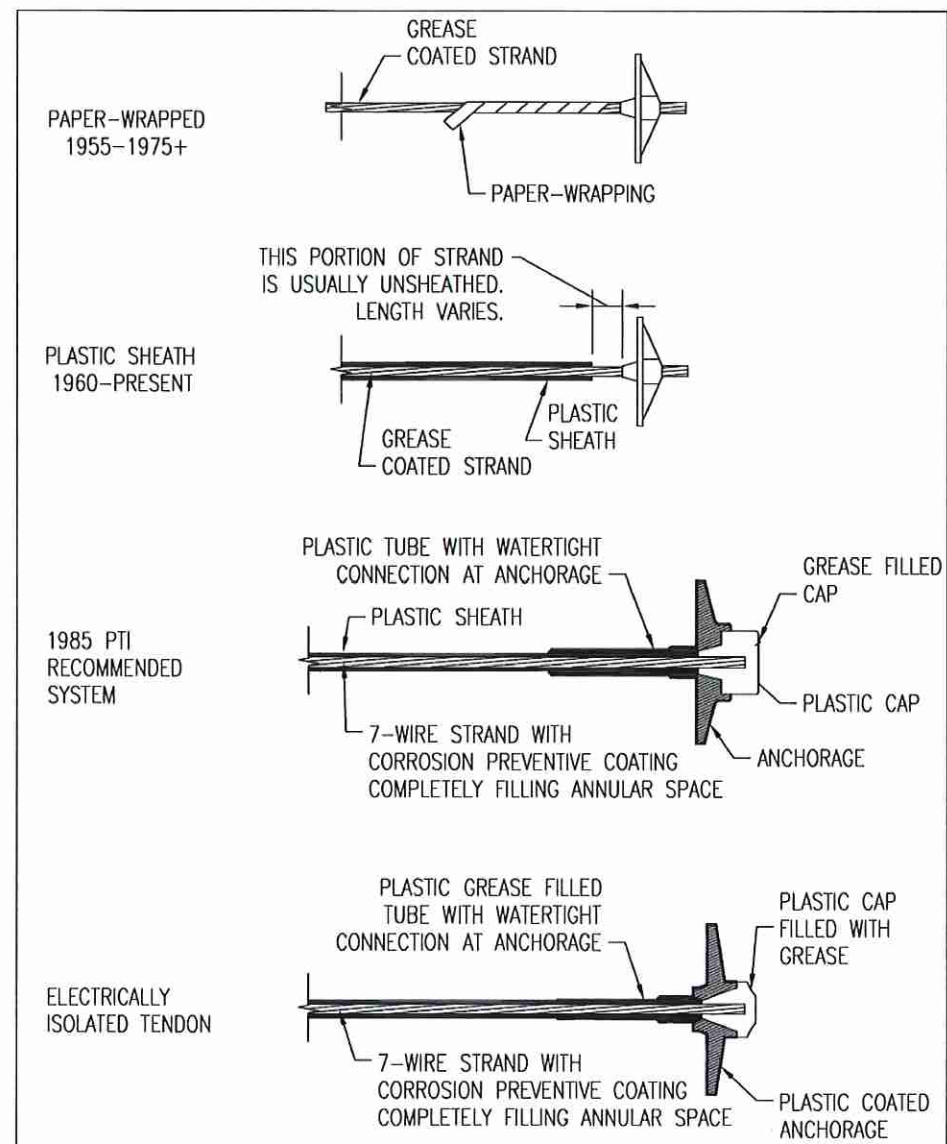
- The anchorages were uncoated and were frequently installed in contact with the back-up reinforcing steel

Figure 1. Deficiencies in corrosion protection details. 25 Sigourney St. uses the 2nd system from top. (Figure adopted from ACI 423.4R-98).

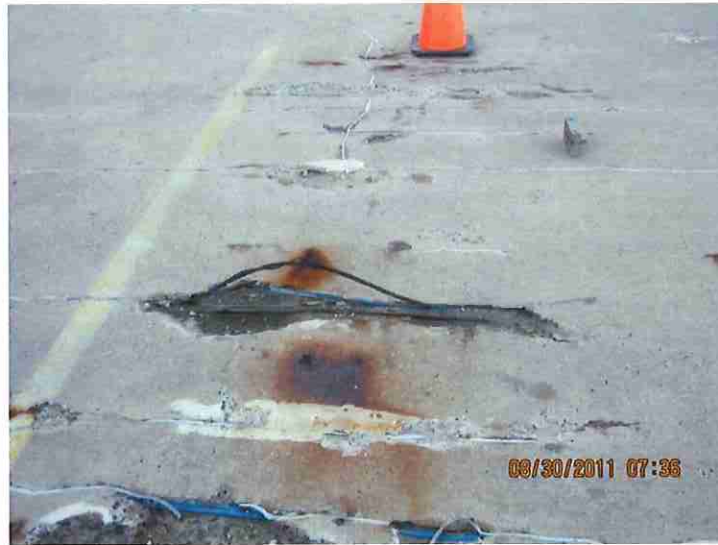
Figure 5. Failed post-tensioning on Level 6.

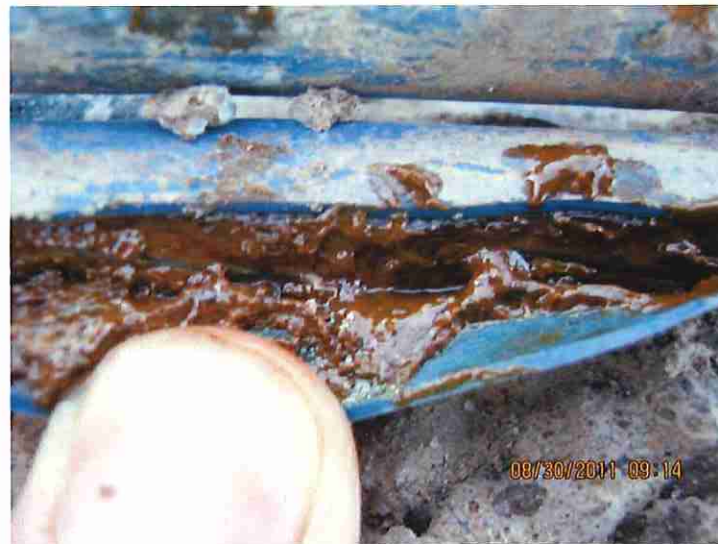
Figure 6. Emulsified grease on post-tensioning grease.

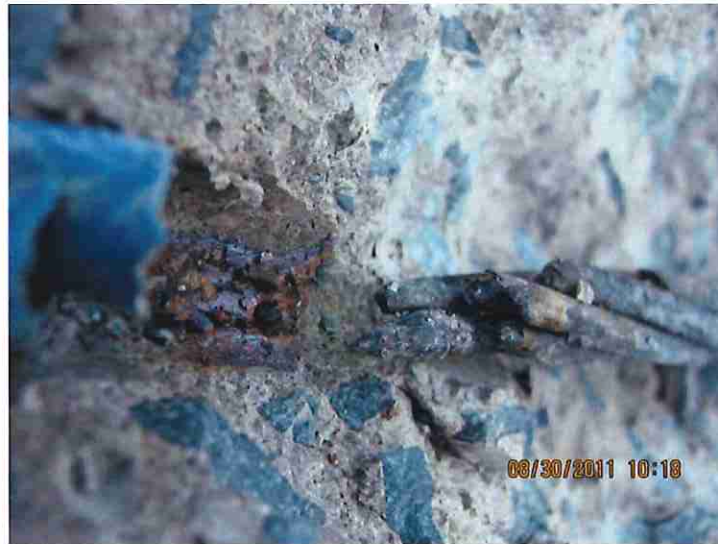
Figure 7. Brittle failure of post-tensioning strand on Level 6.

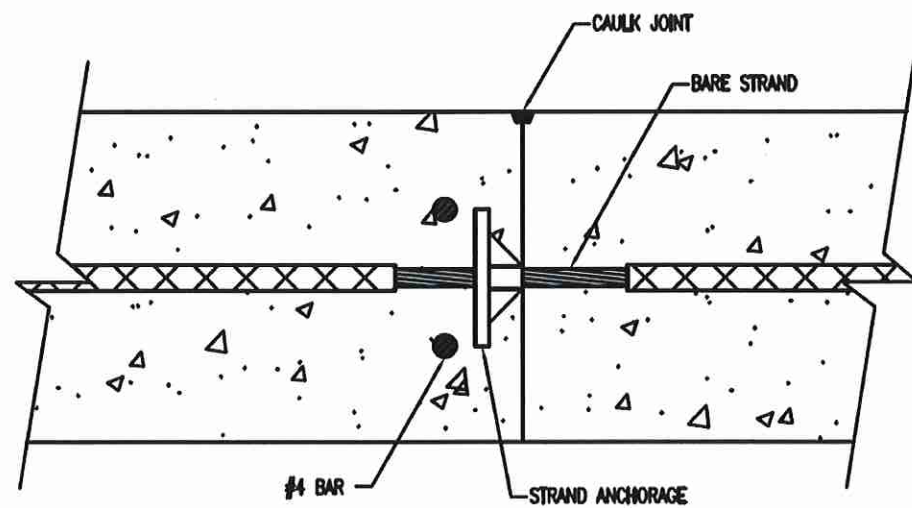
The probe openings on the top slab surfaces revealed that significant corrosion was present at the high points in the tendon trajectories in locations with low concrete cover. Figures 5 to 7 show typical conditions observed at low cover locations. Approximately twelve failed post-tensioning strands were observed on the top slab surfaces at various locations in the structure. Additional openings were made at the construction joint where known deficiencies are present in the corrosion protection. These are shown in Figure 8.

Figure 8. Strand conditions at construction joint. Note lack of positive corrosion protection as strand crosses joint.

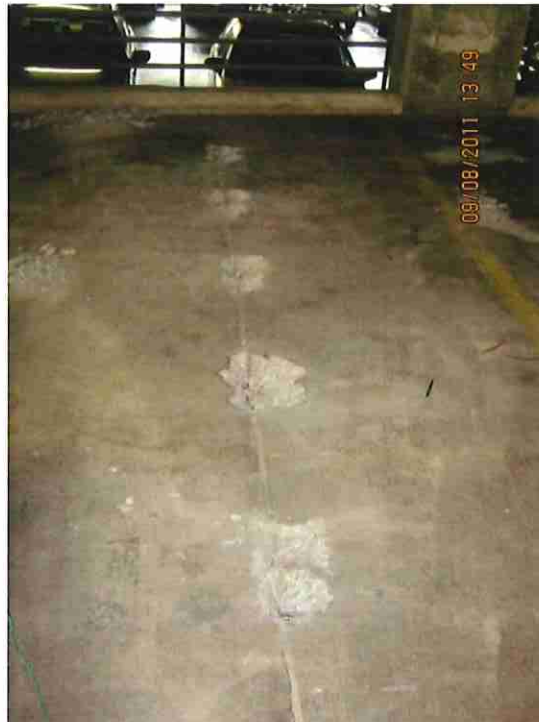
During the evaluation, a section on Level 2 was observed with several failed post-tensioning strands at the construction joint. The failed post-tensioning strands were

observed at the construction joint located between beam lines D and E. Two failed post-tensioning strands were present in this location, at the start of the investigation and water stains were observed on the slab soffit at the construction joint. Three additional broken strands were observed in this area (total of 5 broken strands). Wire breaks and section loss due to corrosion were observed at other locations. Based upon these observations, the area was closed to parking. Figure 9 to 13 show some of the observed conditions in the area. Based upon the observation of the failed strands, the area on the south half of Level 2 from column lines K to A was closed to parking, as well as the area on Level 1 immediately beneath this area.

Our initial calculations indicated that the isolated failure of up to two strands would not reduce the capacity of the slab to an unsafe level. After the observations of the failed strands on Level 2, additional calculations were performed to examine the capacity of the slab with failed post-tensioning strands. The calculations indicated that with a 50% loss (failure) in post-tensioning strands, the slab had adequate strength to resist dead loads only. Therefore the parking area must remain closed until the strands are repaired.

Figure 9. Openings at construction joint on Level 2.

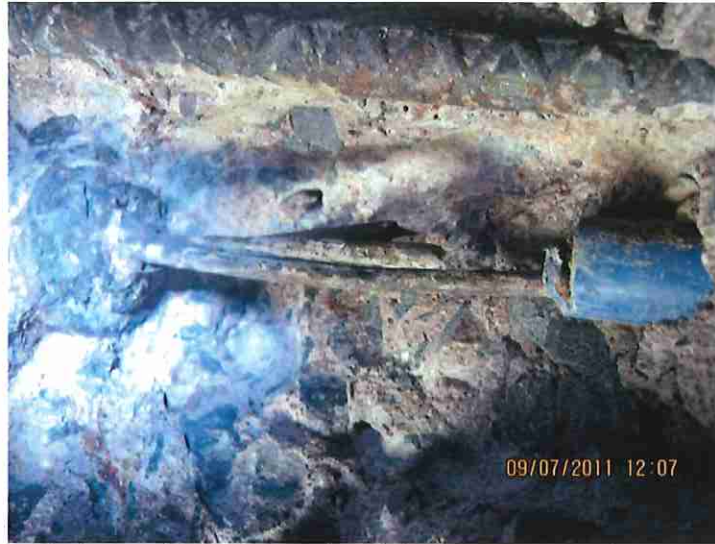
Figure 10. Failed strand at construction joint. Note corrosion on anchorage and failed wires.

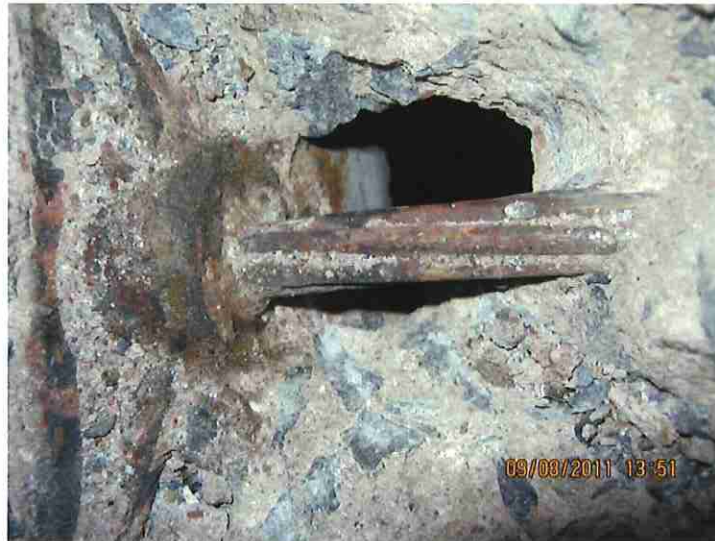
Figure 11. Corrosion damage on strand, without strand failure.

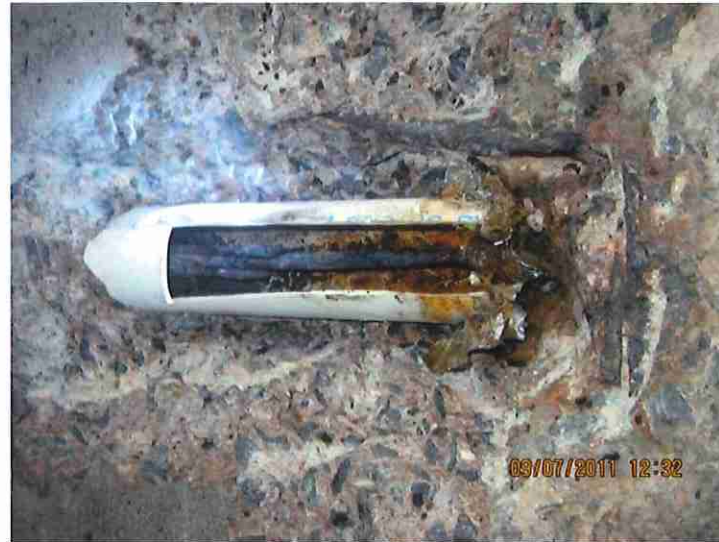
Figure 12. Failed strand at construction joint (possibly failed during original construction).

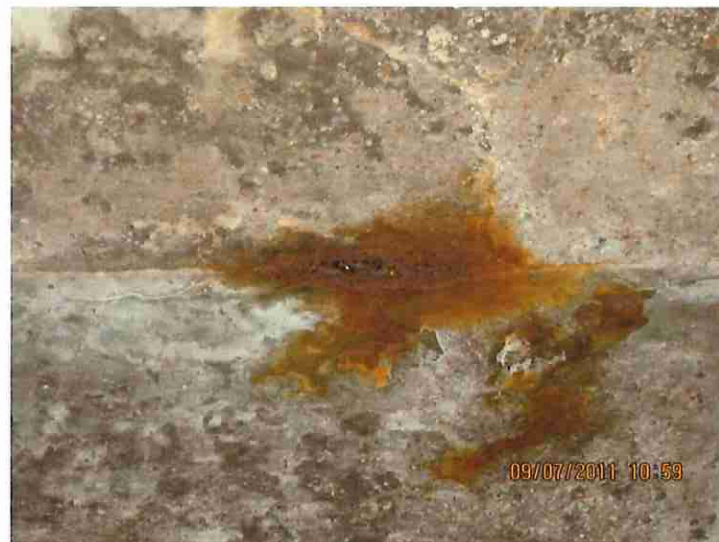
Figure 13. Water dripping through construction joint in vicinity of failed strands.

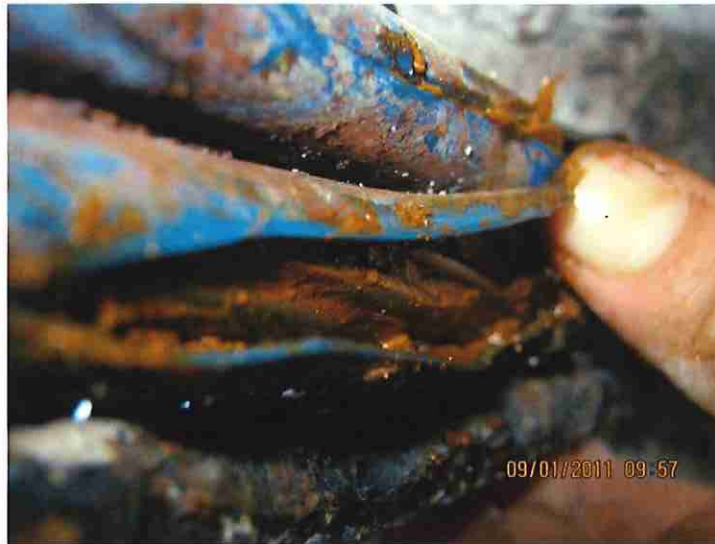
however surface corrosion was typically observed. Significant amounts of water and emulsified grease were also observed. Figures 14 and 15 show representative observed conditions on the slab soffits.

Figure 14. Water and emulsified grease on strand.

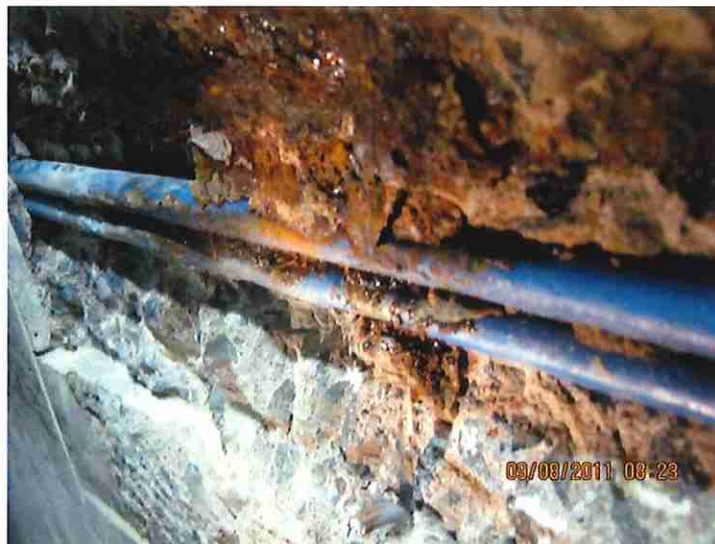
Figure 15. Corrosion damage to mild reinforcing steel and damage to sheathing on soffit.

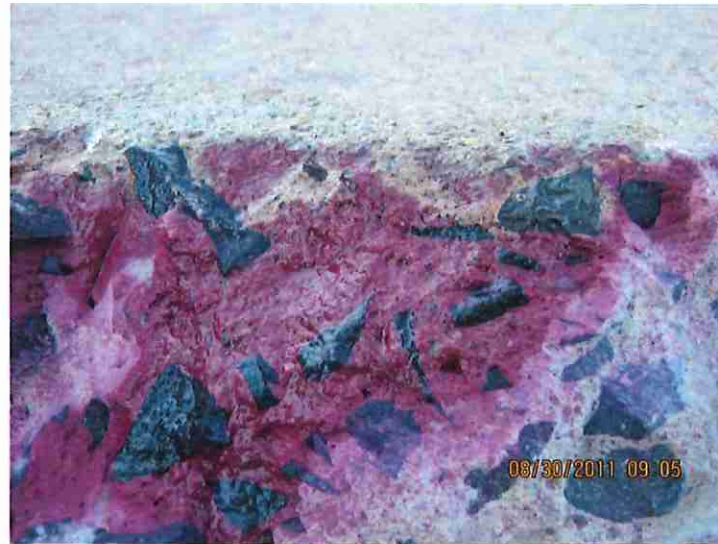
In addition to the chloride tests, carbonation tests were performed on freshly fractured concrete samples using a phenolphthalein solution. Figure 16 shows a tested area on Level 6, in the Figure the carbonation depth is less than ¼” as indicated by the change in indicator color. Similar carbonation results were obtained on tests on the lower levels. The limited carbonation depth was expected based upon the age of the structure and open construction.

Figure 16. Concrete surface on Level 6 with phenolphthalein applied.

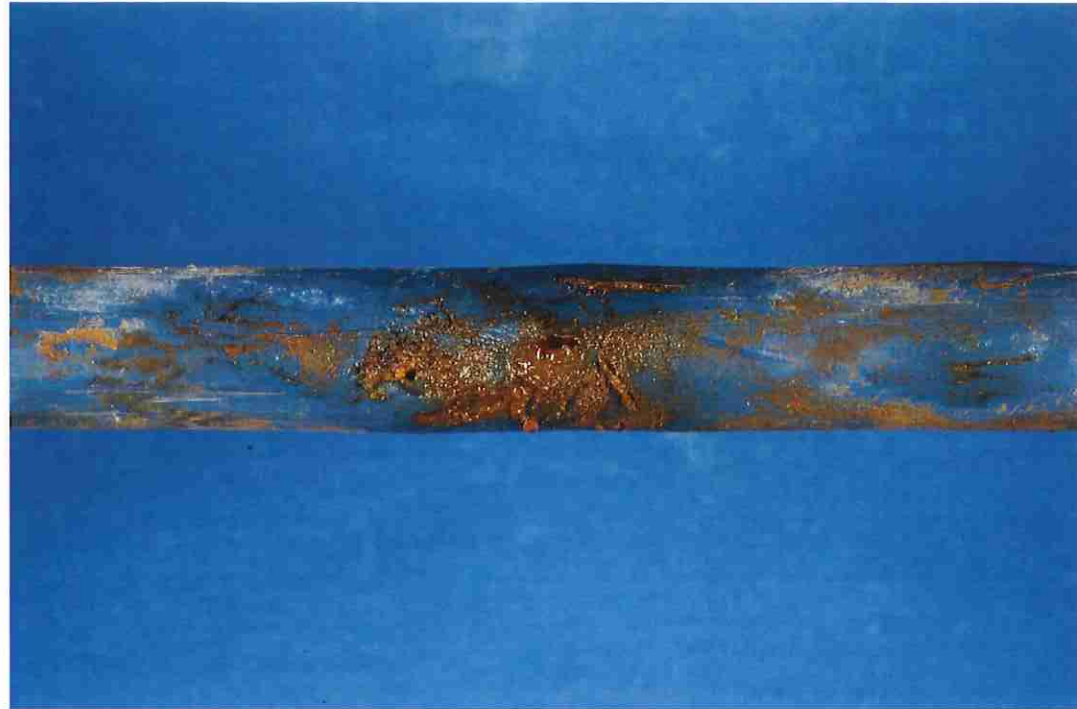
Figure 1. View of a portion of strand #1 identified as “L6 South E Centerline” at a location of damage to the polyethylene (PE) sheath where iron corrosion product stained grease is visible. L3607 093011 01

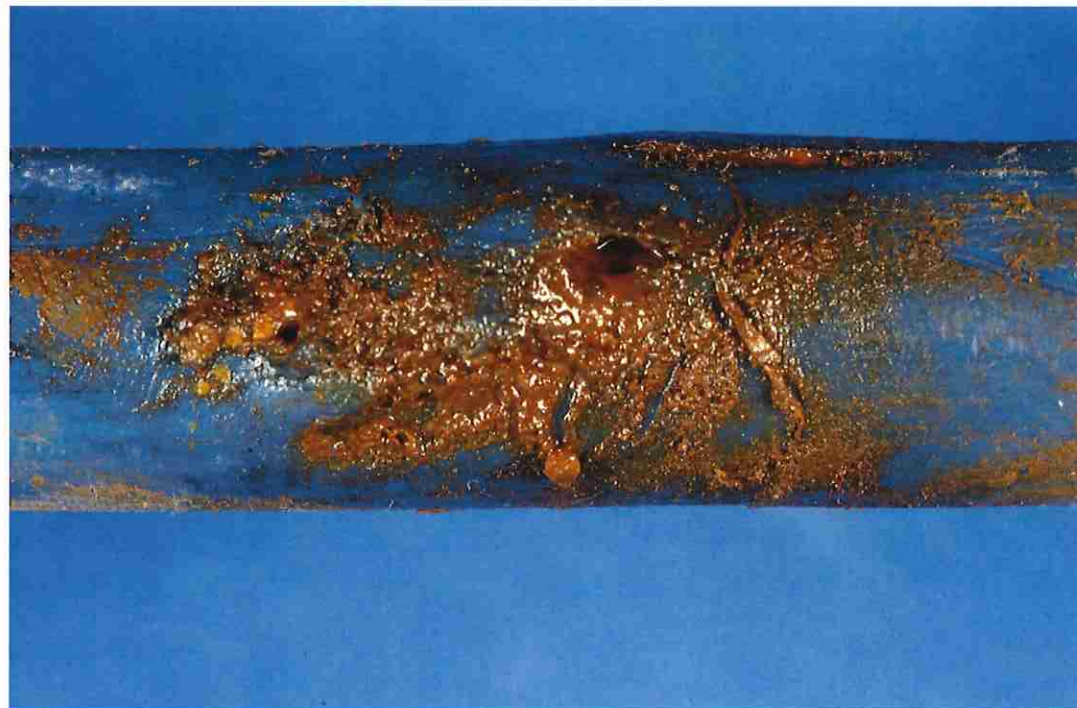
Figure 2. Close view of location shown in Figure 1. L3607 093011 02

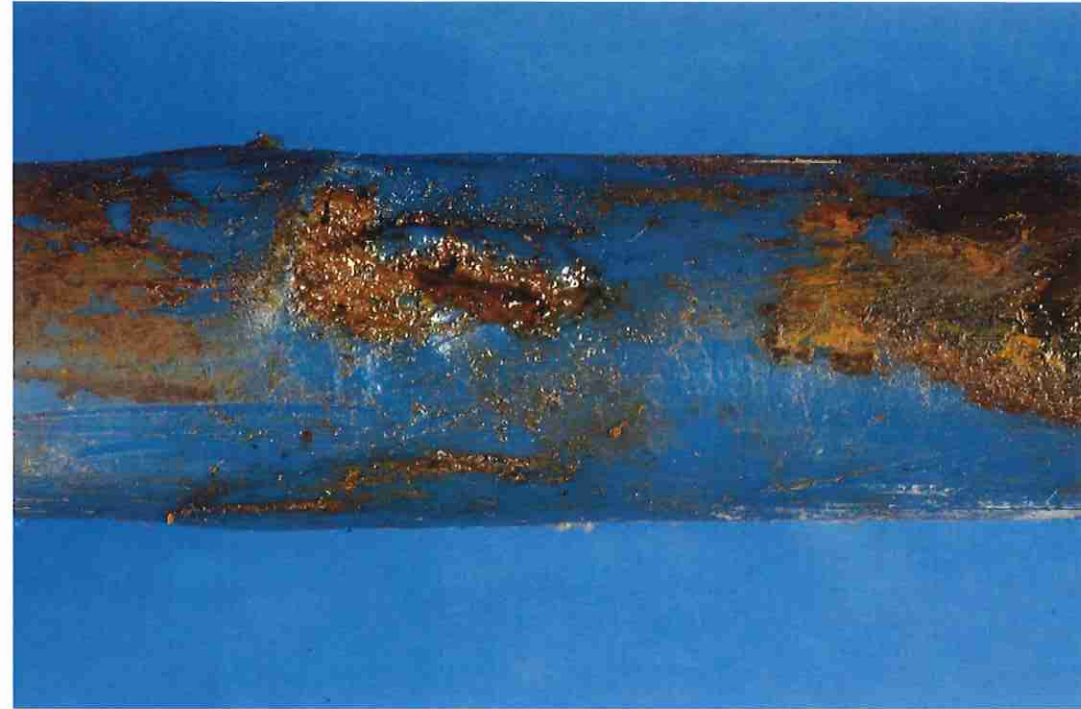
L3607 093011 03

Figure 3. Second location of many on strand #1 showing evidence of sheath damage.

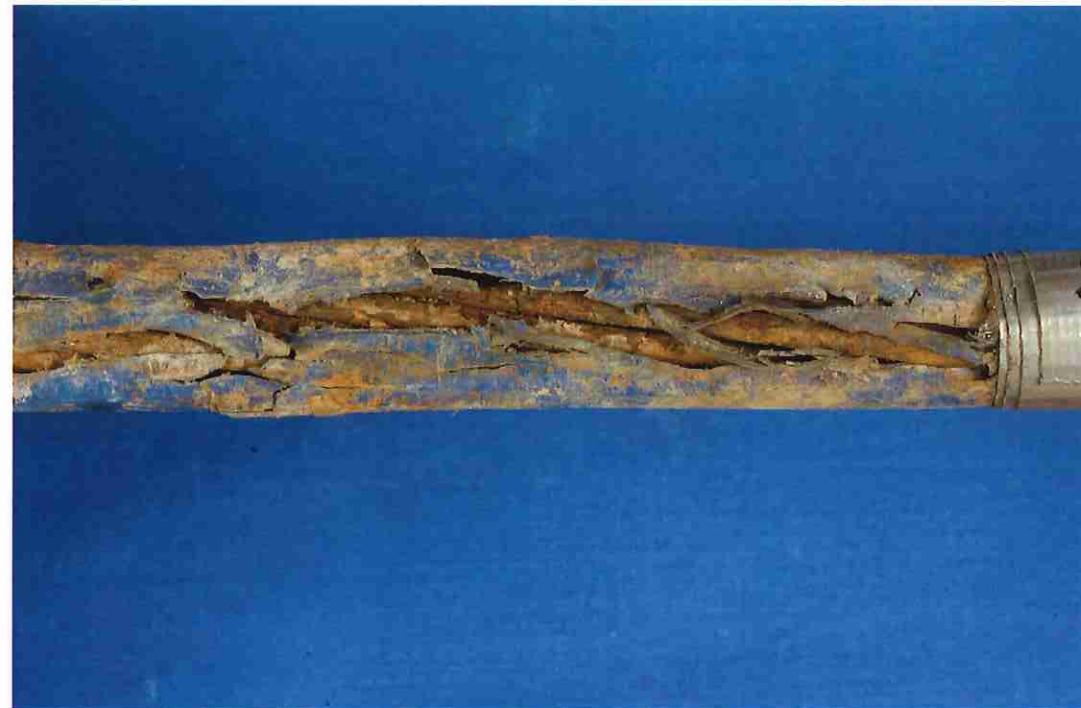
Figure 4. Severely damaged PE sheathing and visibly corroded strand wire on strand #2. L3607 093011 04

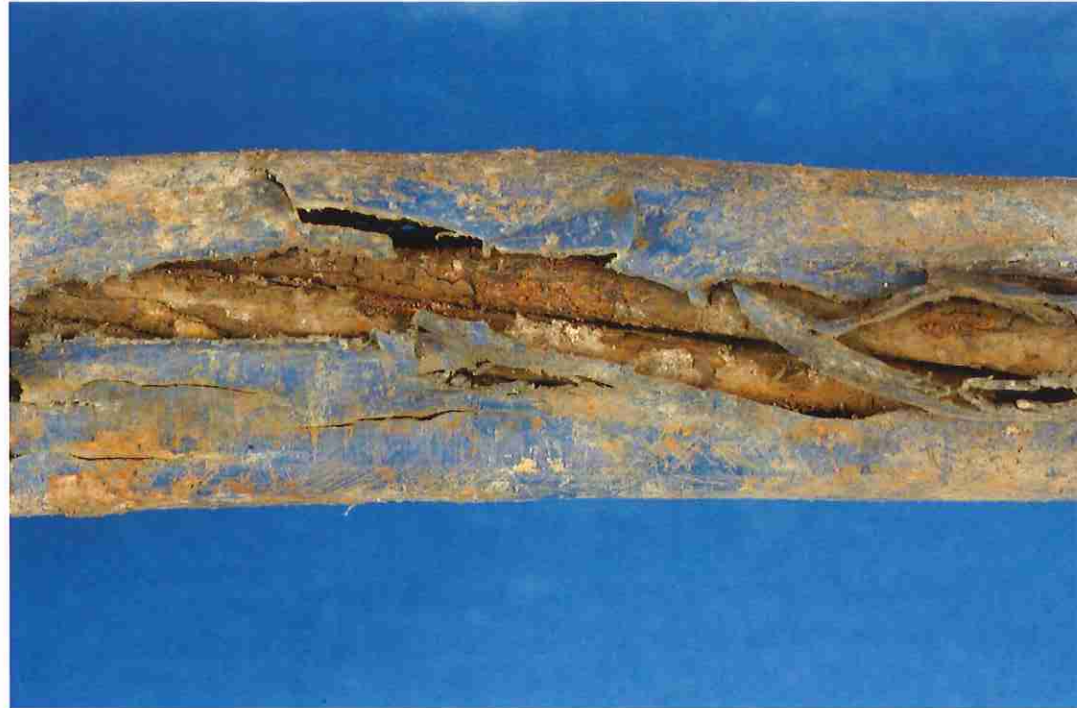
Figure 5. Close view of location shown in Figure 4. L3607 093011 05

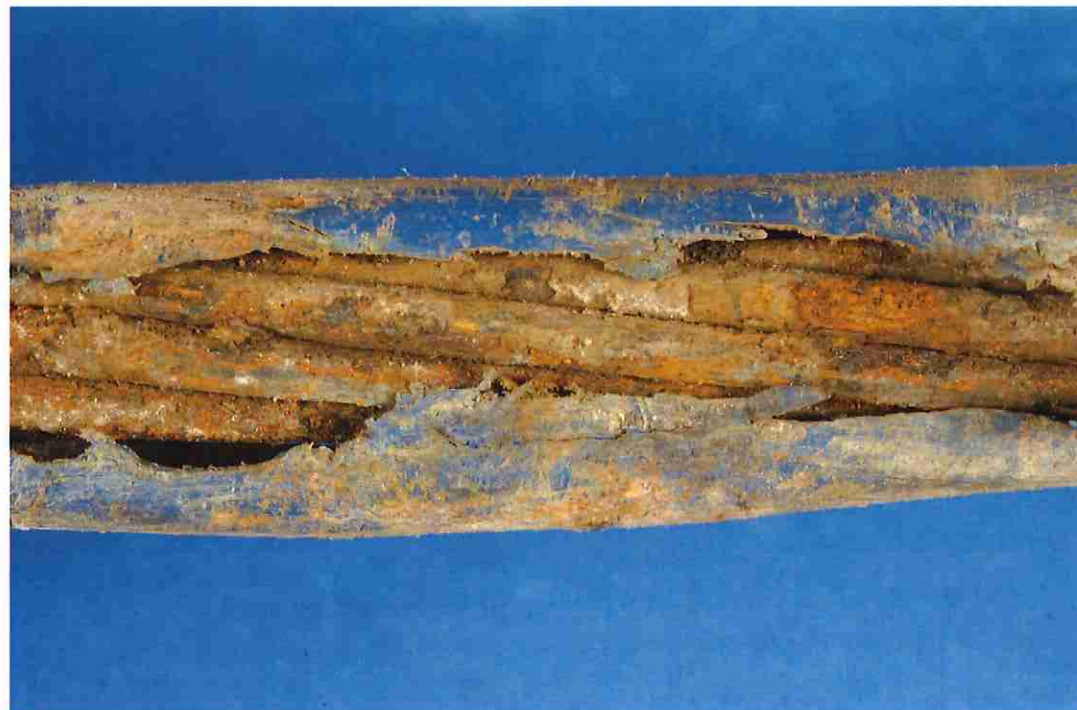
L3607 093011 06

Figure 6. Second location of sheath damage and strand wire corrosion on strand #2.

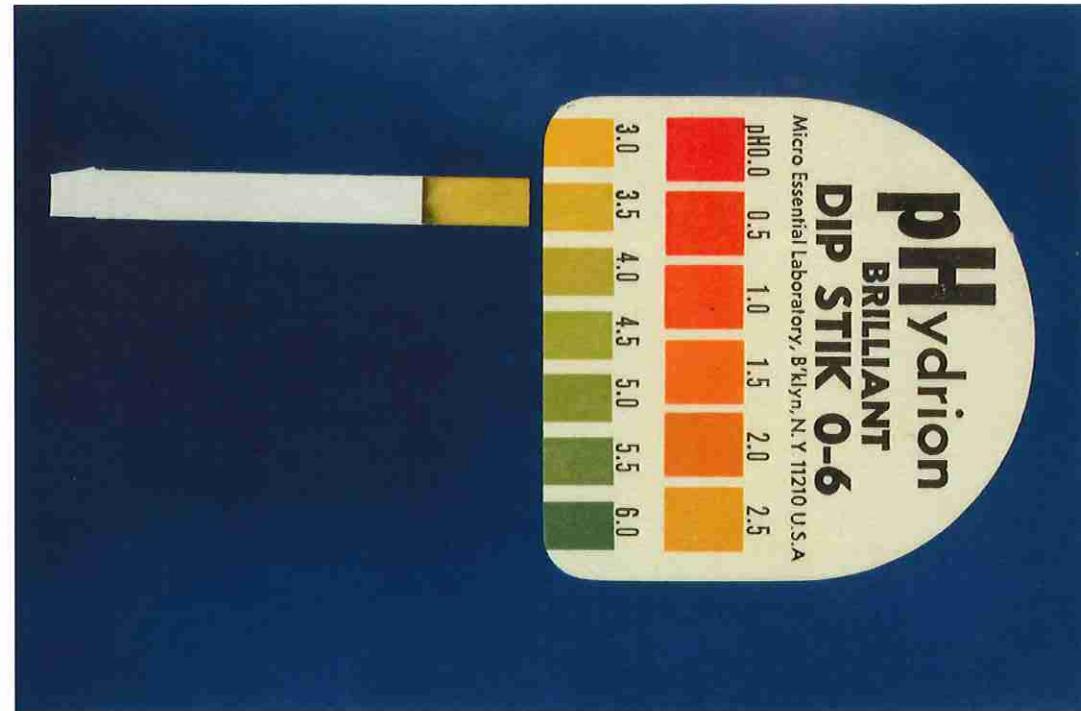
Figure 7. pH indication of 3.5 obtained on water sample prepared by mixing distilled water with finely ground corrosion products on strand #2. L3607 093011 07

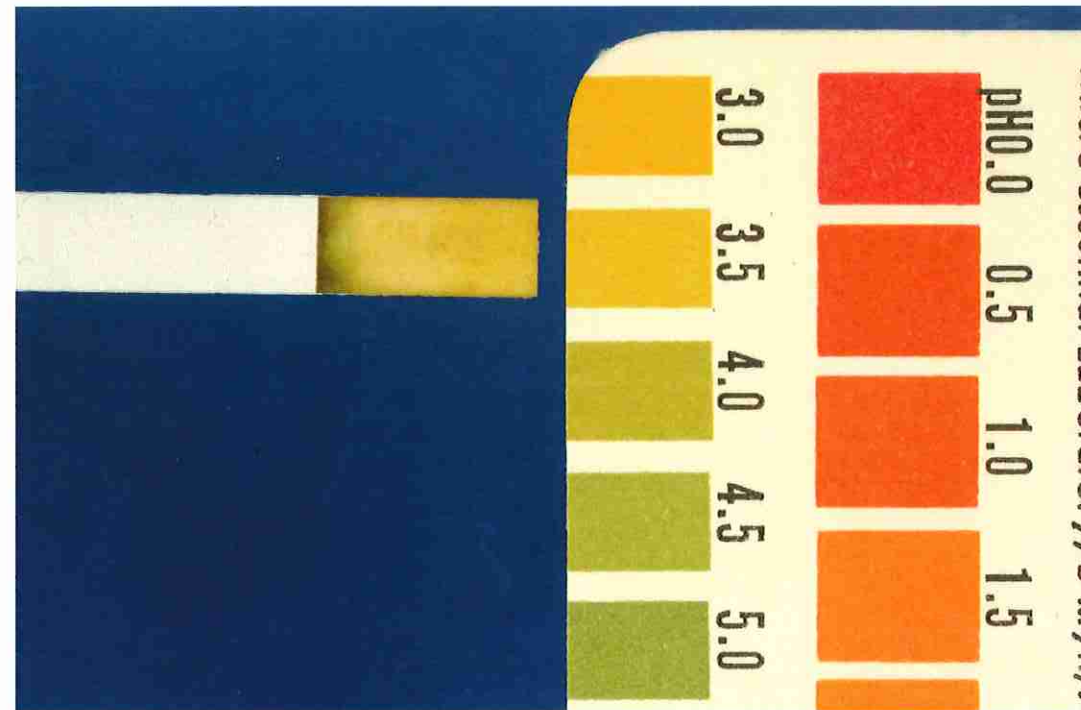
Figure 8. Close image of pH indicating paper and color scale shown in Figure 7. L3607 093011 08

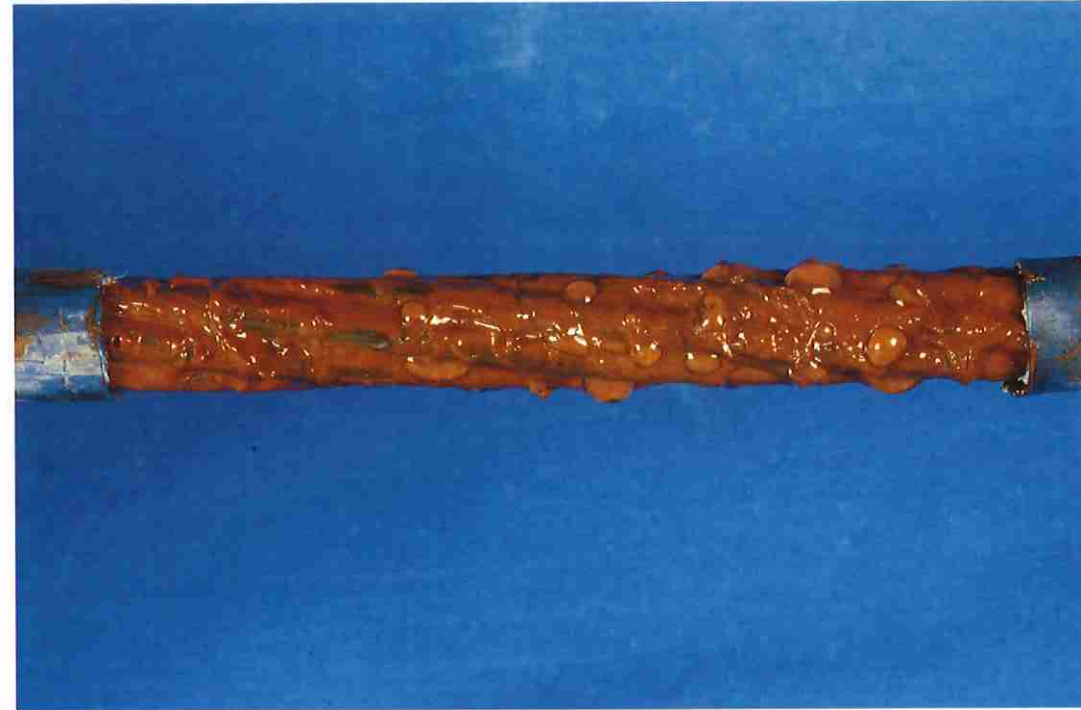
Figure 9. Section of sheathing removed on strand #1 where distilled water has been dripped onto the orange stained grease. L3607 093011 09

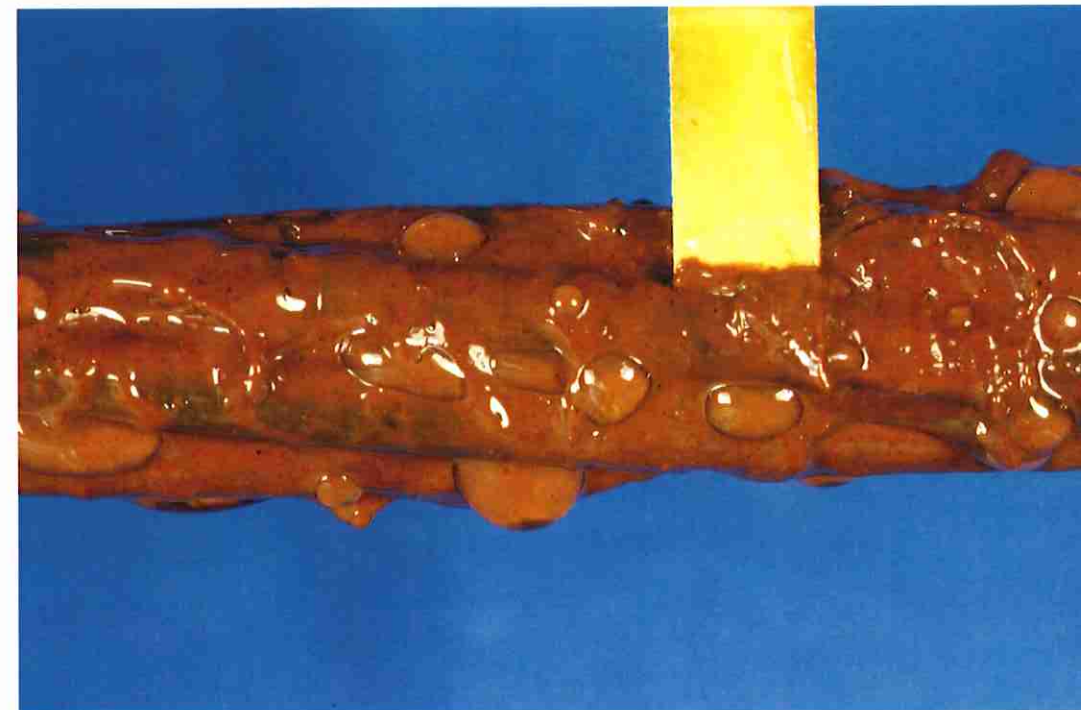
L3607 093011 10

Figure 10. pH indicator strip placed in contact with wetted grease; color reaction indicates a pH of 3.5 when compared to color scale in Figure 7.

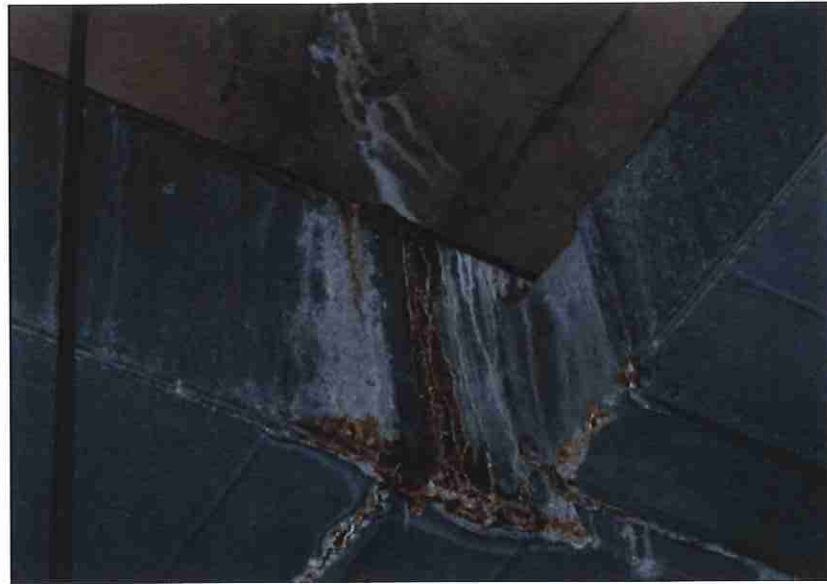
PHOTO 1 Parking Level P3

The majority of the exhaust ductwork within the parking garage is in fair condition; however, a small section of exhaust ductwork on Parking Level P3 is beginning to corrode. Otherwise the majority of the ventilation system remains largely unchanged and the existing Scope of Work requires little modification.

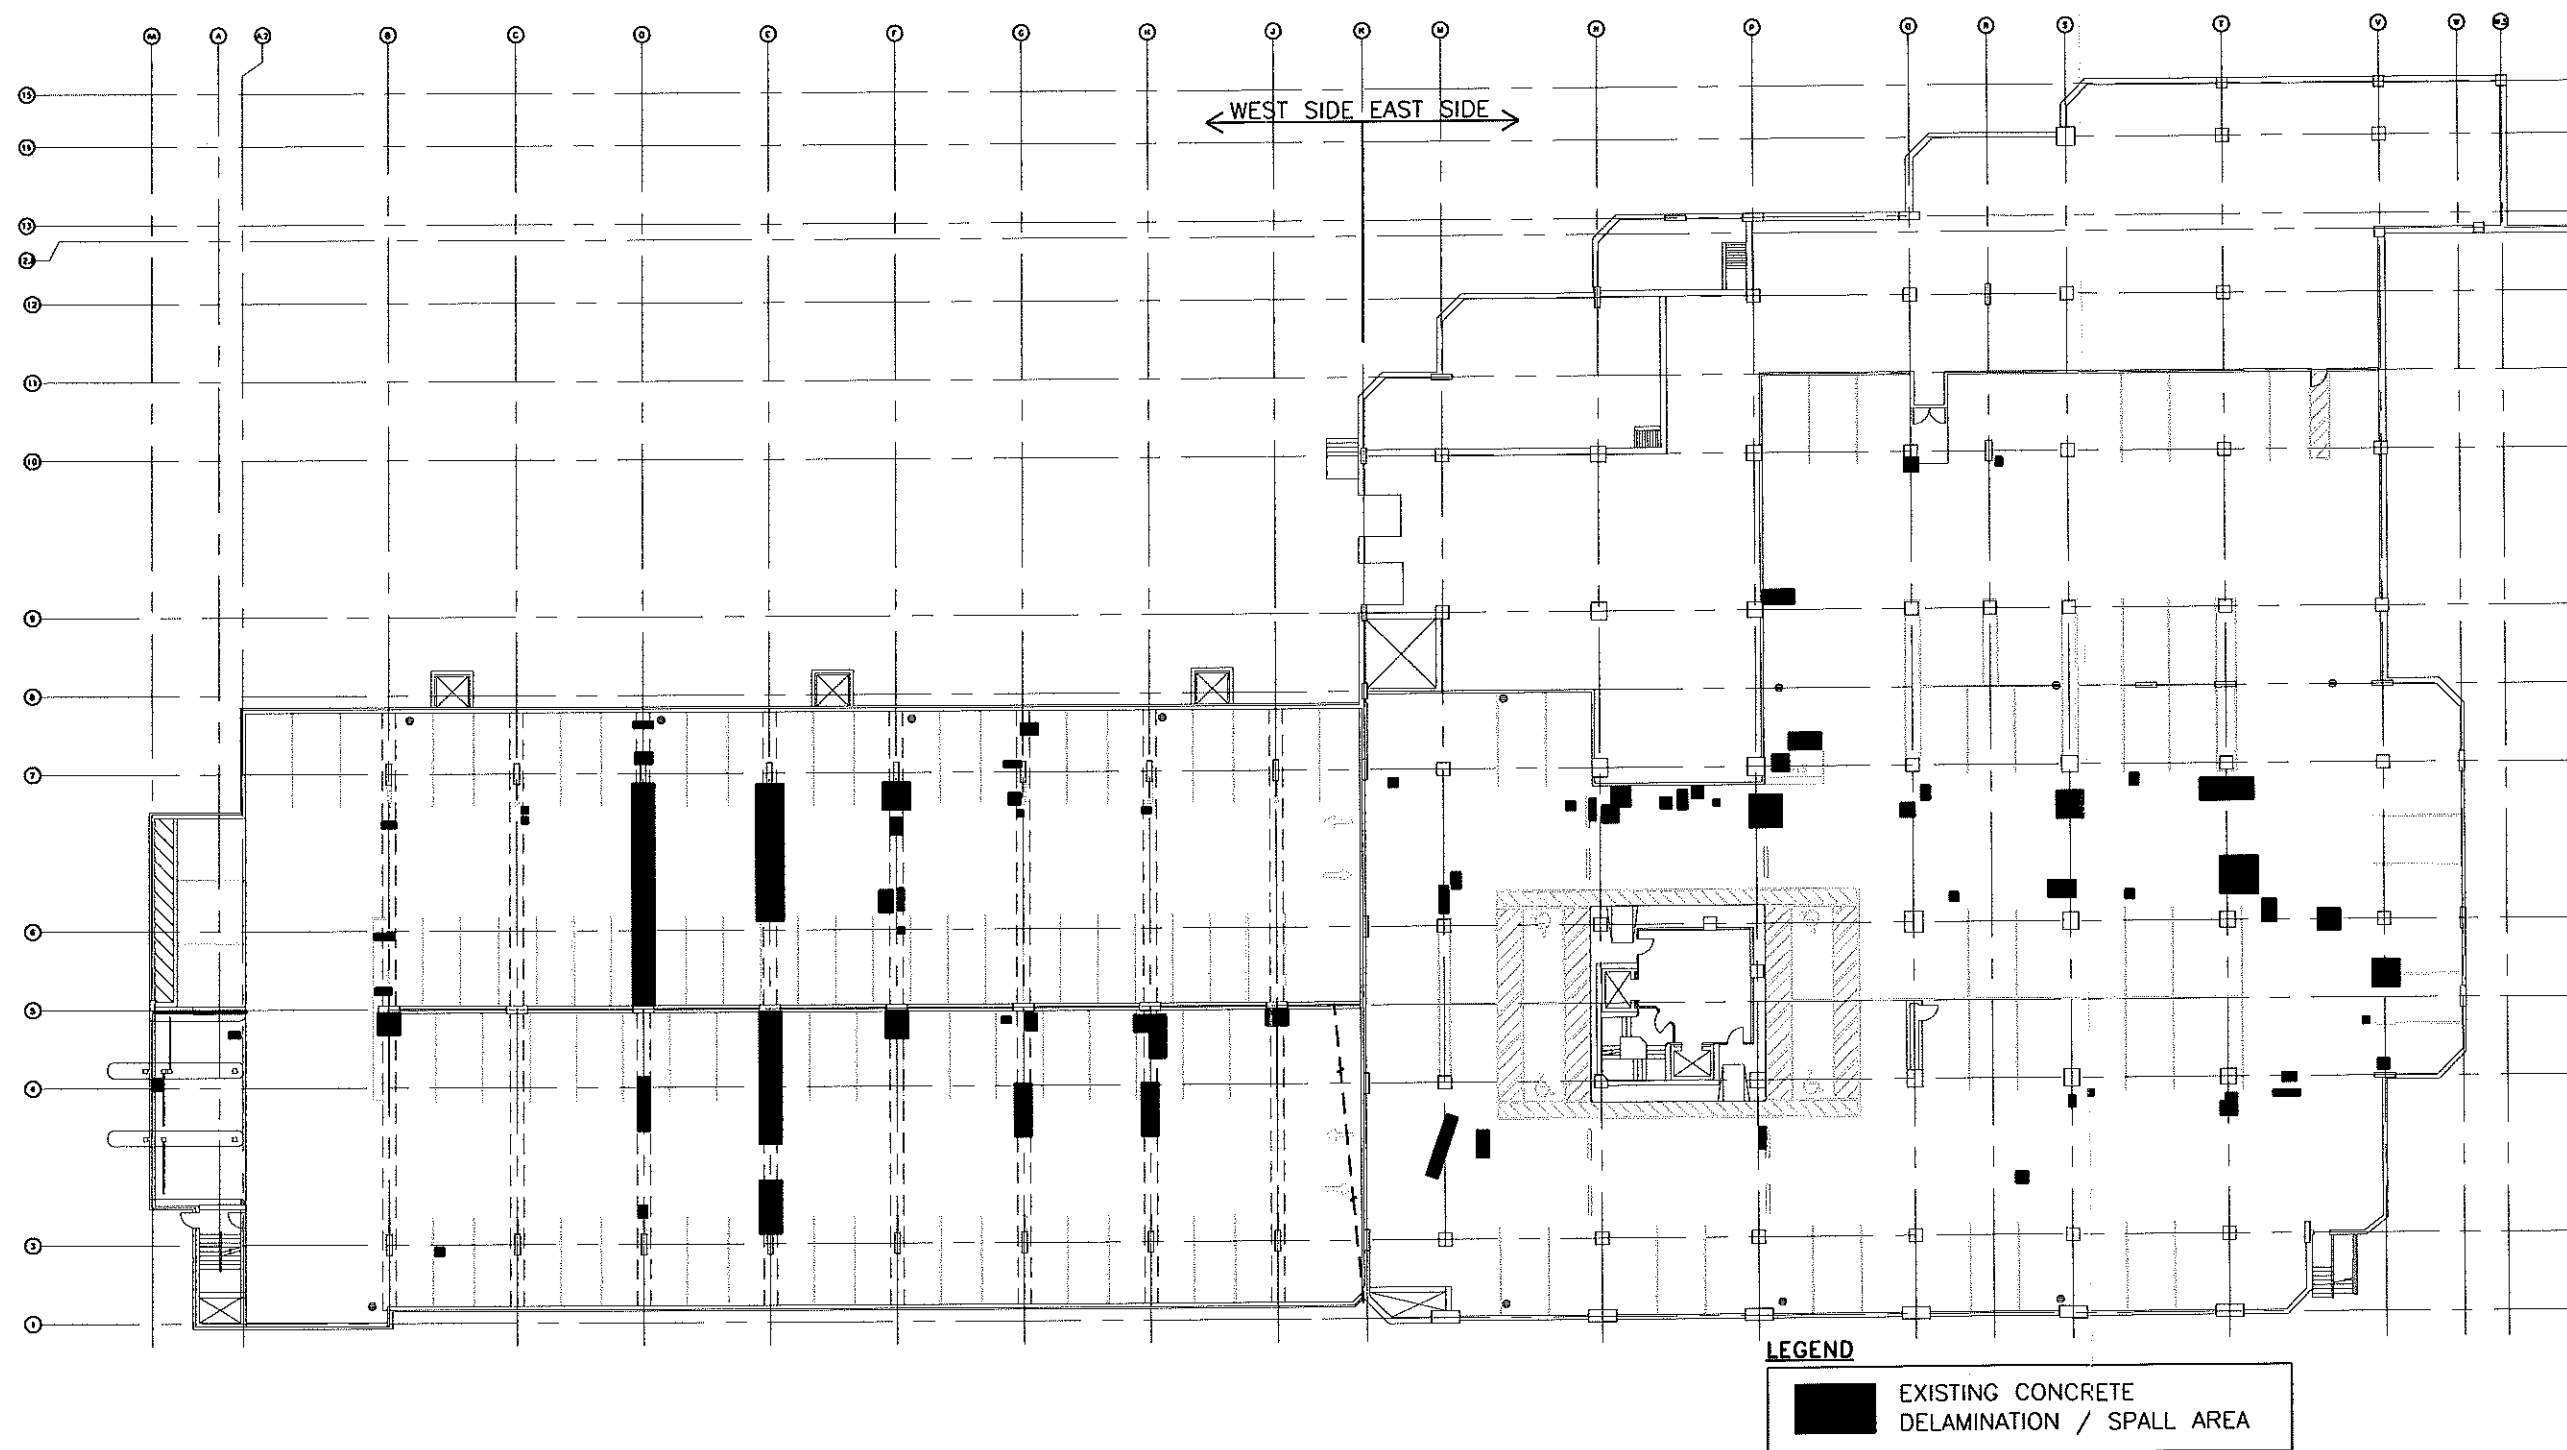
2 **PARKING LEVEL P2 - 2006 DECK LAMINATION SURVEY**
SCALE: 1/32" = 1'-0"

A sounding [lamination] survey was conducted to determine the extent to which laminations in the deck have either grown or multiplied since a sounding survey was last conducted at the garage 5 years ago. This sounding survey consisted of dragging heavy chain over the concrete deck surface and listening for hollow sounds indicative of corrosion induced lamination of the concrete. Based upon this more recent survey, detectable laminations have increased from 4,100 SF in September of 2006 to 17,300 SF in September of 2011. This is an alarming increase of over 320% in measurable deterioration within a 5 year period. Please refer to the Drawings section of this report for drawings showing the extent of laminations detected during the 2006 and current surveys. Both are provided to graphically demonstrate the magnitude of increase in deterioration to the garage.
