**Summary Report
Condition Reassessment and
Post Tension Strand Evaluation
25 Sigourney Street
Hartford, Connecticut**

**DCS Project No. BI-2B-034A
Architects Project No. 206063**

13 October 2011

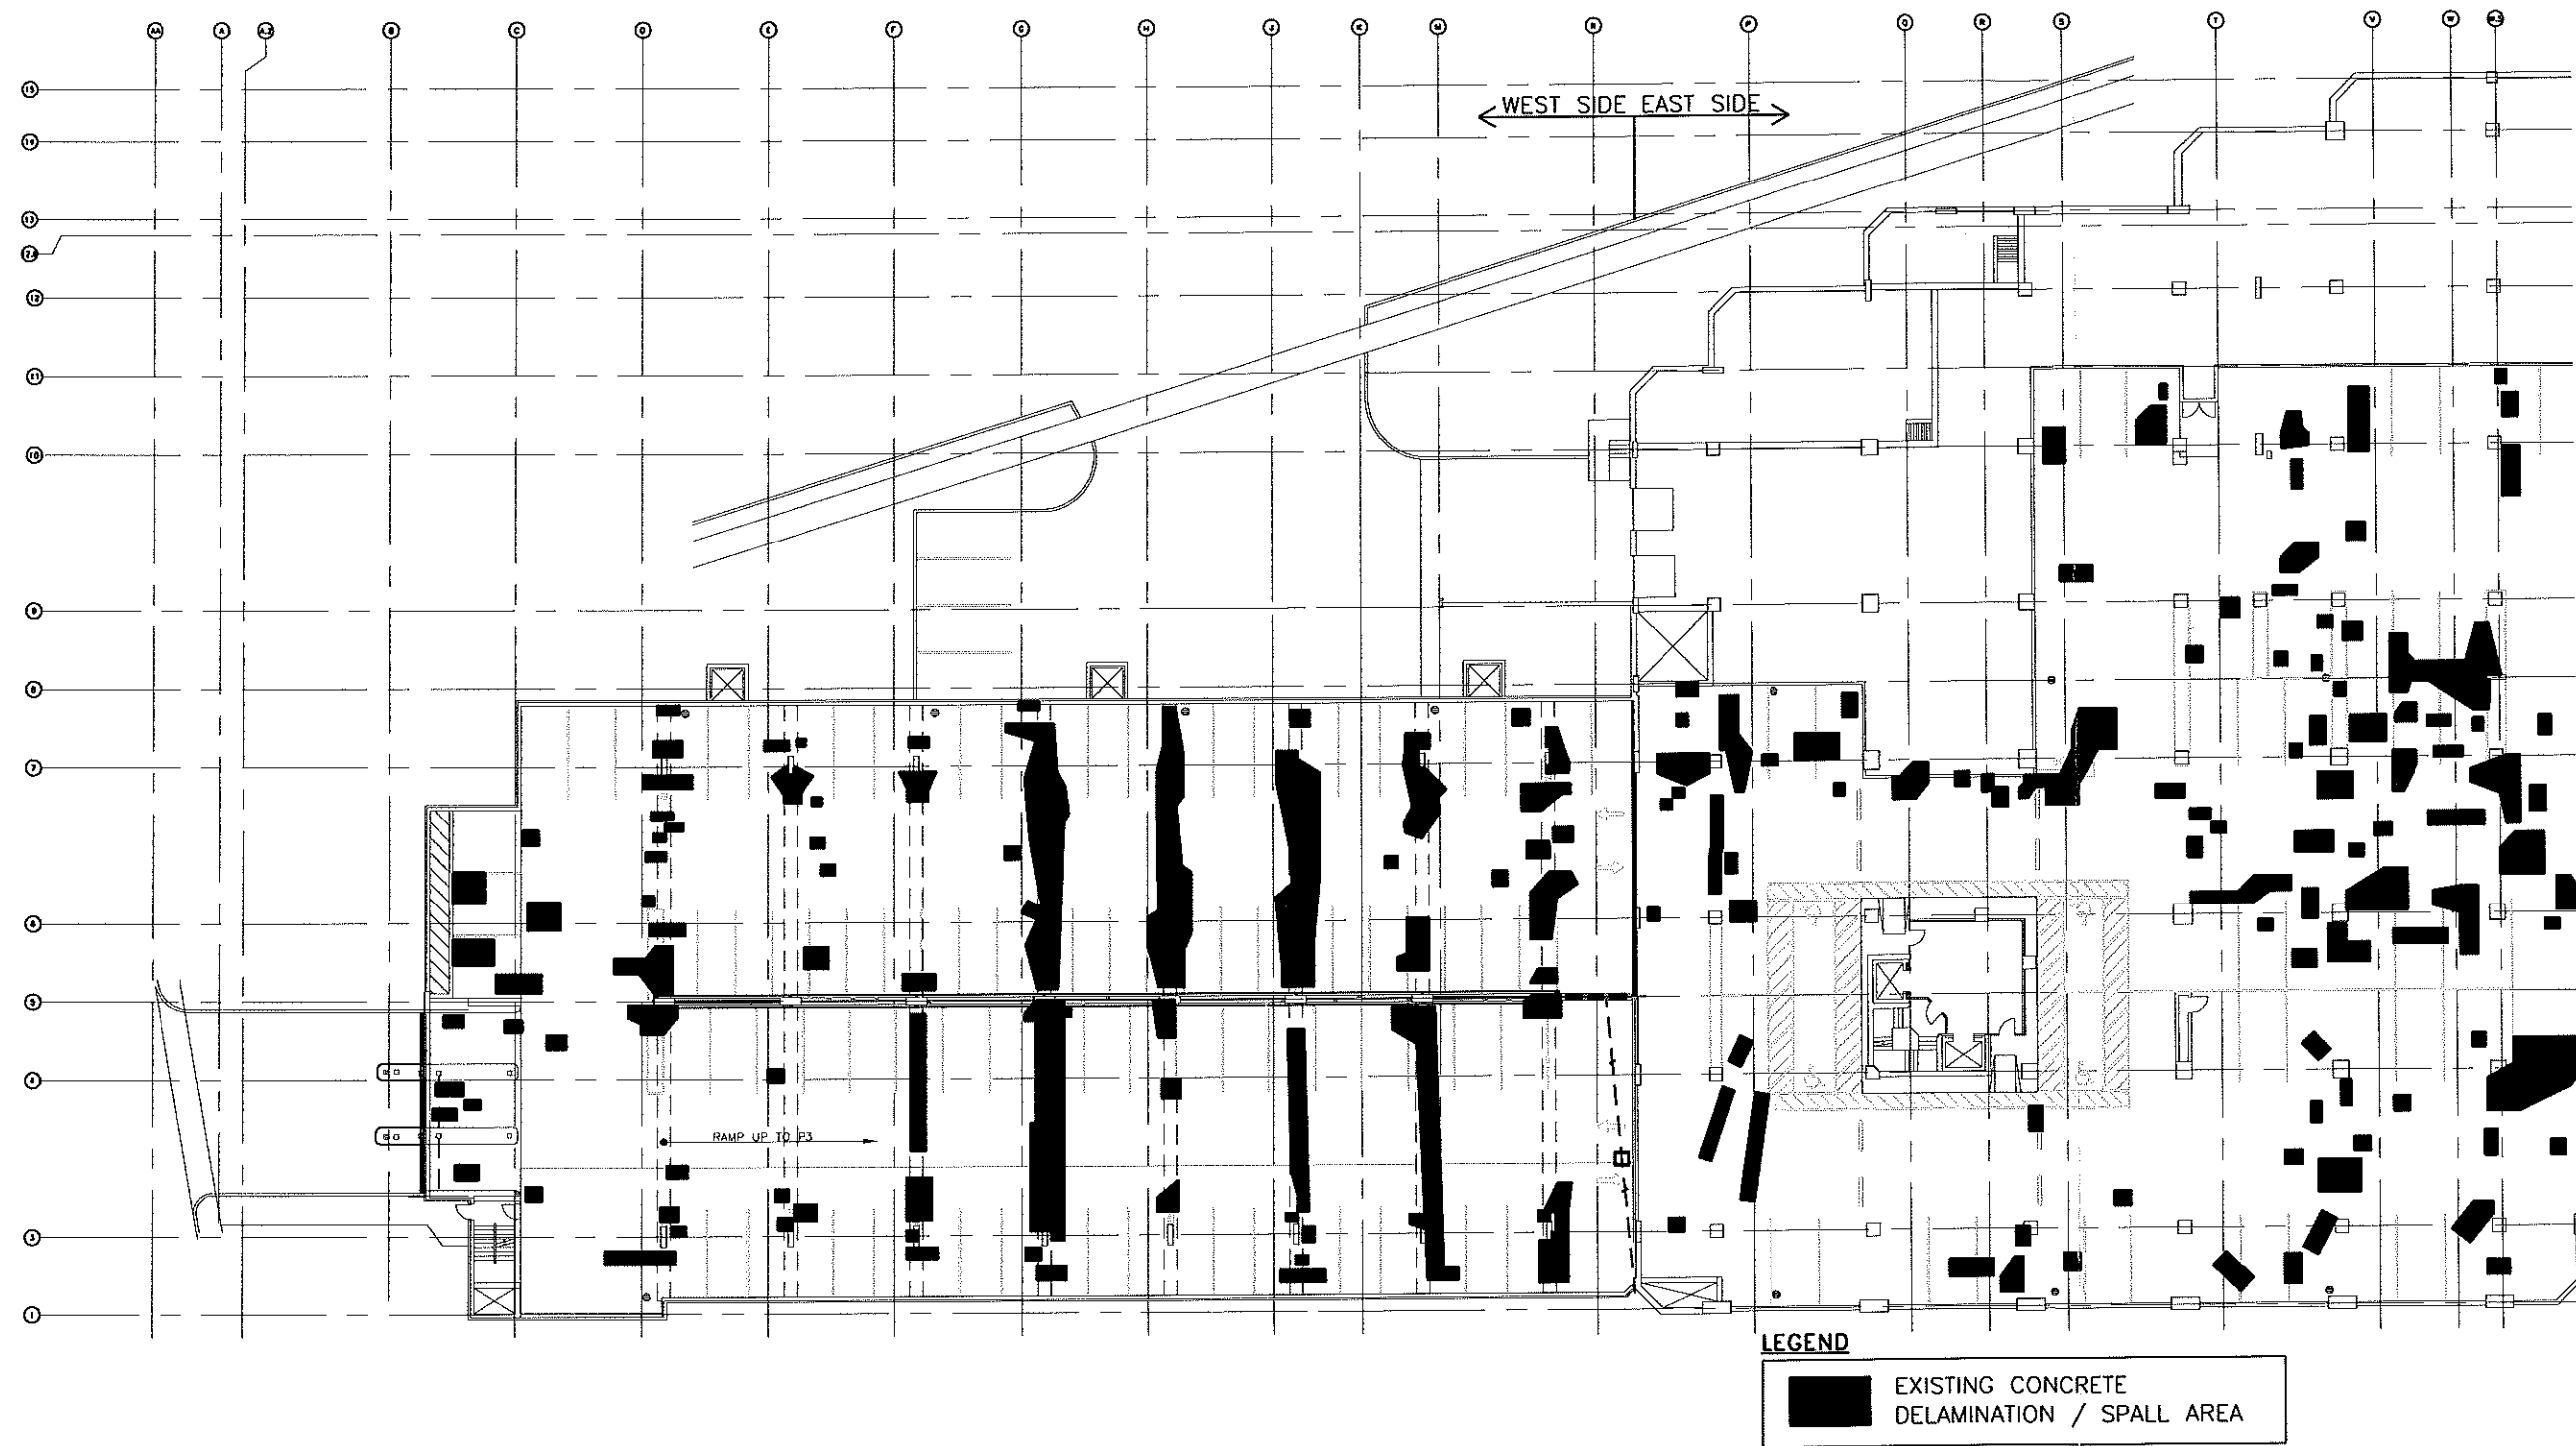
2 **PARKING LEVEL P2 - 2011 DECK LAMINATION SURVEY**
SCALE: 1/32" = 1'-0"

A sounding [lamination] survey was conducted to determine the extent to which laminations in the deck have either grown or multiplied since a sounding survey was last conducted at the garage 5 years ago. This sounding survey consisted of dragging heavy chain over the concrete deck surface and listening for hollow sounds indicative of corrosion induced lamination of the concrete. Based upon this more recent survey, detectable laminations have increased from 4,100 SF in September of 2006 to 17,300 SF in September of 2011. This is an alarming increase of over 320% in measurable deterioration within a 5 year period. Please refer to the Drawings section of this report for drawings showing the extent of laminations detected during the 2006 and current surveys. Both are provided to graphically demonstrate the magnitude of increase in deterioration to the garage.
