Flashing, Lintels and Sealant Investigation Report

For
25 Sigourney Street
Hartford, CT 06106
DPW Project Number B1-2B-033L

Prepared For
STATE OF CONNECTICUT
Department of Public Works

June 26, 2009

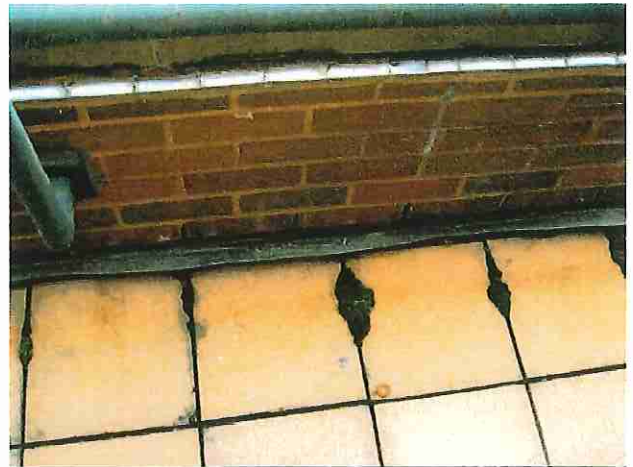
Damaged Thru-Wall Flashing (typical)

4. The thru-wall flashing is in poor shape. It is bent, distorted and starting to fail in several locations. The flashing has come to the end of its useful life and is begin to fail around the building. It is our recommendation to remove bricks at the flashings on the interior side of the parapets and replace flashing at the parapets that are currently leaking. We anticipate that in the future other similarly structured balconies around the building will begin to fail and the flashing will need to be replaced. For the time being we recommend replacing it on a as-needed, case by case basis rather than a complete reconstruction of the balconies (most of which are performing well), which would be expensive, replacing flashing in areas that have not yet, nor may ever fail.

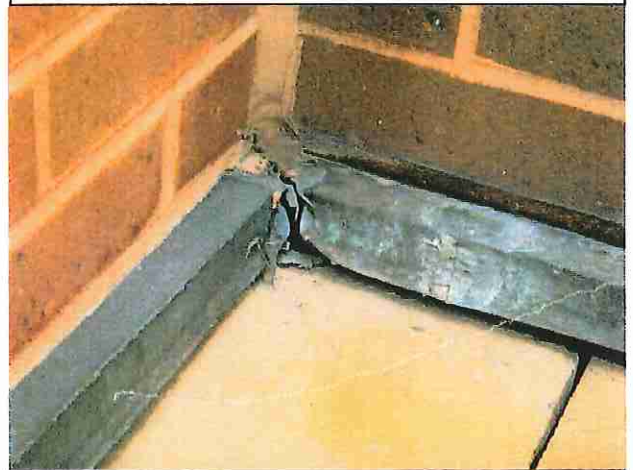
Excessive Sealant and Damaged Flashing

5. The application of excessive sealant over other generations of sealant should be stopped, and any repairs by contractors should be clearly communicated before the work begins and then thoroughly inspected after repairs are completed. Sealants should be installed in accordance with the manufacturer's recommendations which have not been the case in the current over-application of sealant. In most cases, manufacturers require the raking and removal of failed sealants, the chemical cleaning of the masonry joint and the application of a sealant primer before installing the backer rod and sealant.

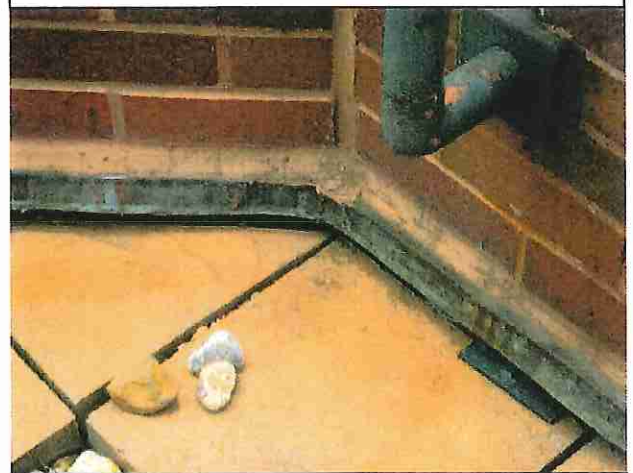
Sealant Covering Weep Holes

1. All failing sealant at balcony parapets should be scraped out and reapplied, making sure restore existing weep hole openings and to cut-in supplemental weep holes every 24 inches just above the thru-wall flashing at the base of the parapet walls.

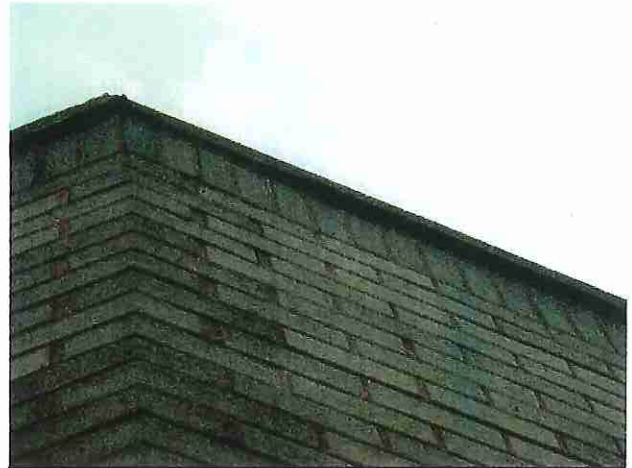
Failing Mortar Joints

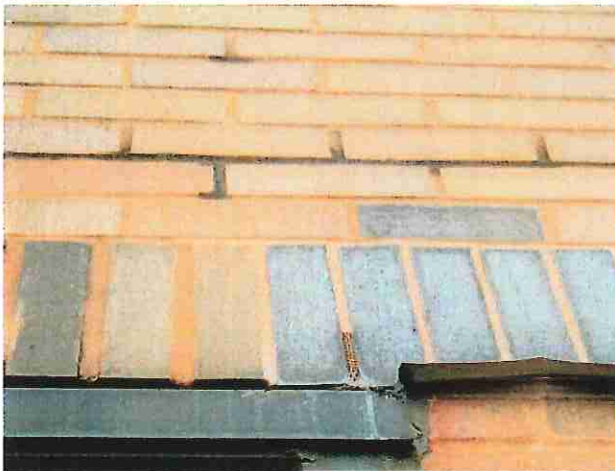
Moisture trapped in wall not coming out weeps

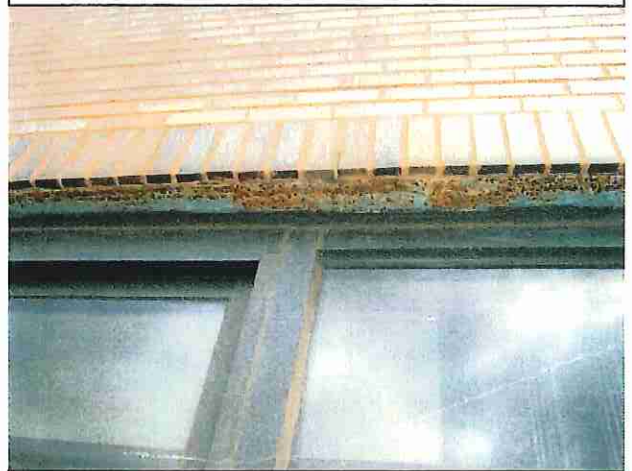
Rusted Lintel

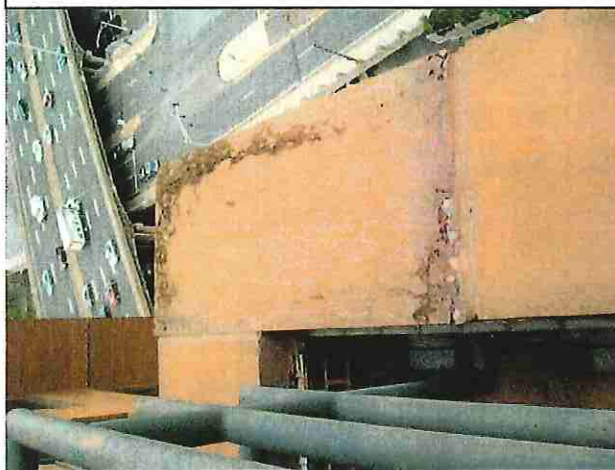
Cracking Capstone

2. All damaged capstones should be removed and replaced and all the balcony pavers should be lifted and moss and plant growth should be cleared from the balconies.

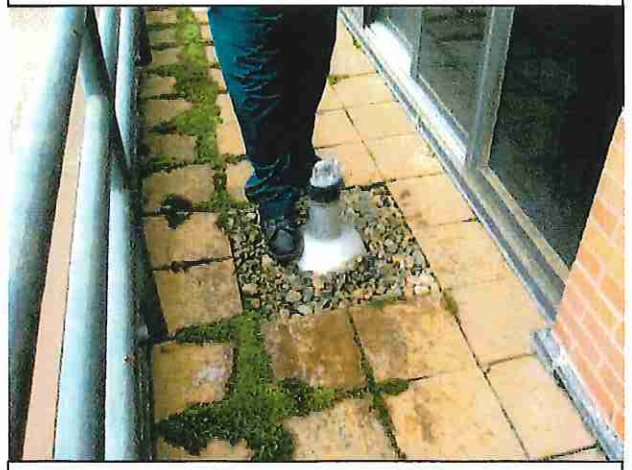
Moss growth / Water Infiltrating scaffolding Anchor Points
