**Study for Outside Air Quantity
25 Sigourney Street
Hartford, Connecticut**

Final Report

August 21, 2006

**State of Connecticut
Department of Public Works
Project Number BI-2B-033 J**

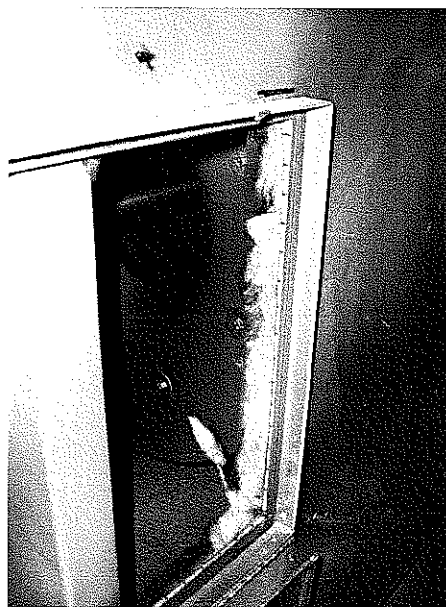
Figure 1 - Air handling unit with failing insulation

insulation within the air handling unit had worn away or fallen off. The existing internal insulation on all units is being replaced and should be complete at the time of the issue of this report.

A likely cause of moisture penetration on the former internal casing of the air handling unit and on fiberglass liner in the ductwork just downstream of the fan is moisture carryover due to a high velocity at the cooling coil. As the moisture condenses on the cooling coil, it drips down the coil and collects in the drain pan. As the velocity increases at the coil, the likelihood that the drops of condensation will be pulled into the airstream increases. Standard design typically limits the face velocity at the coil to 500-550 feet per minute. According to the most recent test report (July 14, 2005 – Wing’s Testing and Balancing), the velocity at design conditions was 760 feet per minute on the typical floors. This velocity is not unusual with limited mechanical space, which is the case with this building.

Moisture carryover can be reduced with larger air handling units (or larger cooling coil face area), by installing moisture eliminators downstream of the cooling coil, or dehumidifying the outside air. The first two options require new air handling equipment in limited mechanical space. The dehumidification unit would have to be sized for economizer operation at 100,000 cfm (to match the original design and maximize the energy-saving capabilities of the system, which is limited by the existing outside air shaft sizes). A dehumidification unit would also reduce the possibility of moisture migration through the walls of the outside air shafts.

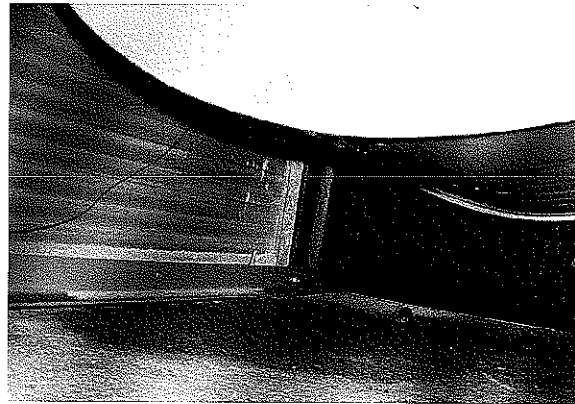
The existing air handling units utilize the floor of the fan section to drain condensate. With the exception of the 19th floor unit (in the penthouse mechanical room), each unit was only drained from one side. The opposite sides of the units were inaccessible and the drain connection was capped. It was not possible to see if all of the bases were sloped to one side, but the floors of the units were not uniformly flat due to their age; the surfaces lent themselves to condensate ponding.

During the time of our survey, the units were in the process of being cleaned and re-insulated and the drain section was being coated with an anti-microbial coating. This process will be complete for all air handling units by the time the final report is submitted. Finished units were clean and in better condition than units that had not been serviced. Internal fiberglass insulation was loose on the unfinished units and the floors of the units in the fan section were corroded and in poor condition in most cases.

Figure 2 - Existing drain pan before refurbishment

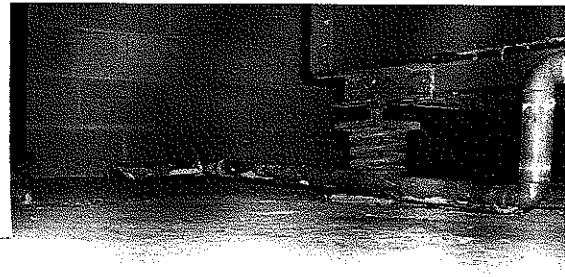
The condensate traps appeared to be properly sized throughout. Condensate discharge piping on many units needed to be adequately secured to the floor to maintain pitch.

Figure 3 - Condensate drain piping pitched away from drain

- Initiate a preventative maintenance program to assure that all existing condensate drain piping is properly pitched and draining on existing units until new units are installed.

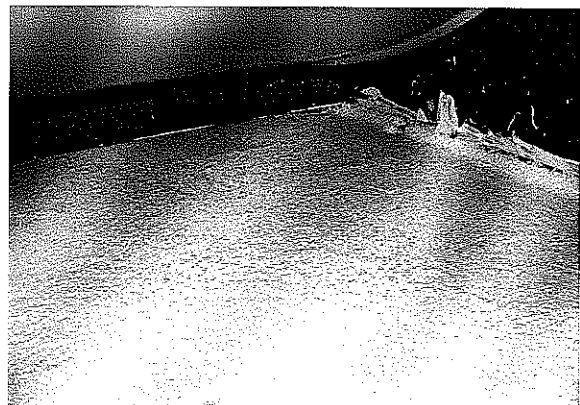
Figure 4 - Refurbished air handling unit floor

The new coating appears to have improved the condition of the floor, but proper pitch inside the unit cannot be verified or corrected because of the drainage arrangement. Since the unit is equipped with two drain connections and only one is connected on most units, it is possible that the floor is not draining properly in all cases. As part of preventative maintenance, pitch of discharge piping should be examined periodically and corrected, if necessary. Additionally, the fan section bases should be examined periodically during high humidity days to assure proper drainage. The units are nearing the end of their expected useful life and should be considered for replacement with units equipped with stainless steel IAQ drain pans.
