**WALKER**  
RESTORATION CONSULTANTS

August 27, 2010

Re: *Condition Appraisal Report*  
*25 Sigourney Street Parking Garage*  
*Hartford, Connecticut*

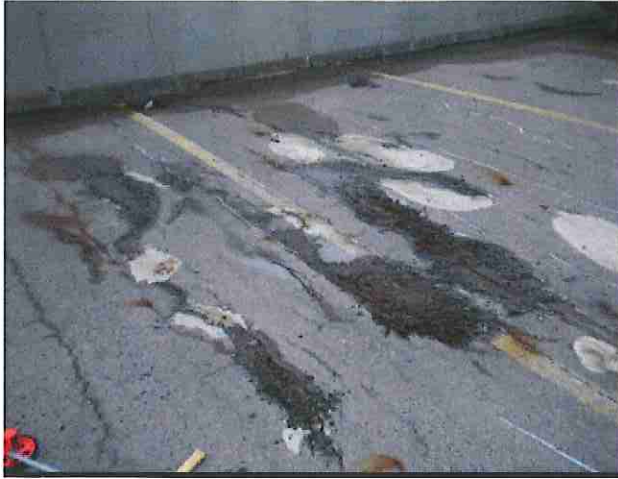
On the post-tensioned west side garage, corrosion induced spalls and delaminations occur in the supported floors primarily over the tops of the concrete beams. At these locations mild steel reinforcing is installed in the slab to supplement the post-tensioning system. Based on visual observations the concrete cover over this steel reinforcing is minimal (<1"), which limits the natural protection concrete gives the reinforcing and makes the steel more susceptible to corrosion from the penetration of moisture and chlorides. This mild steel has corroded resulting in spalls and delaminations. On the west side garage the majority of slab deterioration occurs on the Roof Level and Level P-2.

Photo 1 Typical slab deterioration on the Roof Level

- ✓ Conduct full and partial depth patching to the supported concrete floors – east and west garage;
- ✓ Inject or gravity feed full depth cracks in the supported concrete floors;
- ✓ Repair broken P/T cables and repair damaged cable sheathing (Further investigation of the P/T system must be carried out prior to undertaking a restoration program)
- ✓ Conduct partial depth overhead patching to the underside of the east garage concrete floors.

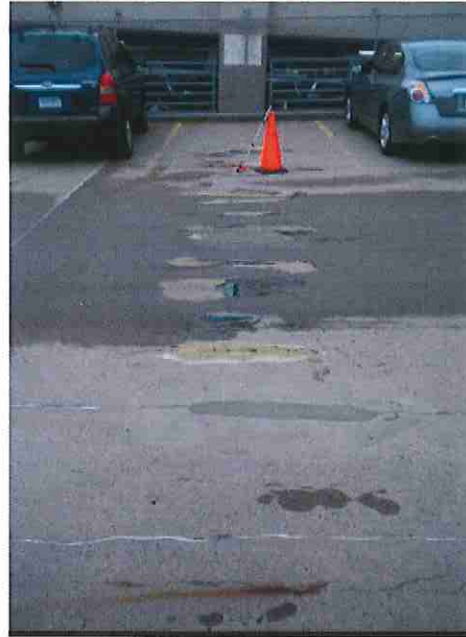
Photo 2 Typical slab deterioration over concrete beams.

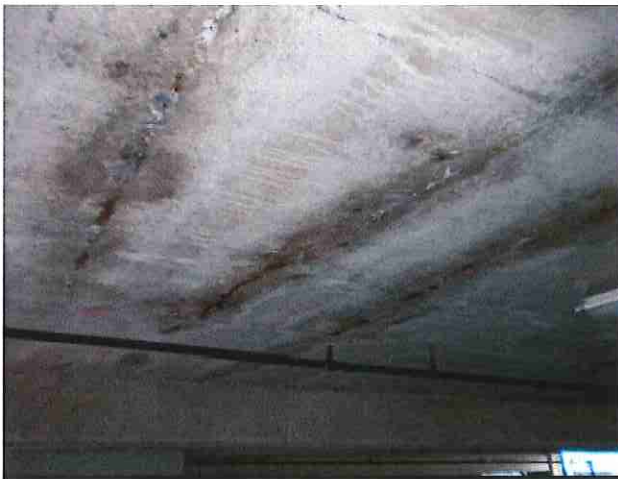
A pattern of leaking cracks was observed on the underside of the slabs running transversely to the direction of the beams and appearing generally in the vicinity of the exterior columns and cantilevered section on both the north and south sides. The cracks exhibited leaching, rust stains and in some locations grease staining (most likely emanating from the encapsulated P/T cable). The cracks were more pronounced on the underside of the roof level, which is likely the result of the drainage profile directing run-off over these cracks. On Level P-3 a P/T cable has broken and burst through the bottom of the slab at a crack that is repeated on most of the supported floors. This may be an indication that additional hidden P/T damage is present in these cracked areas of the supported floor slabs.

Photo 3 Typical cracking in P/T slab viewed from the underside.

Prior to undertaking repairs to the west garage further engineering analysis is required to evaluate the P/T system and to determine the possible causes of the slab cracking in the cantilevered areas of the decks.

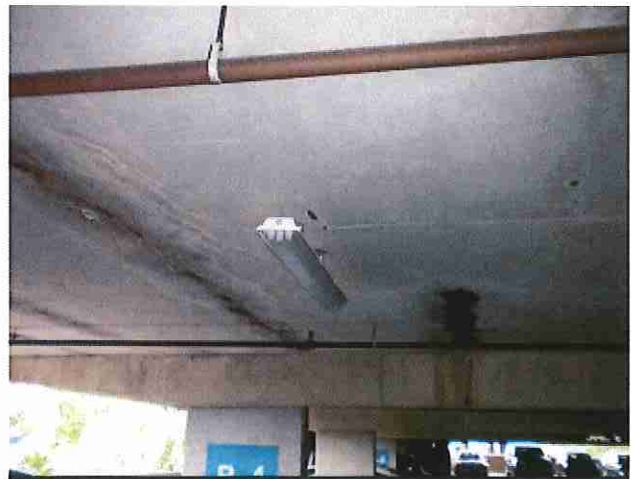
Photo 4 Typical cracking in P/T slab near cantilevered end of beam.

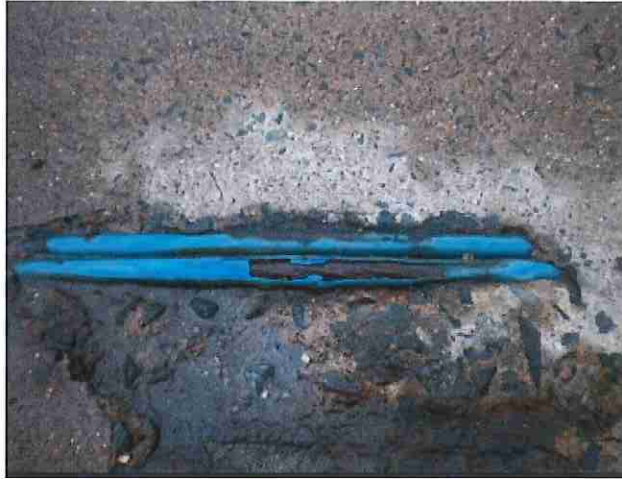
A consequence to the spalling is the cavities expose the post-tensioning cables. The majority of floor spalls have exposed P/T cables. By design the cables are covered with a protective layer of grease and a plastic or PVC sheath. The exposure of the cables has made the sheathing susceptible to damage from vehicles and in many locations the sheathing has been perforated or torn away. Several cables with damaged or missing sheathing were noted to be corroding. In addition, at approximately five spall locations we noted broken and/or released P/T cables.

Photo 5 Exposed P/T cables on the Roof Level with damaged sheathing.

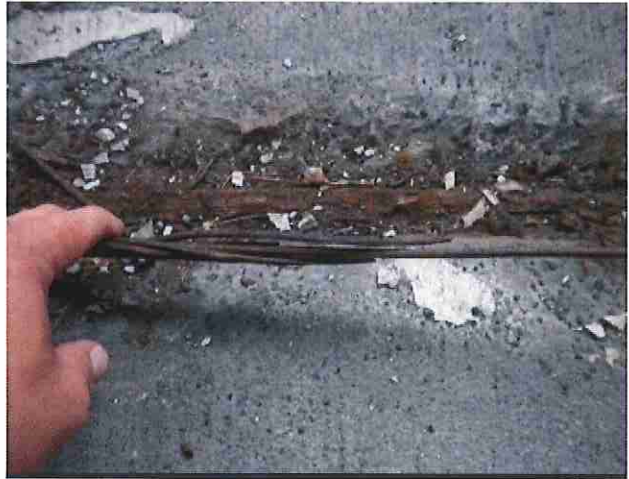
Photo 6 Broken P/T Cable at floor spall.

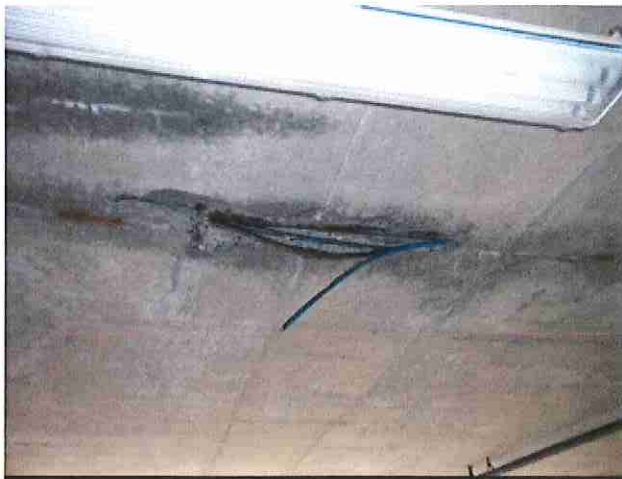
Photo 7 Broken P/T cable that has burst through the bottom of Level P-3 Slab.

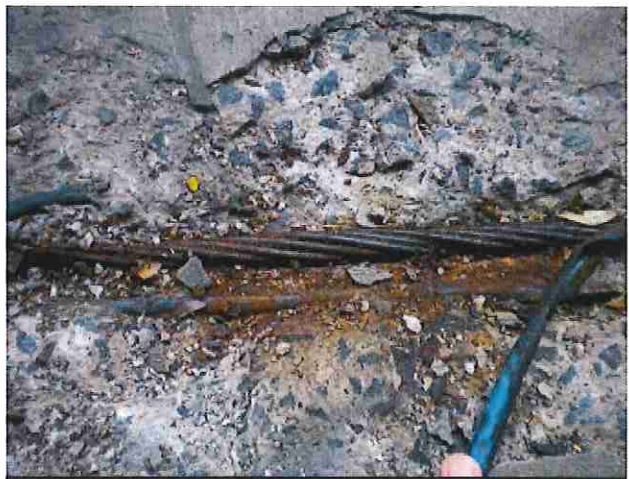
Photo 8 Exposed P/T cable with apparent separation of strands, indicative of a possible break.

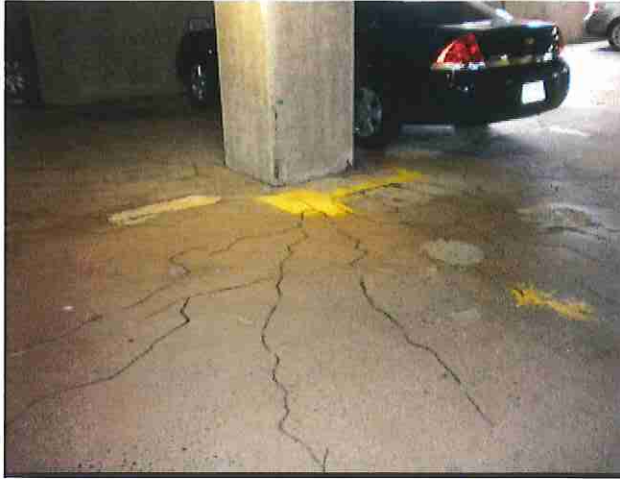
The two-way mildly reinforced floor slabs of the east side of the garage exhibit corrosion induced spalling and delaminations on both the topside and underside of the slab. On the topside of the slab the deterioration occurs primarily around the columns where the slab has a heavy concentration of reinforcing steel. On the underside of the slab the deterioration occurs primarily at construction joints where moisture has penetrated through the slab reaching the bottom layer of steel.

Photo 9 Typical sealed cracks in the East Side floor slabs.

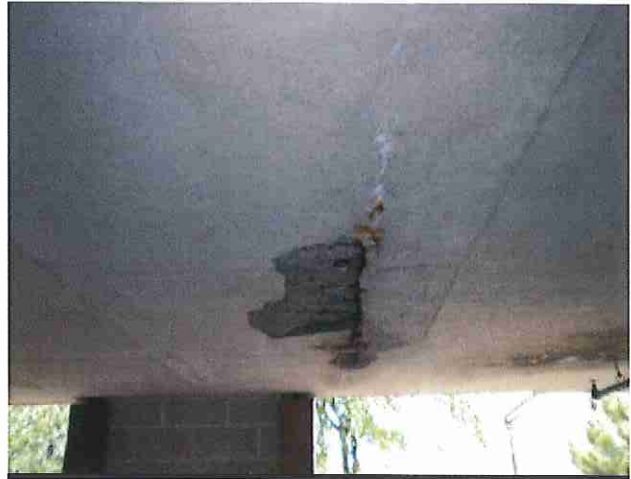
Photo 10 Spalling on the underside of the East Side Slab.

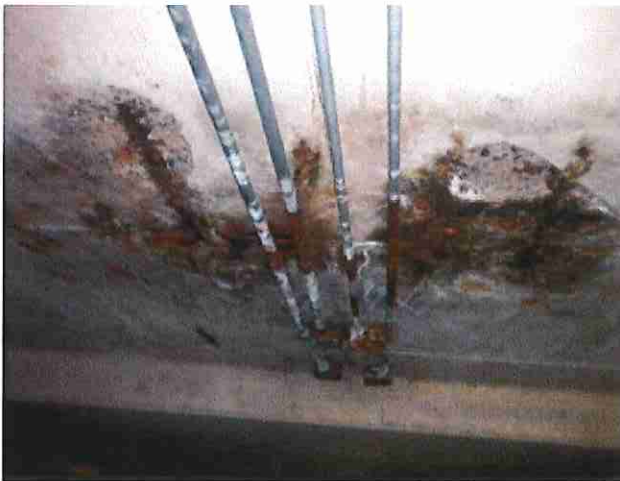
Photo 11 Spalling on the slab beneath the garage exit.

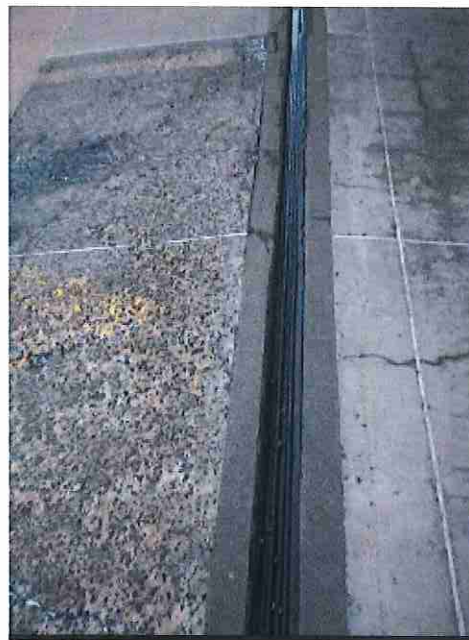
The observed waterproofing systems (sealants and expansion seals) in the garage appear to be at or beyond their useful service life and in need of replacement.

Photo 12 Roof Level expansion joint.  
Note scaling of concrete wash.

- ✓ Replace all deteriorated expansion joints between the east and west garage;
- ✓ Install a traffic bearing waterproofing membrane on all supported floors.

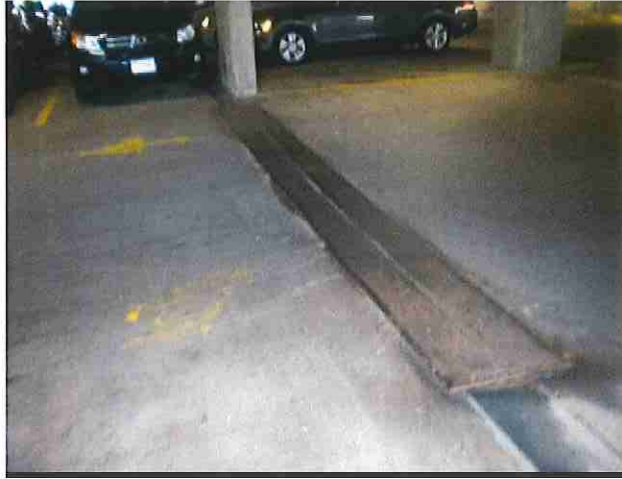
Photo 13 Typical condition of expansion joint between the East and West side. Note steel cover plate.

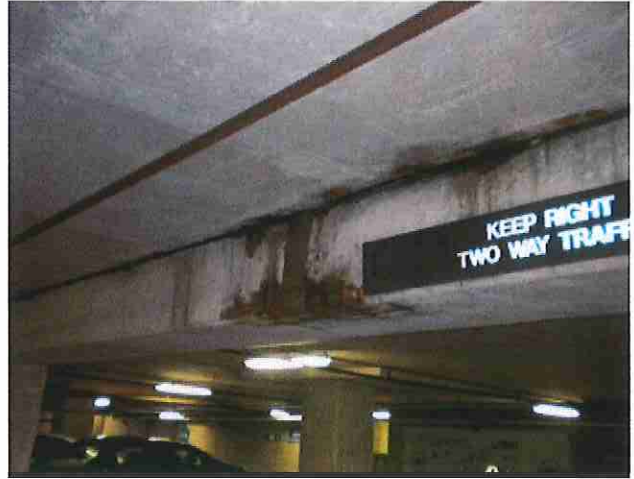
overall with the exception of several beam locations at the expansion joint between the east and west side of the garage. At these locations the long term leakage through the failed expansion seal has saturated the beam, corroding the embedded steel and subsequently causing the observed spalls.

Photo 14 Leakage on beam below the expansion joint.

- ✓ Conduct partial depth patching to spalls and delaminations on columns and beams;
- Exterior Spandrels

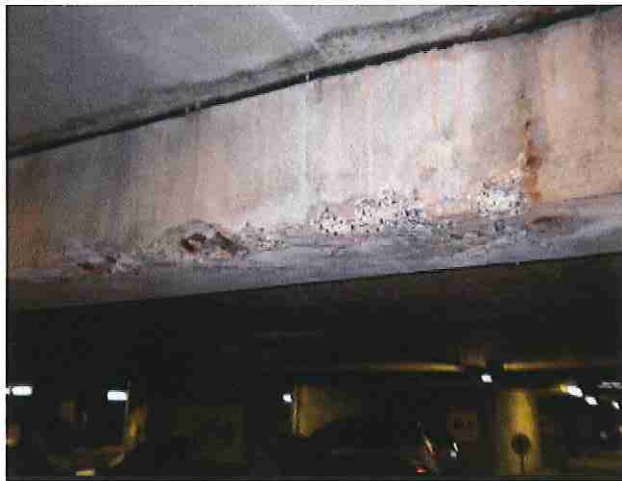
Photo 15 Spalling of concrete beam below expansion joint.

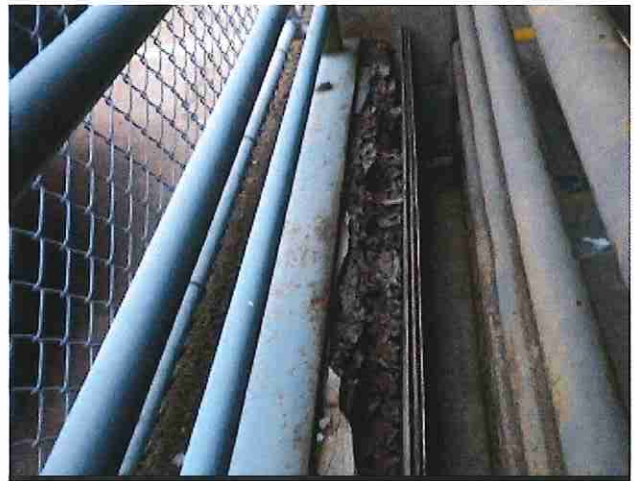
Photo 16 Slab deterioration at pedestrian guardrail.

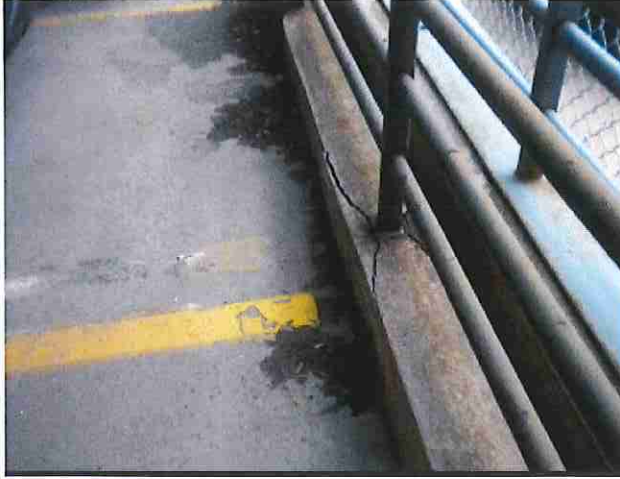
Photo 17 Curb deterioration at pedestrian guardrail.

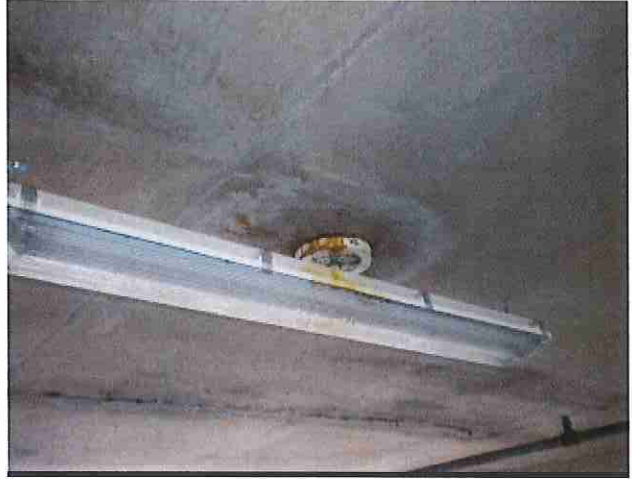
Based on discussion with building management the lighting in the garage was replaced at some point over the last five years. The current fluorescent fixtures are connected through the existing conduit that is embedded in the floor slabs. The embedded conduit is most likely a lightweight metal and given the high chloride levels in the concrete (as determined by a previous engineering study), the conduit is, in all likelihood, corroding and will be compromised by the penetration of moisture. A number of fixtures at the perimeter of the garage were not operating at the time of our visit; however, it is not known whether these fixtures are controlled by photocell or time clock.

Photo 18 Leakage and rust staining at light fixture.

- ✓ Replace the existing lighting system, including new surface mounted conduit;
