*A. Smith cc
rec'd 7/28/98
Job bid by Wood - not
funded*

Parking Garage Study
DPW Project No.: BI-2B-034

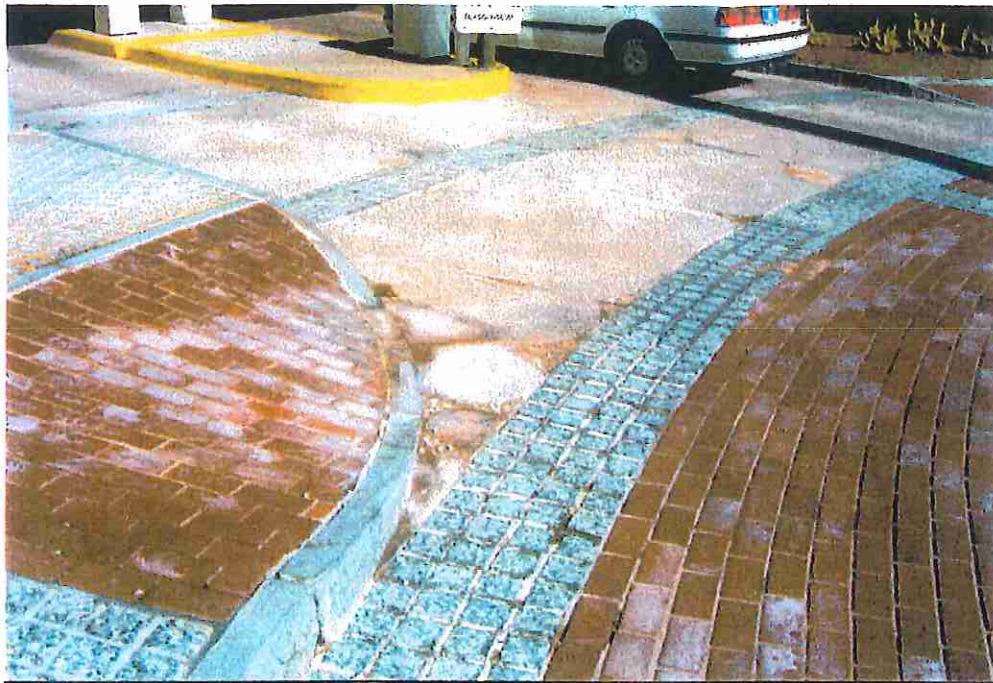
Photo 2: Entrance surface of brick, stone and concrete is deteriorating. Moisture and chlorides are penetrating through to structural elements as shown in photos to follow .

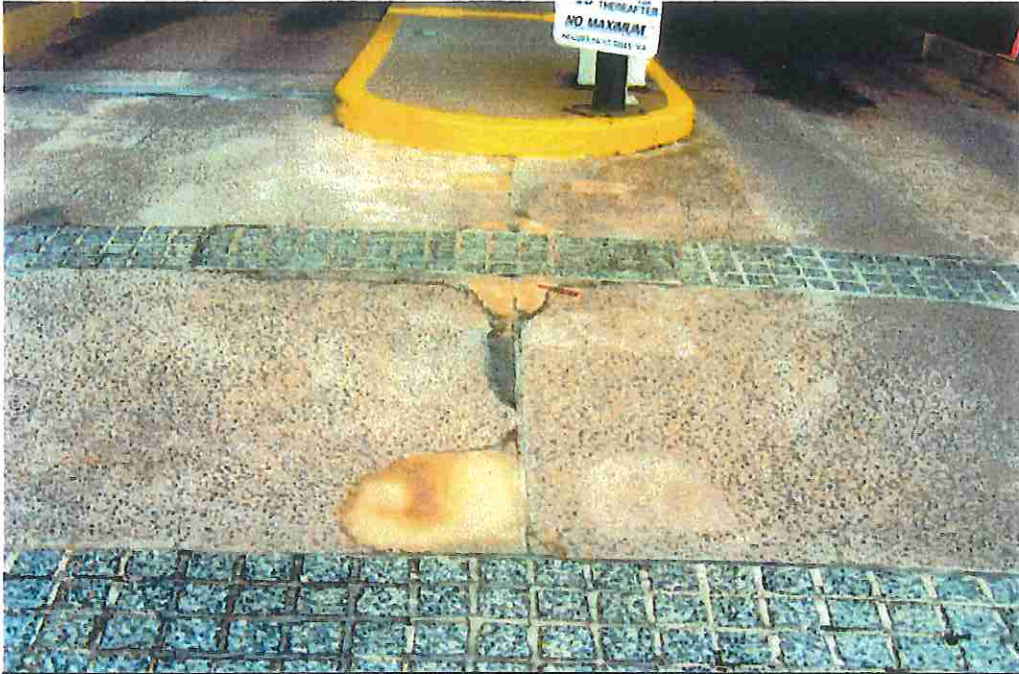
Photo 3: Previous repairs at entrance. Area needs reconstruction to protect structure below.

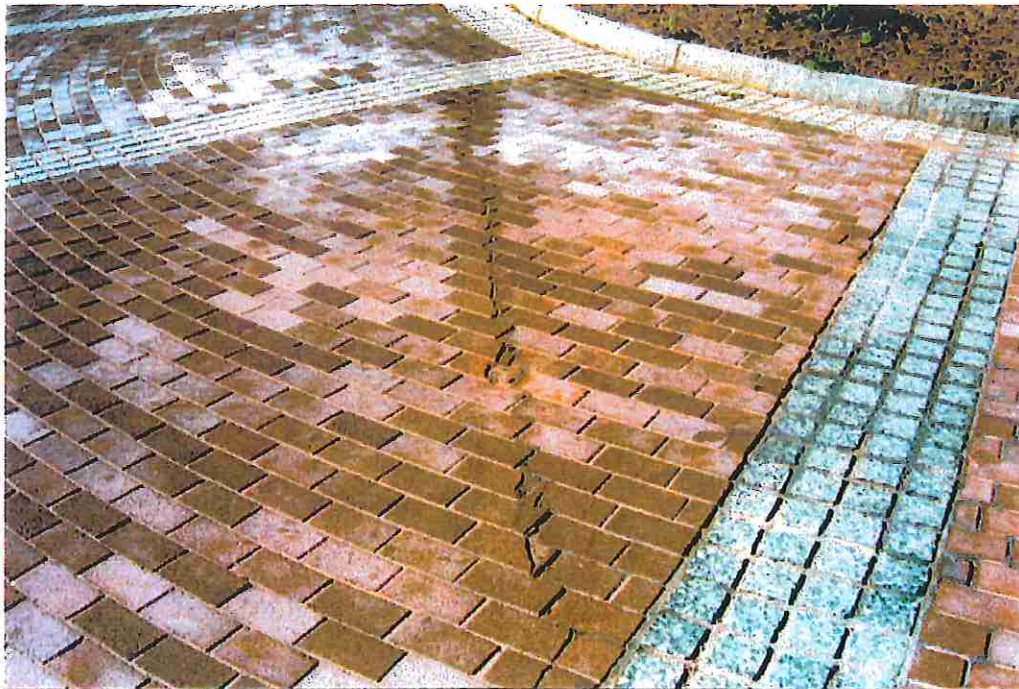
Photo4: Garage extends under the plaza area up to this crack (garage is to the right of the line).

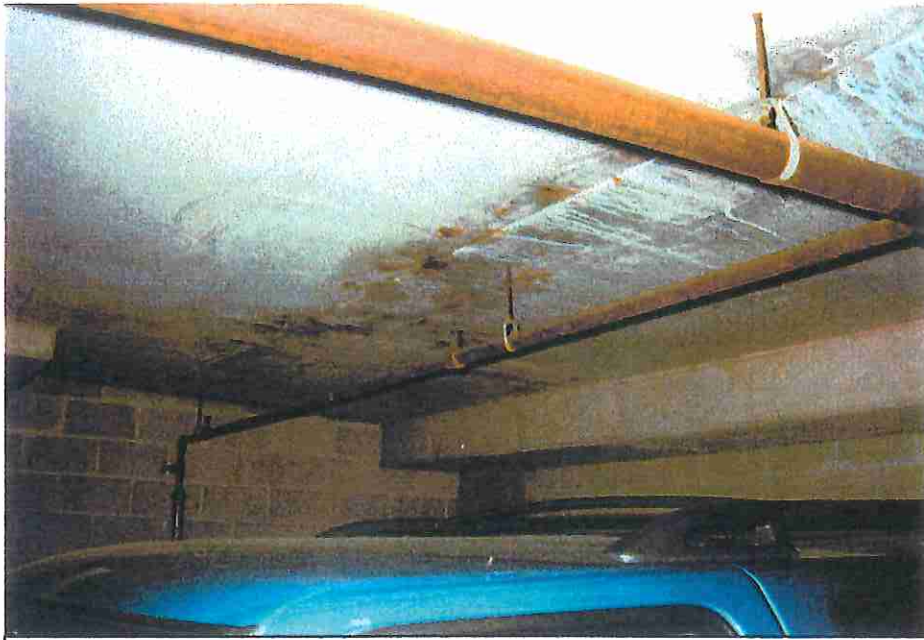
Photo 5: Result of moisture penetration from entrance above; chloride deposits and ongoing corrosion.

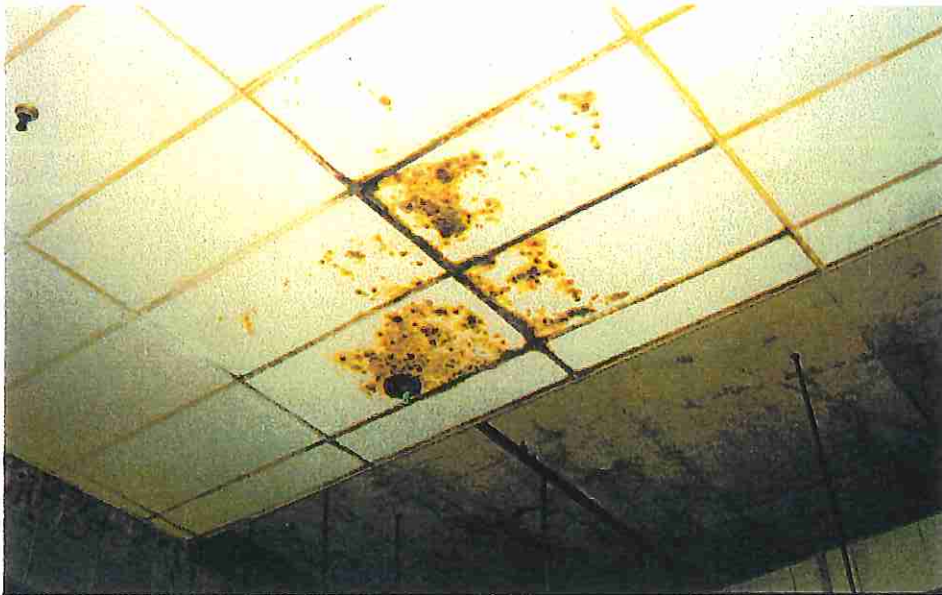
Photo 6: Moisture affects 12" plaza slab, ceiling elements below (P3 level soffit shown here) and any embedded mechanical systems (including slab heating grid)

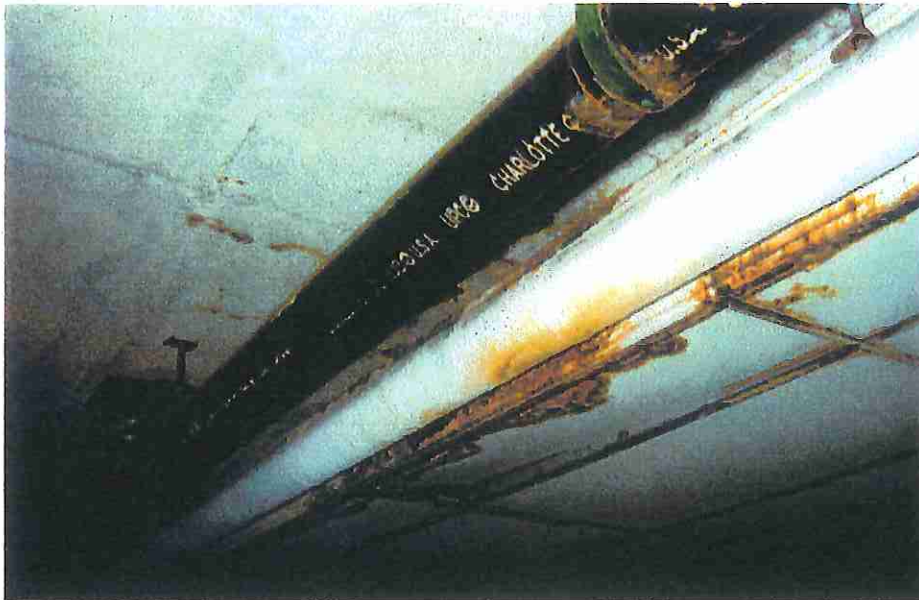
Photo 7: More evidence of soffit deterioration.

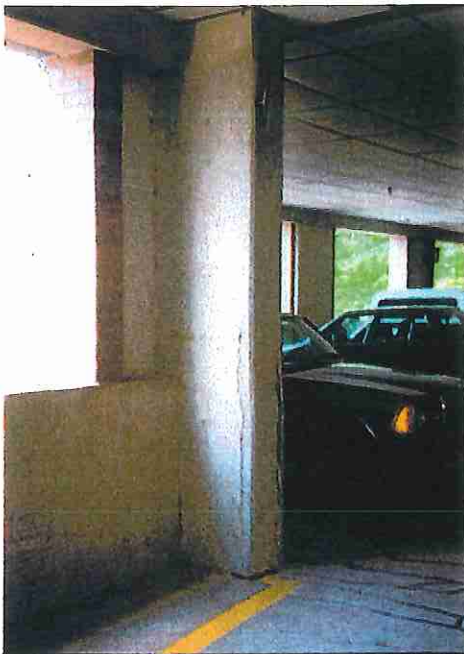
Photo 8: Column near entrance at Column Line intersection "N-12". Two vertical bars (at corners) are bowing out approx. two feet above floor. See photo #10.

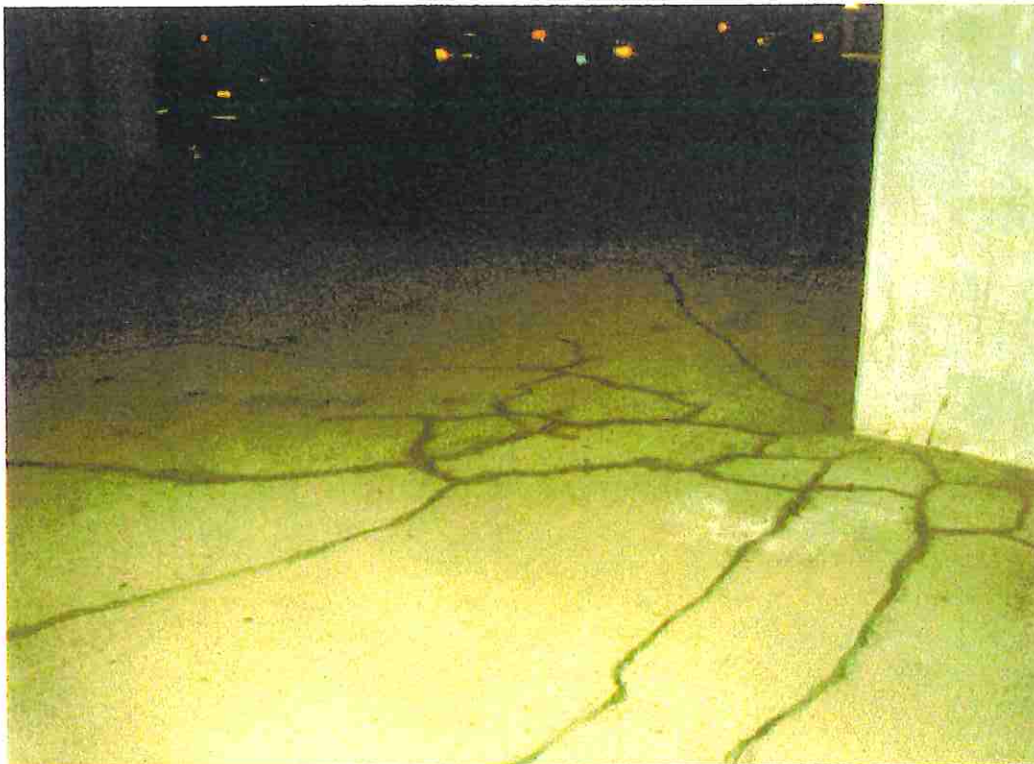
Photo 11 - Typical cracking around columns east of column line "K" in two-way slab negative moment region. Crack seals need repair.

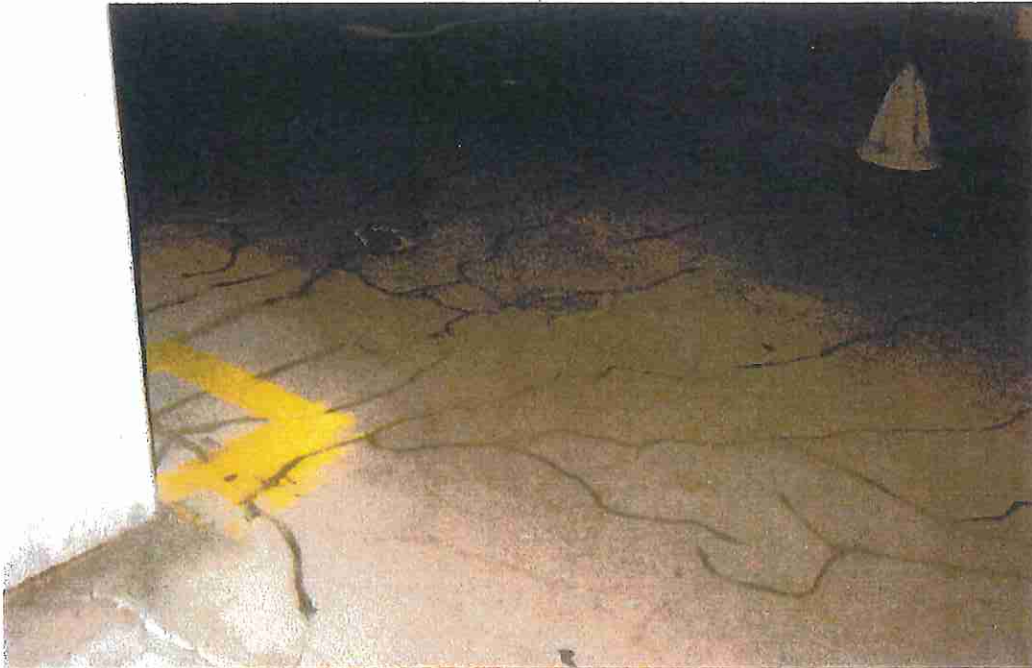
Photo 12 Another example of two-way slab cracking at tower building garage. Note new cracks that need routing and sealing to protect tension reinforcing below.

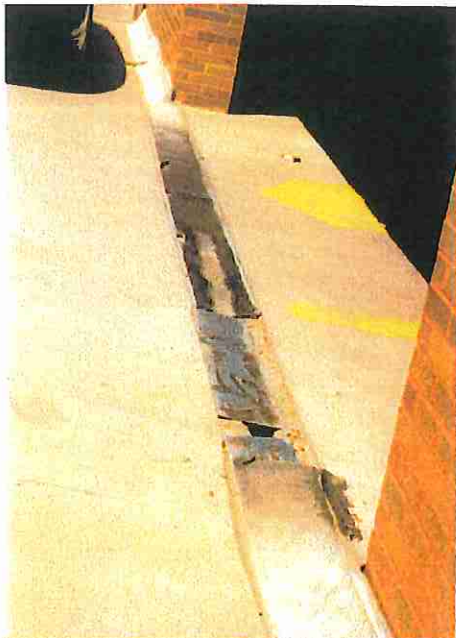
Photo 13 - Expansion joint at roof looking north along column line "K". Joint is damaged and is leaking along entire length. Joints at all levels should be replaced.

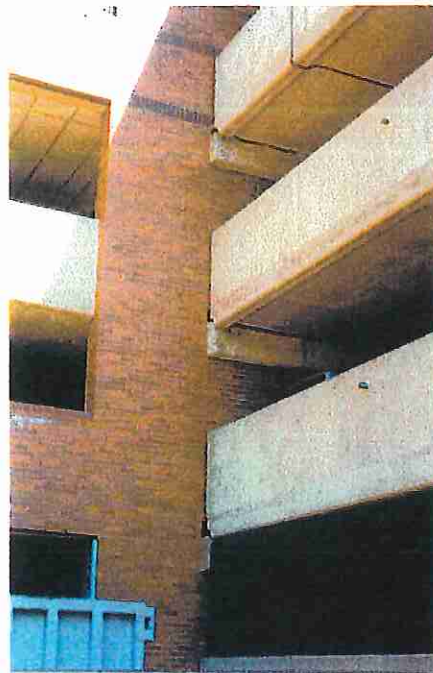
Photo 14 - Expansion movements and leaking joints have caused cracking at support ledge at "K-8". Neoprene bearings on ledge absorb expansions.

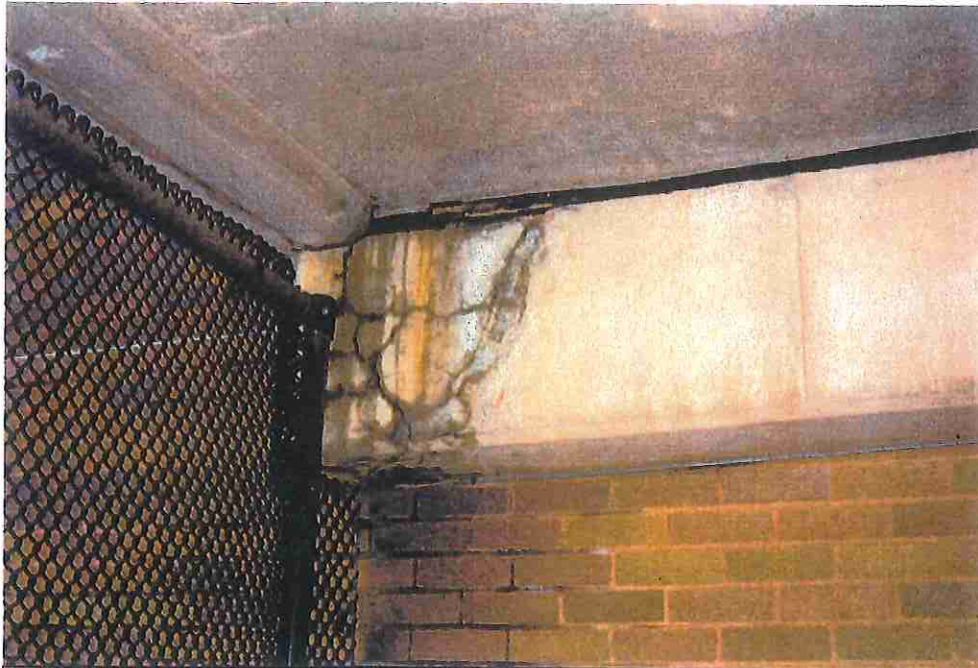
Photo 15 Close-up of typical damage at locations observed in photo 14. Bottom corner of parapet (above fence post) should be chipped back where it is touching ledge support. Note black neoprene bearing disappearing behind this parapet lip.

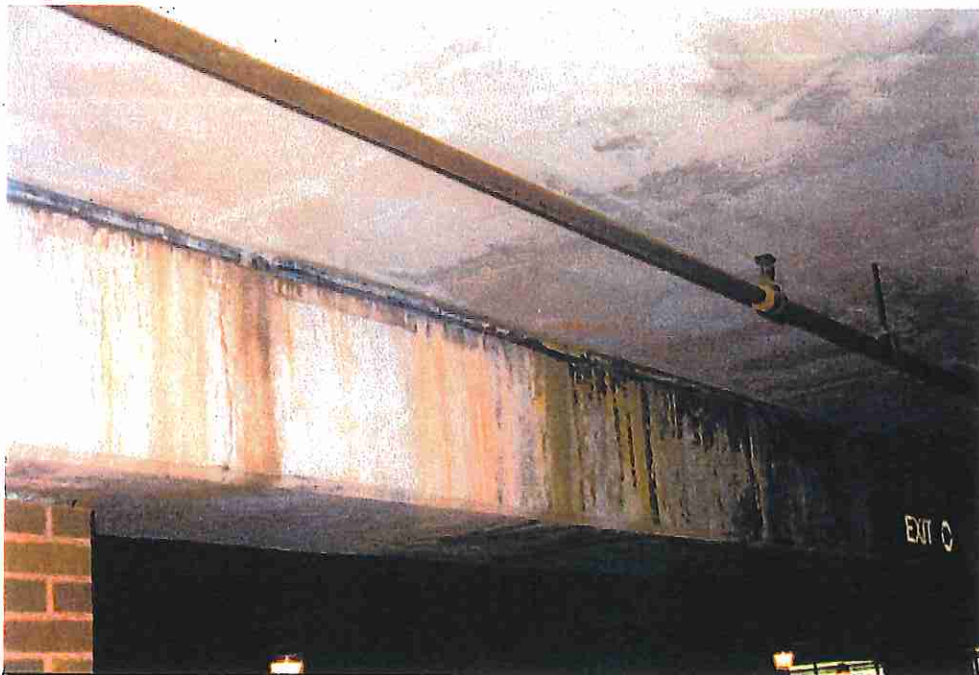
Photo 16 Moisture penetrating down past neoprene due to leaking joints (along column line "K"). Joints must be replaced.

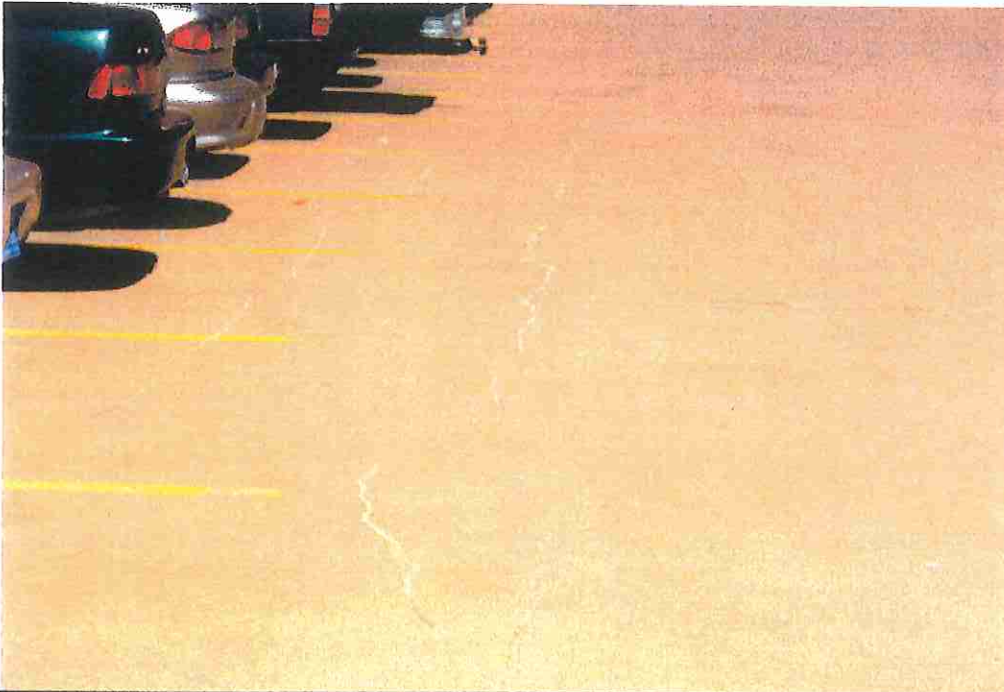
Photo17 - Cracks with white sealant at roof slab run tranverse to axis of cantilever beams (cantilevered section is under cars). PT running in the direction of the cracks cannot prevent them. Tension in this negative moment region tends to open these cracks as the slab acts compositely with the cast-in-place cantilever beams.

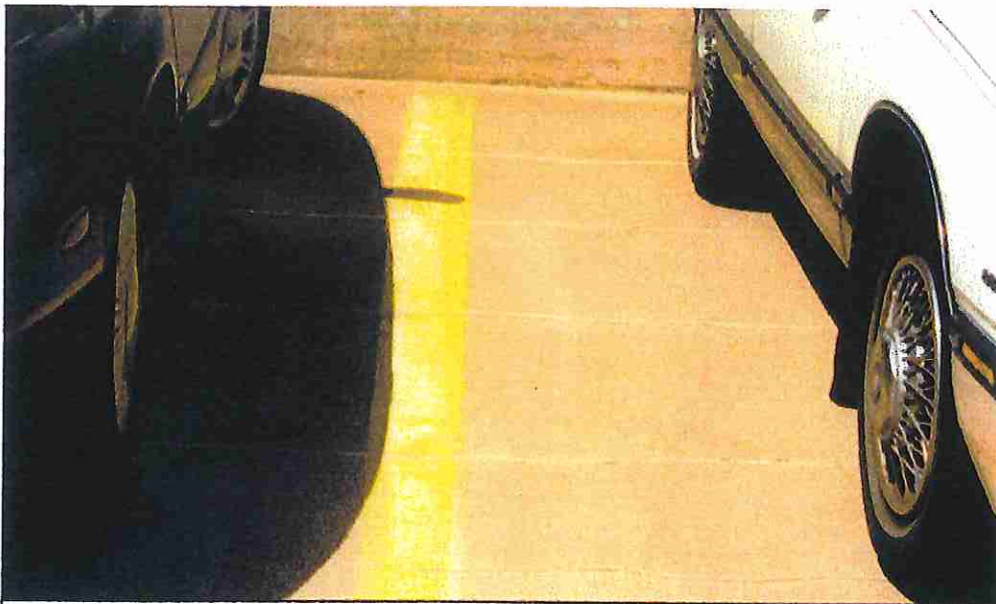
Photo 18 -Again at roof but over cantilevered section of beam. (parapet is in background)

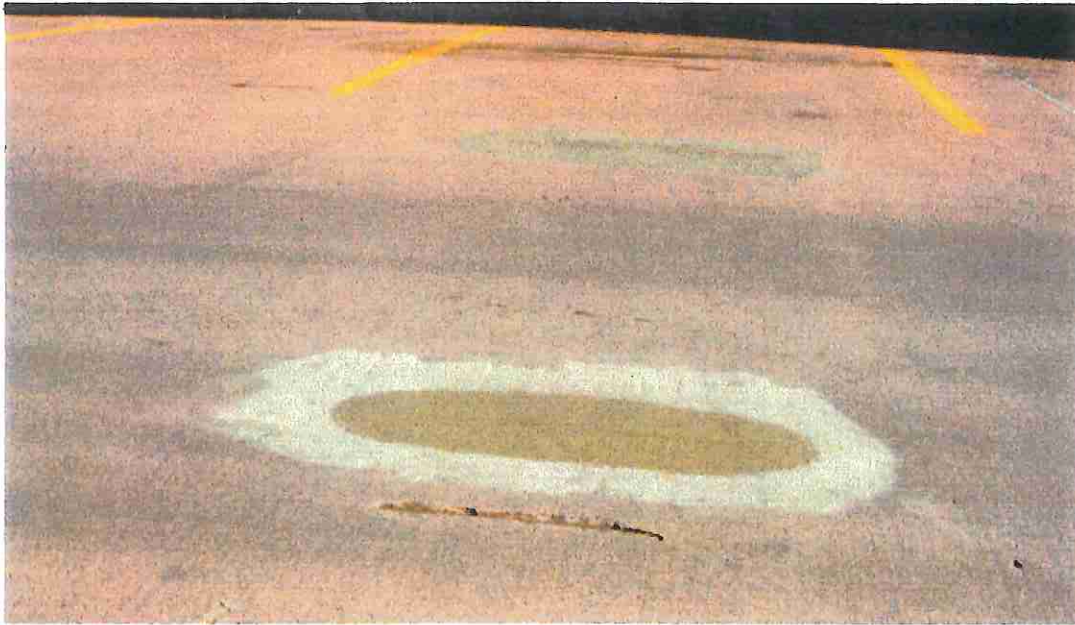
Photo 19 Previous epoxy type repairs in roof deck and exposed embedded rebar in foreground needing similar repair

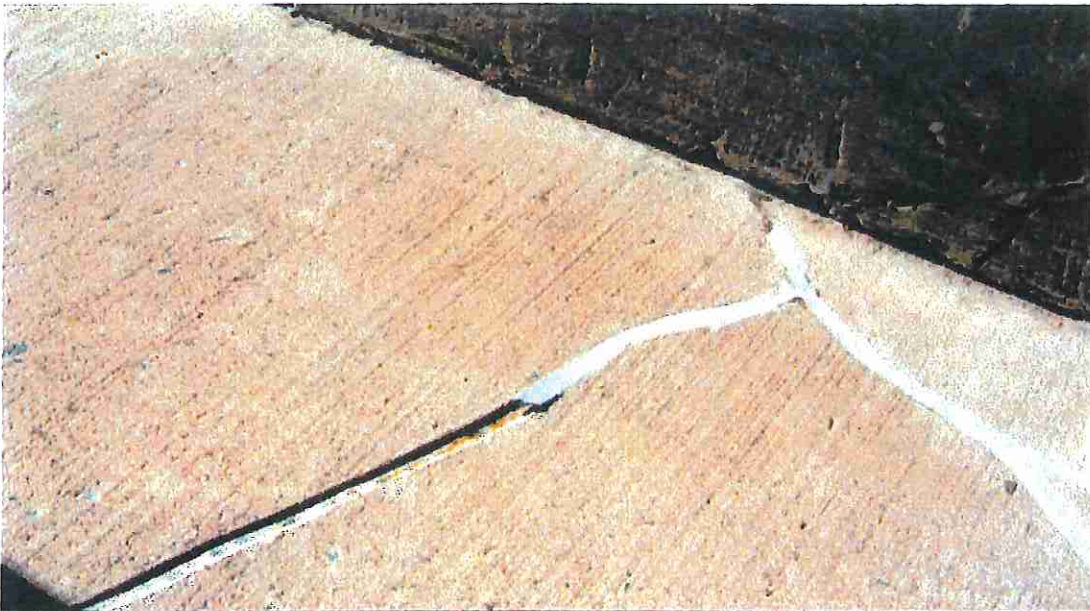
Photo 20 Crack sealant is aging and failing. Note no cove joint at parapet; should install new cove joints.

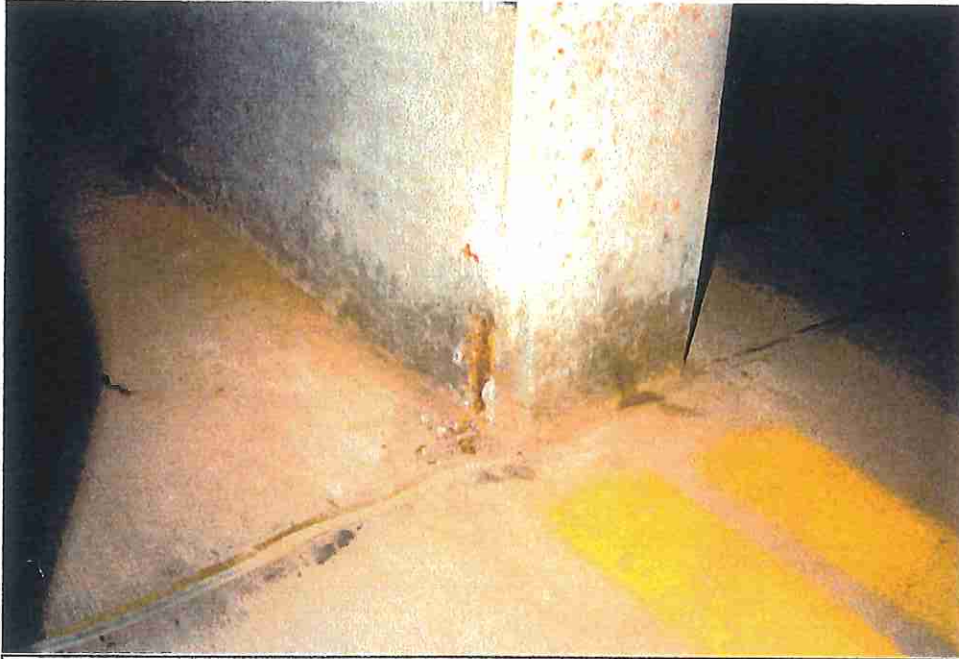
Photo 21: Spalling over column bars has occurred in several places at the floor level. Minimum cover was not provided; repair required.

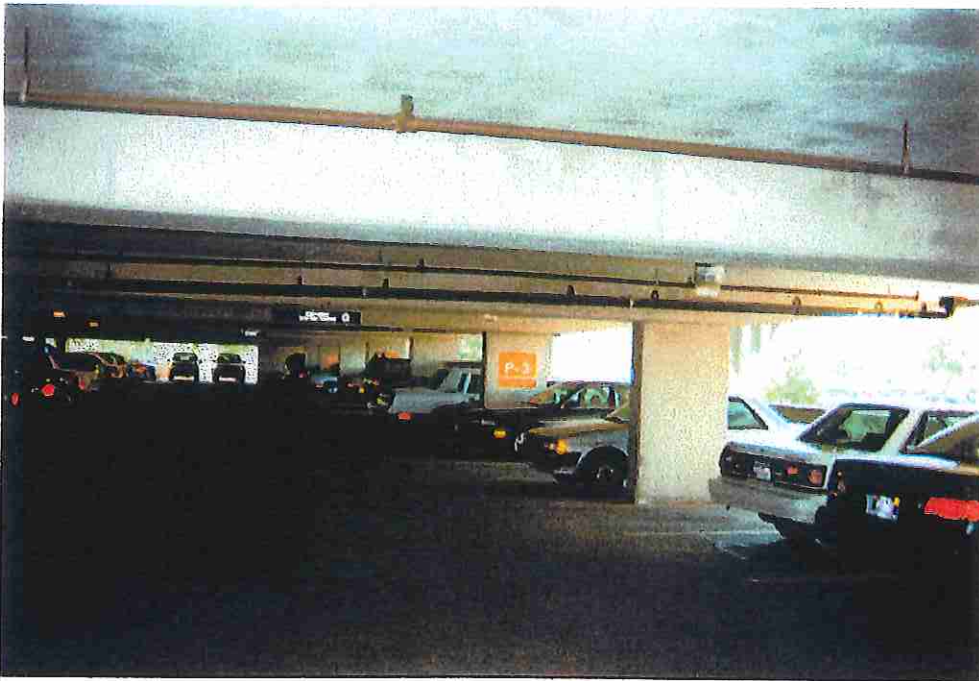
Photo 22: Looking west through cantilevered and post tensioned garage structure.

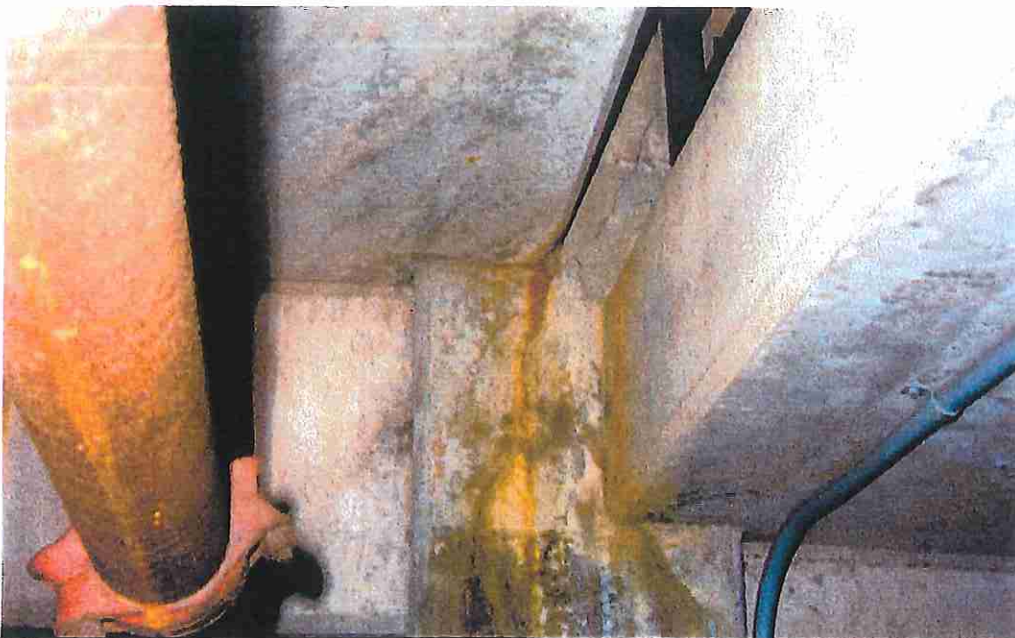
Photo 24: At column line 5, where ramping bay beams connect to columns some cracking is occurring. Note evidence of heavy moisture and that column is loaded asymmetrically at two different elevations (sloping ramp configuration)

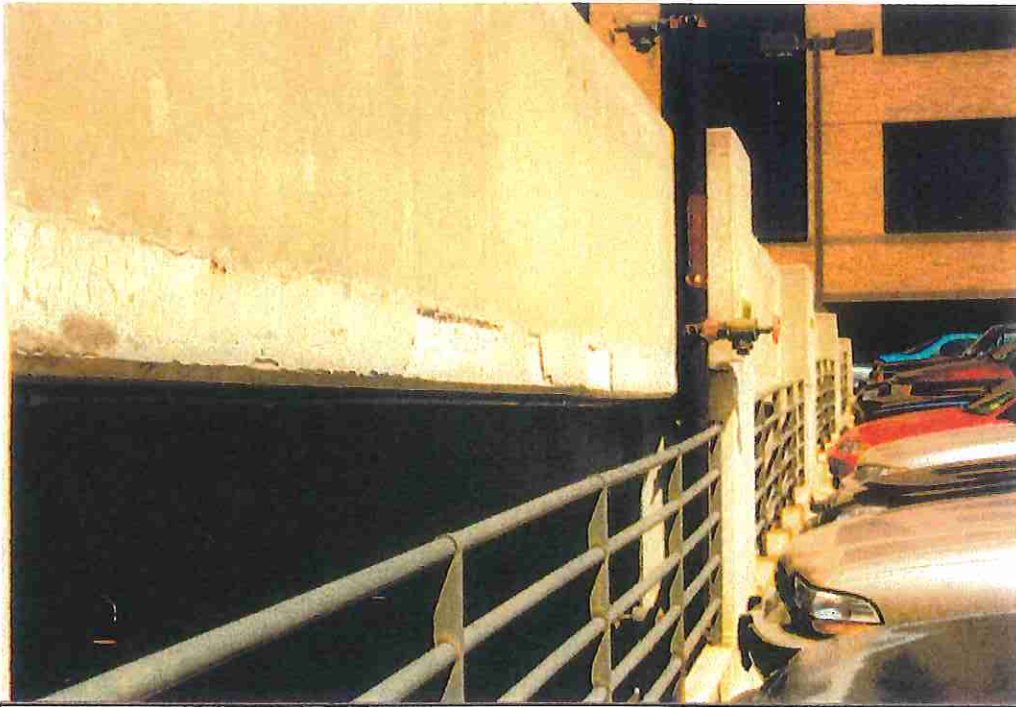
Photo 25 Parapet repairs required at roof and in several other areas.

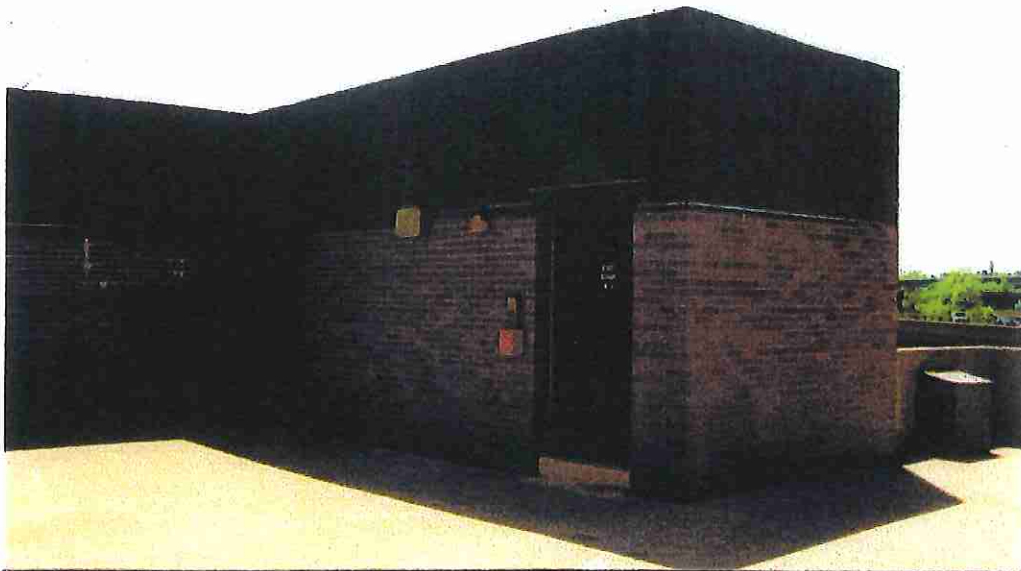
Photo 26 Temporary repairs made to southwest stair core. Needs proper reconstruction

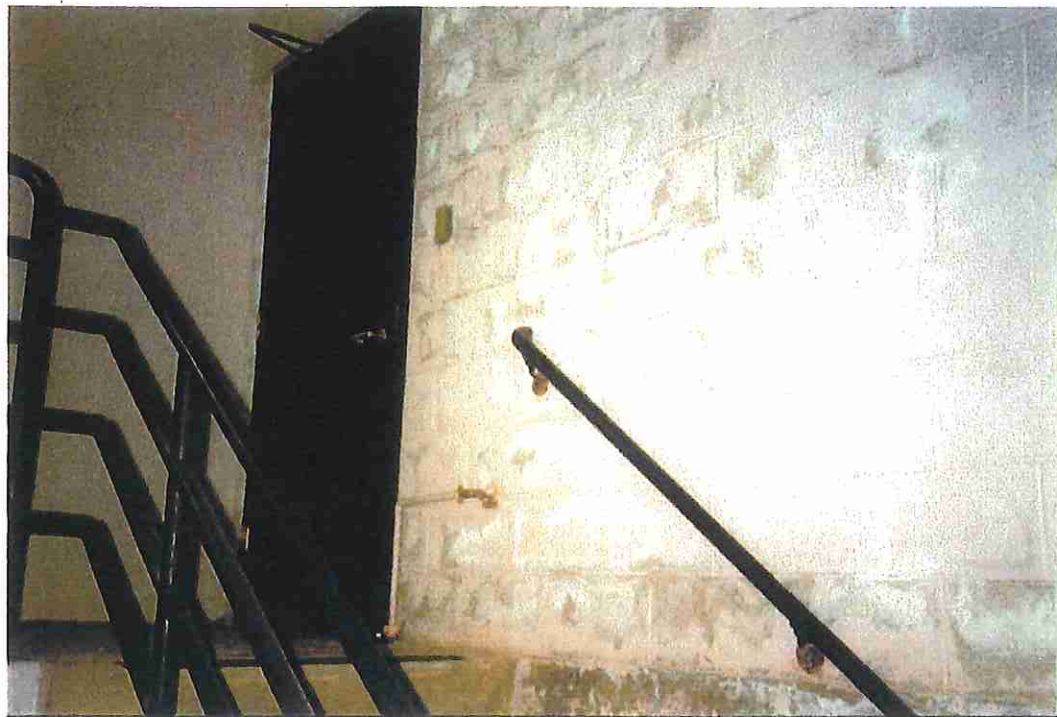
Photo 27 Efflorescence on inside wall of staircore.

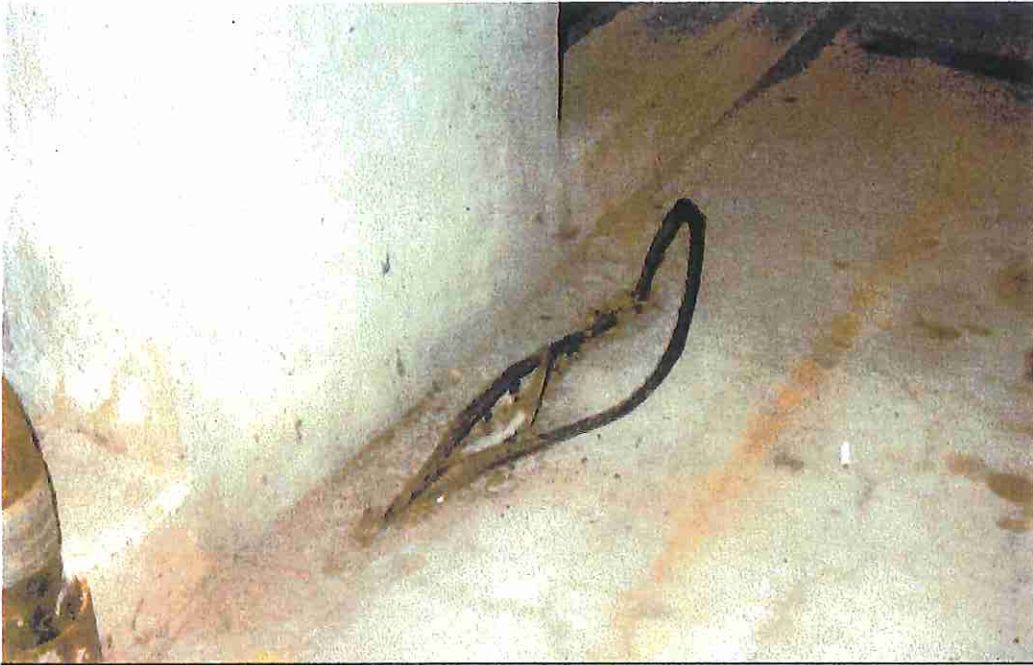
Photo 29 One post-tensioned strand was found “popped”. Due to the location this is not a concern. It is an example, however, of what could happen if proper repair and maintenance is not preformed.

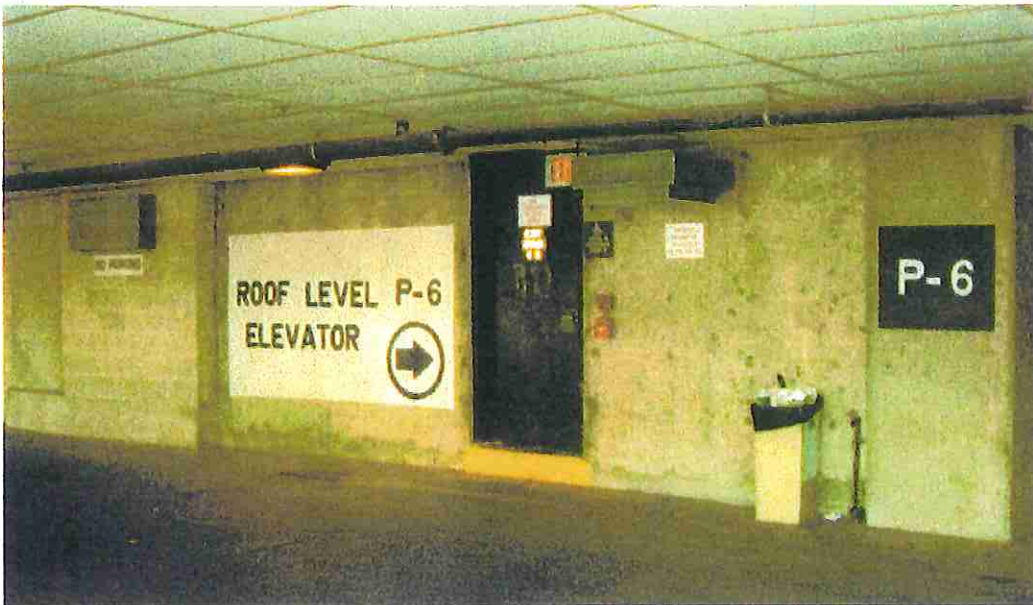
Photo 30 Step at door can catch pedestrian un-aware. Modification required.
