Water Infiltration Field Investigation Report

For
25 Sigourney Street
Hartford, CT 06106
DPW Project Number B1-2B-033L

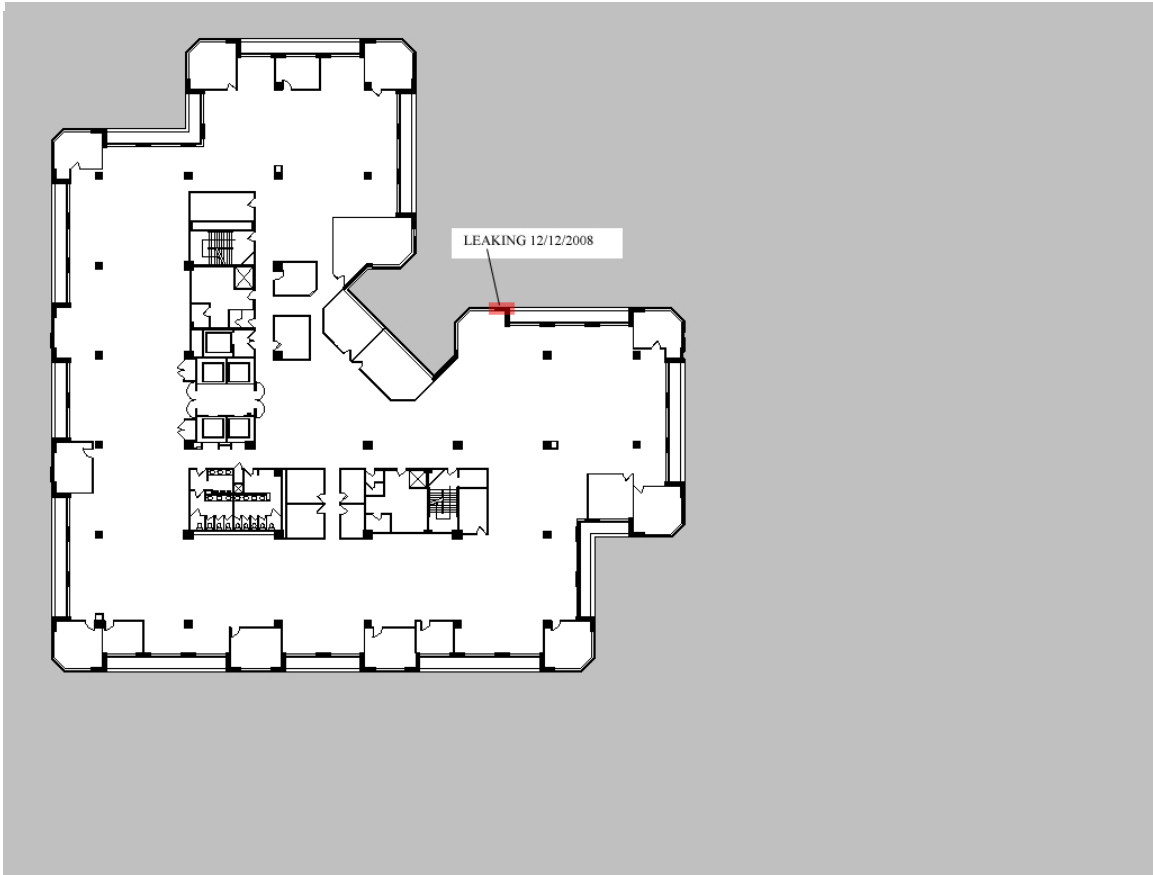
PHOTOGRAPHS OF LEAKS ON DECEMBER 12TH 2008

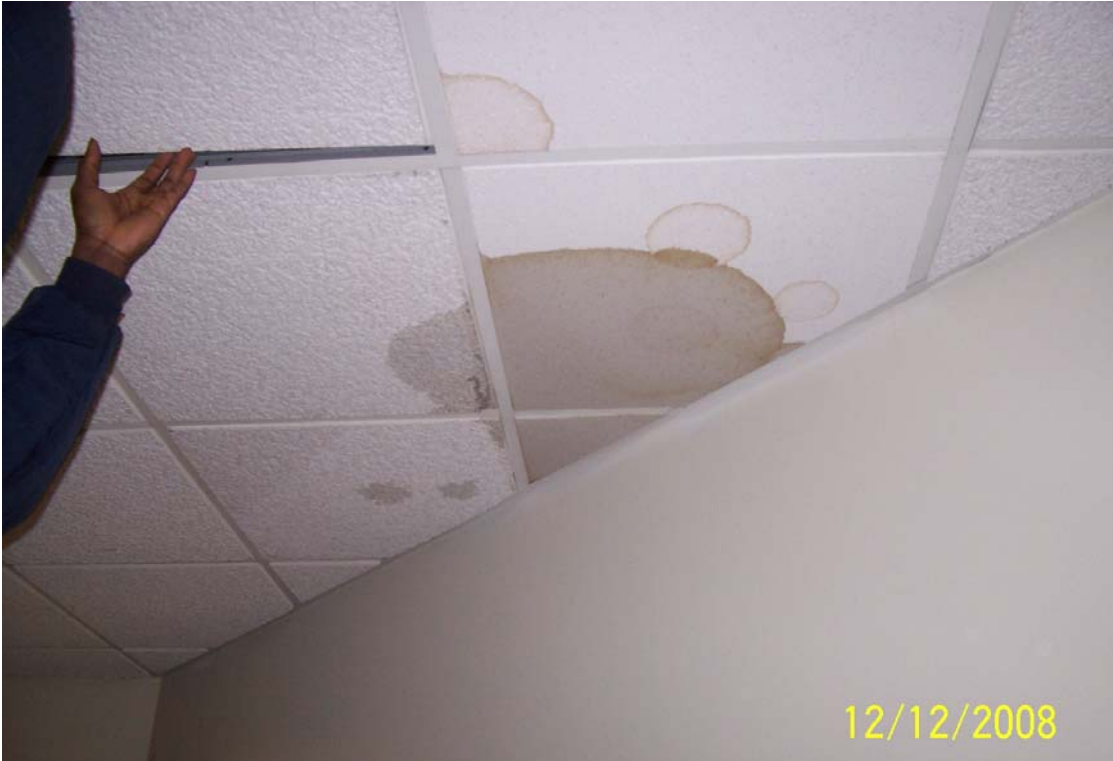
Water Damage in Conference Room on the 6th Floor

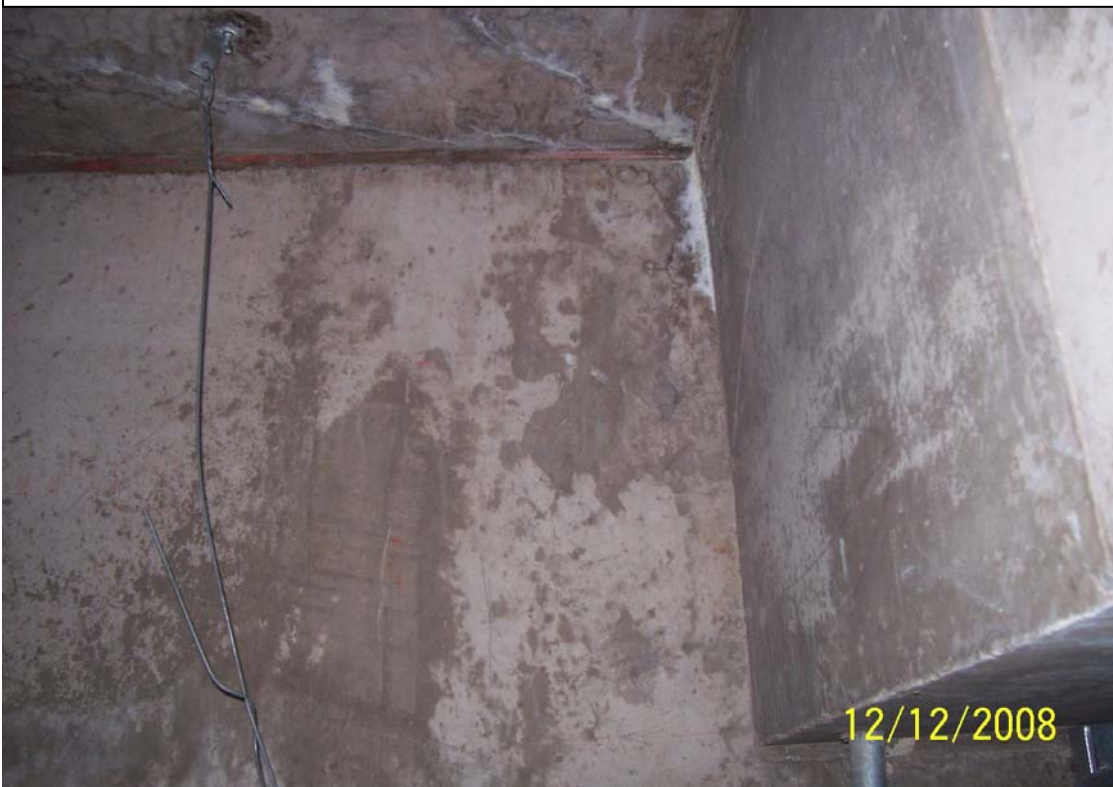
Cracks in Concrete Slab (Water leaks though cracks after in penetrated through the roof membrane)

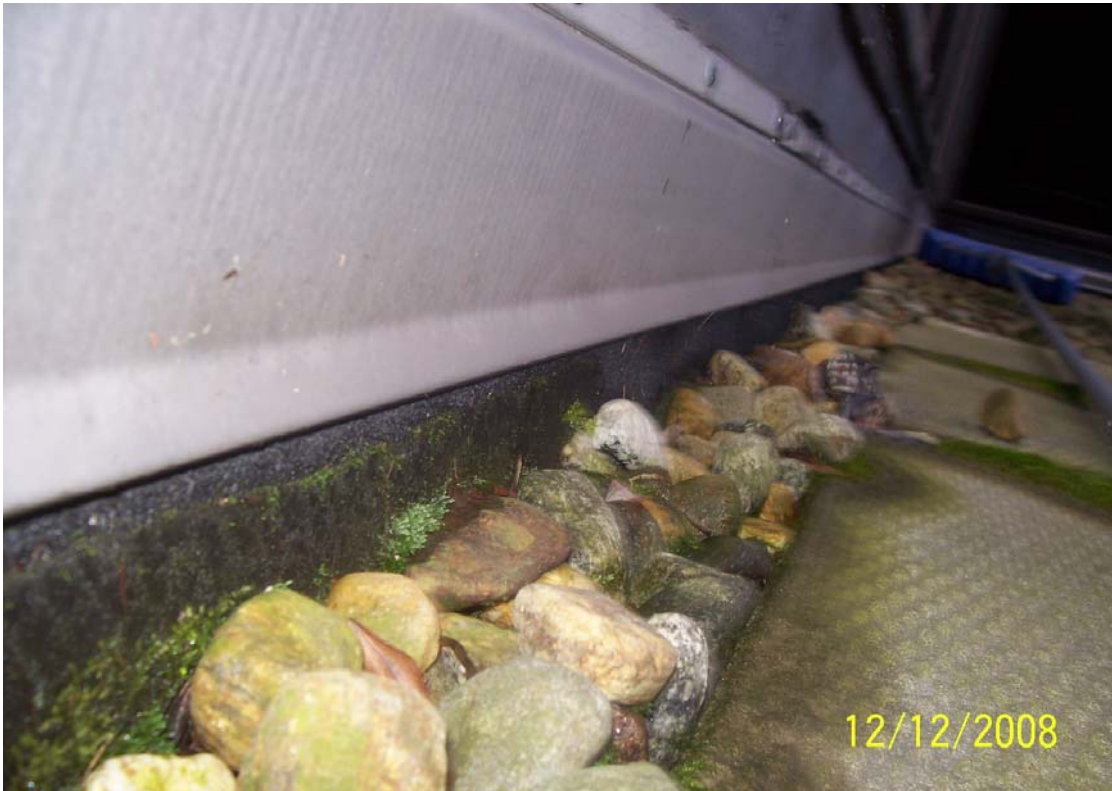
Moss Growing on Roofing Member below Window Sill on 7th Floor Roof
(Located directly above leak on 6th Floor)

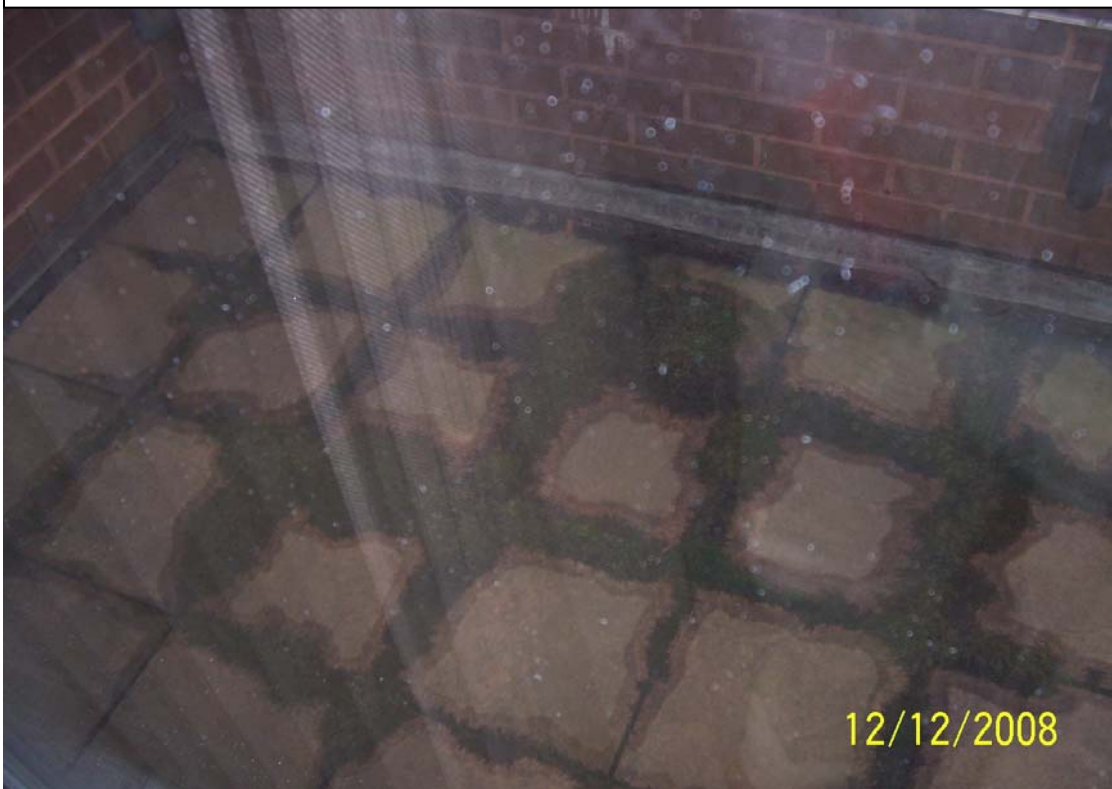
Moss Growing on Balcony on 17th Floor

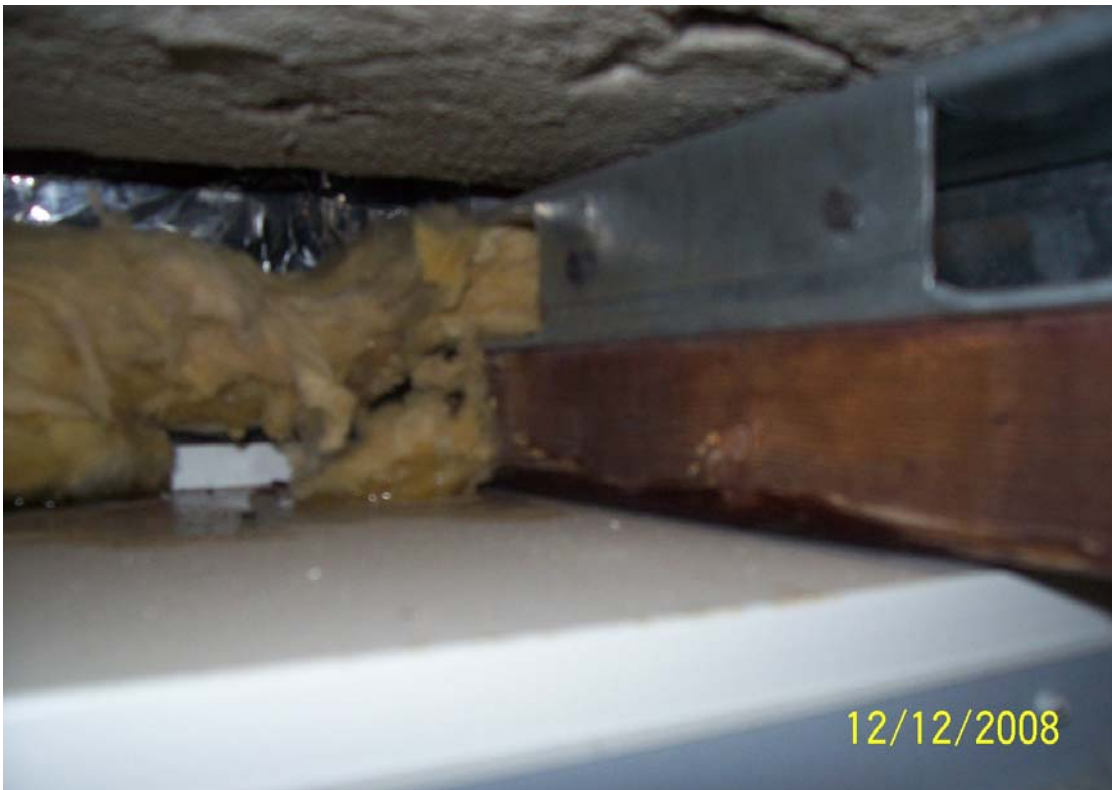
Water Observed Infiltrating the Window Head on the 17th Floor

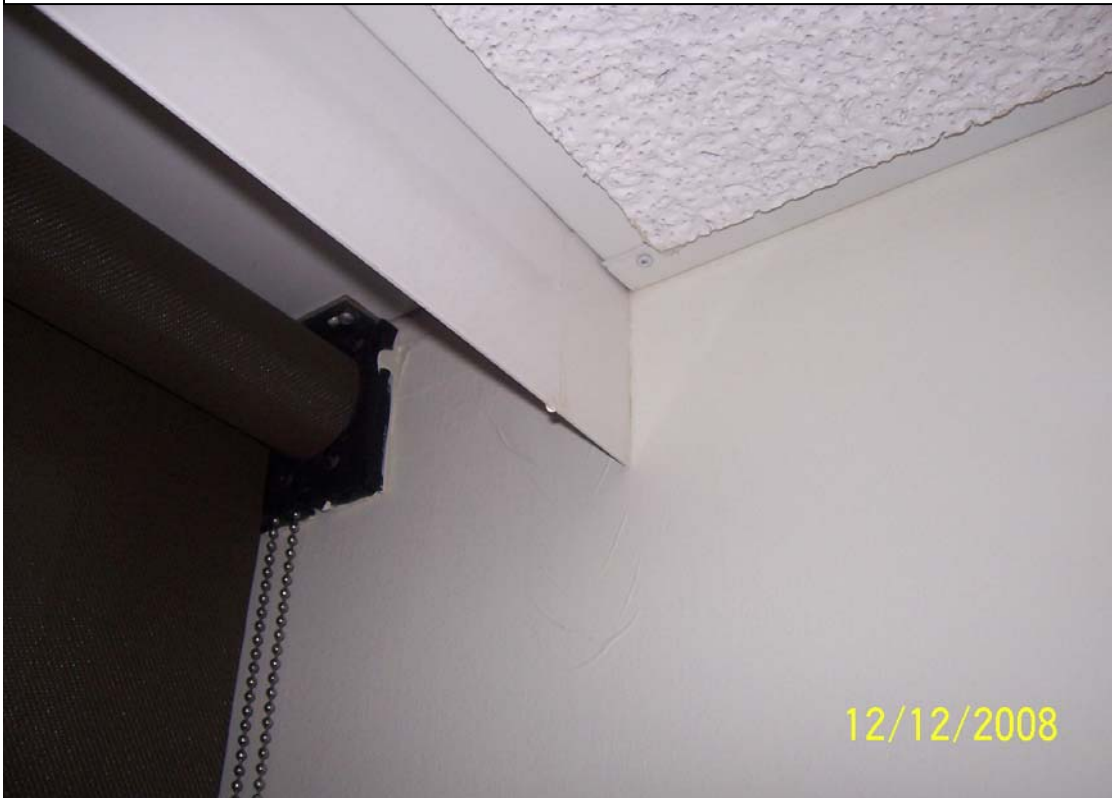
Small Drip of Water in Corner of Window on the 17th Floor
