COMMUNITY
connectivity program

Beacon Falls

Burton Road

– Road Safety Audit

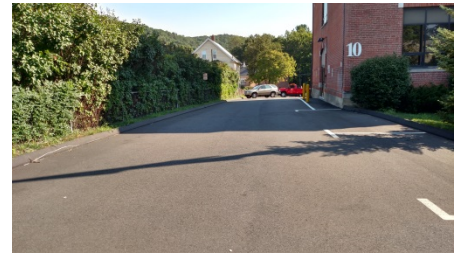
Figure 5. Entrance to Town Hall with Parking Against the Building

- There is no clear path through the town hall parking lot for pedestrians. The best option would be to paint a sidewalk through the town hall against the fence and rearrange the parking (Figure 5).

- The sidewalk does not extend through the town hall driveway (27.5 feet wide) or have a painted crosswalk with tactile warning strips.

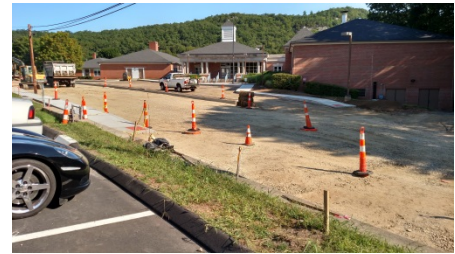
Figure 6. Highland Avenue Reconstruction

- Highland Avenue is undergoing full depth reconstruction between South Circle and Burton Road. The sidewalk is being widened to five feet, and curbing is being added, along with ADA compliant ramps, crosswalks and tactile warning strips. There will be a crosswalk from the town hall to the elementary school. The radius on the south west corner of the Burton Street intersection will be tightened up to provide a snow storage area (Figure 6).

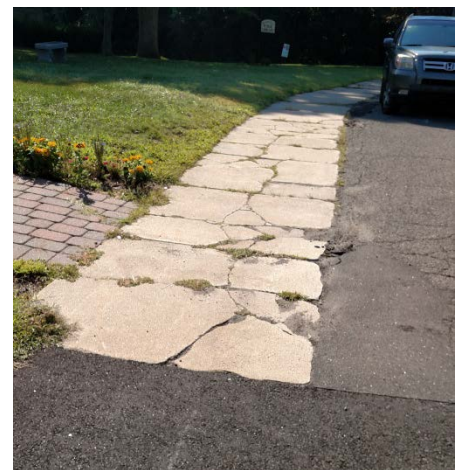
Figure 7. Broken Sidewalk in Front of Town Hall

- The concrete sidewalk in front of the town hall is flush with the roadway and severely cracked. It is five feet wide (Figure 7).
- There is only one entrance to the town hall parking lot. Adding a second entrance on Maple Street could increase parking capacity and still allow for the pedestrian walkway.

6. Repair broken sidewalks on Maple Street in front of the Town Hall.
7. Remove the unused utility pole in the snow shelf which is rotting.
8. Trim the vegetation that blocks the sidewalk and the shoulder.
9. Remove the dead tree with branches leaning against the utility wires (Figure 16).
10. Replace faded and worn out signs.

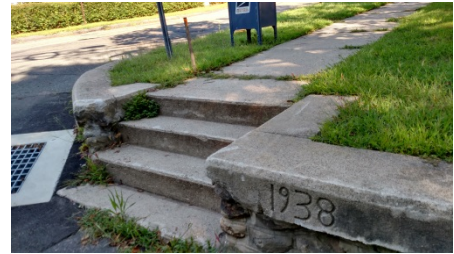
Figure 8. Stairs on Maple Street Sidewalk

- Within the snow shelf there is an old utility pole that is rotting.
- The tree canopy is extending into the sidewalk.
- The sidewalk on Maple Street ends at Burton Road with stairs (Figure 8). One option to remove the stairs would be to move the sidewalk toward the street to lessen the grade. The ramp would be on the corner of the radius, the sidewalk could then sweep back in. Maple Avenue is 32 feet wide, and there is no parking so there is room to move the sidewalk.

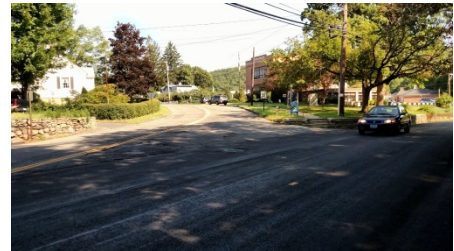
Figure 9. Wide Intersection for Maple Avenue and Burton Road

- Maple Avenue does not have shoulder lines.
- Many of the “no parking” signs are faded.
- Maple Avenue is yield controlled. It is difficult to take a left turn (Figure 9).

- Converting Maple Avenue to a stop controlled intersection with left and right turns would slow vehicles down.
- All crosswalks should have proper advanced warning signs.
- Heaving of the sidewalk has become a serious issue and the wall needs to be stabilized.
- When Maple Avenue and Wolfe Avenue are reconstructed, five foot sidewalks should be installed with a snow shelf. The sidewalk should be pushed against the right-of-way. The sidewalks should be upgraded with ADA compliant ramps and tactile warning strips.
- Clearing vegetation on Burton Road will help improve the sightline. Signage needs to be added to alert motorists that pedestrians might be along Burton Road.

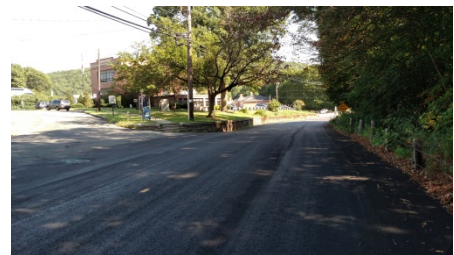
Figure 10. Tree Canopy in Sightline

- Vehicles turning left onto Maple Avenue from Burton Road take the turn at high speeds.
- Burton Road has steep grades on either side.
- Tree branches block sight lines along Burton Road and low growing vegetation impedes the shoulder where there is sidewalk (Figure 10).

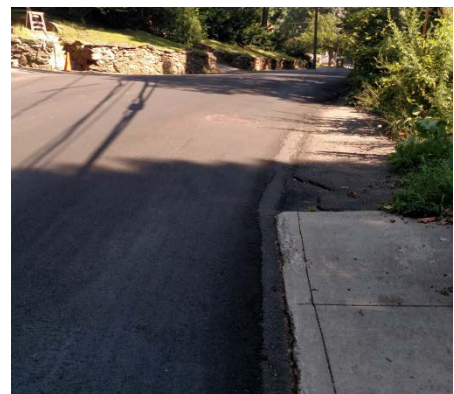
Figure 11. Beginning of Sidewalk on Burton Road.

- The sidewalk begins on Burton Road at Wolfe Avenue. It is on the east side of the road, concrete and four feet wide. There is no snow shelf or barrier between the sidewalk and road (Figure 11).
- On the curve the sidewalk has begun to tip back due to a failing foundation. This is evident with gaps in the wall. It is built on a steep grade. If the sidewalk eventually fails and tips back all of the way the road will also fail. The tipping of the sidewalk has also resulted in poor improper drainage (Figure 12).
- The retaining wall on the opposite side of the Burton Avenue Sidewalk appears to be in good condition.
- There is a dead tree with branches leaning on the utility wires.
- There is sidewalk along Wolfe Avenue but there are no crosswalks across any of the side streets.
- Many of the side streets off of Burton Avenue and connecting streets are in poor condition.

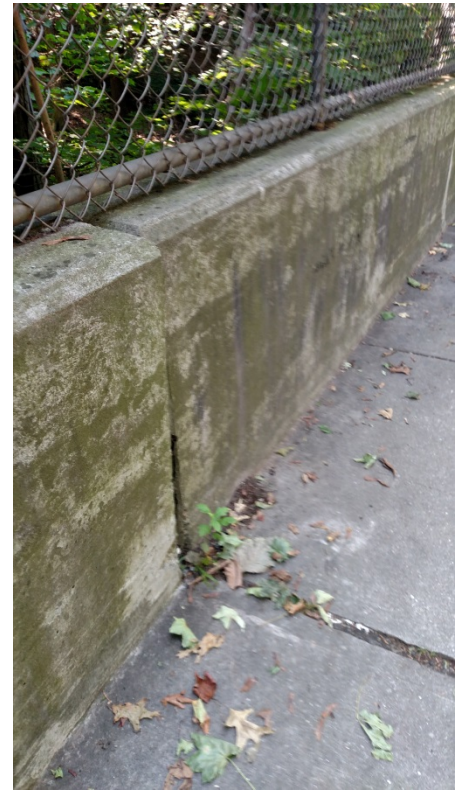
Figure 12. Sidewalk Tipping Back on Burton Road

- The section of sidewalk on Burton Road has experienced heaving because the base is constructed out of rubble, and is failing. A support system is needed to prevent it from shifting any more.

1. Stabilize the heaving/tipping sidewalk.
2. Reconstruct sidewalks to be five feet wide with ADA compliant ramps, proper signage, snow shelf where possible, tactile warning strips, and crosswalks.
3. Extend the sidewalk from its existing terminus on Burton Road to Highland Avenue. Install ADA compliant ramps, five foot wide sidewalks and tactile warning strips.
 - a) Place the sidewalk through the town hall parking lot against the fence, using paint to delineate.
 - b) Use a wood boardwalk with railings where needed due to environmental issues.
 - c) Eliminate stairs on Maple Street by sweeping the sidewalk outwards.
4. Realign the Maple Avenue and Burton Road intersection into a "T" intersection.
5. Install a second entrance for the town hall and a one-way loop through the parking lot, converting the existing entrance/exit to one-way.
