CANTON ROAD SAFETY AUDIT

DOWD AND MAPLE AVENUE (ROUTE 565) AND BRIDGE STREET (ROUTE 179)

JANUARY 2023

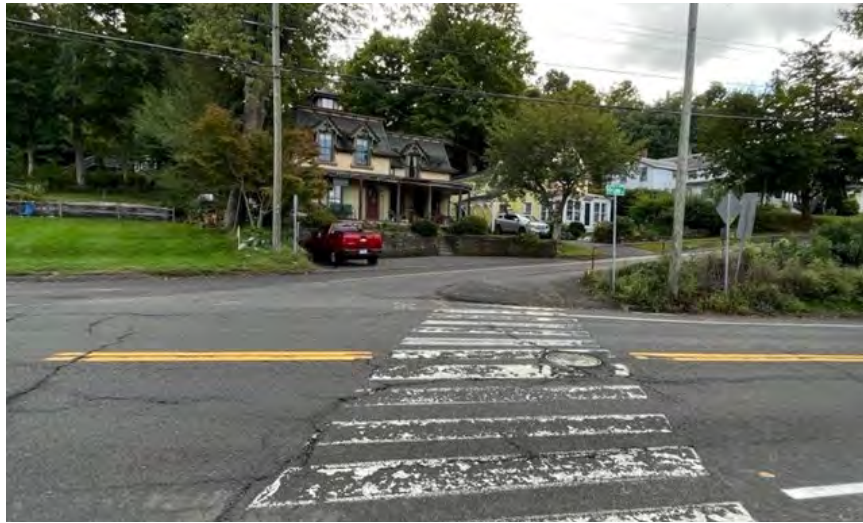
Exhibit 18: Crosswalk on Route 179 (Bridge Street) at Center Street

- RSA participants felt that the unsignalized intersection of Center Street generally functions okay for thru vehicular traffic.
 - The crosswalk at Center Street is widely used as a connection for the Farmington River Trail. Participants noted that the sidewalk on Center Street has grades that make crossing challenging at this location. Exhibit 18 displays the unsignalized crossing.

- Visibility of the crosswalk is reduced due to the poor condition of the pavement markings and the sign placement for the southbound Bridge Street approach and curvature of the roadway. There is an existing sidewalk ramp on the FRT side of the crosswalk, but no ramp on the Center Street side, likely due to the narrow width of the existing sidewalk and steep grade. Exhibit 19 displays this location.

- The speed limit is 30 mph at the intersection. and participants felt that traffic routinely exceeds the posted speed limit by a significant margin creating an unsafe environment for other roadway users.

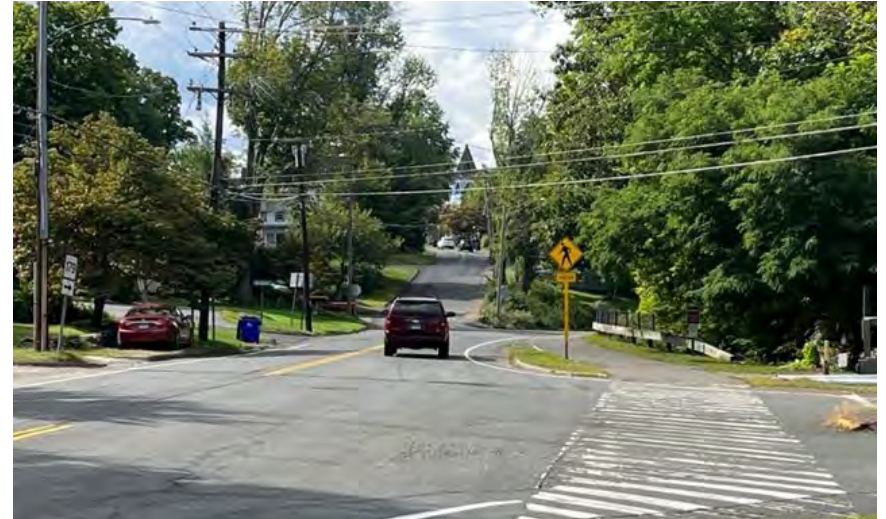
Exhibit 20: Route 179 (Bridge Street)/Route 565 (Maple Avenue) at Route 179 (River Road) Road Intersection. View looking south

- 3) Consider geometric changes at the intersection of Route 179 (Bridge Street)/Route 565 (Maple Avenue) at Route 179 (River Road) such as:
 - a) Roundabout. See Exhibit 37 for an example of a modern roundabout in Glastonbury, CT.
 - b) Realignment of Route 179 (River Road) to T-up this approach to Route 565 (Maple Avenue) and reduce crossing distances.
 - c) Note – Previous recommendations to realign Route 179 (Bridge Street) to continue to Route 179 (River Road) is not recommended. This realignment alternative would significantly increase the number of left-turning vehicles from a minor approach (in this alignment, there would be many vehicles turning from Route 565 [Maple Avenue] southbound to Route 179 [Bridge Street]). This movement has the greatest number of conflict points and could increase crash risk.

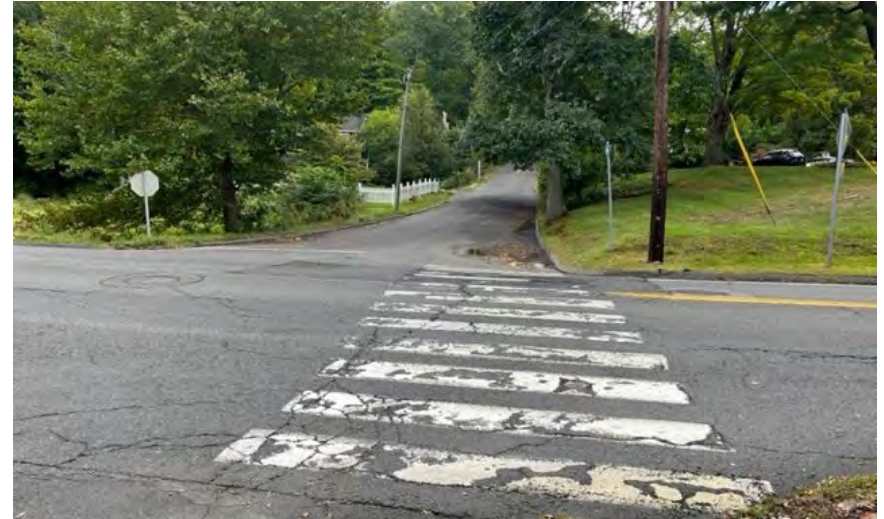
- Pedestrians often cross Route 565 (Maple Avenue) at this location as it is a popular walkway route from Dyer Avenue to the Center, where the library and schools are located. The existing crosswalk pavement marking are in poor condition. See Exhibit 21 for a view of the existing crosswalk.
- Sightlines are restricted to and from the south leg of Route 565 (Maple Avenue) due to a vertical curve in advance of the intersection. Vehicle speeds are a concern at this location.

Exhibit 21: Crosswalk at the intersection of Route 565 (Maple Avenue) and Dyer Avenue and High Street. View looking east.

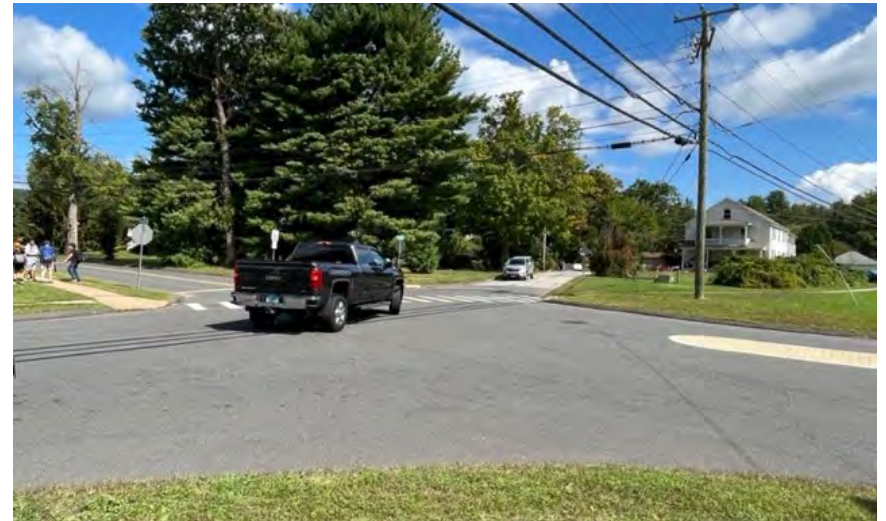
- This is a busy intersection for both vehicles and pedestrians due to the proximity of the school, especially during arrival and dismissal, when backups and delays are prevalent. The intersection geometry is complex, as the approaches are at varying angles.
- Young children often walk in this area between school and home. Heavily traveled school bus corridor.
- RSA participants noted that this location has the potential for a roundabout to replace the existing unsignalized intersection.
- Exhibit 26 and Exhibit 27 display the intersections of East Hill Road with Old Canton Road and Route 565.

Exhibit 26: Intersection of East Hill Road and Old Canton Road, looking northeast

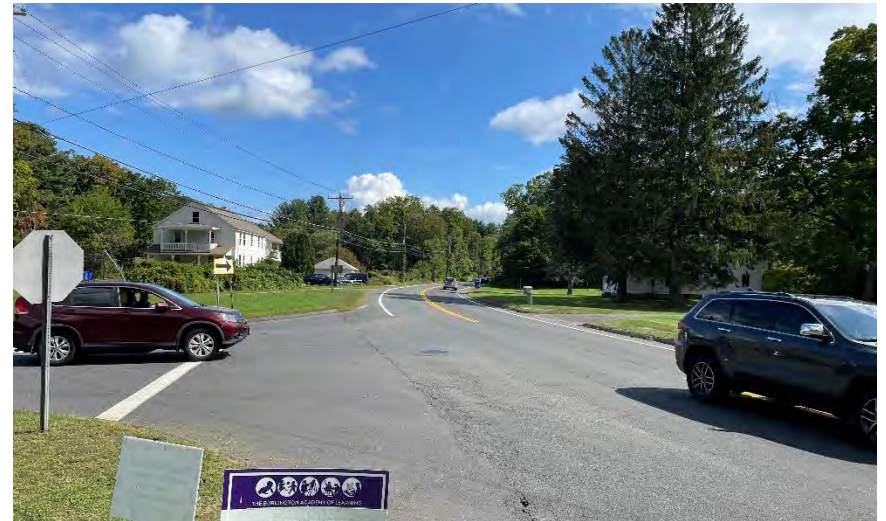
Exhibit 27: Unsignalized intersection of East Hill Road and Route 565 (Dowd/Maple Avenue)
