COMMUNITY
connectivity program

Fairfield

Post Road (CT Route 130) – Road Safety Audit

June 22, 2016

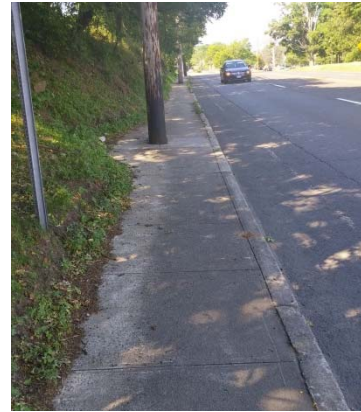
- The sidewalk on the south side of Post Road is narrow (Figure 8).
 - Becomes even narrower in some locations where there is overgrowth on the sidewalk (Figure 9).

- Utility poles are located in the middle of the sidewalk in some areas (Figure 8)
- The crosswalk at the signalized intersection of Post Road and Riverside Drive has an exclusive pedestrian phase. (Figure 9).

Figure 8. Narrow sidewalks/utility poles in

1. The condition of the sidewalks in the study area is inconsistent:
 - a. The south side of Post Road consists of a three foot wide sidewalk with no buffer between the Circle Inn property and Shoreham Village Drive. This already narrow sidewalk is further restricted by overgrowth and utility poles.

1. Remove some of rock ledge on south side of Post Road to make room for widening the sidewalk to five feet. It is noted that there may be right of way implications.
2. Relocate utility poles on the south side of Post Road from the middle to the back of the sidewalk. Relocating utilities underground is an option but would be very costly.
3. Realign the intersection of the Post Road Jug Handle and Kings Highway by squaring off intersection and reducing curb radius.
4. Improve bus stop on the Jug Handle Island across from the Fairfield Circle Inn by installing a shelter and cutting into severe slope (Figure 25).
5. Provide a refuge island for pedestrians crossing between the bus stop on the Jug Handle Island and the Fairfield Circle Inn (Figure 26).
6. Reconfigure the rotary where Post Road meets U.S. 1
 - o Check for 345 KV lines that may be underground

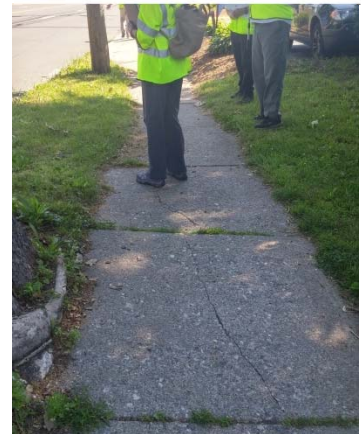
Figure 9. Overgrowth narrowing sidewalk

- a. Paint no parking hash marks where customers park in areas that are not designated spaces in the parking lot opposite Riverside Drive (Figure 18).
3. Sidewalks:
 - a. Clear overgrowth on sidewalks and maintain branches that encroach on sidewalk space.
 - b. Repair damaged sidewalk areas (Figure 19).
4. Add new bike racks along Post Road at popular destinations.
 5. Remove one or two parking spaces on Grasmere Avenue at street corners for bus route stops.
 6. Perform a road diet study on Post Road.

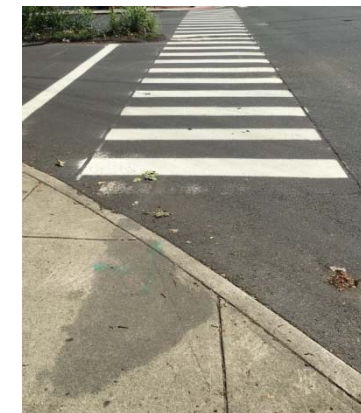
- There is one bike rack on the northwest corner of Post Road and Grasmere Avenue.
- Cyclists were observed riding on the roadway and sidewalk.
- The crosswalk at the intersection of Grasmere Avenue and Post Road (Figure 10):

- Does not have pedestrian push buttons.
 - Is missing a detectable warning strip on the northeast corner.
- The sidewalk on the north side of Post Road ends abruptly at the Intersection of Post Road and Riverside Drive.

Figure 10. Missing pedestrian push button and detectable warning strip

3. Crosswalks:
 - a. Replace sidewalk ramps and/or add detectable warning strips to ramps where needed (Figure 21).
 - b. Coordinate with CTDOT to install pedestrian push button and signal for the Grasmere Avenue crossing at Post Road.

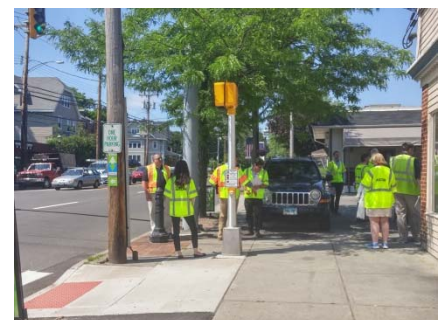
- The sidewalk is interrupted by a parking lot for the local businesses.
 - At the sidewalk's end there is a paved area that is not a parking space. Customers park here and impede pedestrian travel (Figure 11).

Figure 11. Car not parked in a designated space

- b. Connect sidewalks on both sides of the entrance to the parking lot opposite Riverside Drive. This could mean installing a sidewalk, using an alternate textured material or simply painting a crossing.

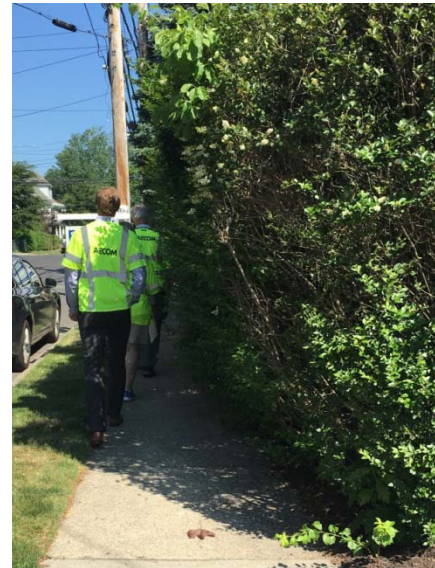
- The northbound travel lane measures 16 feet and the southbound travel lane measures 17 feet. This includes space for on street parking.
- The sidewalks on both sides of Grasmere Avenue are overgrown in multiple areas (Figure 12).

Figure 12. Poorly maintained sidewalk landscaping

- b. Sidewalks are uneven, which may prove especially difficult to navigate by elderly and disabled pedestrians.
 - c. There are lengths of sidewalk on Grasmere Avenue that have overgrown trees and bushes. In these areas leaves and branches encroach upon the sidewalk and pedestrians must walk off of the sidewalk in order to avoid them.

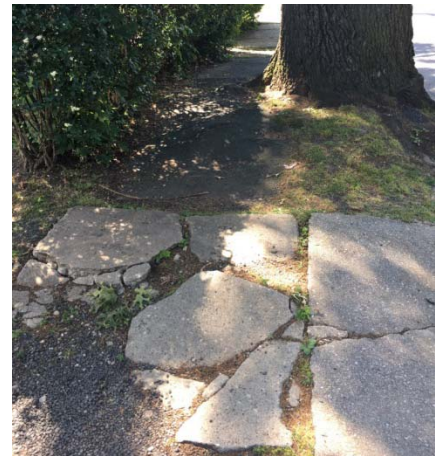
- The sidewalks on both sides of Grasmere Avenue are deteriorating and uneven in multiple locations (Figure 13).
- Some catch basins have not been replaced with bike friendly grates that have smaller openings.

Figure 13. Poor sidewalk condition

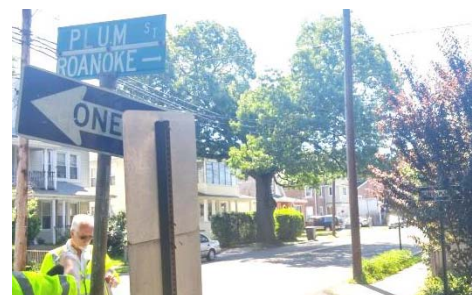
- Vehicles travel much faster where there is no on street parking.
- At the intersection of Grasmere Avenue and Plum Street there is a one way sign pointing in the wrong direction and another one way sign partially blocked by tree branches (Figure 14).

Figure 14. One Way Sign pointing in wrong direction/covered by branches

1. Signage:
 - a. Trim branches in front of one way sign on Plum Street.
 - b. Correct one way sign on Plum Street that is facing the wrong way.
2. Pavement Marking:

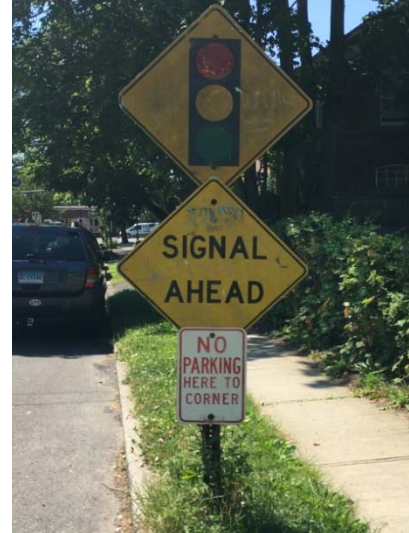
- Intersection with Post Road has a very large turning radius. This is necessary due to heavy truck traffic on Grasmere Avenue.
- Some traffic signs are mounted below standard height (Figure 15).

Figure 15. Signs mounted below standard height

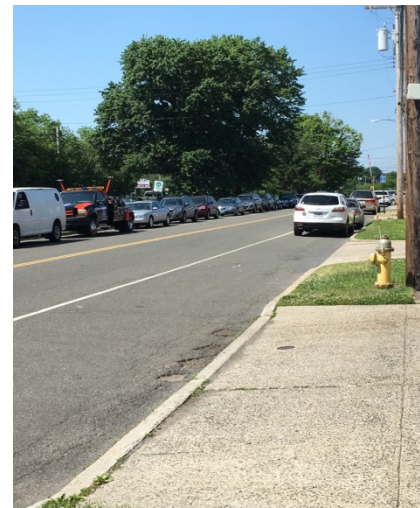
- The road could be converted to a one way street but there is opposition from the businesses on the street.
- There is only a sidewalk on the north side of the road. The sidewalk on the north side is disjointed and ends in front of Physical Synergy (Figure 16).

Figure 16. Disjointed sidewalk

- d. In some areas the sidewalk network is fragmented. The sidewalk stops on the north side of Post Road across from Riverside Drive and in front of Physical Synergy. This occurs in areas where pedestrians may still expect to be able to continue walking.

1. Install shelters at bus stops along the corridor.
2. Sidewalk network:
 - a. Continue sidewalk on Post Road Jug Handle from Physical Synergy to businesses further west on the street.

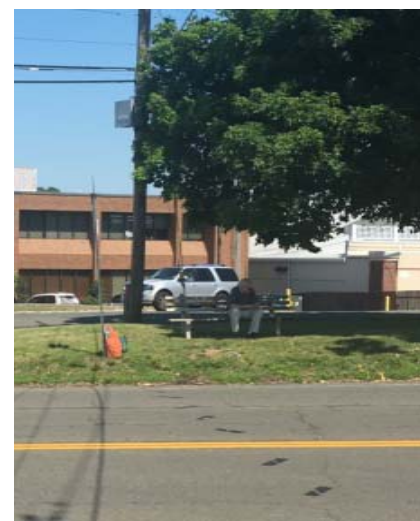
- Bus stop on Jug Handle Island (Figure 17):
 - There are no crosswalks on Post Road or the Rotary for pedestrians to use to reach the bus stop on the island.

- Post Road is 61 feet wide at this location.

Figure 17. Post Road jug handle bus stop

- There is a bench with no shelter.
- Bus riders must navigate a steep grass slope where the bus picks up when boarding or getting off the bus. There is no sidewalk.

- c. Coordinate with CTDOT to install a midblock crosswalk on the Post Road Jug Handle in conjunction with a bus stop placement study.
4. Widen sidewalks where possible.
