COMMUNITY
connectivity program

Greenwich

Downtown

Road Safety Audit

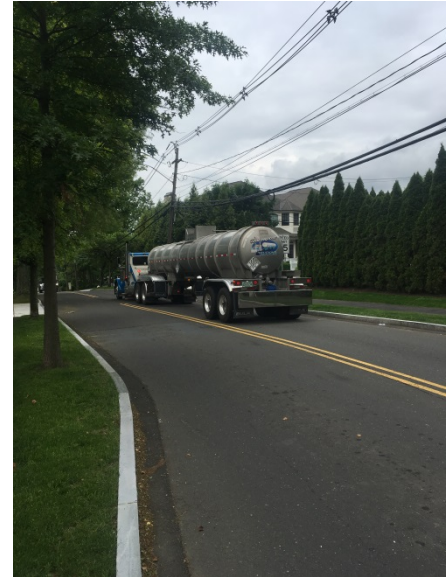
Figure 6 Heavy Truck Route

- Sight distance is restricted coming uphill on Sound View Drive by a stockade fence and vegetation (apparently on private property).
- This is heavily used as a truck route between I-95 and Route 1 (Figure 6).

- Consider adding RRFB for Sound View Drive crosswalk.
- Evaluate installing a Roundabout.
- Evaluate Field Point Road being converted to one-way southbound from Sound View Drive to Railroad Avenue.

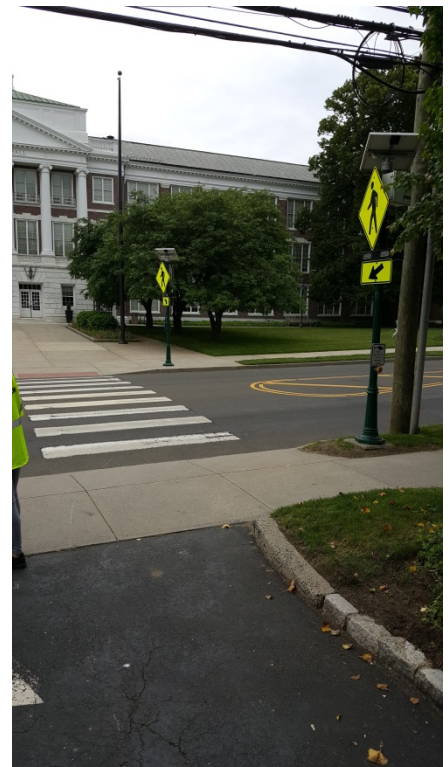
Figure 7 Rectangular Rapid Flashing Beacon Installed

- This mid-block crossing is controlled with a Rectangular Rapid Flashing Beacon (RRFB) (Figure 7).
- The crosswalk on the west side is within the edge of a driveway.
- There are no advance pedestrian crosswalk signs.
- The west side sign is placed behind a utility pole,

blocking visibility for northbound approaching traffic.

- Install advance crosswalk signs on Field Point Road.
- Move crosswalk and RRFB installation north to avoid driveway touchdown on west side, and to improve visibility to west side RRFB.

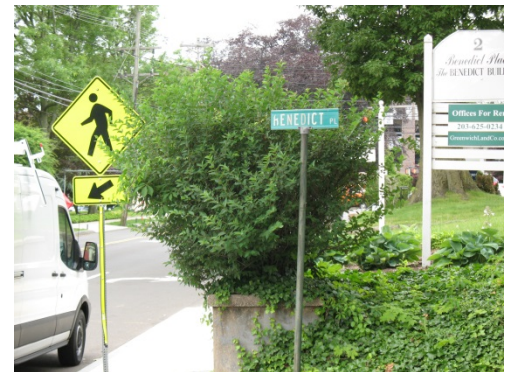
Figure 8 Overgrown vegetation

- This is a stop sign controlled T-intersection.
- The crosswalk is within the driveway on the south side.
- The crosswalk signs are mounted too low.
- The west leg has a bar-type crosswalk. The other crosswalk is a parallel line crosswalk.
- There is overgrown vegetation along the sidewalk (Figure 8).

- Relocate west leg crosswalk to the east leg of the intersection to eliminate driveway touchdown.
- Consider adding a bumpout to shorten the crossing distance.
- Raise crosswalk sign to 7' vertical clearance.
- Maintain overgrown vegetation on Benedict Place sidewalk.
- Standardize type of crosswalk markings.

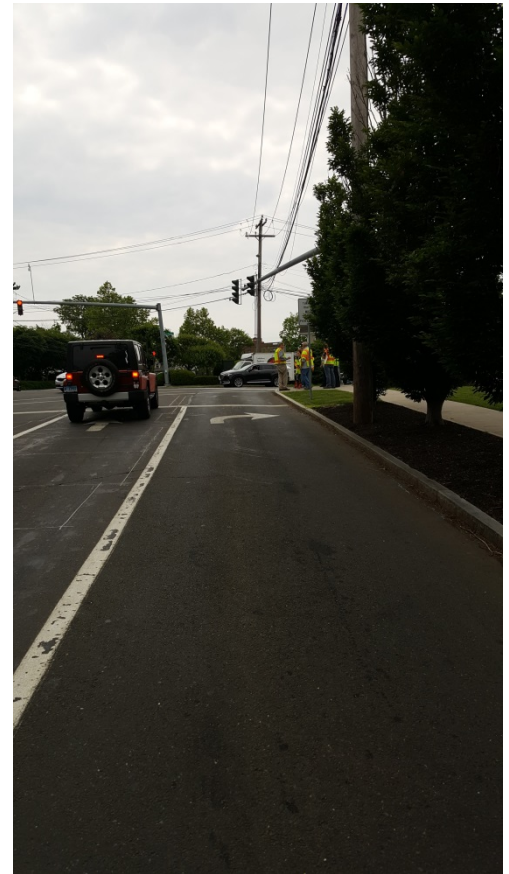
Figure 9 Overgrown Vegetation Blocking Signs

- This is an Offset intersection, with Lafayette Court intersecting from the north and Greenwich Avenue intersecting from the south, approximately 125 feet apart. Greenwich Avenue is one-way to the south (away from the intersection).
- The three intersections are operated by a single controller. The pedestrian phase is exclusive.
- Westbound vehicles at Lafayette Place previously had problems that cluttered sightlines looking downstream to the signal at Greenwich Avenue and not seeing the signal at Lafayette Place. The mast arm was relocated to help solve this problem.
- There are three crosswalks to cross West Putnam Avenue: one at Greenwich Avenue and two at Lafayette Place.

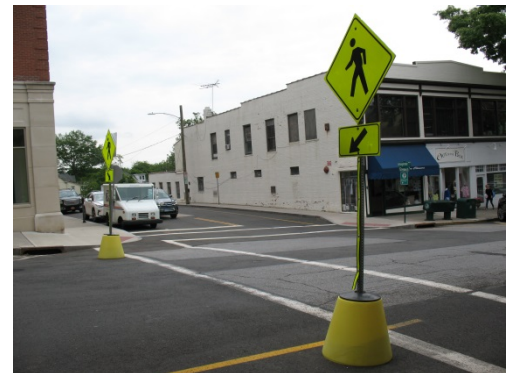
Figure 10 New Pedestrian Crossing signs

- This is a stop sign controlled T-intersection. Greenwich Avenue is one-way southbound. Head-in angle parking is located on both sides of Greenwich Avenue.
- There are crosswalks on the Amogerone Crossway leg and on the north leg of Greenwich Avenue.
- Drivers on Greenwich Avenue were not seeing signs or pedestrians crossing due to the angle parking. New Pedestrian Crossing signs were installed on moveable bases in the street at the rear of the parking spaces. They are working well (Figure 10).

- Bumpouts should be considered for both crosswalks to shorten crossing distances and protect parking areas.
- If bumpouts are constructed, the Pedestrian Crossing signs could be permanently mounted in the widened sidewalk area.

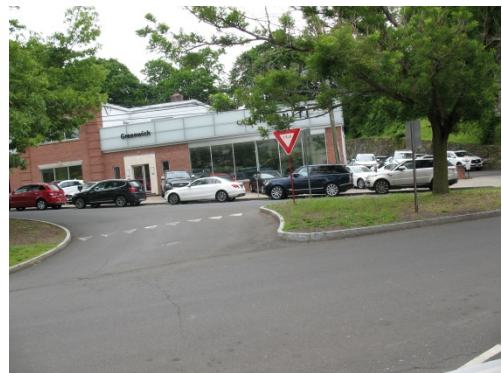
Figure 11 Yield Sign in Roundabout

- The Yield sign within the roundabout creates traffic queues on Fawcett Place and Mason Street for traffic heading south on Mason Street (Figure 11).
- There is no sidewalk on the west side of Millbank Avenue, and the east side sidewalk is asphalt.

- A traffic study should be conducted to determine ways to improve the operational efficiency of the roundabout. The study will include obtaining turning movement counts and tracking counts. Geometric improvements can be evaluated, including the overall circumference, the approach and departure angles, the size and location of splitter islands, sight lines, and the locations of traffic controls.

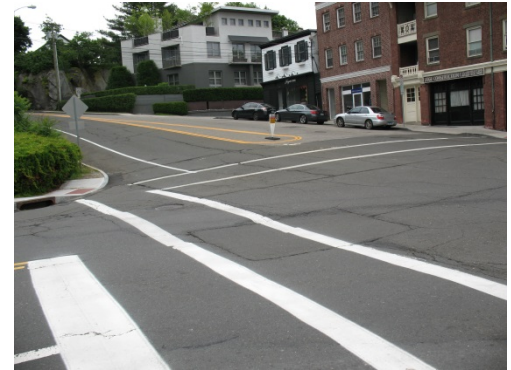
Figure 12 Wide Intersection

- This is an unsignalized T-intersection, with stop sign control on Mason Street.
- The west leg of Bruce Park Avenue has a through lane and a left turn lane toward the intersection and departing the intersection, with parallel parking on both sides. This creates a very wide roadway (Figure 12).

- There is a steep grade therefore the sight distance is restricted for westbound traffic on Bruce Park Avenue by a hedgerow immediately behind the sidewalk on Mason Street and just behind the curb on Bruce Park Avenue.

- Consider installing a pedestrian refuge island in the center of Bruce Park Avenue east of the intersection. The pedestrian sign can then be permanently installed in the island. The new sign should use the proper legend "Yield to Pedestrian".
- Consider relocating the crosswalk or adding a new crosswalk on the west side of the intersection.
- Remove parking spaces conflicting with the crosswalk sight distances.
- Add bumpouts on northwest corner and on the south side of the street at the final crosswalk location(s).
- Evaluate road diet options including roundabout and single-lane approaches.

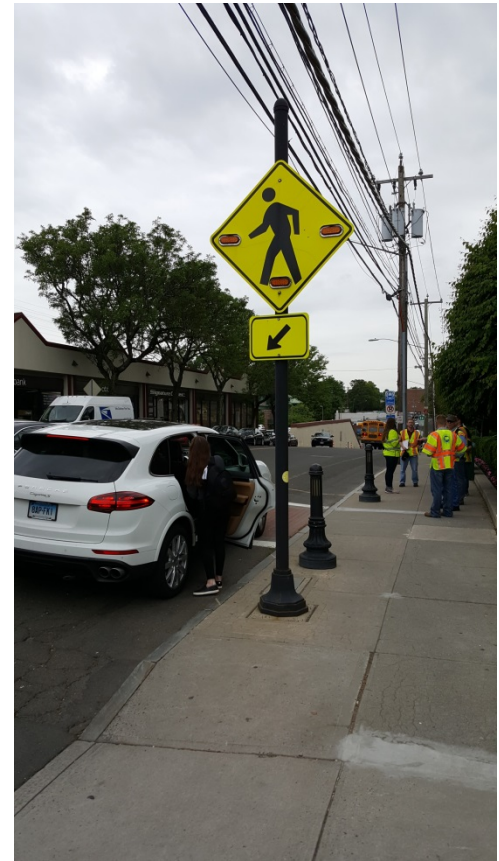
Figure 13 Midblock Crosswalk Blocked

- This is a raised, textured crosswalk located mid-block between Greenwich Avenue and Arch Street.
- The crossing has non-standard “high-visibility” flashers mounted within pedestrian crossing

signs, and in-pavement warning lights. Presently, the system is not functioning. There is also a flex-mount pedestrian crossing sign in the center of the road.

- The system uses passive pedestrian detection.
- The crosswalk is frequently blocked by parked cars discharging passengers, or by short-duration stops (Figure 13).

- Repairs should be made to the broken Pedestrian Flashing sign and/or in-pavement warning devices to make them operational.
- Consideration should be given to converting to a standard RRFB installation, which may be better understood by motorists.
- Consideration should be given to eliminating some parking and placing bumpouts on both sides of the street to discourage illegal parking, calm traffic and shorten the crossing distance.
- Consideration should be given to installing a pedestrian refuge island to provide better visibility and safety for pedestrians, as well as calming traffic.
