COMMUNITY
connectivity program

Manchester

Downtown – Road Safety Audit

August 3, 2016

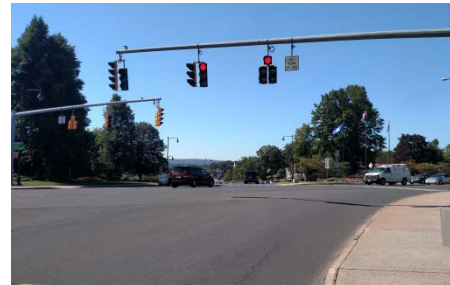
Figure 8. Intersection of Main Street and Route 44

- Intersection of Main Street and Center Street/East Center Street (Route 44) (Figure 8):
 - There is no turn on red from southbound Main Street to Center Street westbound.
 - This intersection has an exclusive pedestrian phase. The pedestrian signal heads are not countdown. They are audible.
 - The ramps do not have tactile warning strips.
 - The crosswalks are the "Zebra Style."
 - The sidewalks on the south side of the intersection are 10 feet wide.

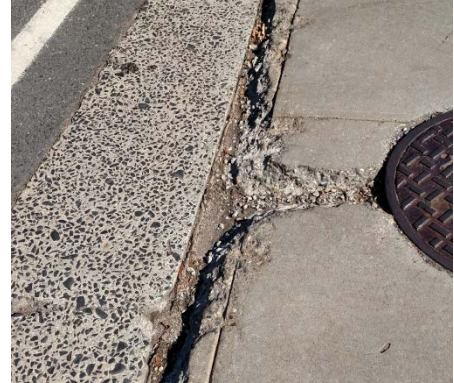
Figure 9. Deteriorating Curbing

- Manchester is currently retrofitting the street lights with LED and positioning them in such a way to maximize the light shed.
- The curbing is deteriorating in places (Figure 9).

13. Perform sidewalk maintenance where the curbing/sidewalk is deteriorating.

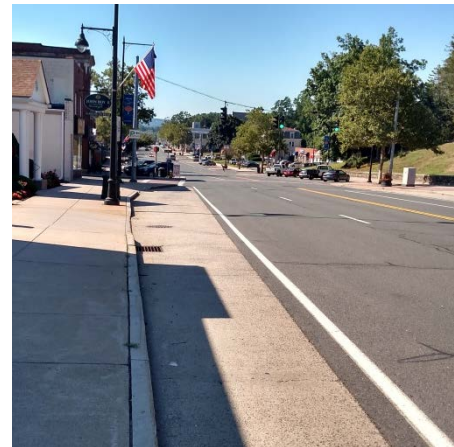
Figure 10. Bus Stop Pull Out on the East Side of Main Street

- There are bus bay pull outs on both sides of Main Street in front of Center Memorial Park. The stop on the west side has a shelter, but the east side does not (Figure 10).

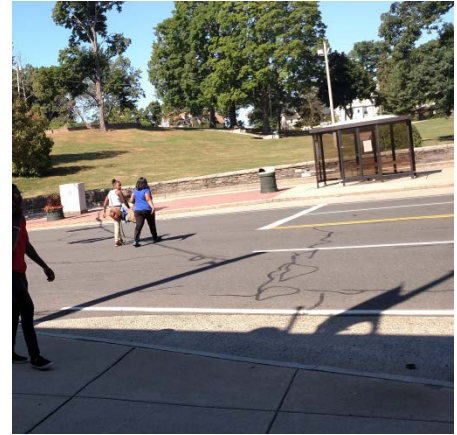
Figure 12. Pedestrians Crossing Mid-Block

- Several pedestrians were observed Jay-walking at several points along the corridor (Figure 12).
- There are bump outs at Brainard Place and the 7-Eleven (Figure 13). This intersection is not signalized. These bump outs shorten the crossing distance and many pedestrians cross mid-block here. A formalized mid-block crossing treatment here, such as a rapid flashing beacon, could prove useful.

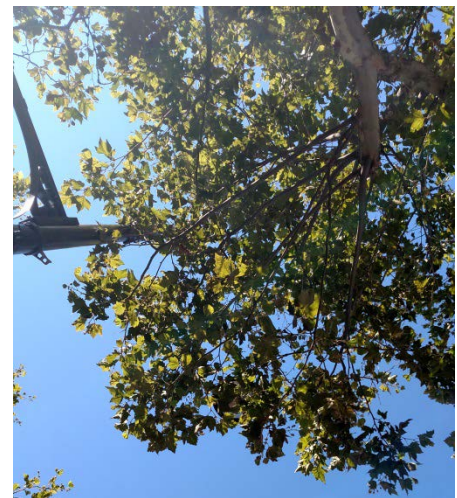
Figure 14. Light Blocked by Tree Canopy

- Many of the street lights are obstructed by the trees diminishing the light shed (Figure 14).

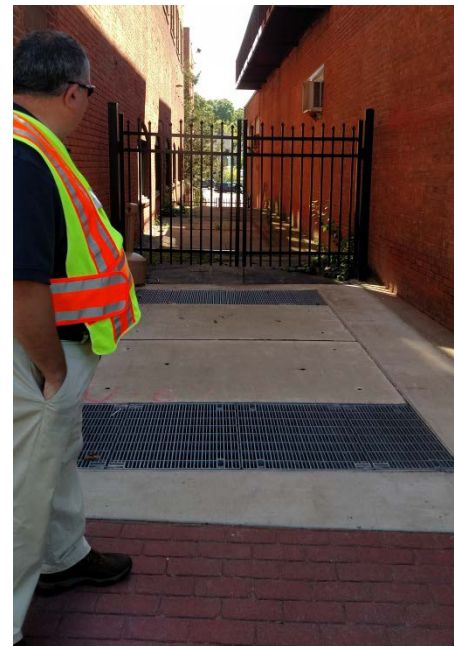
Figure 17. Private Alley to Parking Lot Closed to Public

- There is a private alleyway on the east side of Main Street between Bray Jewelers and One Heritage Place from Main Street to the public parking lot behind. It is closed off and locked, blocking access. (Figure 17).

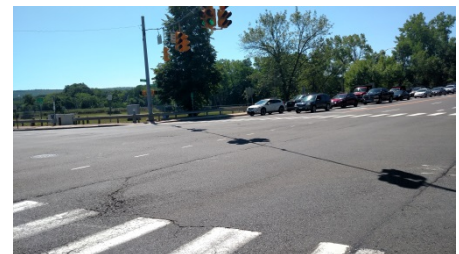
Figure 20. Hartford Road Intersection

- The intersection of Hartford Road and Main Street has crosswalks across all four legs. The crossings are long and do not have tactile warning strips. (Figure 20).
