COMMUNITY
connectivity program

Waterford

Route 156 and Logger Hill Road – Road Safety Audit

April 6 - 2016

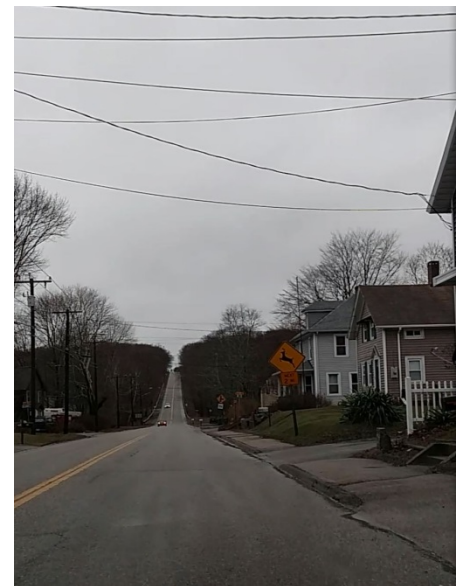
Figure 5. Rope Ferry Road Looking West

- The roadway has 12 foot wide travel lanes, with shoulders that vary between one and three feet wide. The shoulders are widest at Jordan village, and narrow approaching the hill.
- The grade of the roadway is steep. (Figure 5).
- Sidewalks are on the north side of the road between North Road and B Lane. They are asphalt, without a buffer, ramps, or tactile warning strips. The eastern section has granite curbing with a low curb reveal, the western has bituminous curbing.
- East of B Lane there is no shoulder striping on the north (westbound) side of the road, there is shoulder striping on both sides in all other locations.

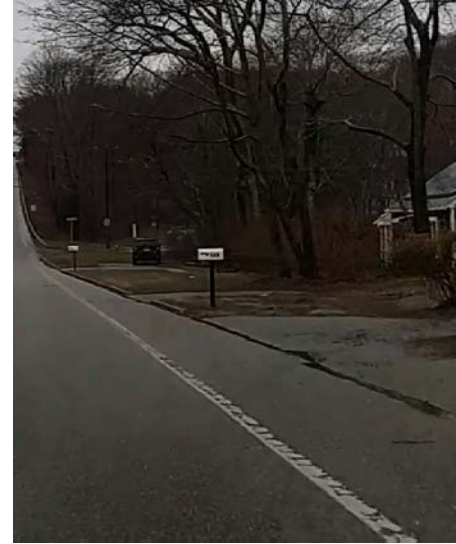
- The houses on the north side of the road are set back a distance and vehicles use this space to park off the street (Figure 6).
- The mail boxes east of Logger Hill Road are set to the curb line.

Figure 6. Area Where Vehicles Park Due to Large Set Back

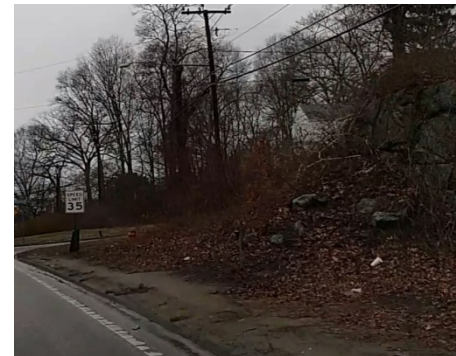
- Worn foot paths are evident along Rope Ferry Road (Figure 7).
- There is an erosion and drainage issue on the north (westbound) side of the road west of Logger Hill Road. It is evidently due to scouring.

Figure 7. "Worn Foot Paths Along Roadway"

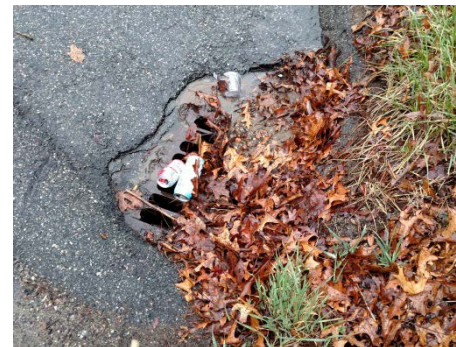
- Several catch basin grates were full of debris and trash, preventing proper drainage (Figure 8).

Figure 8. Clogged Catch Basin

1. Investigate right-of-way along Rope Ferry Road.
2. Apply to the Office of State Traffic Administration CTDOT to remove the 35 MPH speed sign as you approach the village and reduce the speed to 25 mph from the west end of Jordan Village to the intersection of Route I and 156.
3. Raise the height of the steep grade sign to meet MUTCD standards.
4. Conduct a Branding and Gateway Plan for Jordan Village which includes wayfinding within the village and to ancillary locations. This should be coordinated with any state wayfinding plans and updates including the supplemental Destination Guide Signs-Connecticut booklet
5. Create a bicycle and pedestrian plan for Waterford.
6. To reduce sign clutter, create a signage plan that integrates local and state signs.
7. Restripe Rope Ferry Road to 11 foot travel lanes.
8. Clean out catch basin.

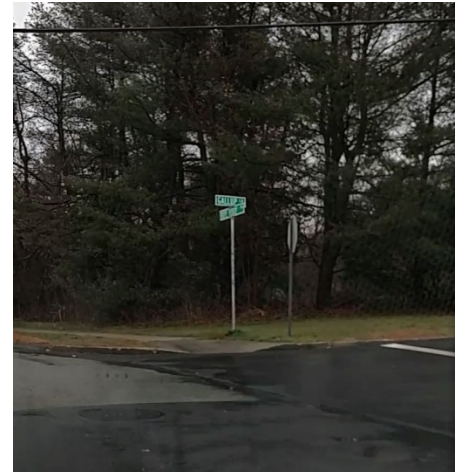
- The sidewalk west of Gallup Lane is positioned behind the guide rail. There are no tactile warning strips at the ramp (Figure 9).
- The radii at Gallup Lane are large, allowing for vehicles to take the turns at higher speeds.

Figure 9. Lack of Tactile Warning Strip on Sidewalk Ramp

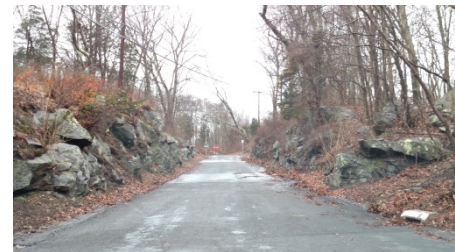
Figure 10. Pinch Point Along Logger Hill Road

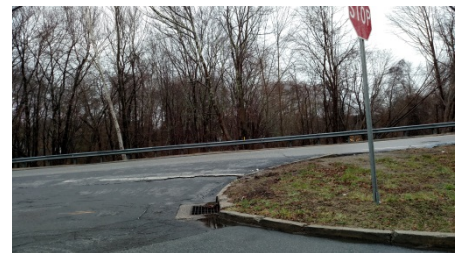
- The roadway width varies between 18 and 20 feet and there are no pavement markings or striping.
- Utility poles are along the south (eastbound) side of the road.
- The catch basin grates are of the older style.
- The road is heavily cracked.
- There are concrete curbs on the north (westbound) side of the road and no curbing on the south (eastbound).
- At the west end of the road there is a pinch point created by steep side slopes and rock. Widening the roadway here would require blasting (Figure 10).
- Sight distance is poor for vehicles trying to turn left on onto Rope Ferry Road due to the crest in the road.
- The stop sign at the east end is set back from the stop bar, and the stop bar is faded (Figure 11).

Figure 11. Stop Sign Set Back From Bar
