# West Hartford

Albany Avenue (U.S. Route 44) & North Main Street

(Route 218) Bishops Corner – Road Safety Audit

March - 2016

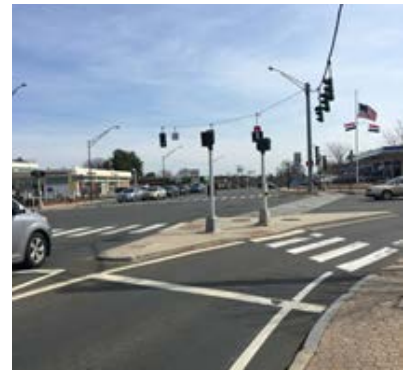
Figure 6. Pedestrian Crossing and Triangular Channelizing Island

- The exclusive right-hand turn lanes create a difficult environment for pedestrians to cross. Vehicles turning right often are not looking out for pedestrians (Figure 6).
- The triangular channelizing island sizes vary and pedestrians do not have the feeling of being protected while on the triangular channelizing island (Figure 6).
- Heading southbound on North Main Street, when approaching the southwest triangular channelizing island, there is a tight squeeze for cyclists due to the direction of the curve and triangular channelizing island alignment.
- Pedestrian pushbuttons are directional due to the concurrent walk phases. Their placement makes

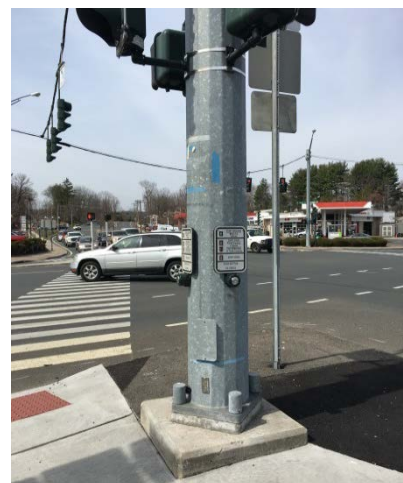
Figure 7. Unclear Pushbutton Direction

it difficult to be sure of the correct button to push (Figure 7).

2. Add ADA compliant pushbuttons and countdown pedestrian heads. Accessible pedestrian signals have pushbutton locator tones, a vibrotactile arrow pushbutton, and have an audible signal during the walk phase. The design should be confirmed with the Connecticut Services for the Blind. Orient buttons and add pedestals, where necessary, to improve accessibility and eliminate confusion about direction (Figure 21 and Figure 22).

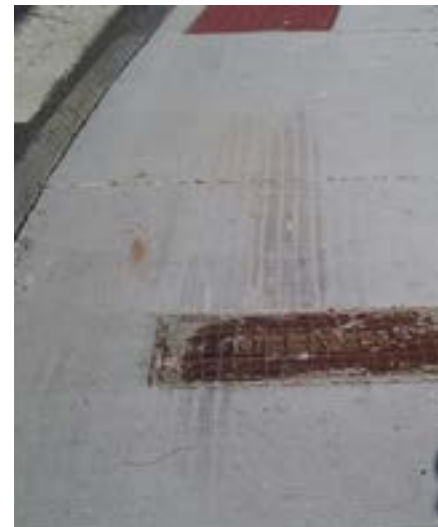
Figure 8. Tire Marks on Sidewalk

- Pedestrians crossing non-designated areas.
- Southbound tractor trailers on North Main Street using the right-hand turn lane often drive over part of the sidewalk due to the narrow lane and tight angle (Figure 8). This a safety concern for pedestrians who are waiting to cross the street at that sidewalk. This corner has a lot of visible wear (brick pavers have settled, curbs are very worn).

- b. Reconstruct northwest radius to accommodate large vehicle movements.
5. Remove trees/shrubs for better sight distance on northwest corner.

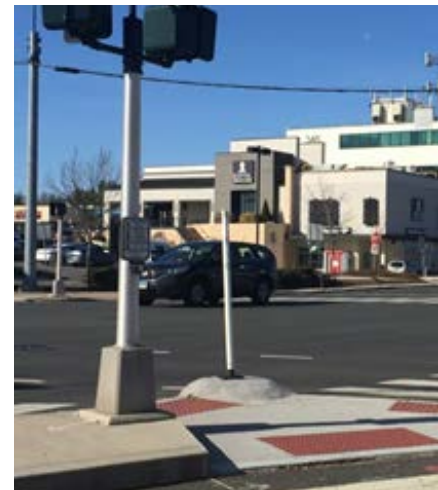
Figure 9. Pylon

- Northbound on North Main Street, channelizing pavement markings, also called "cat tracks", were added through the intersection because cars were hitting the far-side triangular channelizing island. A reflective pylon (Figure 9) was also added to the N/E triangular channelizing island corner to highlight it.

- b. Add pylons (a traffic cone used to direct vehicles, see Figure 9) for visibility.
5. Sidewalks/Crosswalks:
  - a. Repaint crosswalks (Figure 16).
  - b. Repair damaged sidewalk areas (Figure 17).

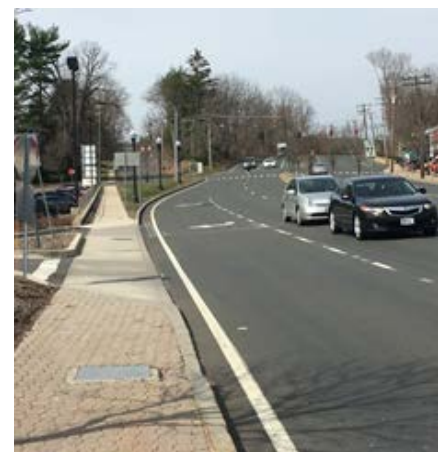
Figure 10. Inadequate Shoulder Area

- Shoulder area in some places is less than one foot (Figure 10).
- The gas station driveways are close to the intersection and vehicles queue past the driveways making it difficult for vehicles to exit.

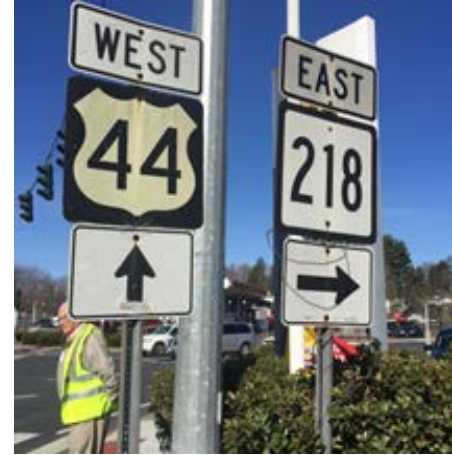
Figure 11. Directional Signage

- The far side (S/W) triangular channelizing island sticks out into the shoulder, creating a choke point for southbound cyclists.
- Pedestrians waiting on the triangular channelizing islands can create a blind spot for vehicles making right turns.
- The triangular channelizing islands vary in condition. Some are fairly new concrete, while others are badly worn concrete or asphalt. Tactile warning strips are inconsistently installed.
- Signing is generally adequate. Striping is worn due to heavy traffic loads.
- Reflective paint on triangular channelizing islands is either worn or nonexistent.
- Directional route signing is too close to the intersection (Figure 11).

1. Signage:
  - a. Adjust signage height to meet the required seven (7) feet standard.
  - b. Adjust route signs to improve visibility (Figure 15).
  - c. Replace worn-out signs with reflective signs based on current standards..

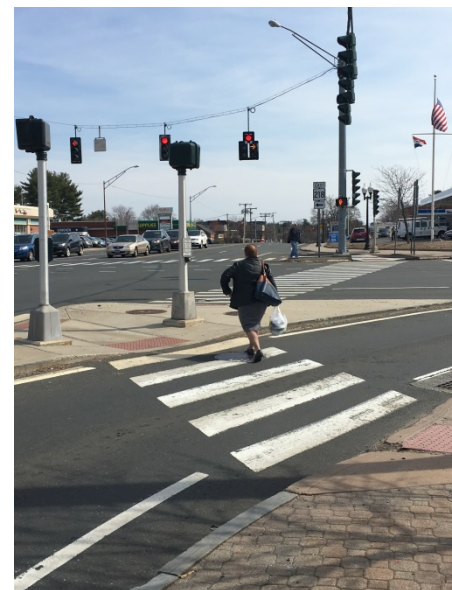
Figure 12. Pedestrian Crossing

1. There is a conflict between right turning vehicles and pedestrians crossing to the triangular channelizing islands. Pedestrians cross the right turn lane without a pedestrian signal, although they are in a marked crosswalk and the turning vehicles are controlled by the signal operation (Figure 12 and Figure 13). The vehicle has the legal right-of-way when the signal is green or green arrow, but the pedestrian has the legal right-of-way if the vehicle signal is red. Neither drivers nor pedestrians are always fully aware of the rules, and pedestrians often don't look up to see the vehicle signal. Furthermore, at the two corners lacking an auxiliary signal, visibility is even

more difficult, since the signal controlling the right turn is not obvious. Multiple alternatives were discussed, including elimination of the right-turn green arrow, reverting to the exclusive pedestrian phase, and adding auxiliary heads where they are missing. In addition, various methods for controlling the triangular channelizing island crossings with a pedestrian signal were discussed, with the most obvious solution being the use of an exclusive pedestrian phase.

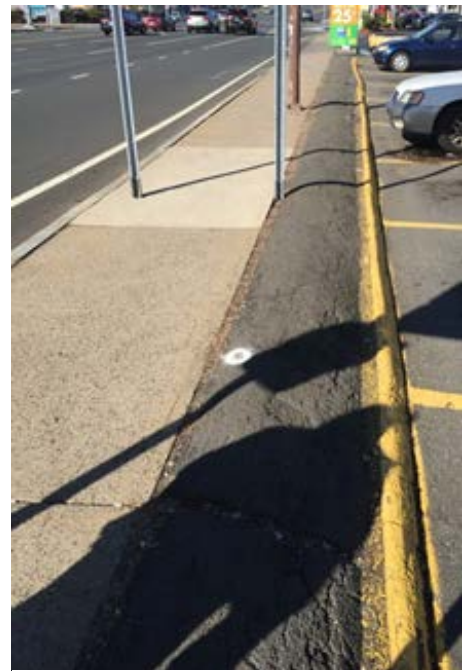
Figure 14. Sidewalk

7. West Hartford's standard sidewalk width is a minimum of five (5) feet. In the winter, extra room on the sidewalk is needed for snow (Figure 14).
