COMMUNITY
connectivity program

Westport

Hillspoint Road, Compo Road and Compo Beach Road
Road Safety Audit
August 23, 2016

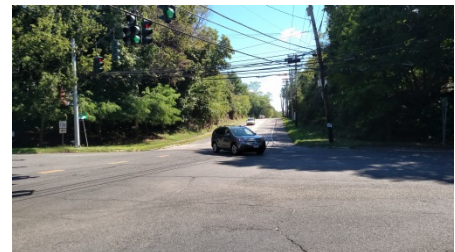
- The radius on the southwest corner is large. This increases the crossing distance and encourages vehicles to go faster.
- There is no crosswalk across Green Farms Road even though there is sidewalk on either side (Figure 6).

Figure 6. No Crosswalk Across Green Farms Road

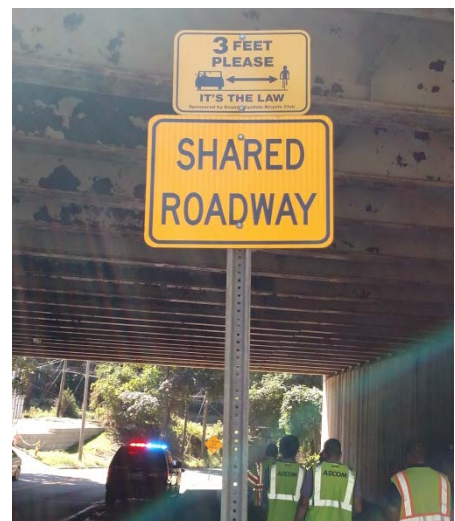
- Six runners/walkers and ten cyclists were observed along Compo Beach Road during an off-peak mid-morning period on a weekday.
- Westport has installed share the road signs along Compo Road South, to the south of the I-95 Bridge (Figure 7).

Figure 7. Share the Road Sign

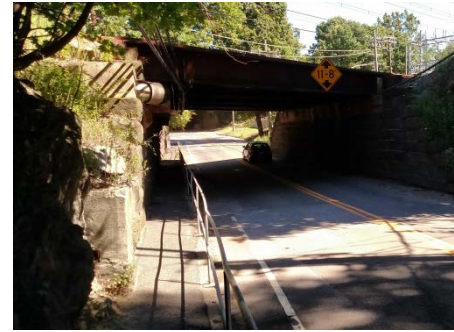
- South of Elaine Road the sidewalk narrows and transitions from five feet wide concrete with a snow shelf to three to four feet wide asphalt without a snow shelf. The sidewalk is narrowest passing under the Metro North railroad bridge. Conduit on the north side of the bridge further creates a pinch point, narrowing the passage down to less than three feet. The sidewalk is elevated under the bridge, requiring a railing (Figure 8).

Figure 8. Narrow Sidewalk and Lack of Lighting Under the Metro North Bridge

- Under the Metro North railroad bridge there is no lighting (Figure 8).
- The road narrows going under the Metro North railroad bridge creating an unsafe space for cyclists. Widening the road would require replacing the bridge and adding retaining walls.
- Dirt and leaf debris have begun to encroach on the sidewalk just south of the railroad bridge narrowing the sidewalk (Figure 9).

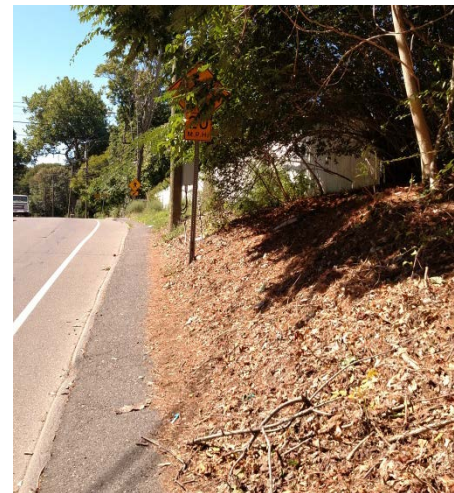
Figure 9. Narrowing Sidewalk Due to Leaf Debris

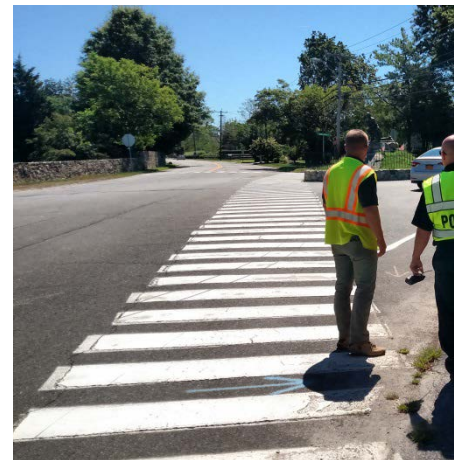
Figure 10. Long Crosswalk for Compo Beach Road

- The intersection of Compo Road South and Compo Beach Road is a three way stop, but due to the Minuteman Statue the crosswalk for Compo Beach Road is 150 feet long (Figure 10).

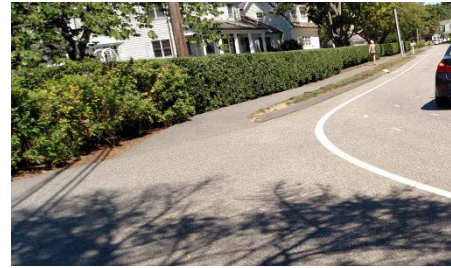
Figure 11. Sidewalk Ends at Owenoke Park

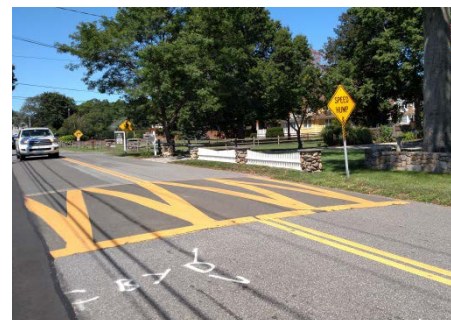
Figure 13. Speed Hump on Compo Beach Road

- There are two speed humps on Compo Beach Road (Figure 13).
- Where Compo Beach Road becomes Soundview Road the sidewalk can get washed out during large storm events.

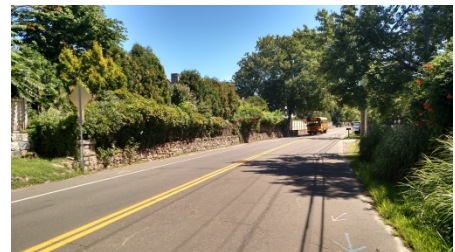
- There is no sidewalk along Compo Road South from Compo Beach Road to Hillspoint Road. The road is narrow and installing a sidewalk would require right-of-way acquisition or converting this segment of the road to one way. Utility poles are on the south side of the road. Many properties have stone walls built to the property line which may need to be relocated if the road is widened (Figure 16).

Figure 16. Compo Beach Road, Narrow With Stone Walls

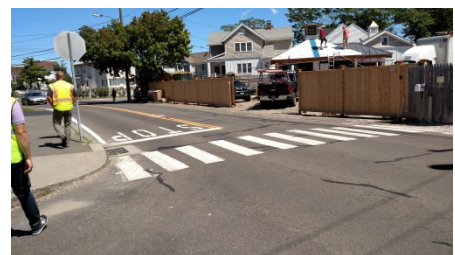
Figure 17. Crosswalk at Compo Hill Avenue Intersection Lacks Sidewalk Connection on the East Side

the west but does not connect to the sidewalk on the east (Figure 17). The sidewalk on the east ends just before the crosswalk. The crosswalk does not have a landing ramp.

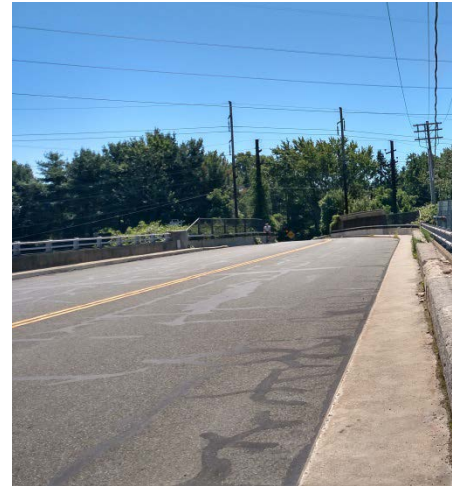
- There is no shoulder line striping on either the bridge over I-95 or the Metro North Rail Road on Hillspoint Road. The sidewalk over both bridges is only three feet, the travel lanes are 20 feet. A load analysis should be done to determine if the sidewalk can be widened on the bridge and travel lanes narrowed (Figure 18).

Figure 18. I-95 Bridge With Narrow Sidewalk and Wide Lanes

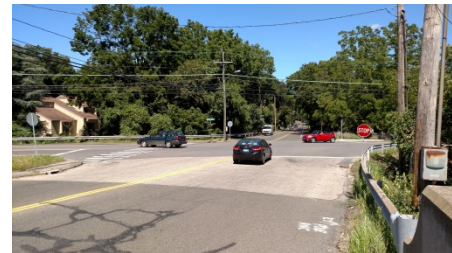
- There is no protective fence on the I-95 bridge to prevent people from leaning over the railing.
- There is no formal right turn lane at the Hillspoint Road (Northbound) and Green Farms Road intersection but since the lane is wide cars often create their own lane (Figure 19).

Figure 19. Wide Lane Leads to Vehicles Creating Own Turn Lanes

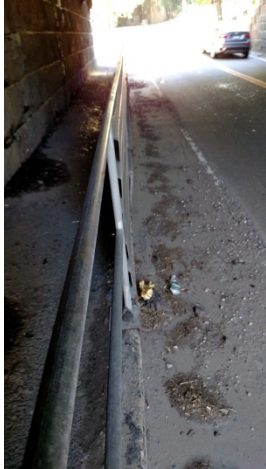
Figure 20. Guard Rail to Improve

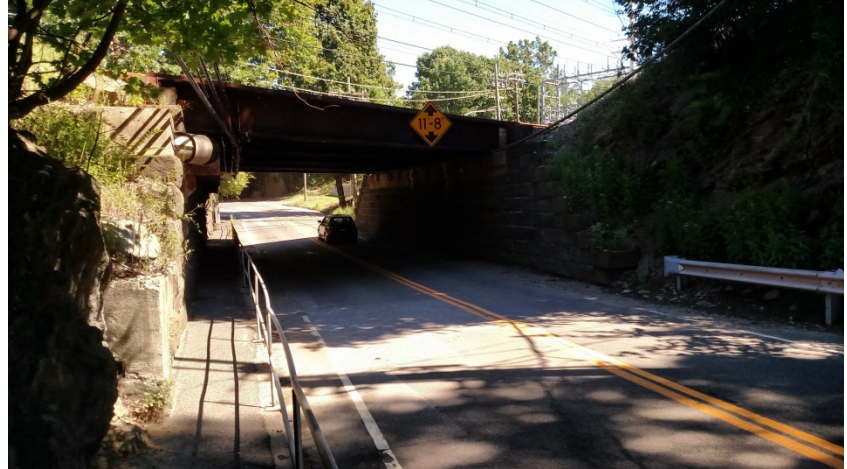
Figure 21. Add Lighting Under the Bridge

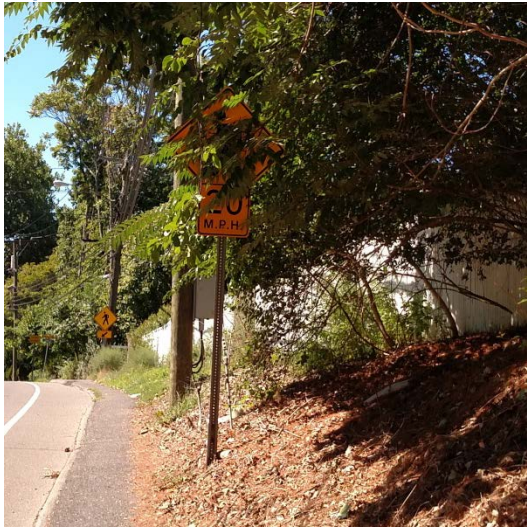
Figure 22. Trim Branches Blocking Sign

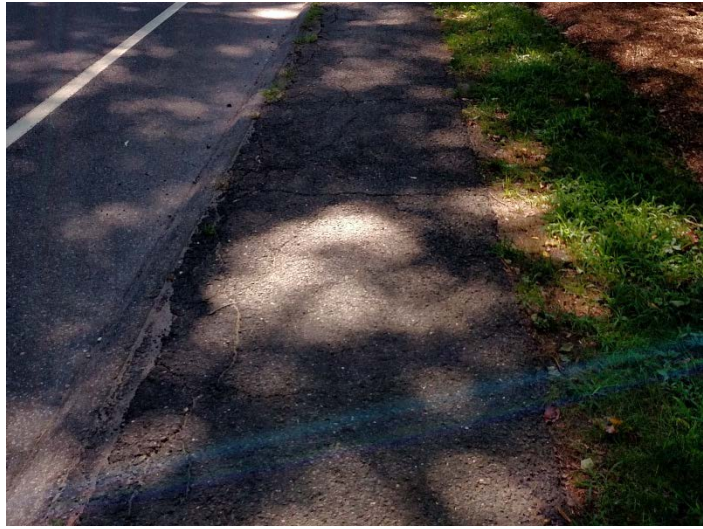
Figure 23. Repair Cracked Sidewalks

9. Perform sidewalk maintenance (Figure 23).
10. Install pedestrian crossing signs at unsignalized crosswalks where missing.
11. Paint a shoulder line on the side of Compo Beach Road.

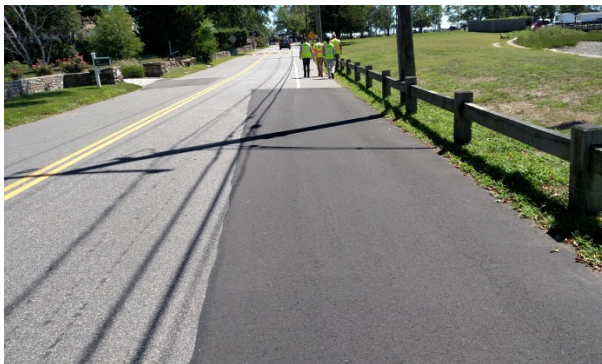
Figure 24. Add Shoulder Strip Line

12. Repaint shoulder on Compo Beach Road where missing due to recent repaving (Figure 24).
13. Replace signs with newer retro-reflective ones.
14. Examine right-of-way along Hillspoint Road to determine potential for widening the sidewalk and painting shoulder lines on both sides.

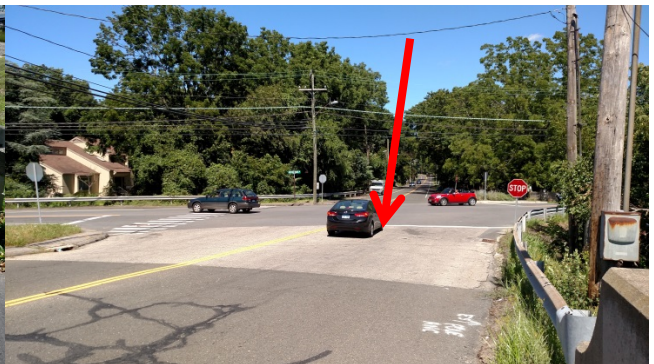
Figure 25. Add Right Turn Lane

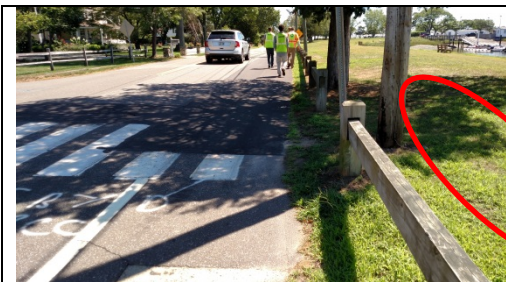
Figure 27. Multi-Use Path Behind Guard Rail

6. Create a multi-use path from Owenoke Park to Soundview Drive. Place it behind the guide rail (Figure 27).
7. Investigate the best way to add a sidewalk on Compo Road South from Compo Beach Road to Hillspoint Road. Possible alternatives include widening the roadway or converting the road to one-way.

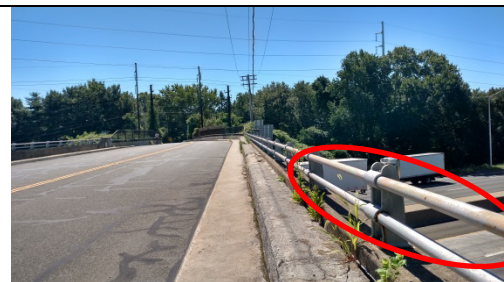
Figure 28. Add Fence to Railing

8. Improve the sidewalk conditions from Bridge Street to Baker Avenue.
9. Extend the bike lane north to Route 1.
10. Install a protective fence on the I-95 bridge to prevent people from leaning over the railing and potentially falling on the highway (Figure 28).
