# CONNECTICUT DEPARTMENT OF TRANSPORTATION

## CONDITION INSPECTION FOR THE ANSONIA STATION

**CONN. DEPT OF TRANSPORTATION  
STATION INSPECTION**

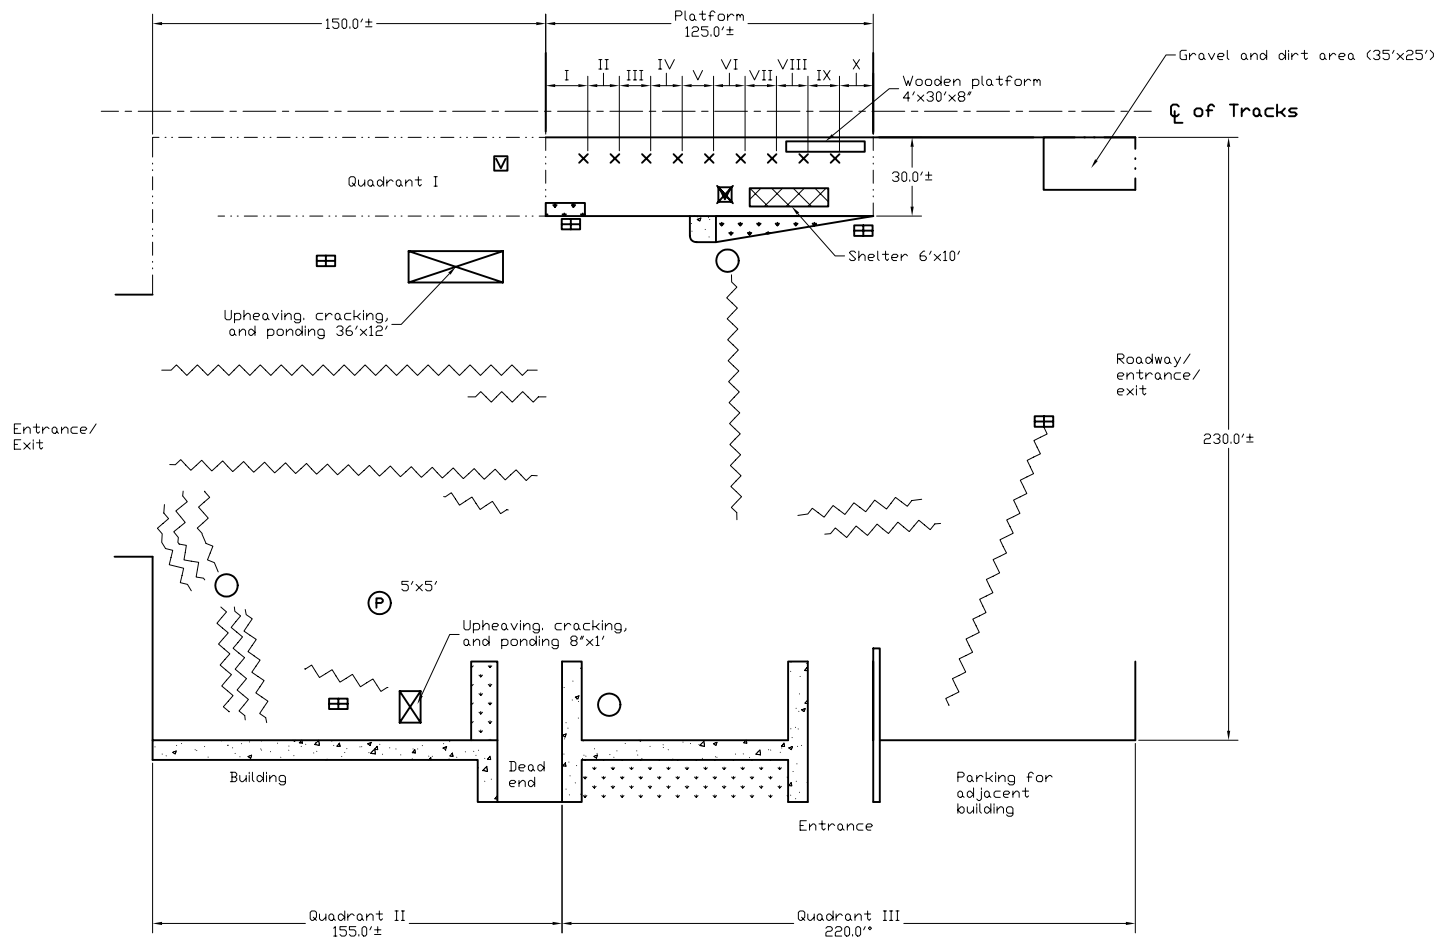
Urbitran Associates, Inc.
Connecticut Dept. of Transportation
Ansonia Station General Plan
Date: 11-19-01

- NOTES:
1. The timber columns in Spans I, VII, VIII, and IX are cracked.
  2. The surface of Quadrant I is a mix of gravel and asphalt which contains uneven driving surface, cracks, potholes, and vegetation growth.

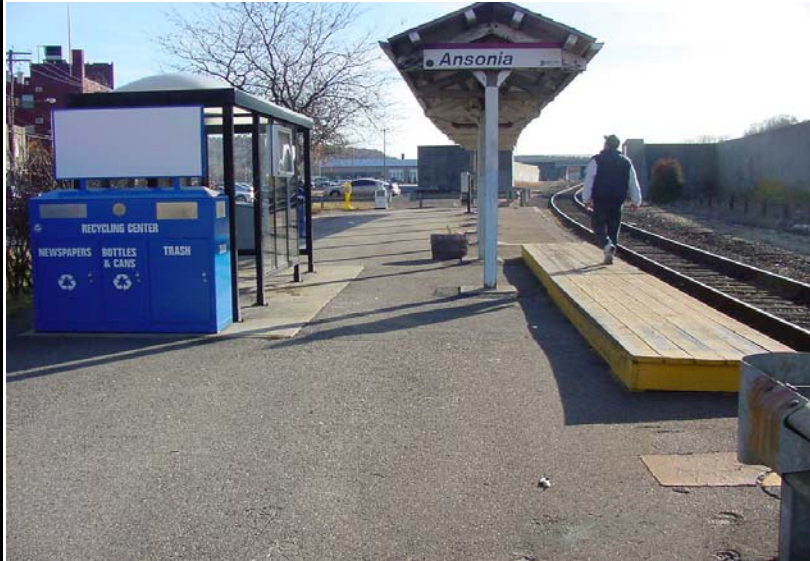
PHOTO NO. 1

Description: \_\_\_\_\_  
General view of the  
platform

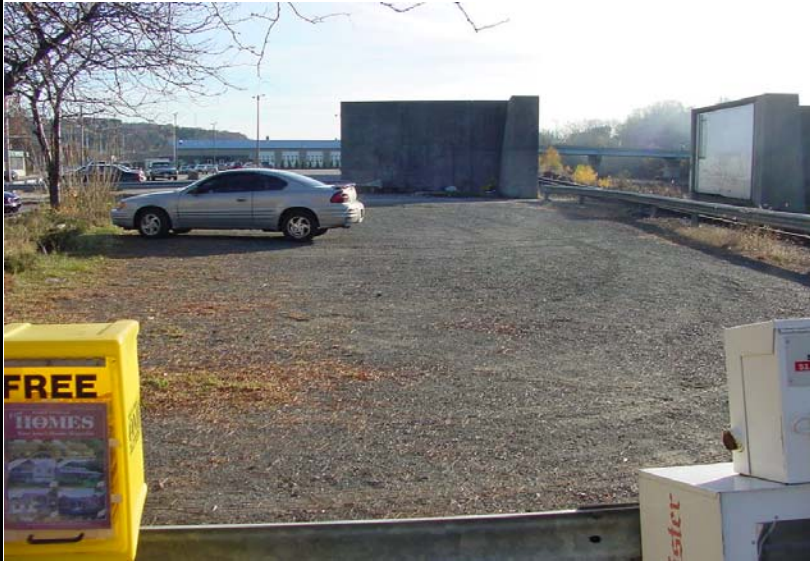
PHOTO NO. 2

Description: \_\_\_\_\_  
General view of Quad I

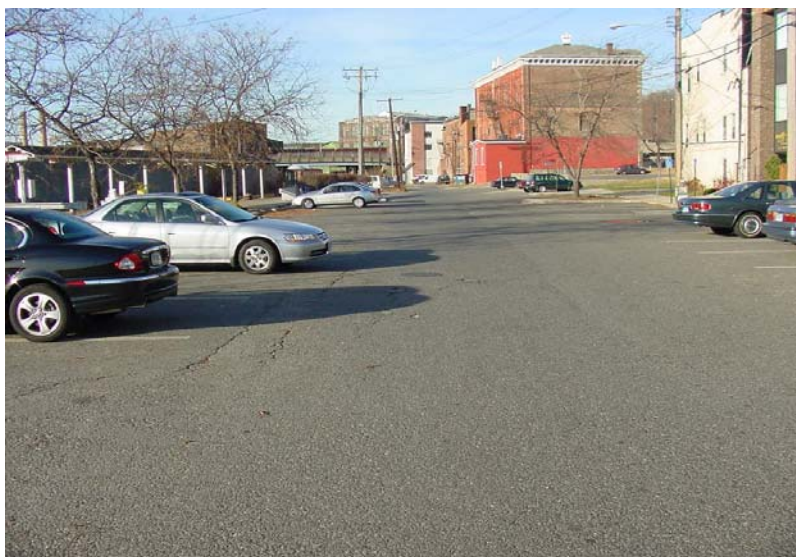
PHOTO NO. 3

Description:  
General view of Quad II

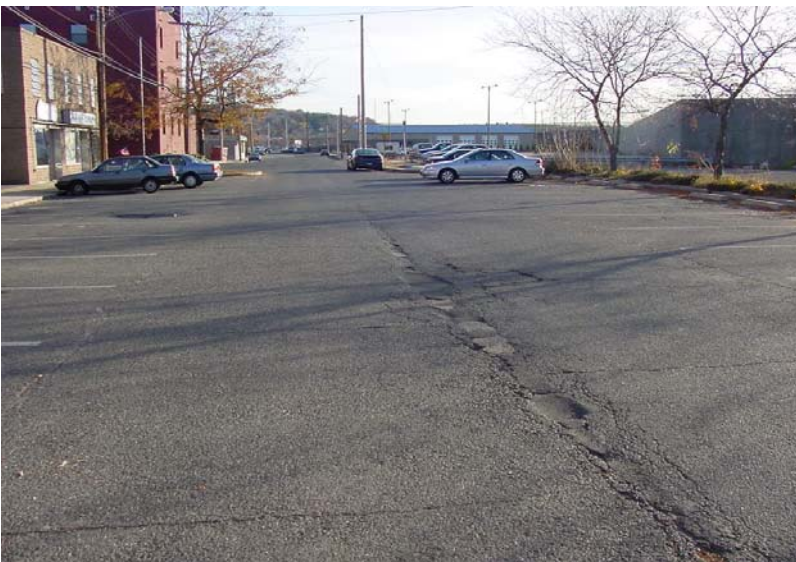
PHOTO NO. 4

Description:  
General view of Quad II  
Note the crack that  
extends the length of  
the surface

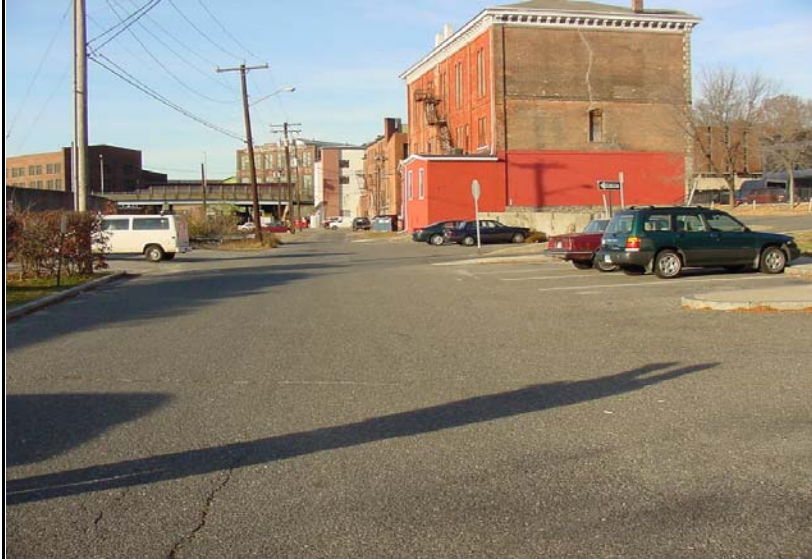
PHOTO NO. 5

Description: General view of Quad III

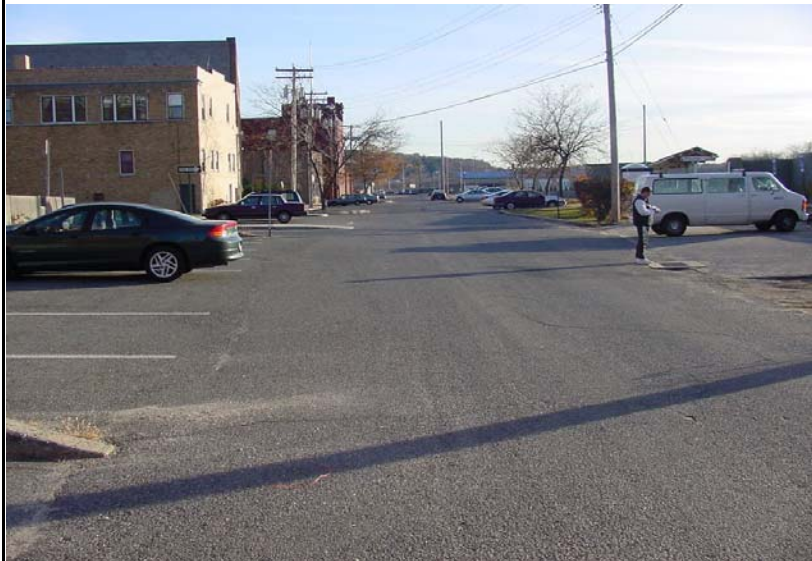
PHOTO NO. 6

Description: General view of Quad III

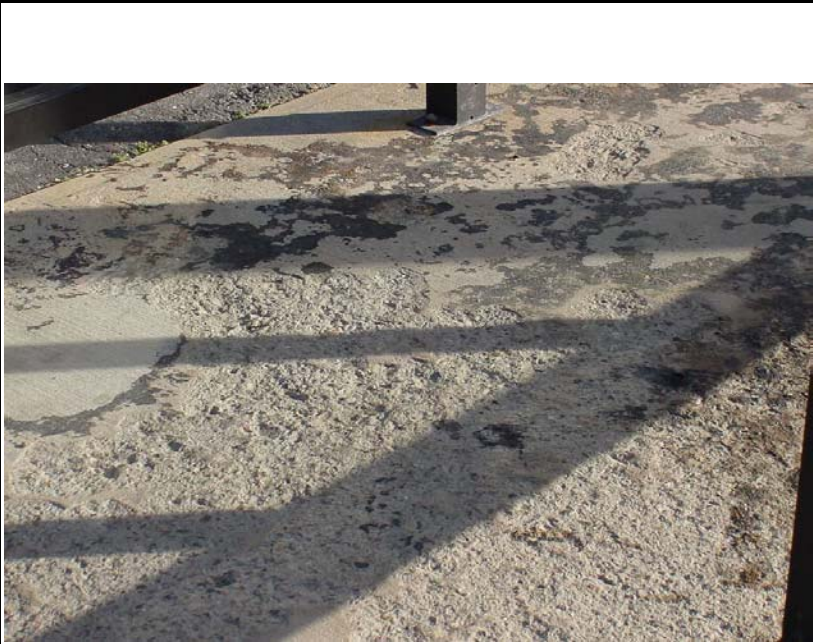
PHOTO NO. 7

RATINGS		PHOTO NO.	REMARKS:
NEW	PREV		
2		7	Span VII-IX <b>5</b> - The concrete beneath and adjacent to the shelter is spalled and scoured
3		8	Span VIII <b>7</b> - The bottom of the sign is bent but functioning
3		10	Span I, VII-IX <b>11</b> - The timber column is cracked
3		11	Span I-X <b>13</b> - The timber truss supporting the canopy is deteriorated at isolated locations
2		9	Span I-X <b>14</b> - The paint of the canopy is chipping, peeling, and missing throughout the canopy
2		12	Span VII-IX <b>NA</b> - There is graffiti on the side of the shelter
1		13-15	Quad 1 <b>Surface</b> -The gravel and asphalt surface contains numerous potholes and vegetation growth
1		2	Quad I <b>Striping</b> -The striping is faded throughout the parking area
2		15	Quad I <b>Landscape</b> - There are weeds and dead vegetation throughout the surface of the parking area
2		17	Quad II <b>Surface</b> -The asphalt surface contains various areas of cracking, ponding, and up heaving

Description:  
The concrete beneath and adjacent to the shelter is spalled and scoured

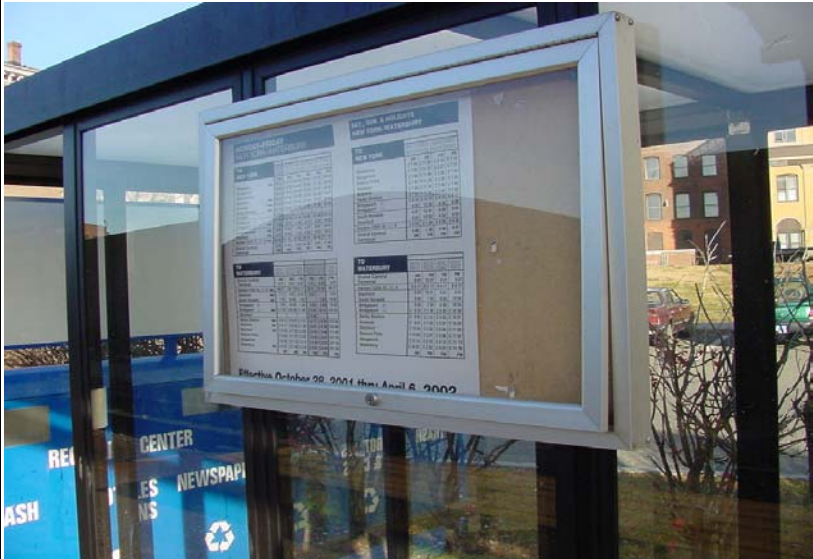
PHOTO NO. 8

Description:  
The bottom of the sign is bent but functional

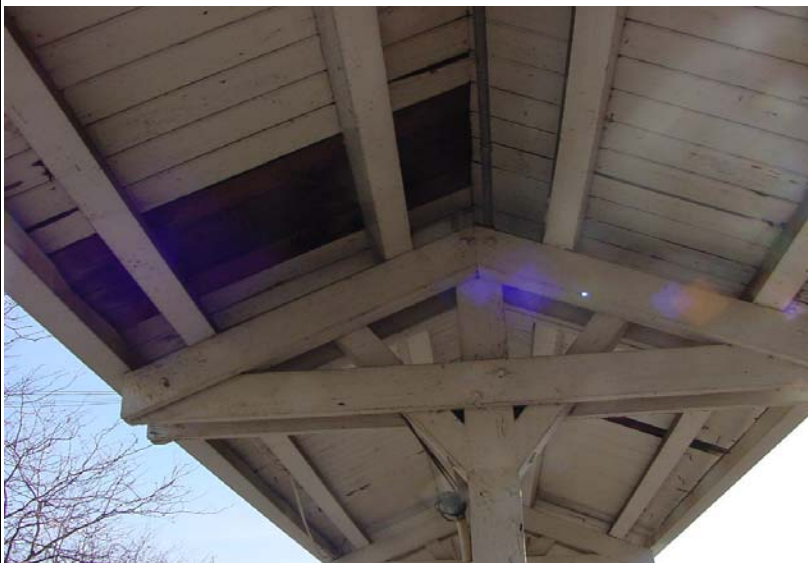
PHOTO NO. 9

Description: \_\_\_\_\_  
Chipped, peeled, and  
missing paint through-  
out the canopy  
\_\_\_\_\_  
\_\_\_\_\_

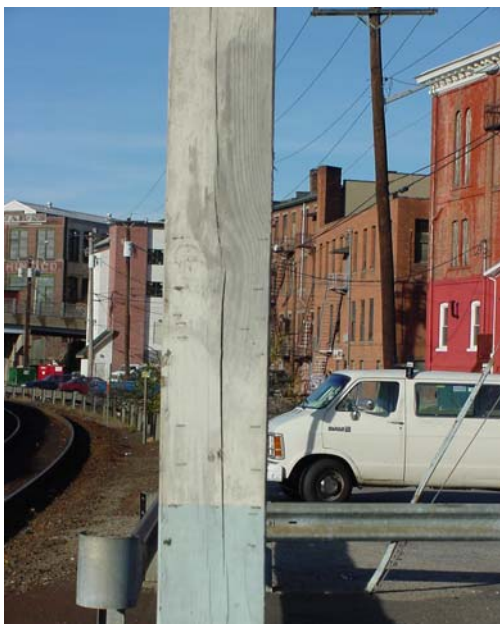
PHOTO NO. 10

Description: \_\_\_\_\_  
Typical cracked column  
\_\_\_\_\_  
\_\_\_\_\_

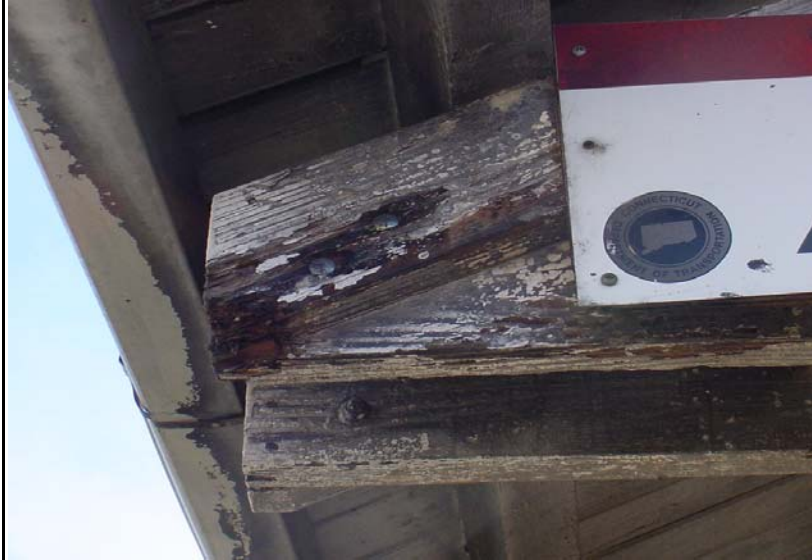
PHOTO NO. 11

Description: \_\_\_\_\_  
The timber truss  
supporting the canopy  
is deteriorated at  
isolated locations

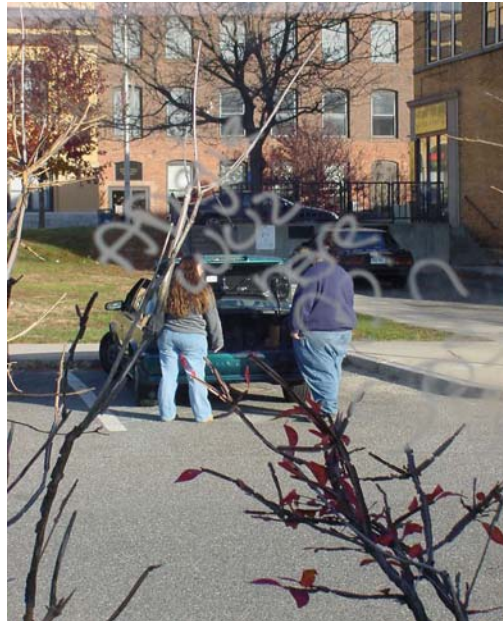
PHOTO NO. 12

Description: \_\_\_\_\_  
There is graffiti on the  
side of the shelter

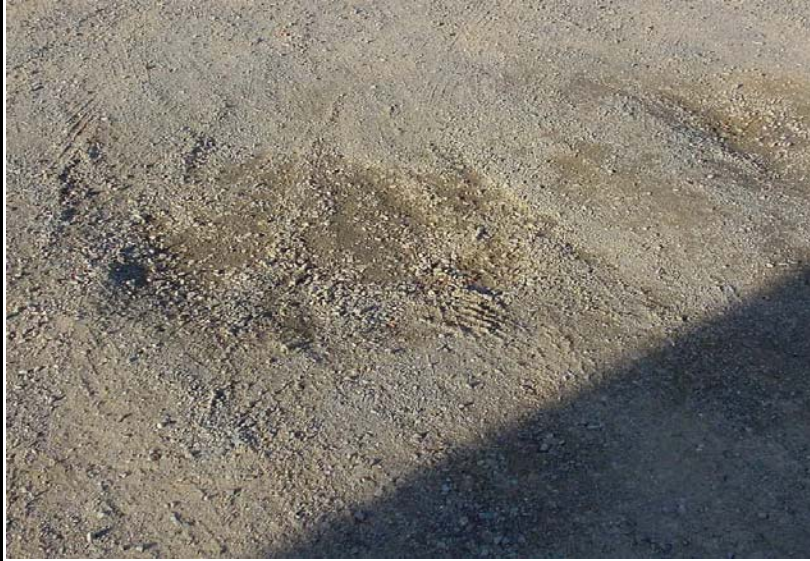
PHOTO NO. 13

Description: \_\_\_\_\_  
The gravel/dirt surface  
contain potholes

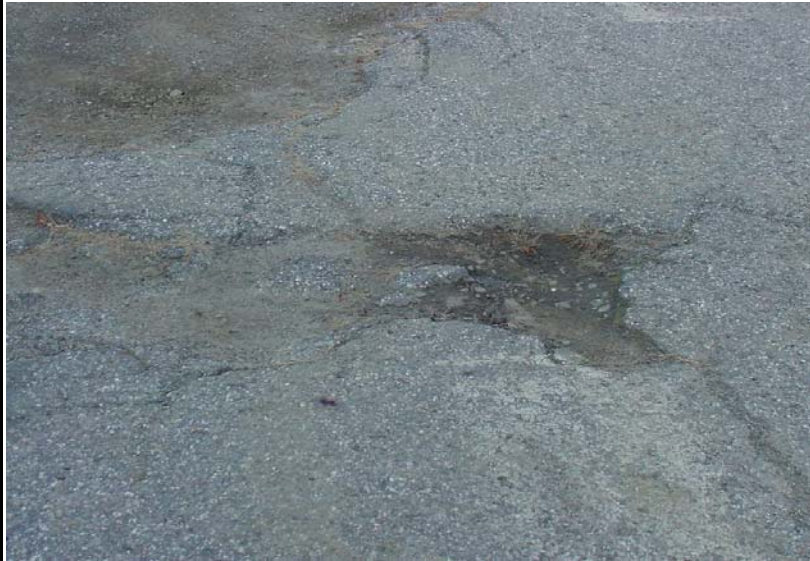
PHOTO NO. 14

Description: \_\_\_\_\_  
The asphalt surface  
contains potholes and  
cracking

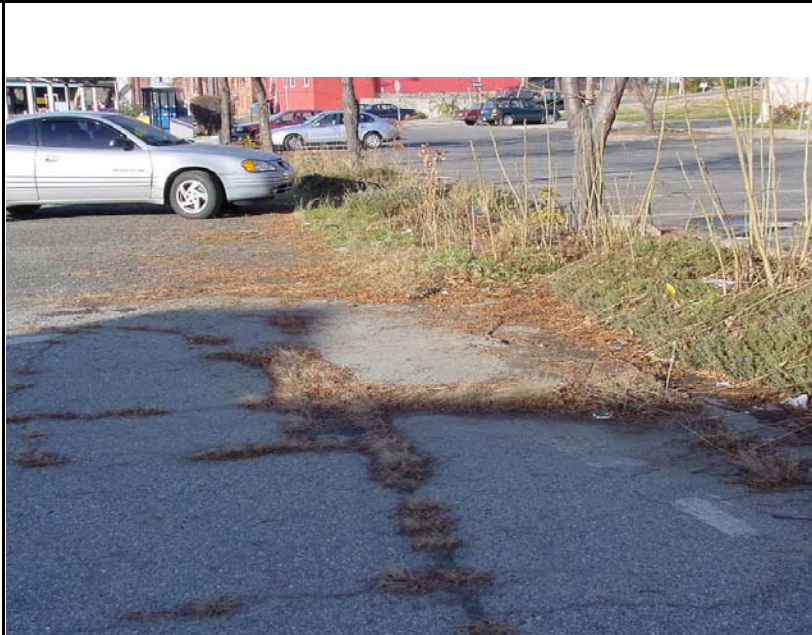
PHOTO NO. 15

Description: \_\_\_\_\_  
There are weeds and  
dead vegetation  
throughout the driving  
surface

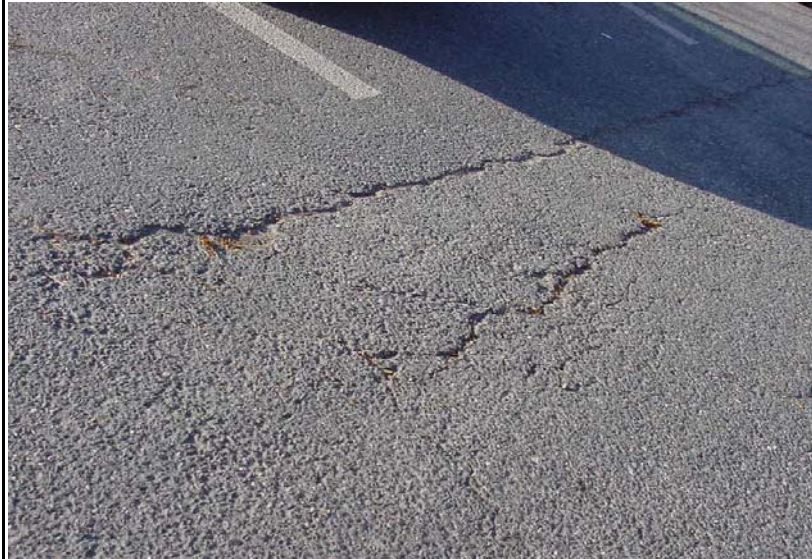
PHOTO NO. 16

Description: \_\_\_\_\_  
Typical crack

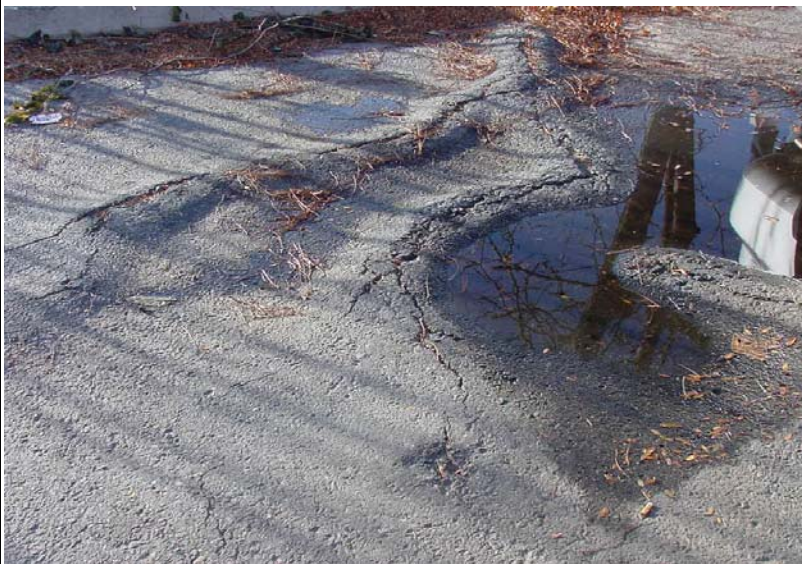
PHOTO NO. 17

Description: \_\_\_\_\_  
The asphalt surface  
contain cracking, pond-  
ing, and up heaving.

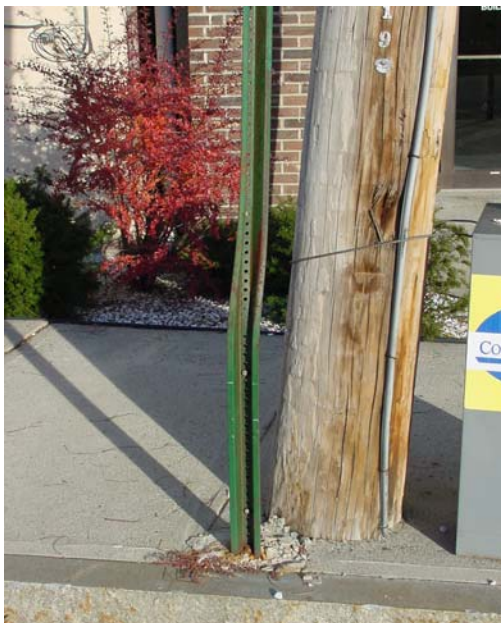
PHOTO NO. 18

2		18	Quad II <b>Signage</b> -The sign on the west side is bent
1		20	Quad III <b>Surface</b> - There is an area (25'x35') that is cracked, missing gravel and uneven
3		16	Quad III <b>Surface</b> - There are random cracks throughout the surface of the parking area
2		19	Quad III <b>Signage</b> - The sign along the west side is missing and the pole is bent

Description: \_\_\_\_\_  
Bent sign post in  
Quad II

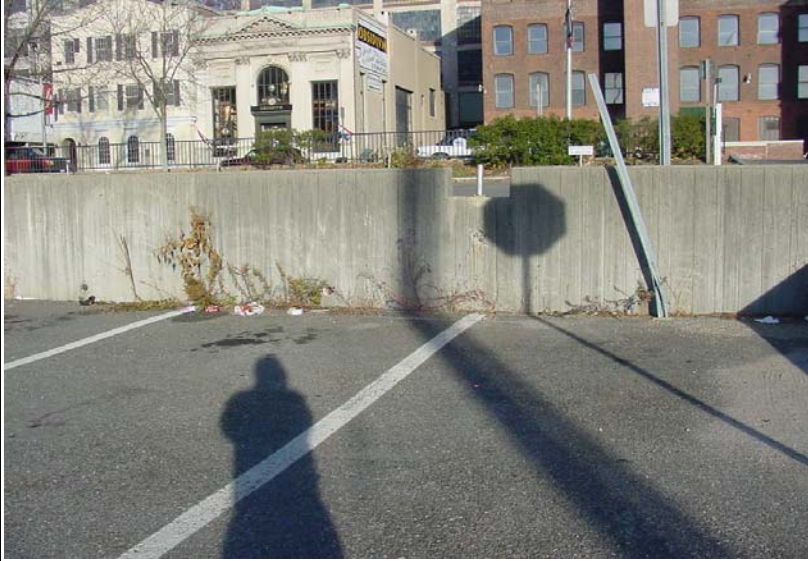
PHOTO NO. 19

Description: Bent post and missing sign in Quad III

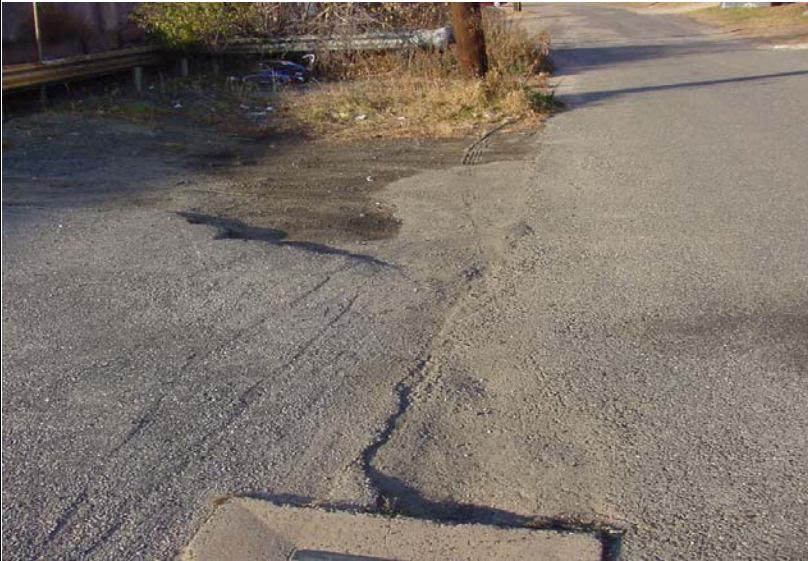
PHOTO NO. 20

Description: The surface (25'x35') is cracked, missing gravel, and uneven

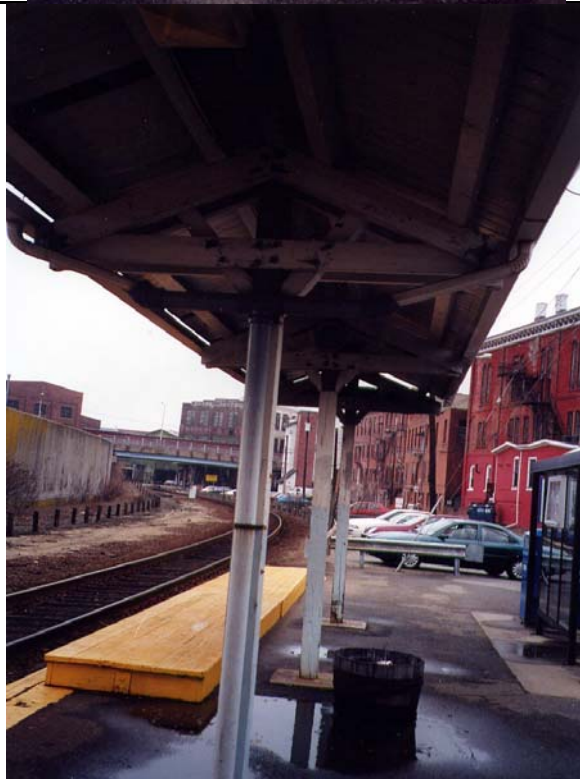
PHOTO NO. 22

Most of the aluminum gutters on the platform are in good repair. Some gutters are sagging in places and require maintenance or replacement. Downspouts are constructed of aluminum and PVC pipe into a drainage system. Some downspouts may have to be replaced at the time the gutters are replaced. There is one shelter on the platform with a plastic curbed roof. There is not a need for gutters and downspouts on this shelter.

Description:  
Platform Gutters  
& Downspouts

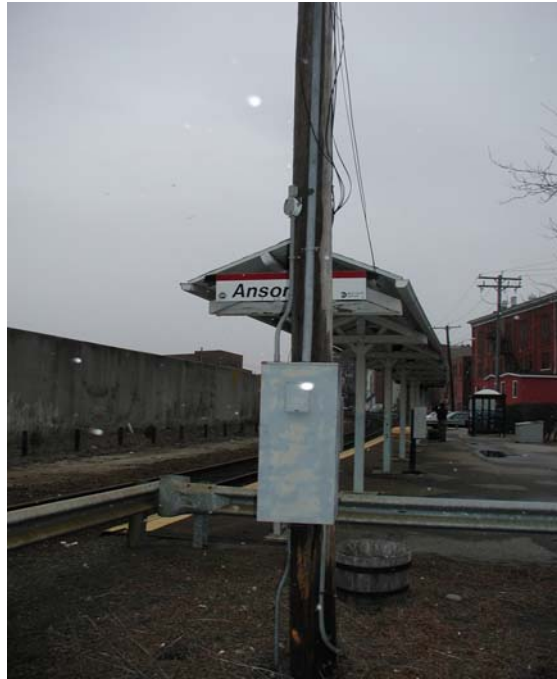
PHOTO NO. 23

Remarks: The utility transformer is mounted on pole number 2818, which is not the utility service drop pole mentioned above. We were unable to gain access to the locked electrical enclosure to verify the exact size and condition of the main panelboard.

Description: \_\_\_\_\_  
electrical utility  
service pole

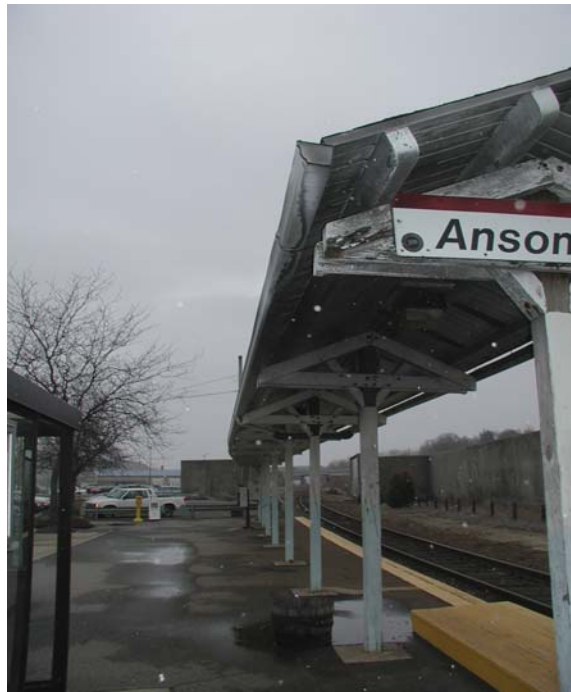
PHOTO NO. 24

Remarks: A typical section of the platform was measured at the location indicated and found to average 16.7 fc.  
Most fixture lenses are yellowing.

Description: \_\_\_\_\_  
platform lighting

Luminaires are mounted beneath the canopy and measured an average of 16.7 foot-candles, which is above the minimal light levels as recommended by the IESNA for train station platforms. However, the lenses are yellowing and should be replaced to better replicate the luminaire manufacturers original design.
