CONNECTICUT
DEPARTMENT
OF
TRANSPORTATION

CONDITION INSPECTION
FOR THE
DARIEN STATION

**CONN. DEPT OF TRANSPORTATION
STATION INSPECTION**

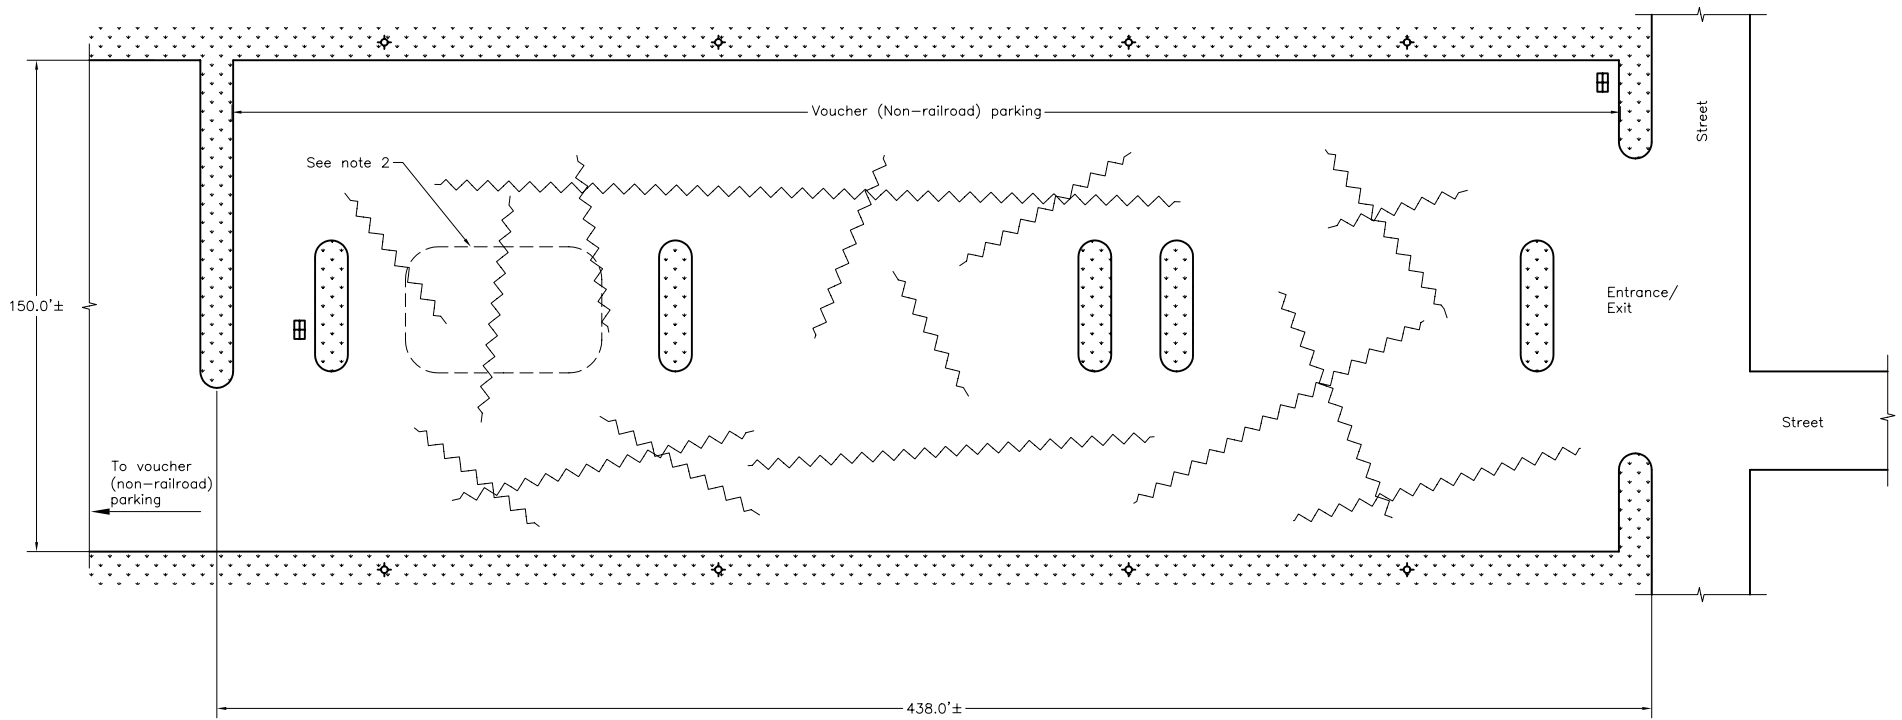
Urbitran Associates, Inc.
Connecticut Dept. of Transportation
Darien Station Quadrant III Plan
Date: 8-01-02

1. The entire surface is cracked with vegetation growth.
2. The stripping paint is faded for 50 parking spots.

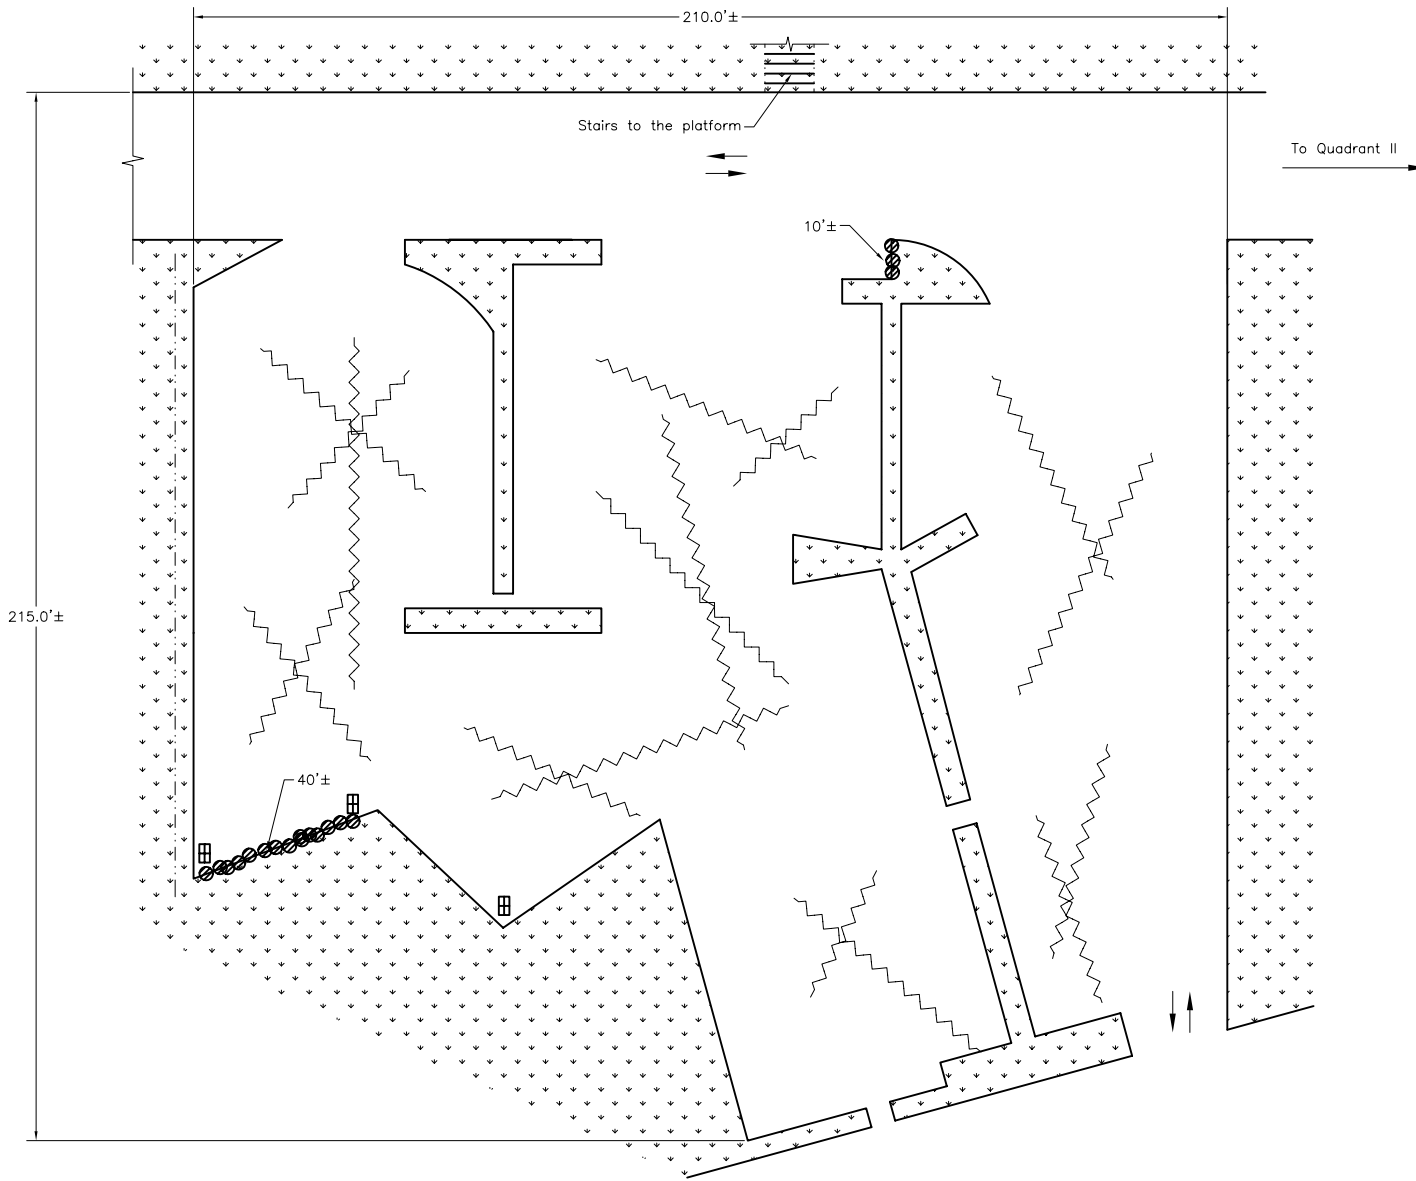
Urbitran Associates, Inc.
Connecticut Dept. of Transportation
Darien Station Quadrant IV Plan
Date: 8-01-02

- Pedestrian Railing
- Guardrail
- ~~~~~ Crack
- [Grass symbol] Grass
- [Drain symbol] Drain
- [Damaged curb symbol] Damaged or missing curb

1. The entire surface is cracked with vegetation growth.

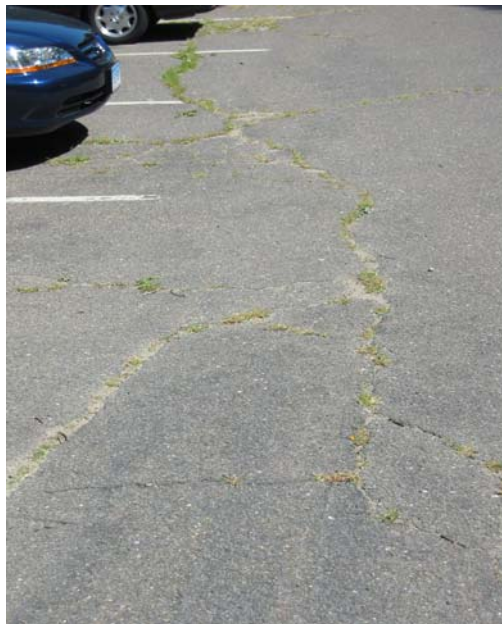
PHOTO NO. 13

Location: Middle of Quad III

Description: Typical cracks with vegetation growth

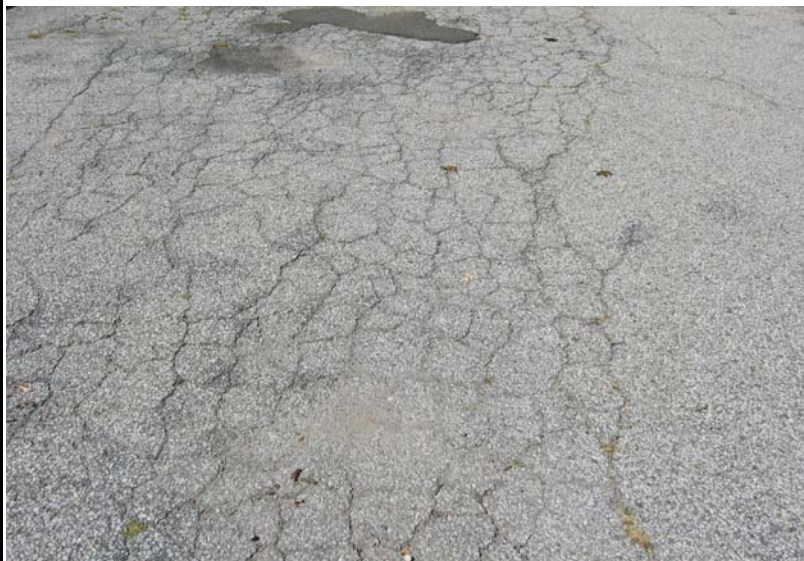
PHOTO NO. 14

Location: Middle of Quad IV

Description: Typical map cracking

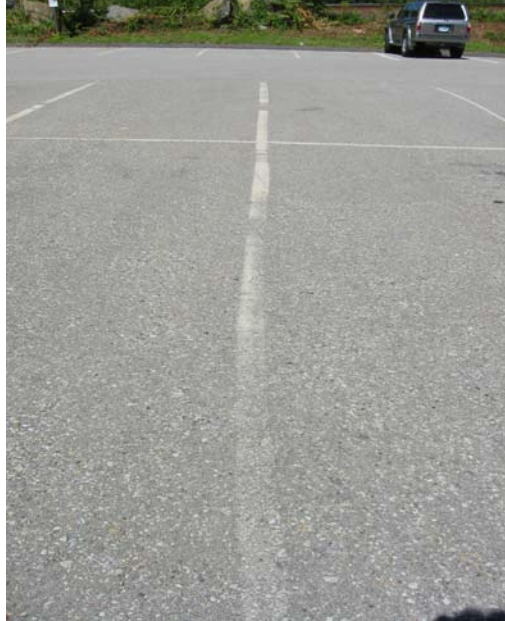
PHOTO NO. 15

Location: South side of Quad III

Description: Faded stripping

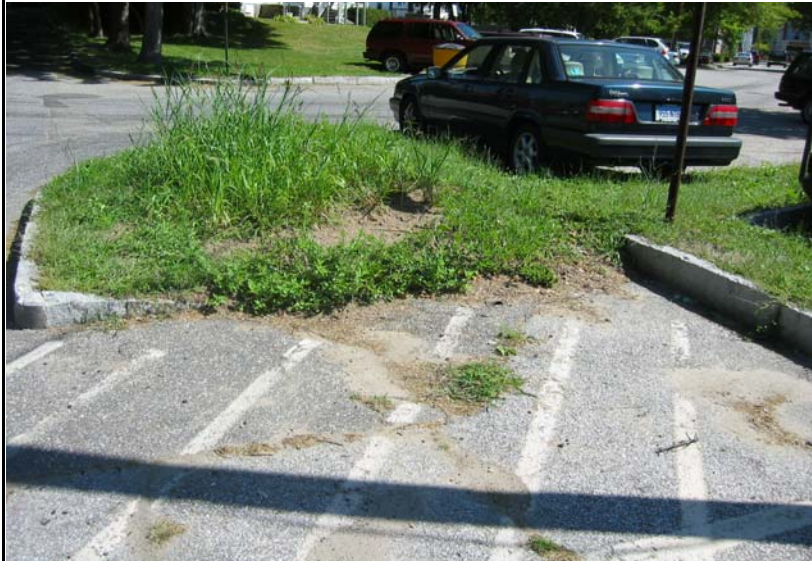
PHOTO NO. 16

Location: West side of Quad IV

Description: Typical missing curb

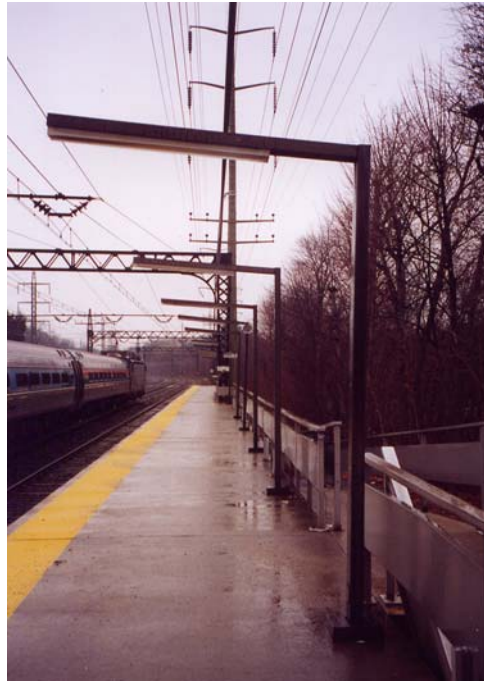
PHOTO NO. 19

Description:
existing platform
lighting to be
removed under a
current construction
construction

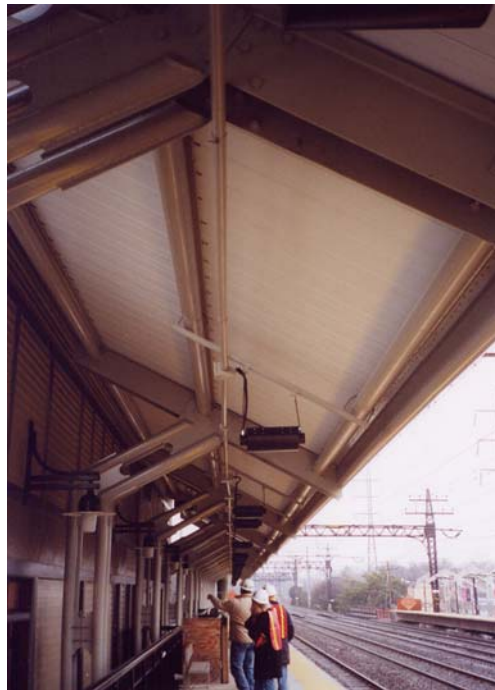
PHOTO NO. 20

Description:
new platform
lighting still
under construction
