CONNECTICUT
DEPARTMENT
OF
TRANSPORTATION

CONDITION INSPECTION
FOR THE
MILFORD STATION

**CONN. DEPT OF TRANSPORTATION
STATION INSPECTION**

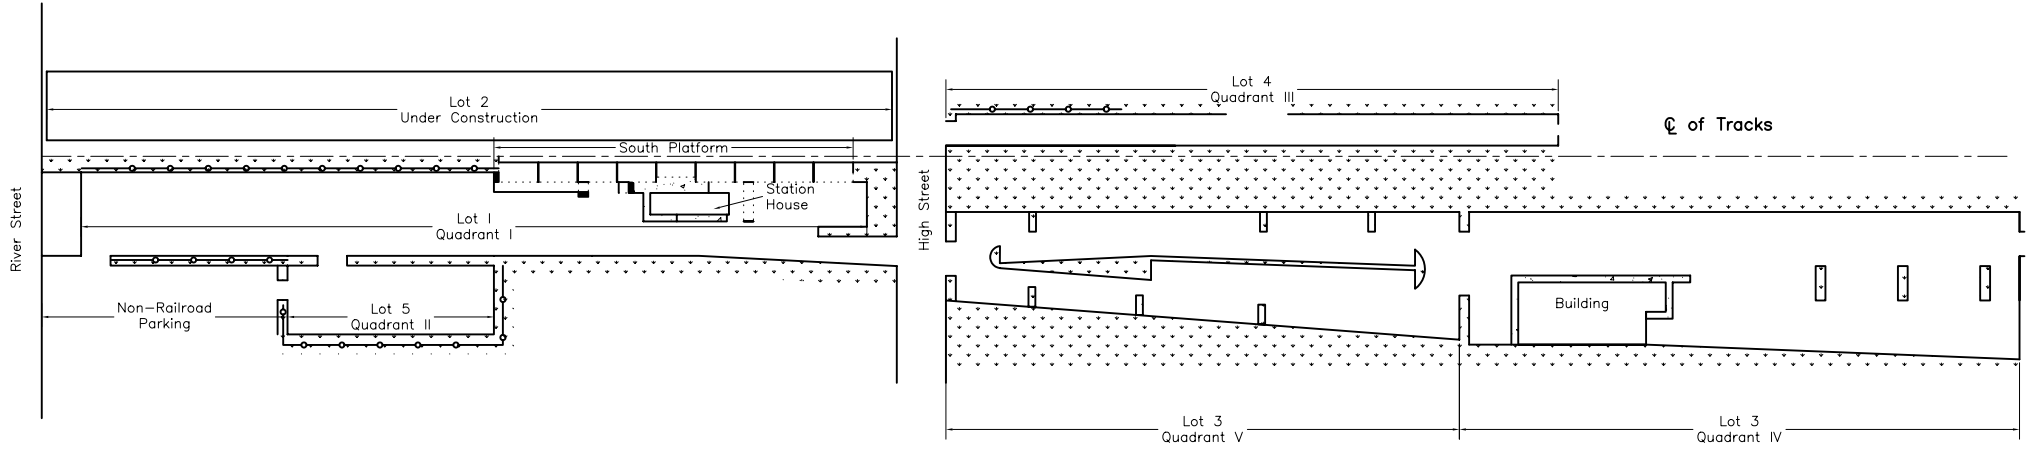
Urbitran Associates, Inc.
Connecticut Dept. of Transportation
Milford Station General Plan
Date: 8/23/02

- NOTES:
1. The entire north platform was under construction during the time of inspection.
 2. Lot 2 was under construction during the time of inspection as well as parts of Lot 1 and Lot 3.
 3. Parts of the south platform was under construction during the time of our inspection.

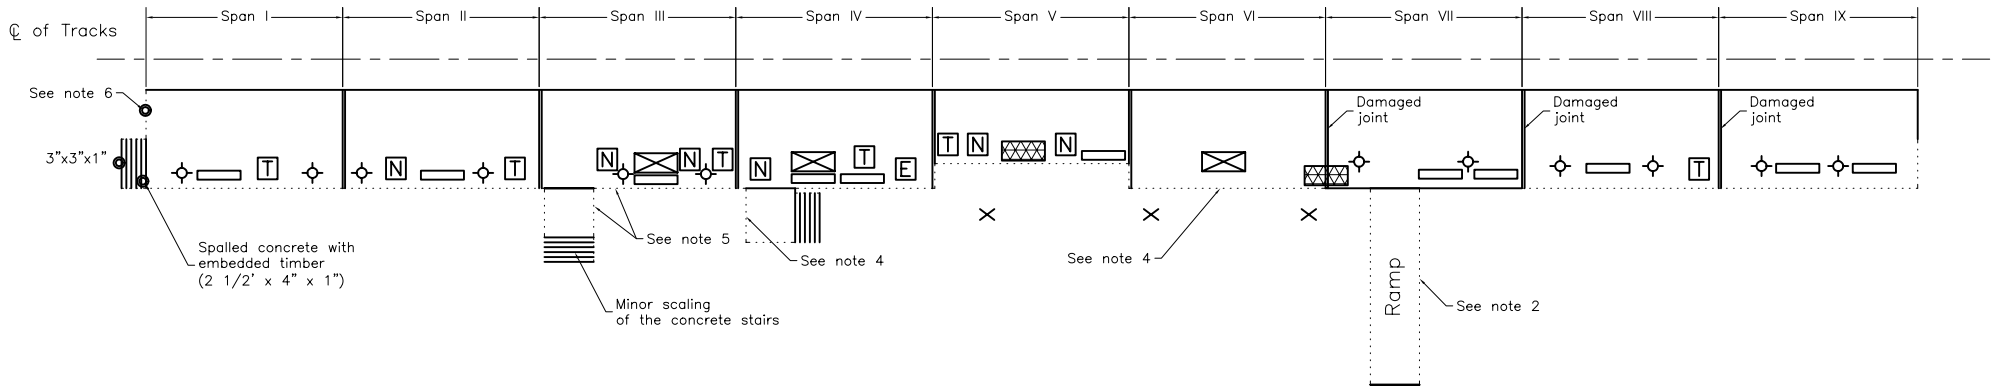
Urbitran Associates, Inc.
Connecticut Dept. of Transportation
Milford Station South Platform Plan
Date: 8/23/02

1. The base plates for the double tees are typically rusted and deteriorated.
2. There is spalled concrete adjacent to the railing base plates (12) which are deteriorated and rusted.
3. There is a combination of timber and metal pedestrian railing.
4. The timber railing is loose.
5. The metal railing is damaged and replaced with timber.
6. The web of the double tee is spalled with exposed rebar (6"x4"x1/2").
7. At the time of out inspection construction was being performed.

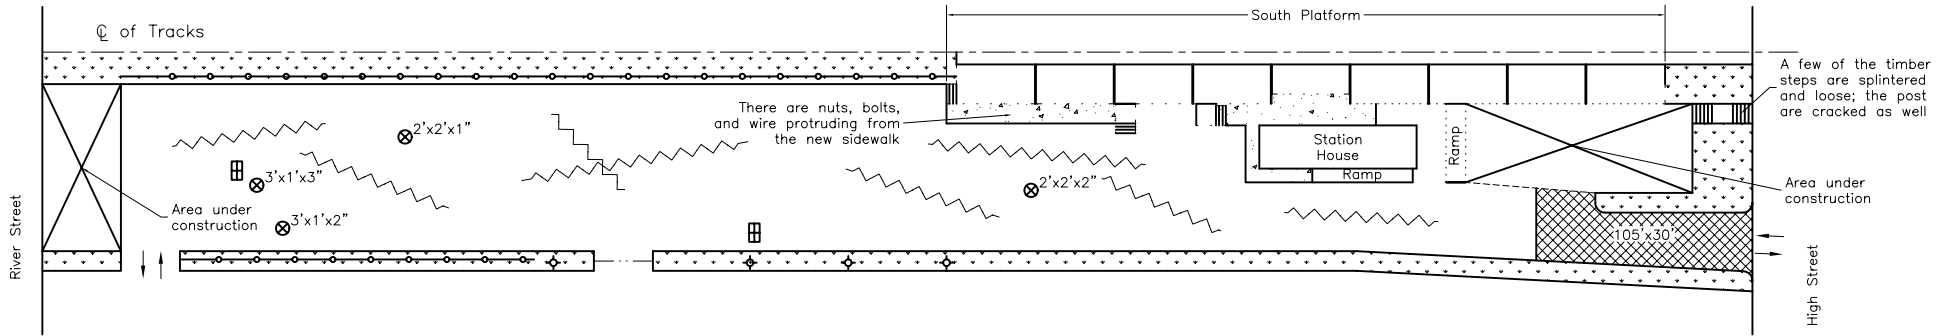
Urbitran Associates, Inc.
Connecticut Dept. of Transportation
Milford Station Quadrant I Plan
Date: 8/23/02

A few of the timber steps are splintered and loose; the post are cracked as well

There are nuts, bolts, and wire protruding from the new sidewalk

- NOTES:
1. 10% of the surface is cracked.
 2. The striping is faded throughout the Quadrant.

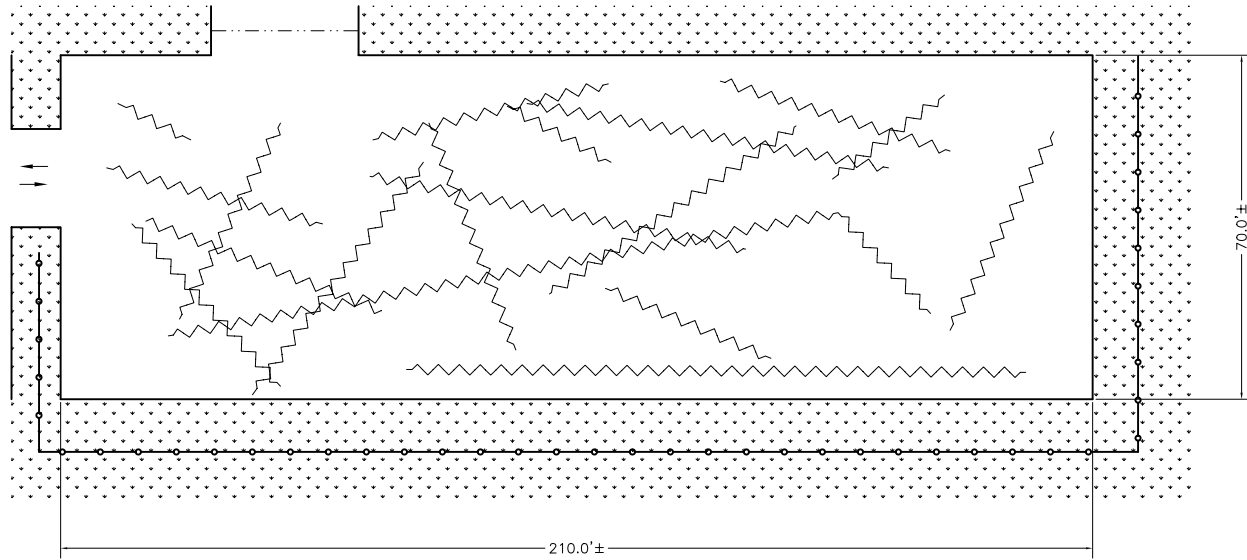
Urbitran Associates, Inc.
Connecticut Dept. of Transportation
Milford Station Quadrant II
Date: 8/23/02

1. 40% of the surface is cracked with vegetation growth.

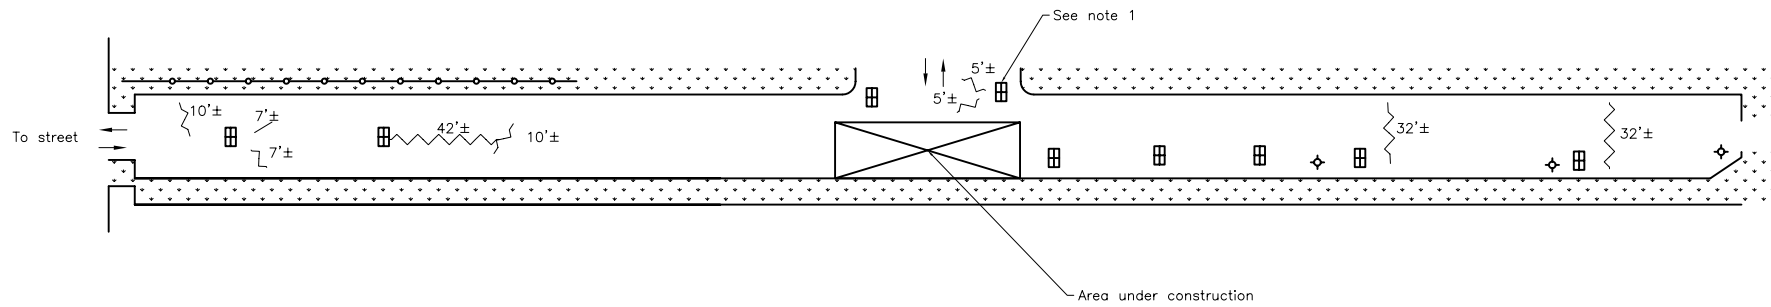
Urbitran Associates, Inc.
Connecticut Dept. of Transportation
Milford Station Quadrant III Plan
Date: 8/23/02

1. There is spalled concrete and vegetation growth adjacent to the drain.

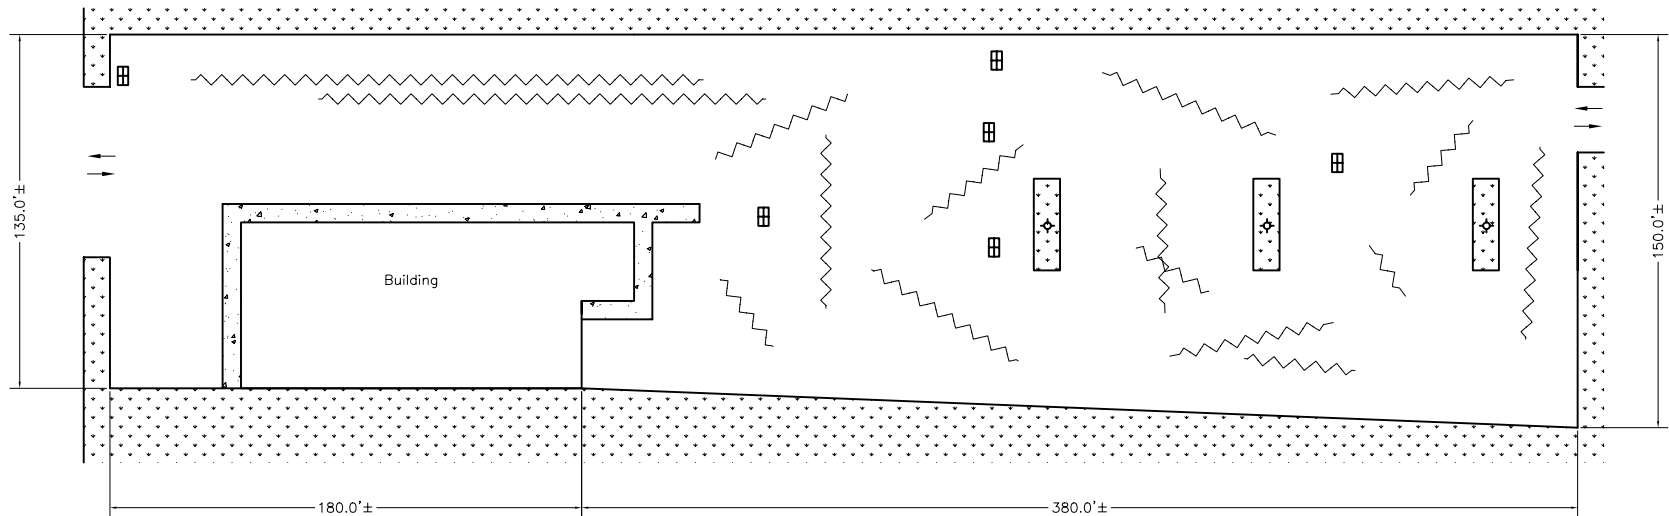
Urbitran Associates, Inc.
Connecticut Dept. of Transportation
Milford Station Quadrant IV Plan
Date: 8/23/02

1. 20% of the asphalt surface is cracked with vegetation growth.

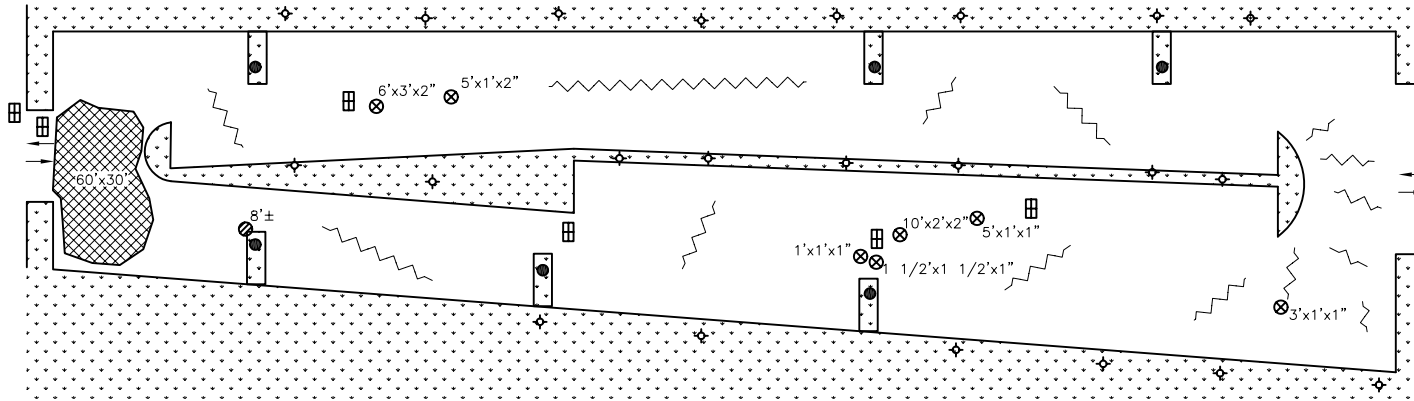
Urbitran Associates, Inc.
Connecticut Dept. of Transportation
Milford Station Quadrant V Plan
Date: 8/23/02

1. 10% of the asphalt surface is cracked.

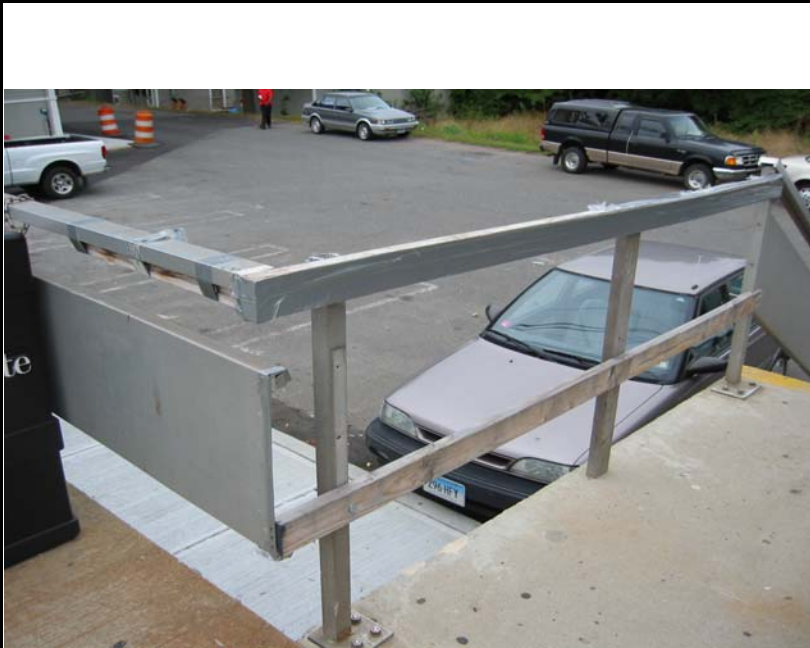
PHOTO NO. 9

Description: _____
Metal railing which is
repaired with timber

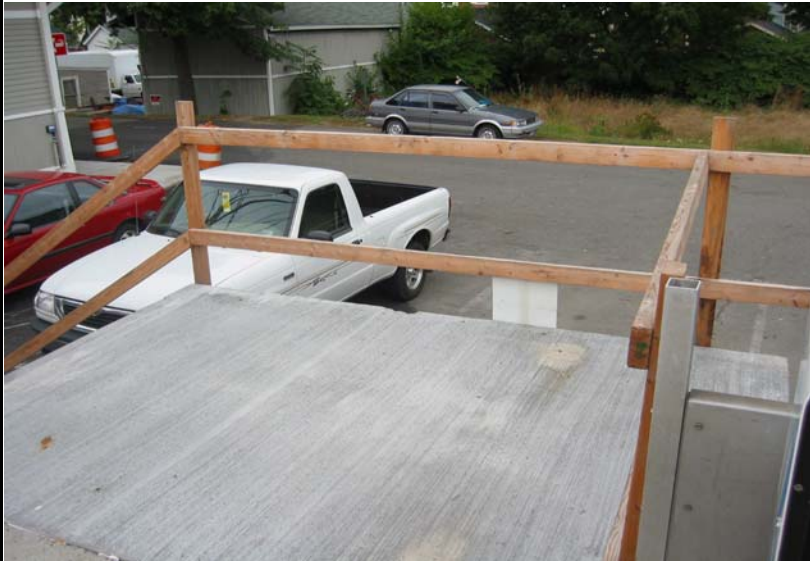
PHOTO NO. 10

Description: _____
Loose timber railing

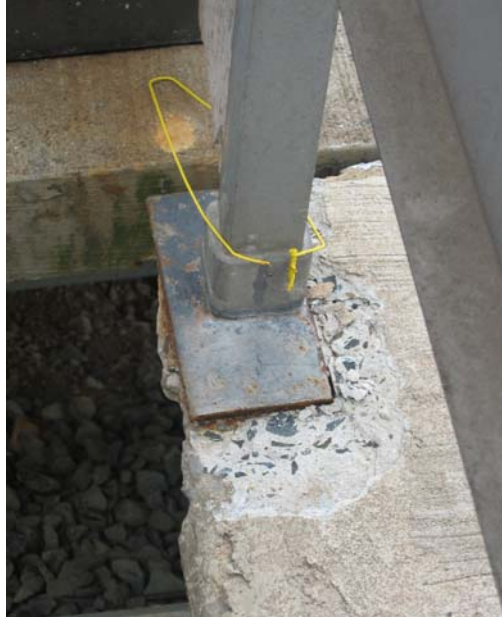
PHOTO NO. 11

Description: _____
Spalled concrete
adjacent to the rusted
railing base plate

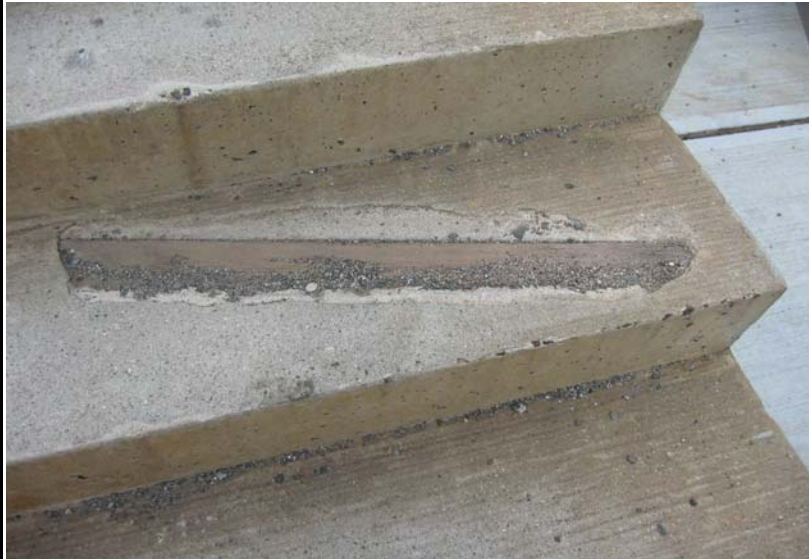
PHOTO NO. 12

Description: _____
Embedded timber in
concrete beneath
spalled area
(2 1/2"x4"x1")

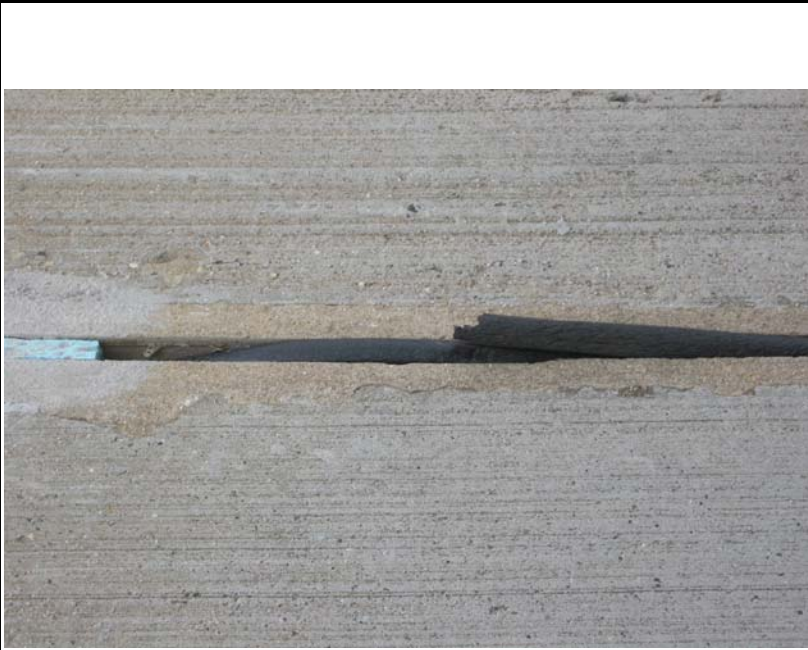
PHOTO NO. 13

Description: _____
The joint material is
uplifted and torn

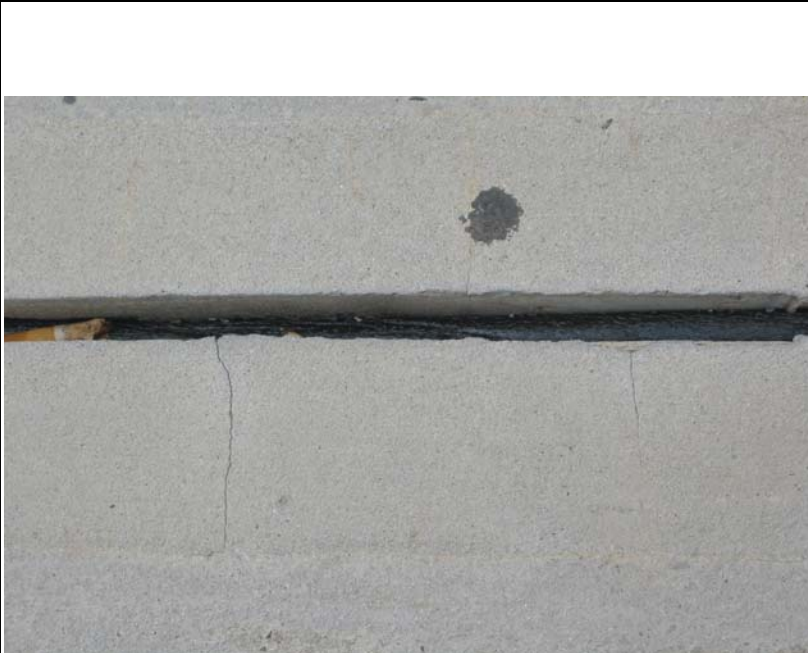
PHOTO NO. 14

Description: _____
The joint material
is depressed

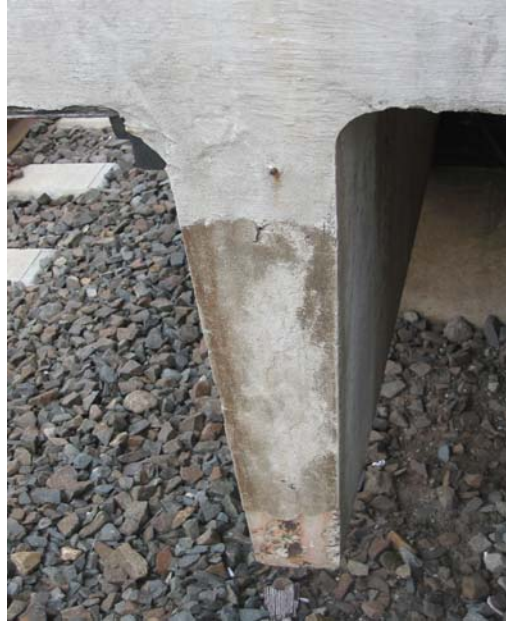
PHOTO NO. 15

Description: _____
Spalled concrete with
exposed rebar
(6"x4"x1/2")

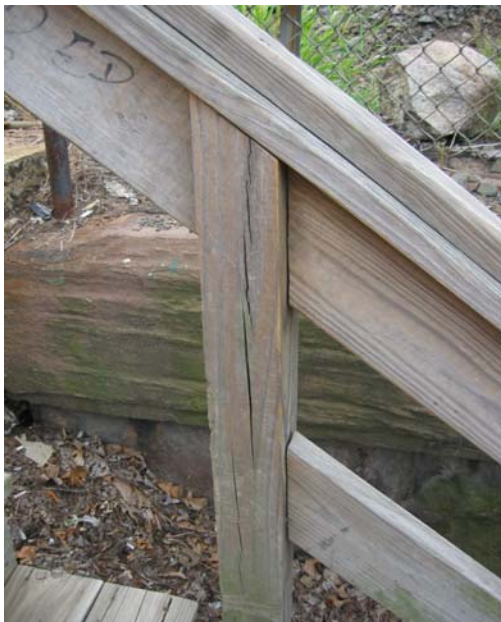
PHOTO NO. 17

Description: _____
The timber railing post
is cracked

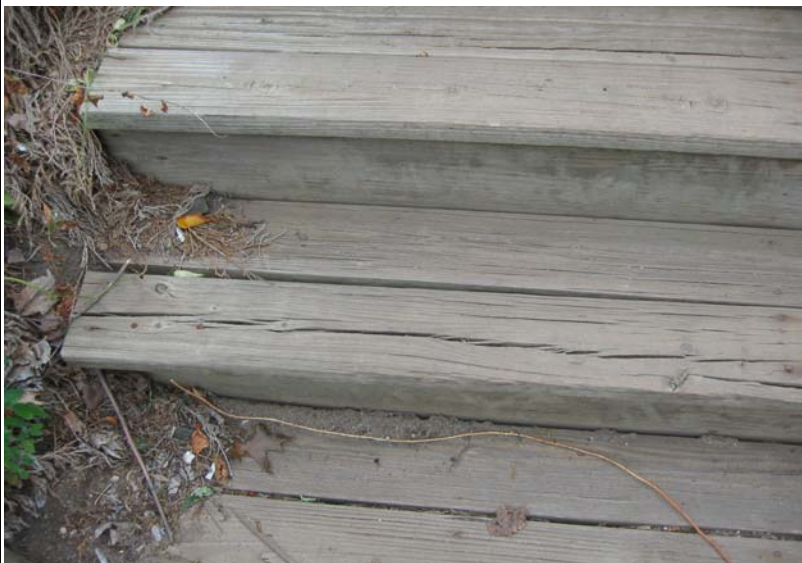
PHOTO NO. 18

Description: _____
The timber stairs are
cracked and loose

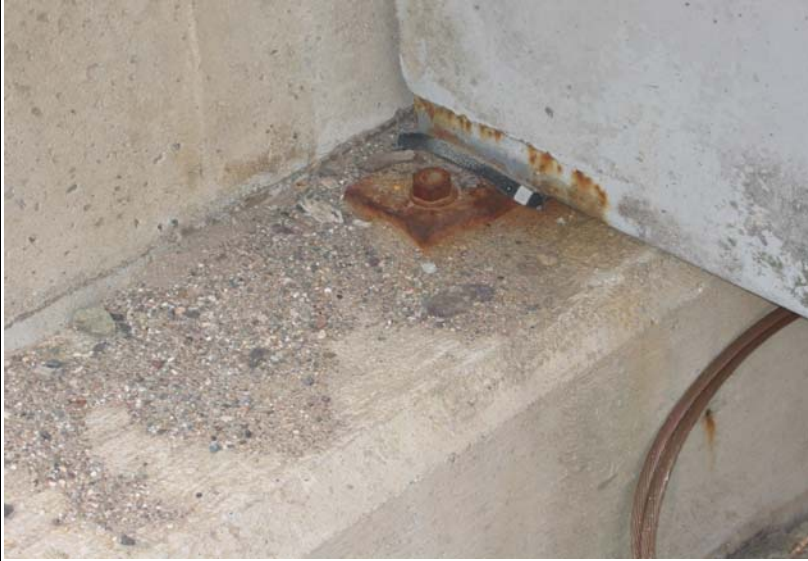
PHOTO NO. 19

Description: Typical rusted base plate below the double tee

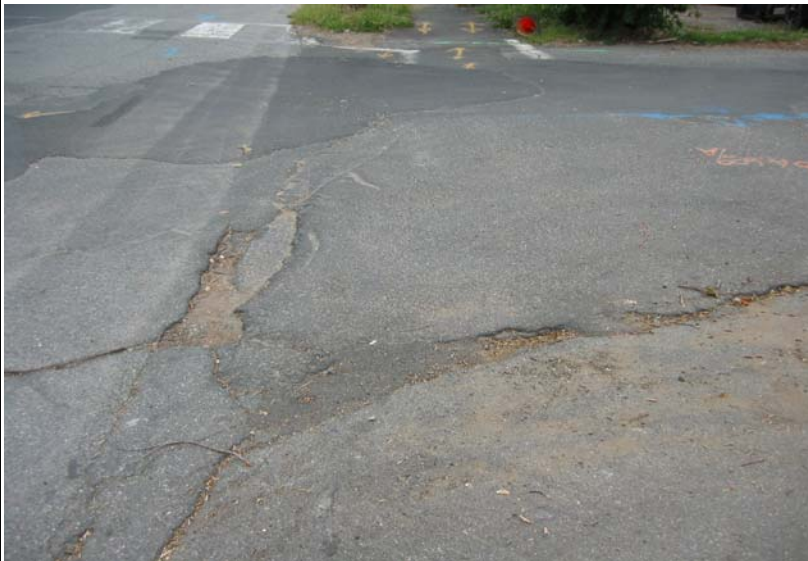
PHOTO NO. 20

Description: Cracked and unven asphalt surface with potholes

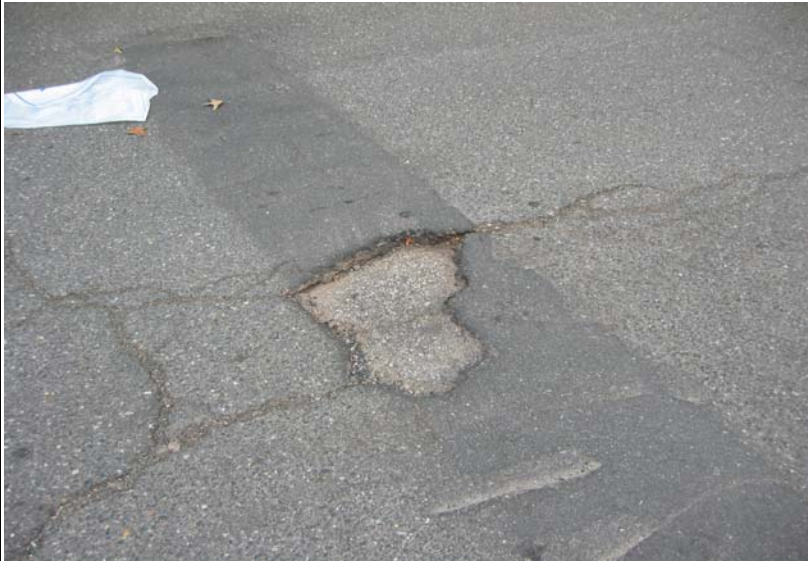
PHOTO NO. 21

Description: Typical pothole

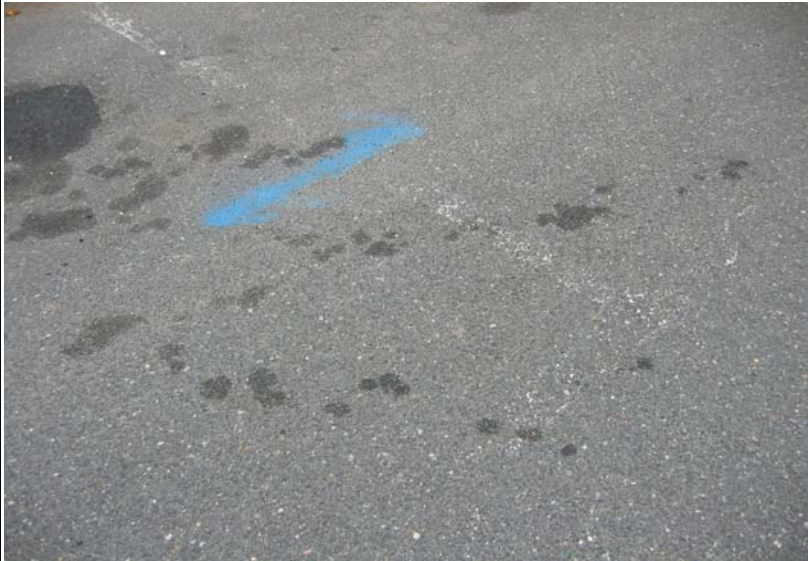
PHOTO NO. 22

Description: Typical faded striping

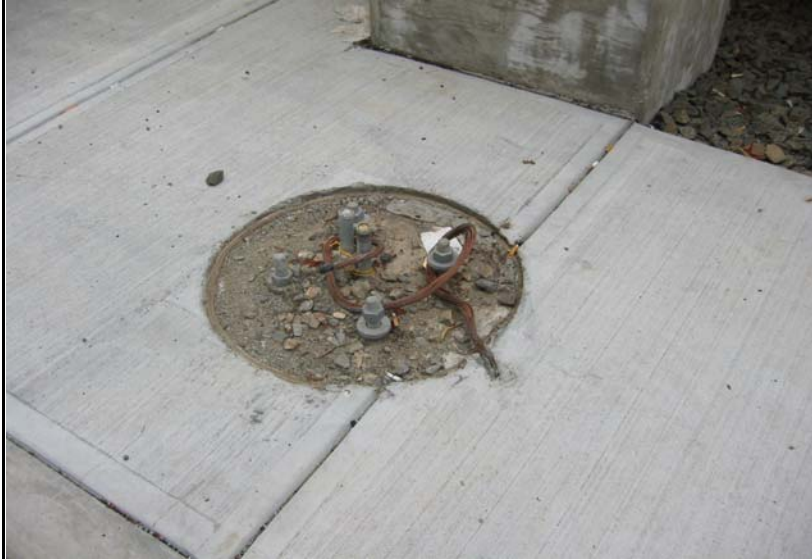
PHOTO NO. 23

Description: Missing / uninstalled utility pole with exposed nuts, bolts, and wire

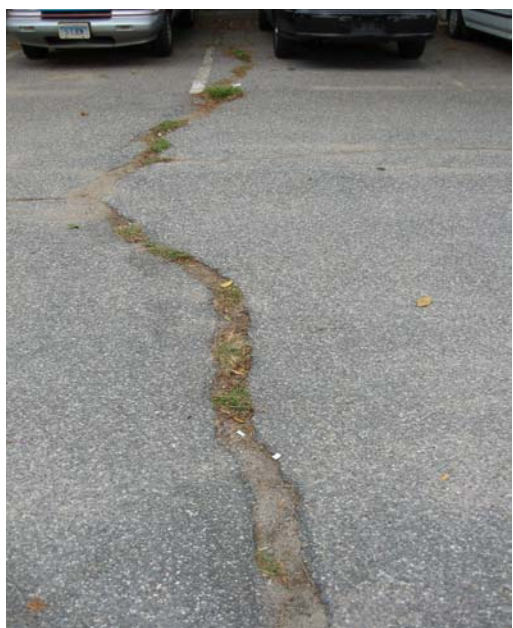
PHOTO NO. 26

2		26	Quad II	Surface - Typical asphalt cracks with vegetation growth
3		27	Quad III	Surface - There is spalled concrete and vegetation growth adjacent to the drain

Description:
Typical crack with vegetation growth

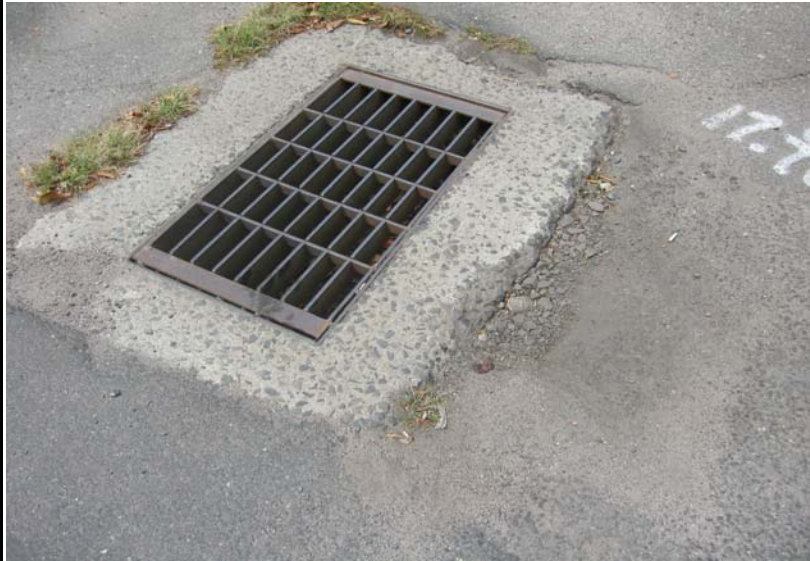
PHOTO NO. 27

Description: Spalled concrete, and
vegetation growth
adjacent to the drain

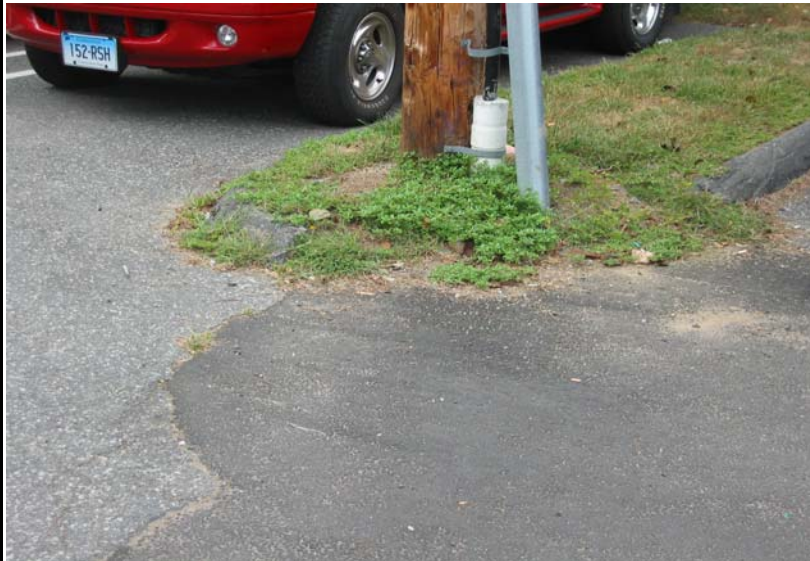
PHOTO NO. 28

Description: Missing asphalt curb
(8')

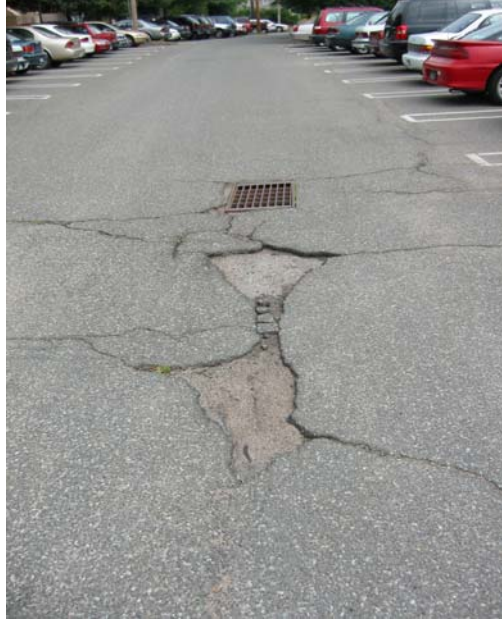
PHOTO NO. 29

Description: Typical cracks adjacent to the potholes

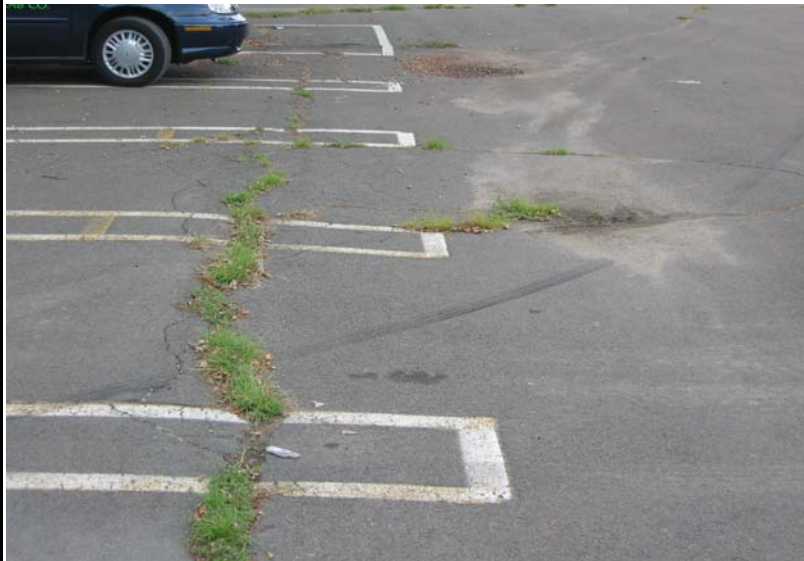
PHOTO NO. 30

Description: Typical crack with vegetation growth and uneven asphalt surface

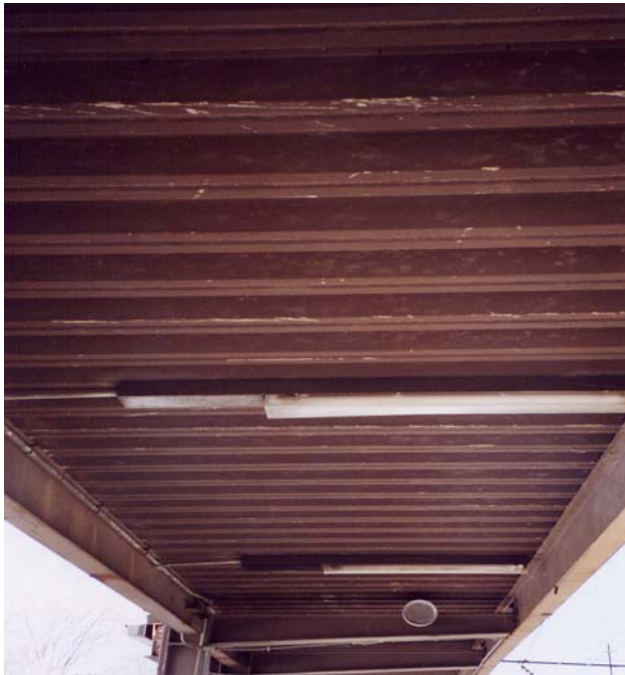
PHOTO NO. 32

Description:
existing platform
lighting to be
removed under a
current contract

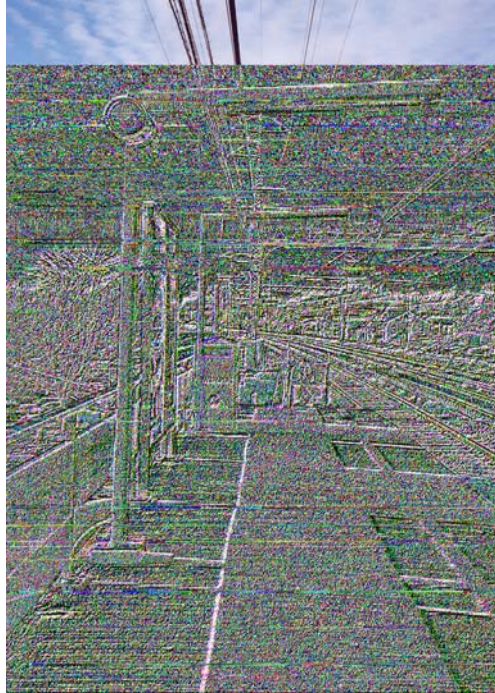
PHOTO NO. 33

Description:
existing
platform lighting
to be removed
under a
current contract

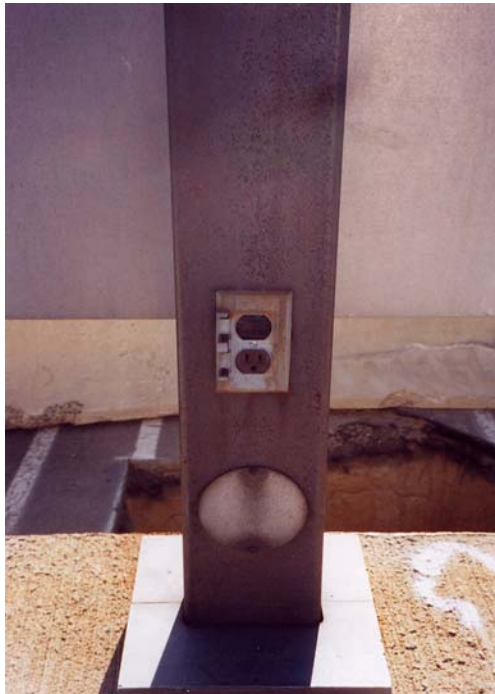
PHOTO NO. 34

Description:
an existing
receptacle to be
removed under a
current
construction

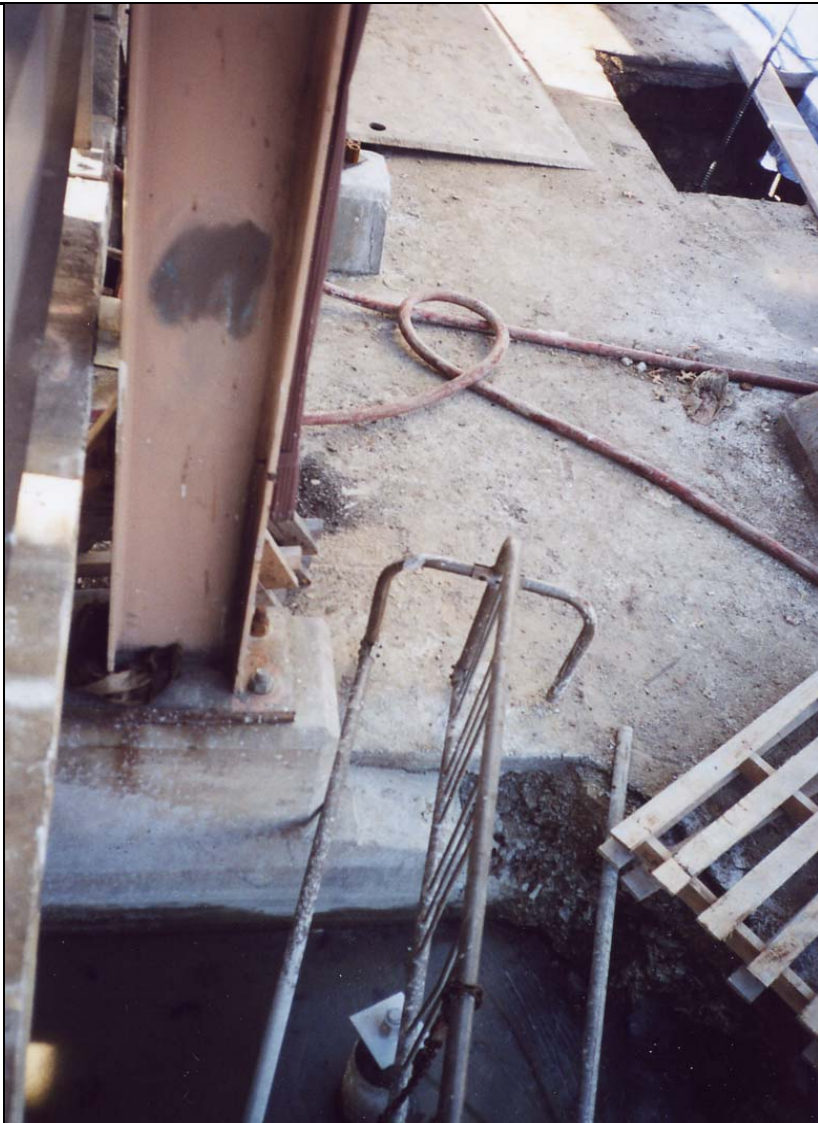
PHOTO NO. 35

Description:
Platform only
Station is in
total reconstruction

Reference:
Downspouts
from platform
not completed
