CONNECTICUT
DEPARTMENT
OF
TRANSPORTATION

CONDITION INSPECTION
FOR THE
NEW CANAAN STATION

**CONN. DEPT OF TRANSPORTATION
STATION INSPECTION**

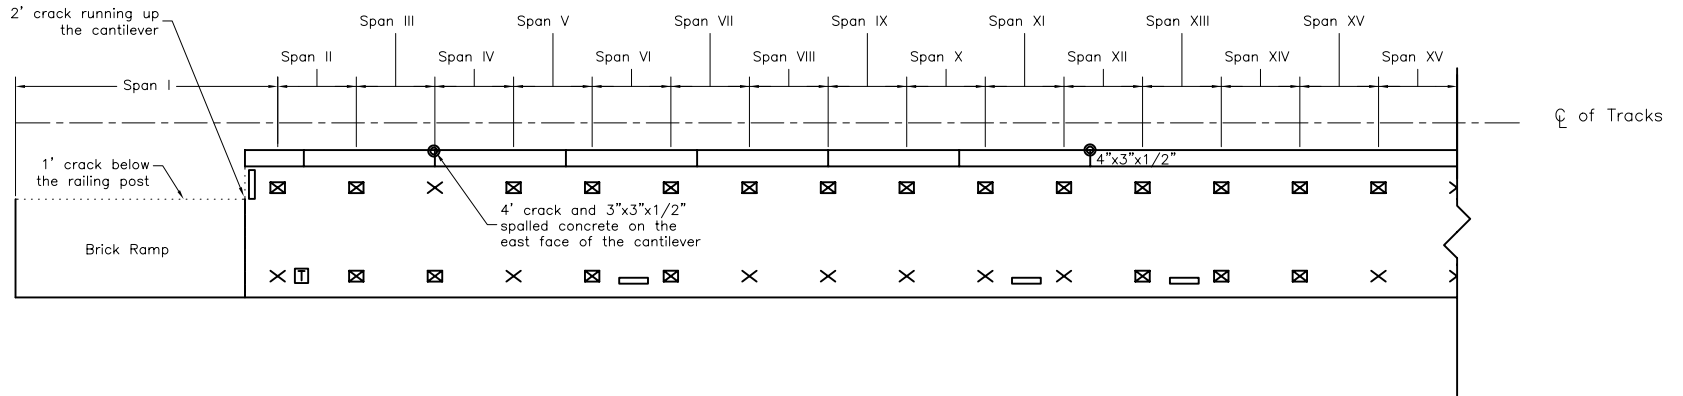
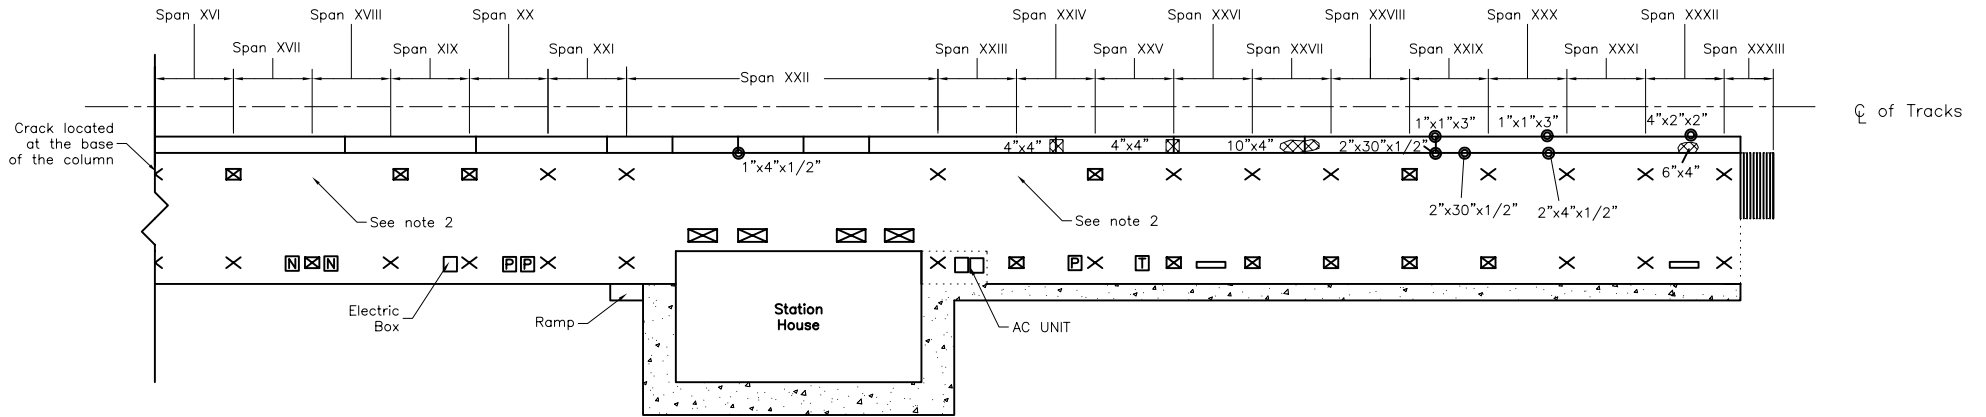
Urbitran Associates, Inc.
Connecticut Dept. of Transportation
New Canaan Station General Layout
Date: 12-20-01

1. Columns exhibit centerline cracks that extend the height of the columns, but are reinforced with metal bolts.
2. Two of the columns have been removed and replaced with a cable support

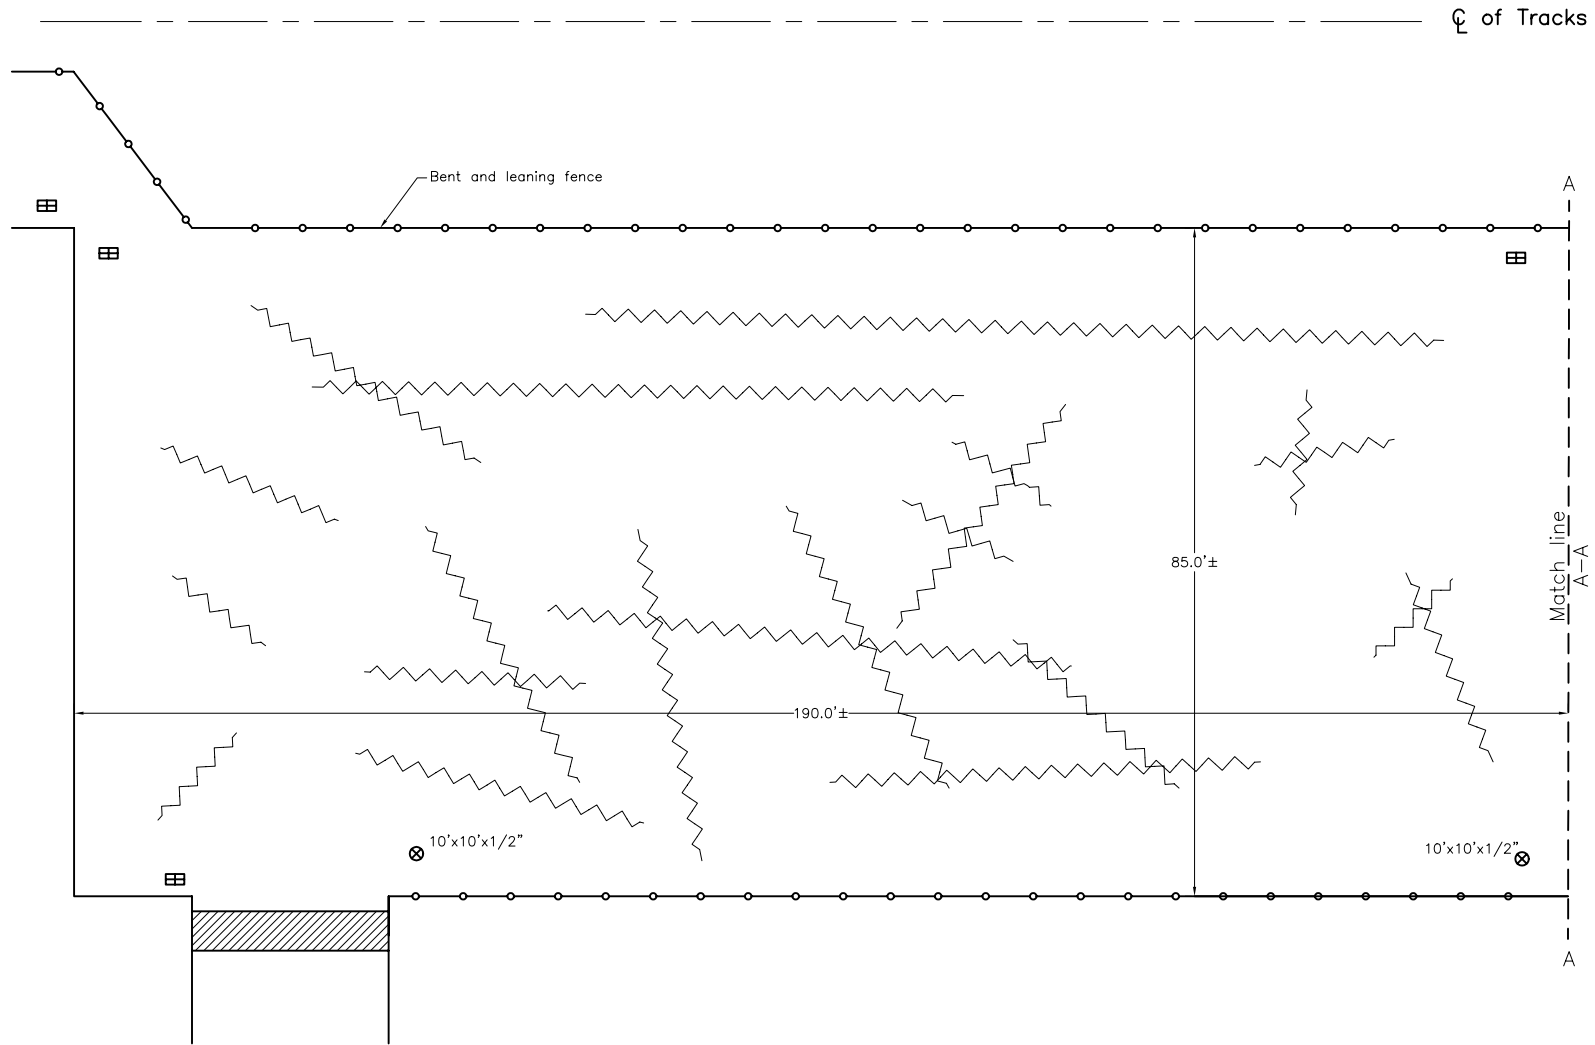
Urbitran Associates, Inc.
Connecticut Dept. of Transportation
New Canaan Station (LOT 1) Quadrant I Details
Date: 12-20-01

NOTES:
 1. 40% of the asphalt surface exhibits cracks up to 3" wide

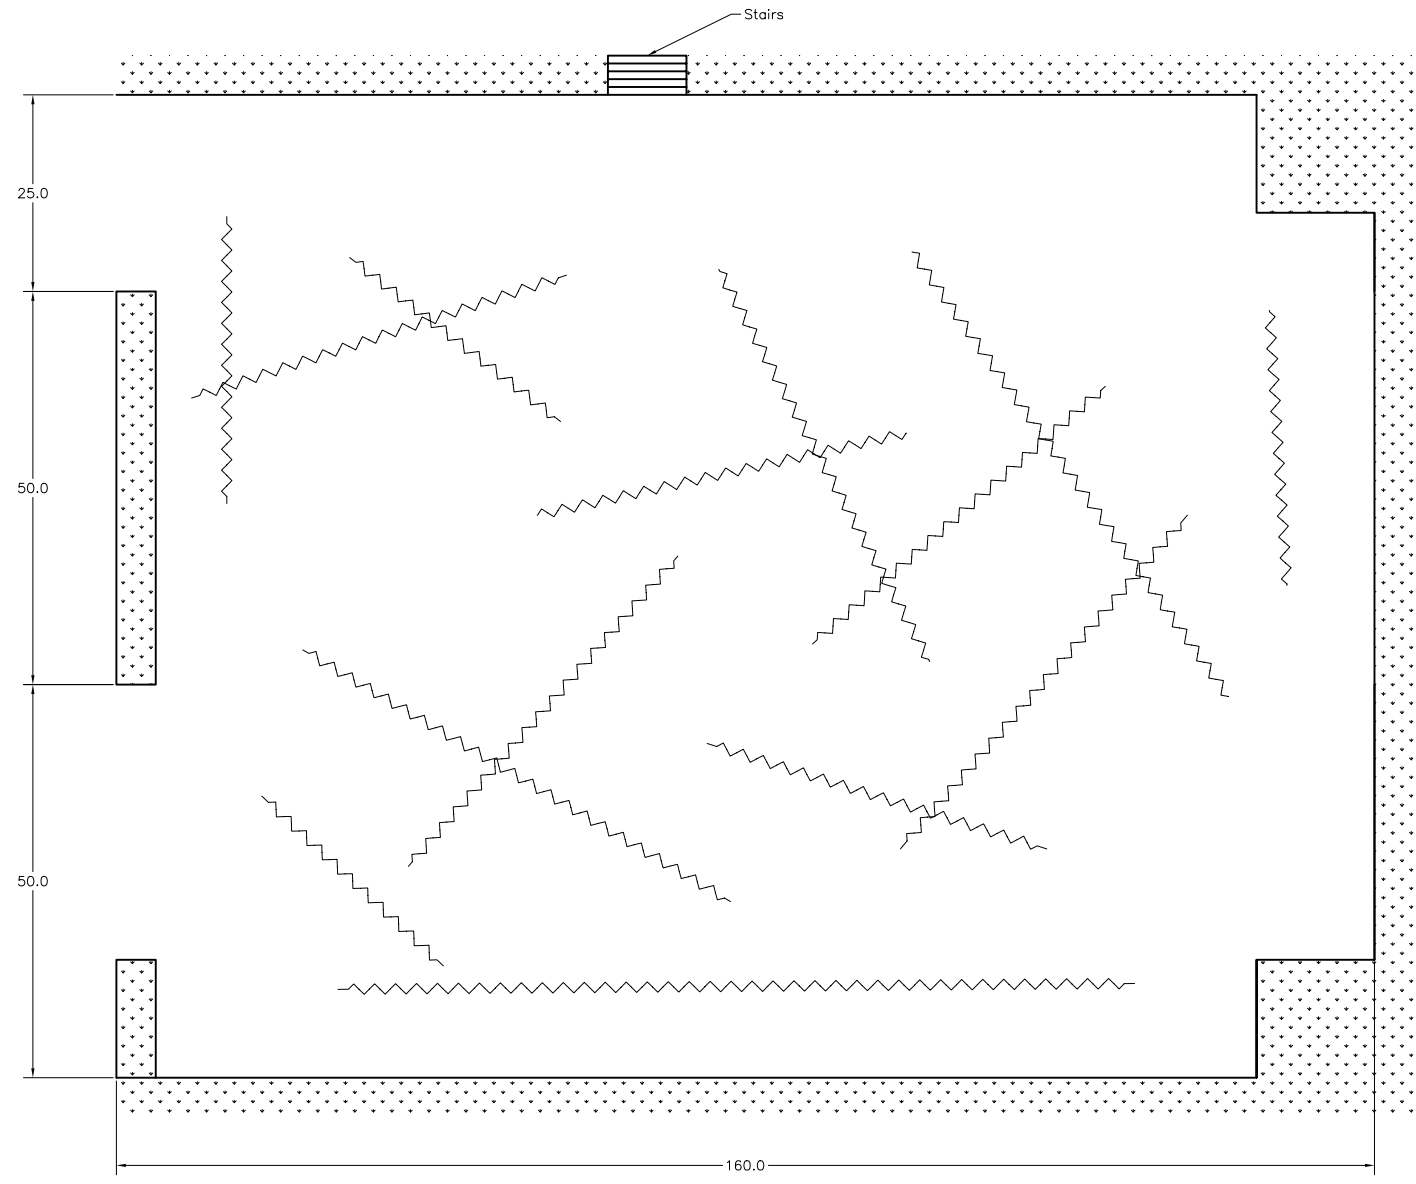
Urbitran Associates, Inc.
Connecticut Dept. of Transportation
New Canaan Station (LOT 3) Quadrant V Details
Date: 12-20-01

- NOTES:
1. 35% of the asphalt surface is cracked.
 2. The striping is faded.

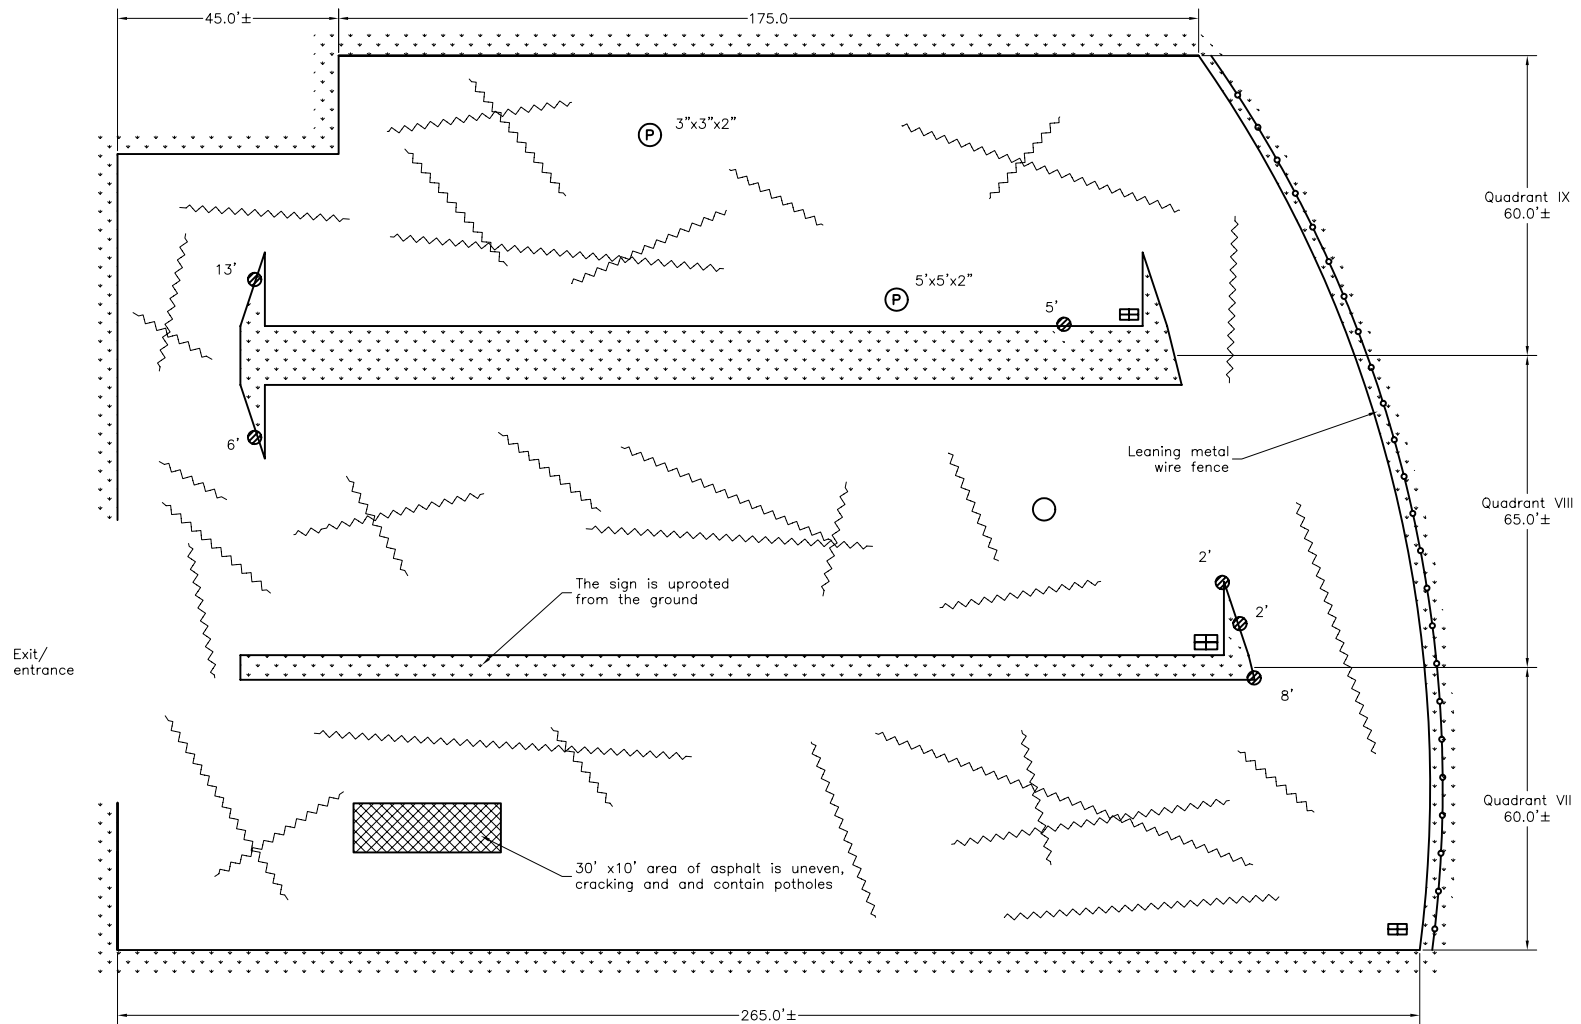
Urbitran Associates, Inc.
Connecticut Dept. of Transportation
New Canaan Station (LOT 4) Quadrant VI Details
Date: 12-20-01

- NOTES:
1. Quadrant VIII contains an additional 20% of cracked asphalt.
 2. Quadrant IX contains 30% of cracked asphalt.
 3. Quadrant X contains 40% of cracked asphalt.

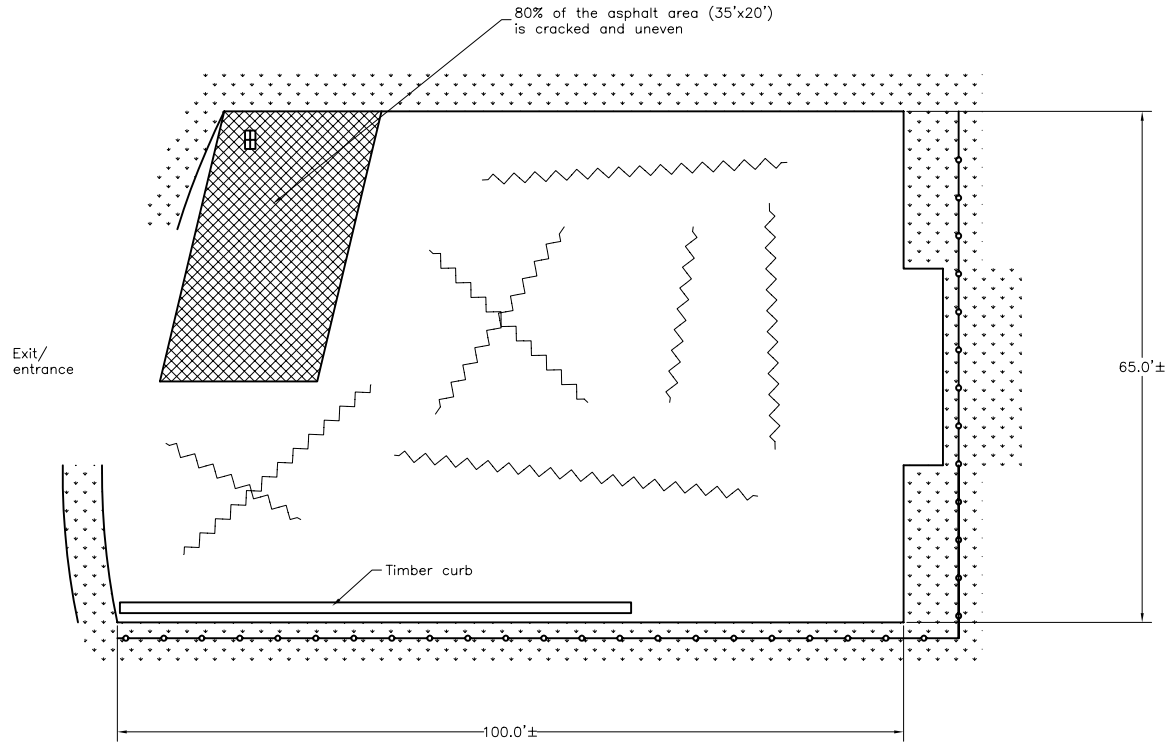
Urbitran Associates, Inc.
Connecticut Dept. of Transportation
New Canaan Station (Lot 9) Quadrant VII, VIII, IX, Details
Date: 12-20-01

1. 10% of the asphalt pavement is cracked.

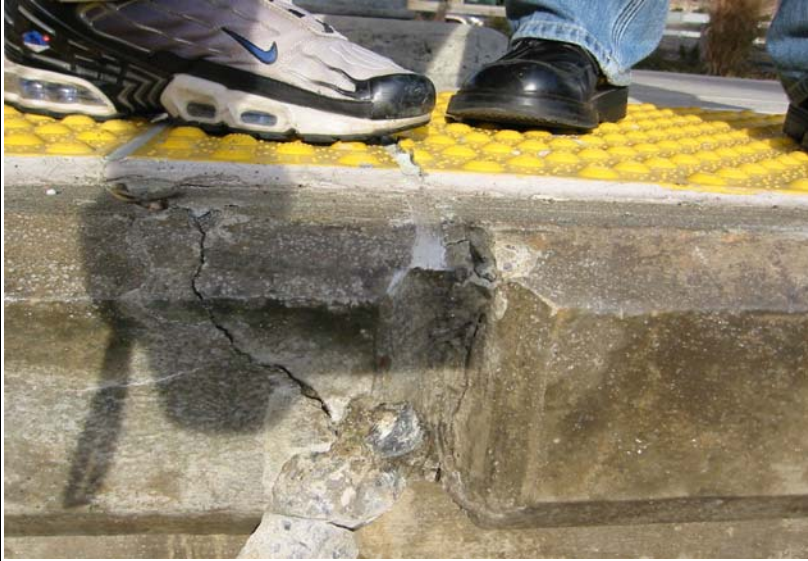
Description: _____
Spalled and cracked
concrete 1'x1'x4"

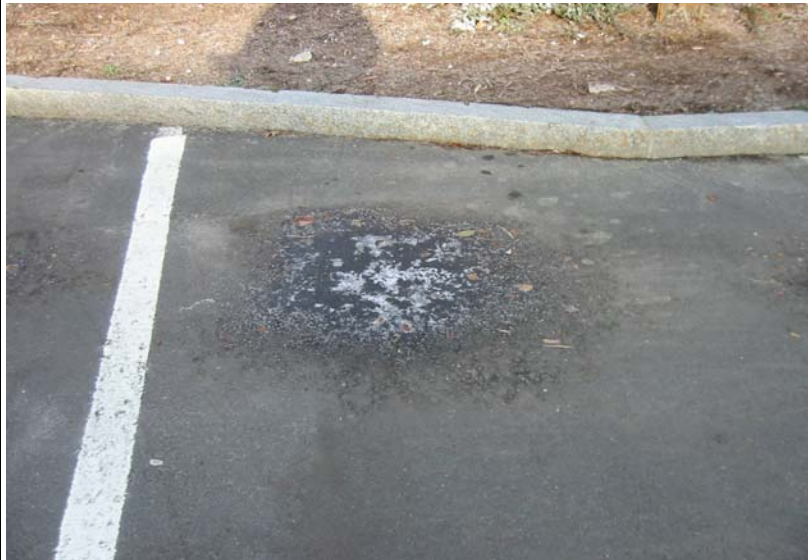
PHOTO NO. 30

Description: _____
Ponding of water which
has frozen

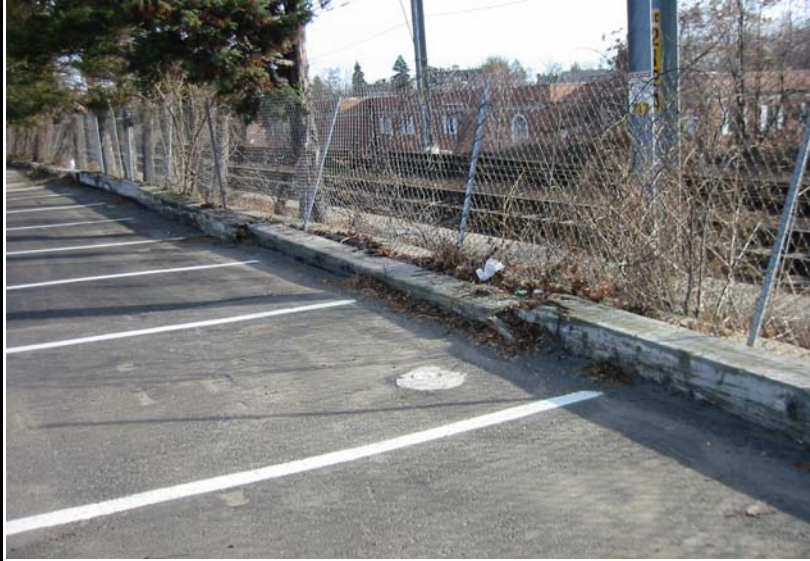
Description: Leaning fence and timber curb

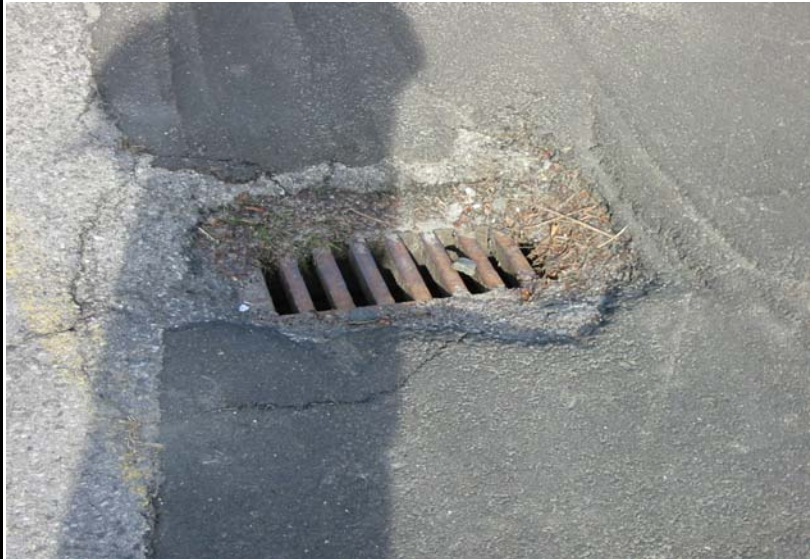
PHOTO NO. 32

Description: Sunken drain surrounded by cracks and uneven asphalt

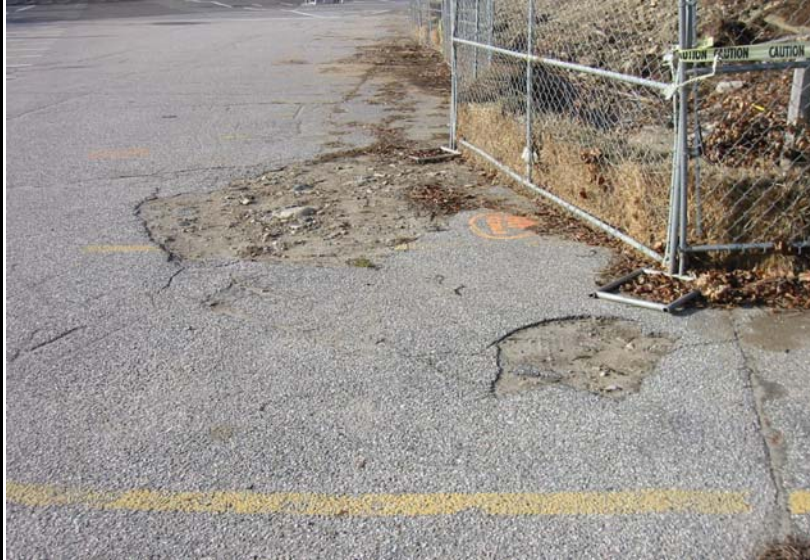
Description: _____
Two potholes 3'x3' and
13'x9'

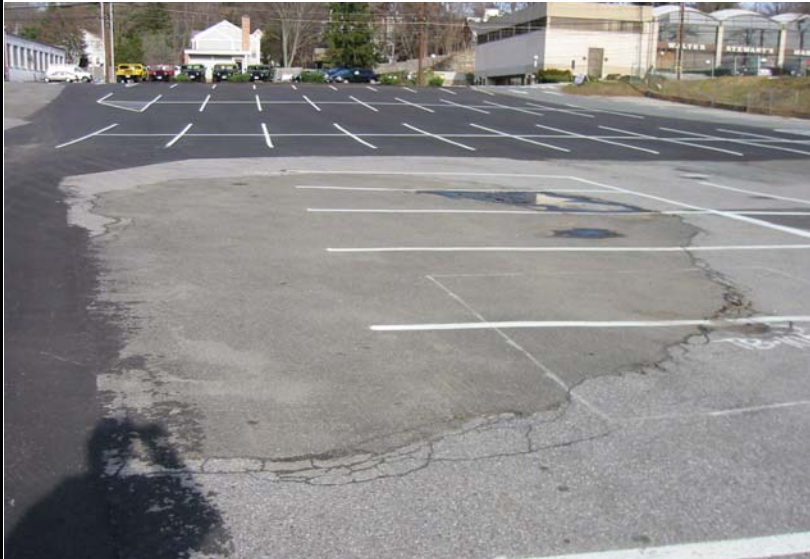
PHOTO NO. 34

Description: _____
Patched asphalt with
ponding and cracking
around the perimeter

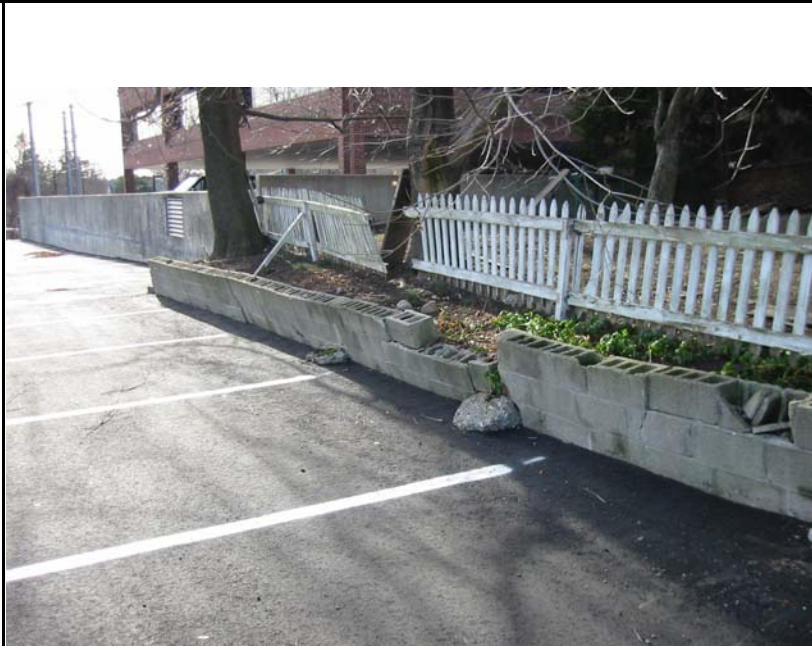
Description: Retaining wall and fencing is damaged and collapsing into the parking area

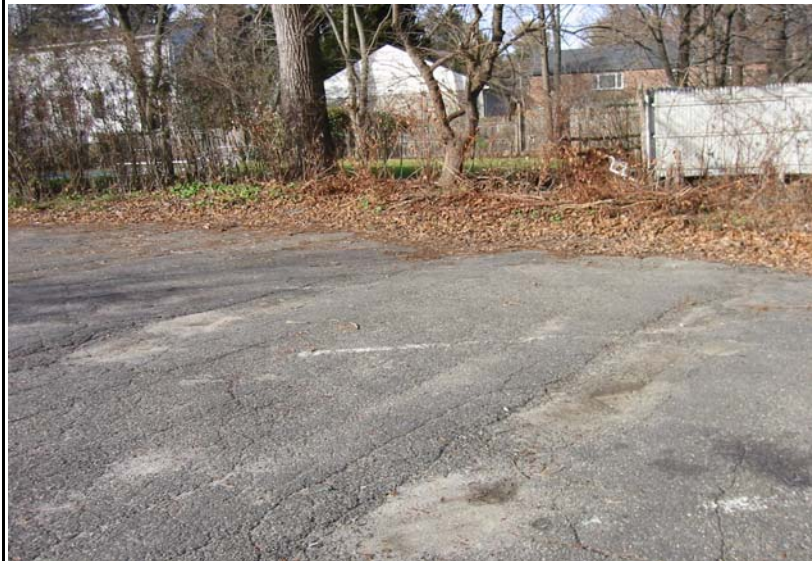
PHOTO NO. 36

Description: Accumulation of leaves in the parking area, and uneven alignment and cracked asphalt

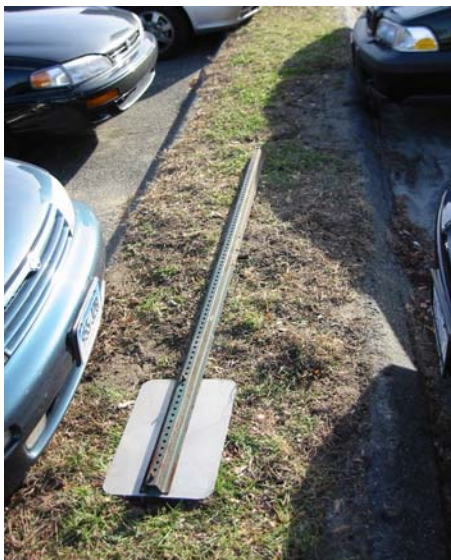
Description: Uprooted sign

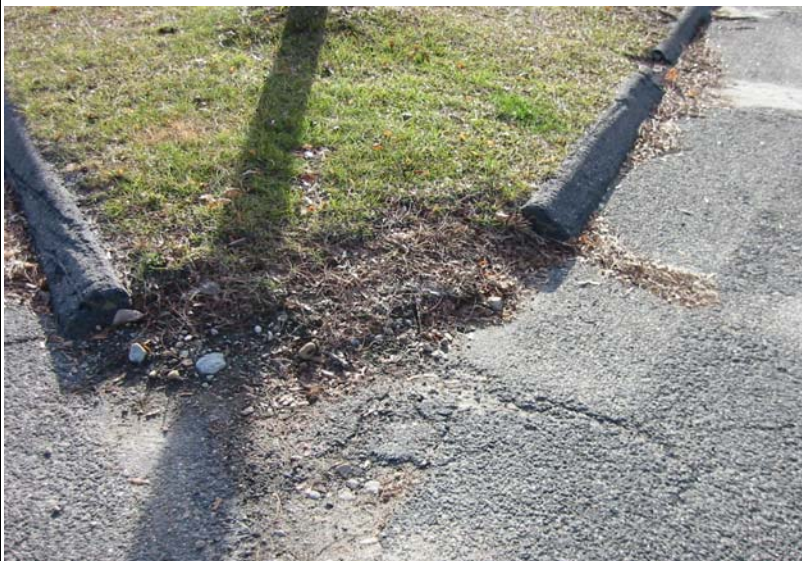
PHOTO NO. 38

Description: Typical missing, and cracking asphalt curb

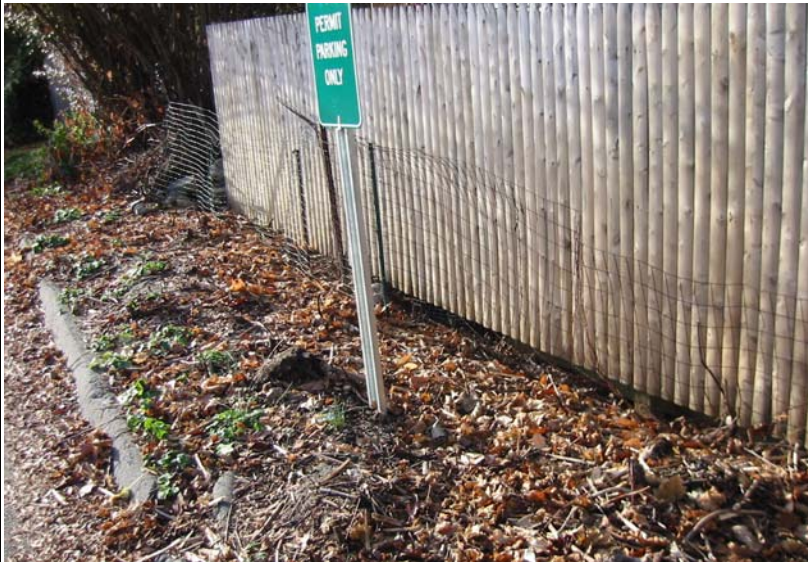
Description: _____
Typical leaning metal
wire fence
