CONNECTICUT
DEPARTMENT
OF
TRANSPORTATION

CONDITION INSPECTION
WEST REDDING STATION

**CONN. DEPT OF TRANSPORTATION
STATION INSPECTION**

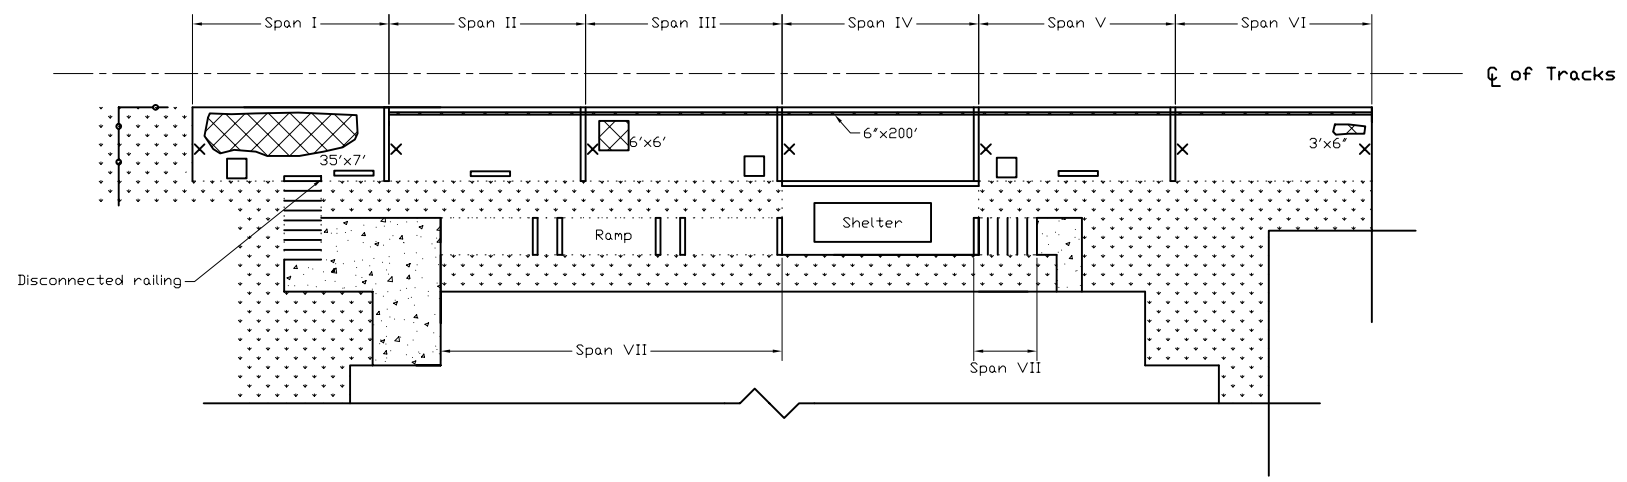
Urbitran Associates, Inc.
Connecticut Dept. of Transportation
West Redding Station Platform Plan
Date: 12-12-01

- NOTES:
1. 1'x3' area that contains cracked and broken concrete at the bottom of the North end of the double-tee.
 2. 2'x6'x6' section that contains cracked and broken concrete at the bottom of the South end of the double-tee.
 3. Hairline crack around the perimeter of the South end footing (The perimeter = 90')
 4. The concrete under the 30'x10' shelter exhibits a rough surface with minor holes.

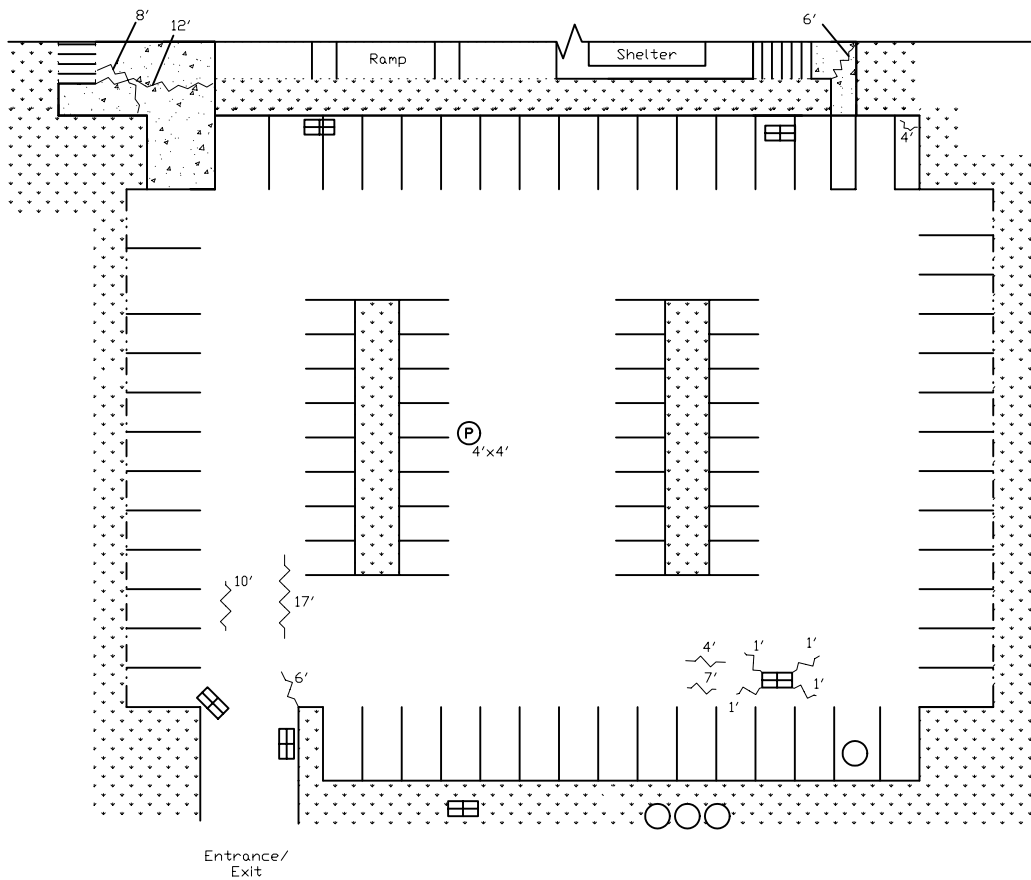
West Redding Station
Quadrant I Plan

1. The wooden post of the wooden guard rails exhibit centerline cracks running up and down each face.

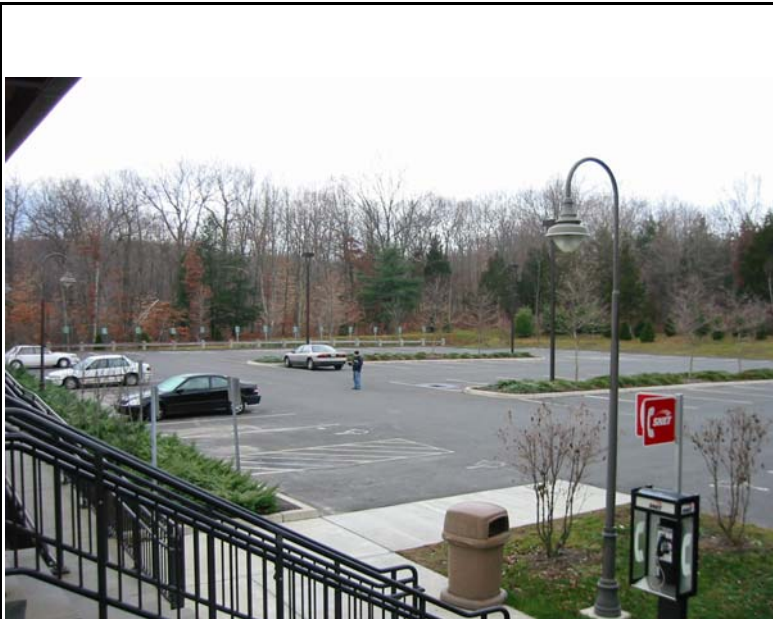
PHOTO NO. 1

Description: _____
General view of Quad I

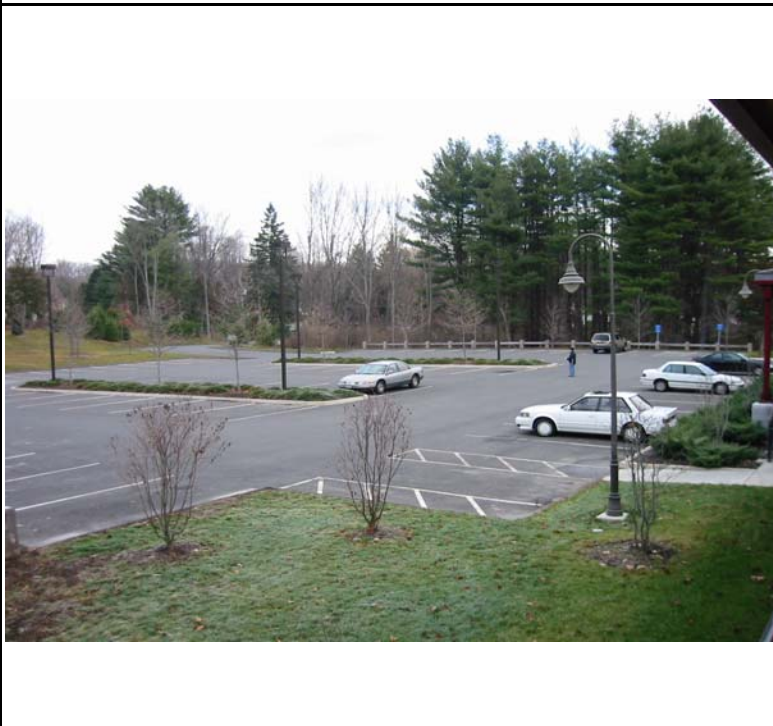
PHOTO NO. 2

Description: _____
General view of Quad I

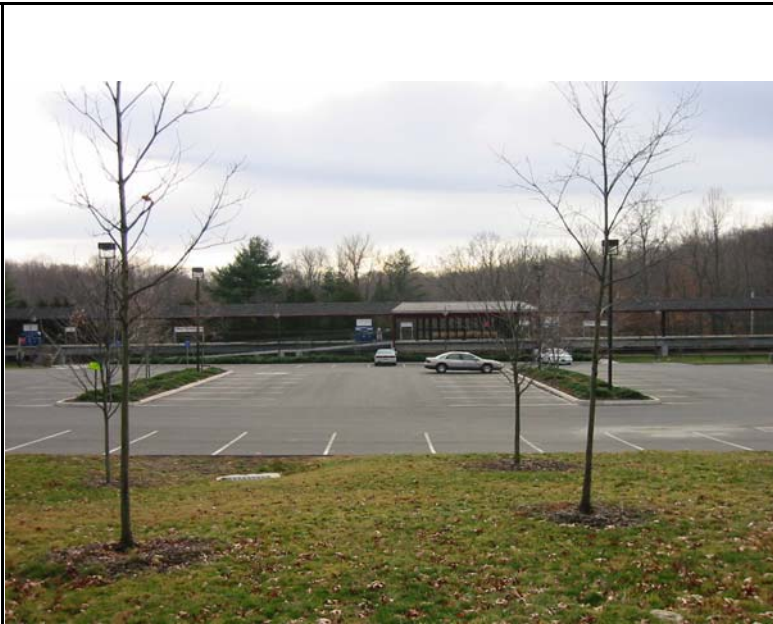
PHOTO NO. 3
Location: West side of Quad I
Description: General view of Quad I
Reference: Looking east

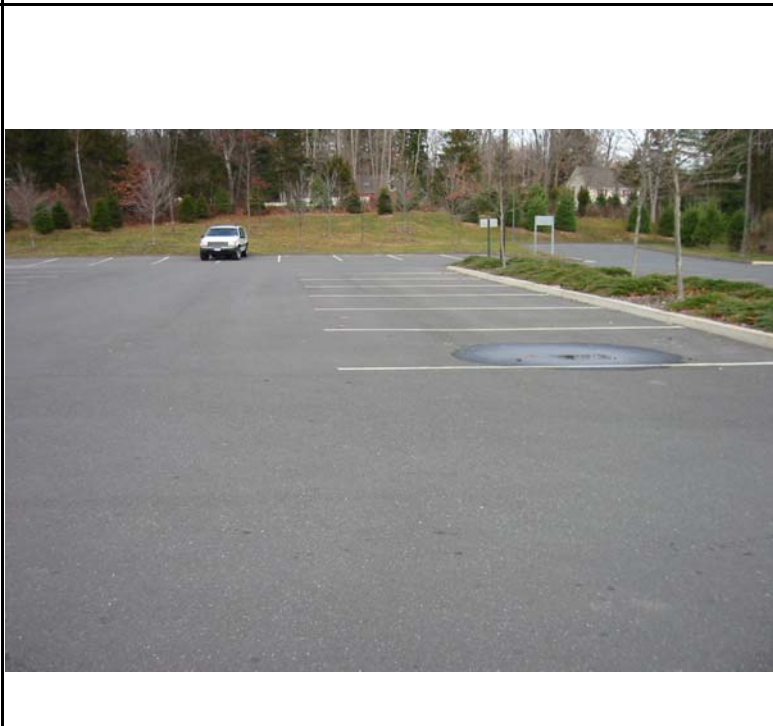
PHOTO NO. 4
Location: East side of Quad I
Description: General view of Quad I; ponding (4'x4')
Reference: Looking west

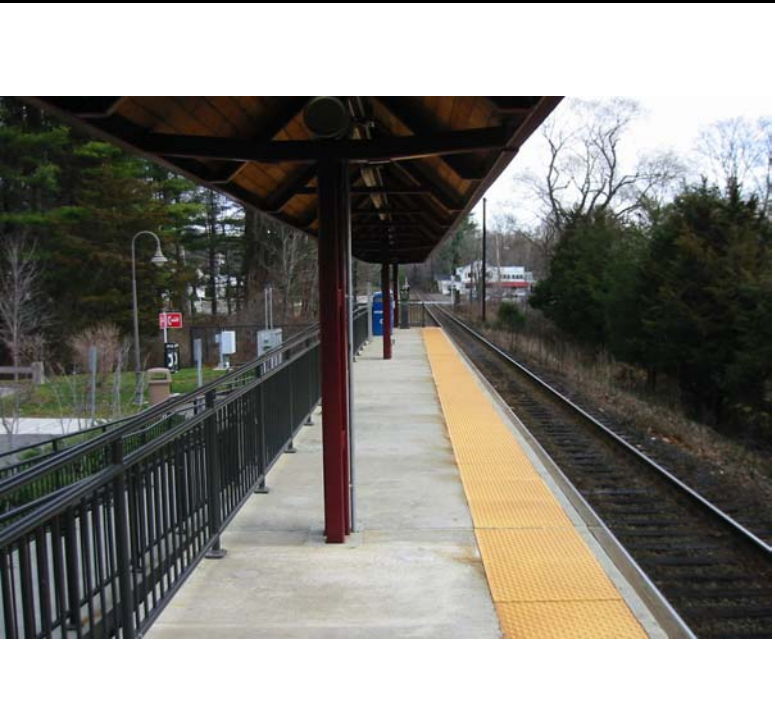
PHOTO NO. 5

Description:
General view of the platform

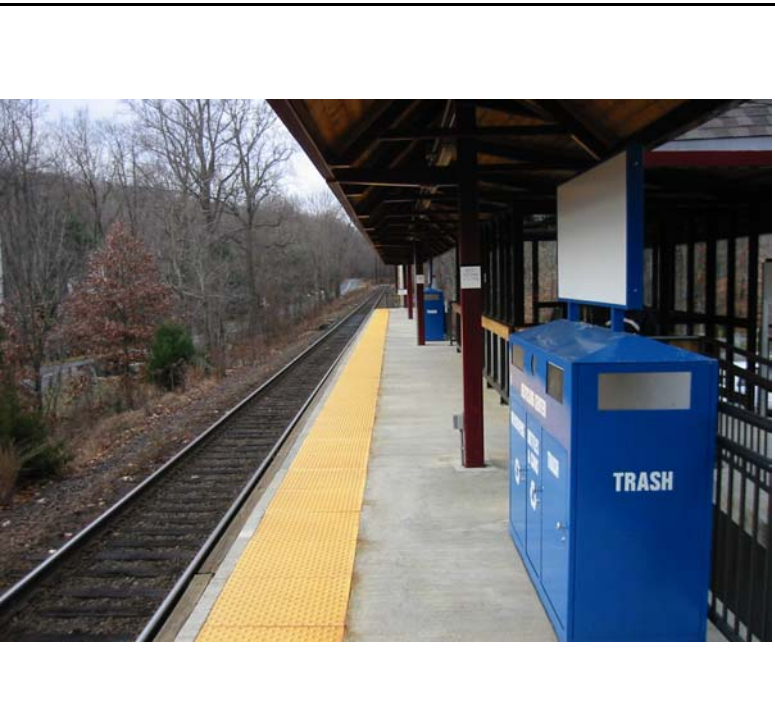
PHOTO NO. 6

Description:
General view of the platform

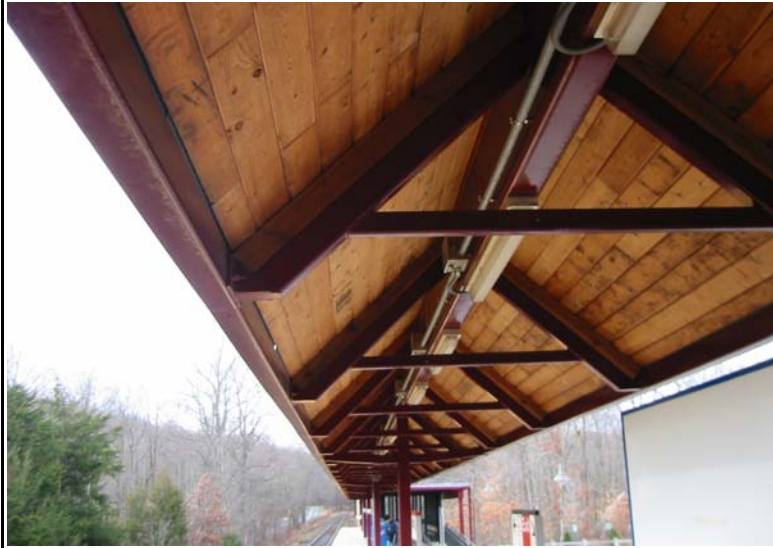
PHOTO NO. 7

Description:
General view of the canopy above the platform

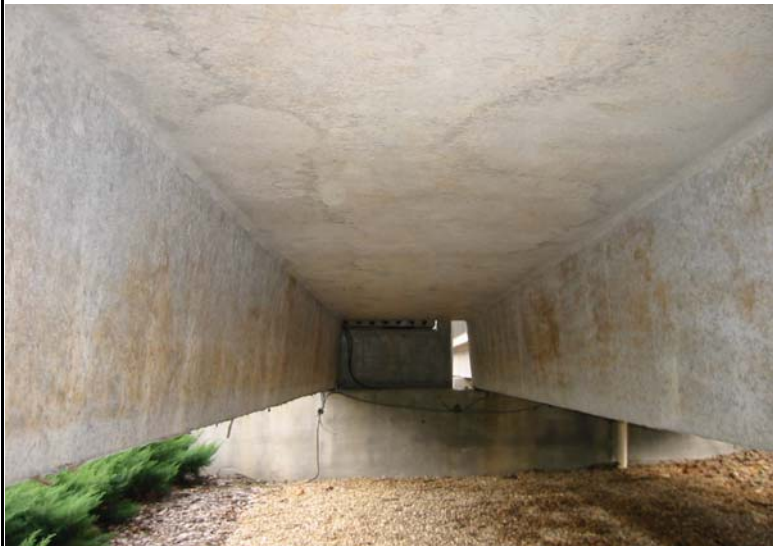
PHOTO NO. 8

Description:
General view of the underside of the double-tee

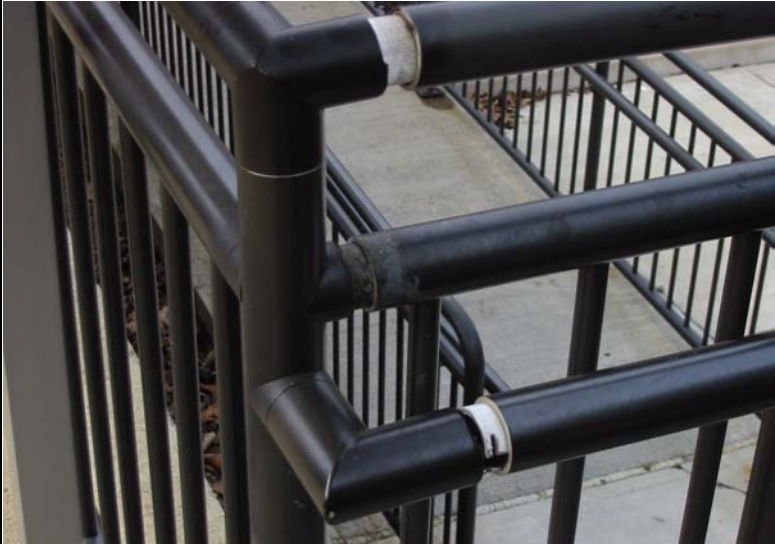
PHOTO NO. 9

Description:
Disconnected railing

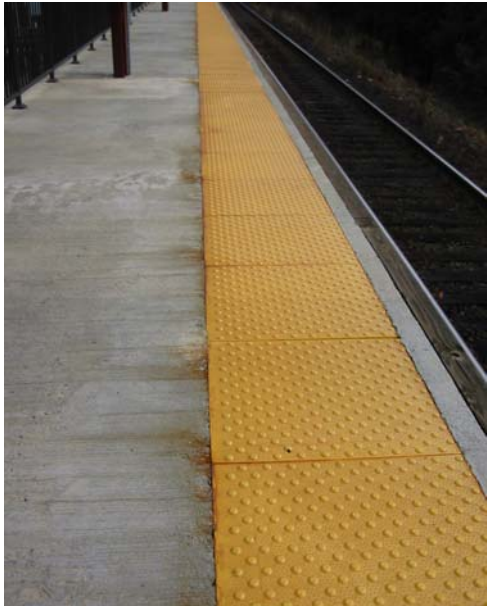
PHOTO NO. 10

Description:
Typical minor concrete
scaling

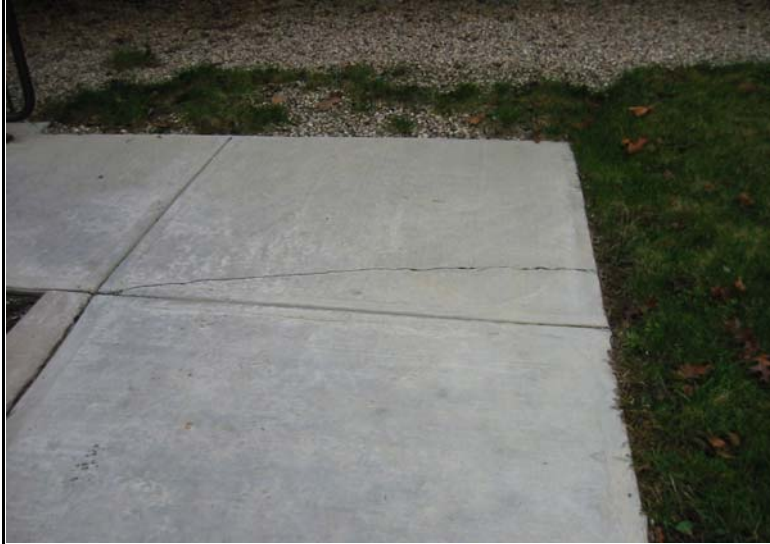
PHOTO NO. 11

Description:
6' concrete crack

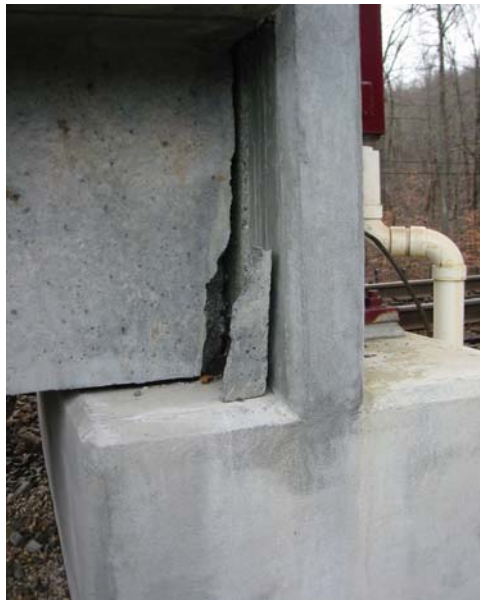
PHOTO NO. 12

Description:
A section of concrete
located at the bottom of
the double tee is spalled;
Note that there is a
similar condition on
the east side and north
end of the double-tee

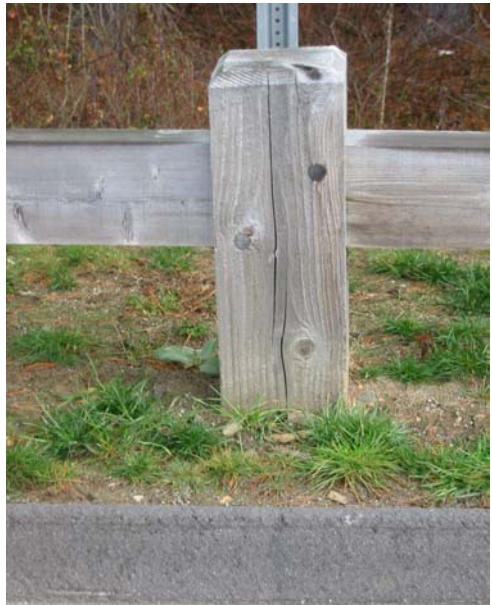
PHOTO NO. 15
Location:
North side of Quad I
Description:
Vertical crack that extends top to bottom of the south face of the timber post; typical for all faces and posts
Reference:
Looking north

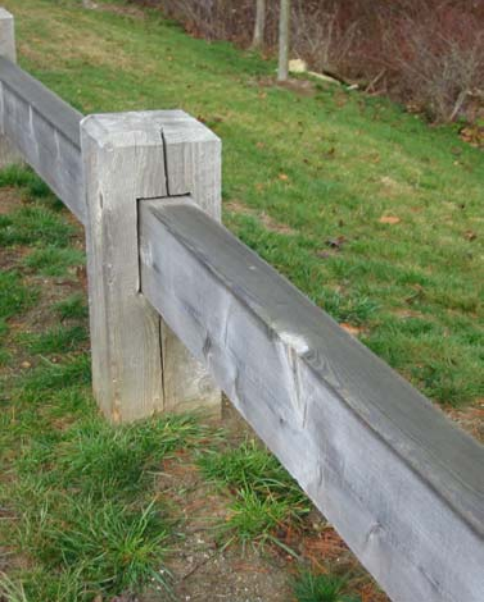
PHOTO NO. 16
Location:
North side of Quad I
Description:
Vertical crack that extends top to bottom of the west face of the timber post; typical for all faces and posts
Reference:
Looking west

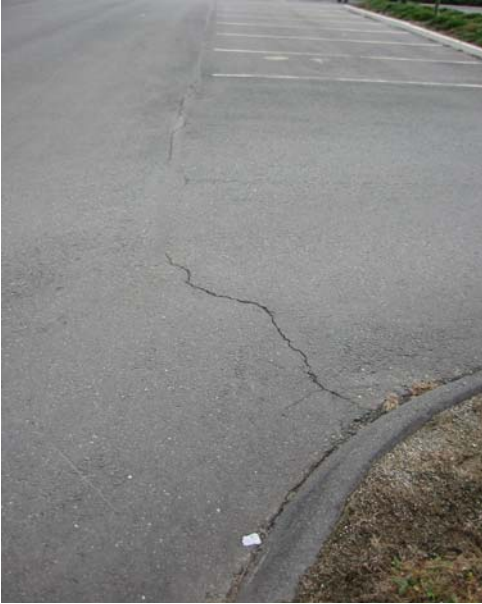
PHOTO NO. 17
Location: Northwest corner of Quad I
Description: 17' and 6" asphalt crack
Reference: Looking east

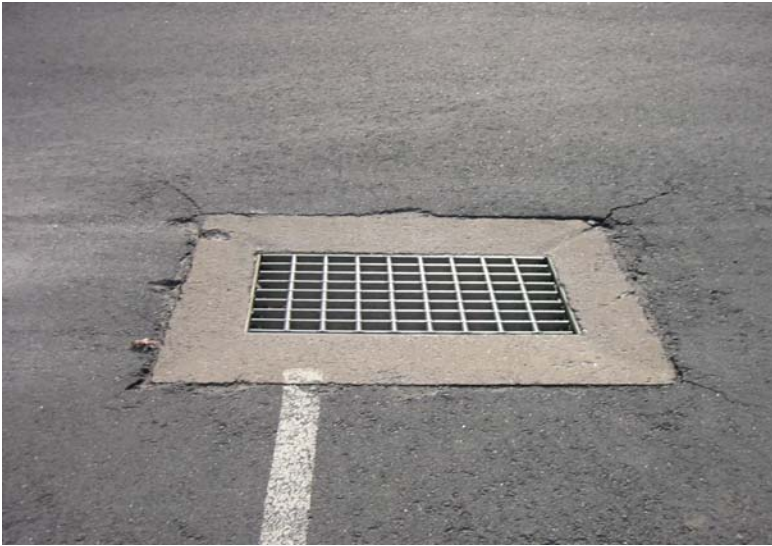
PHOTO NO. 18
Location: West side of Quad I
Description: Minor cracks surrounding the drain
Reference: Looking east

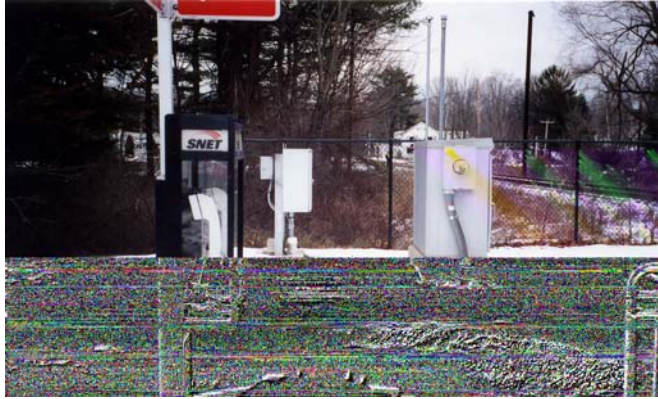
PHOTO NO. 20

Remarks: We were unable to gain access to the electrical service enclosure to verify the size and condition of the main panelboard. However, the platform appears to be relatively new.

The platform is relatively new including the electrical cabinet mounted adjacent to the platform. We were unable to gain access to the locked electrical cabinet to visually inspect the main panelboard, but the cabinet is new, probably with a new panelboard inside. There are several GFCI type receptacles located on the platform and are all in a good working condition.

Description:
electrical service
enclosure

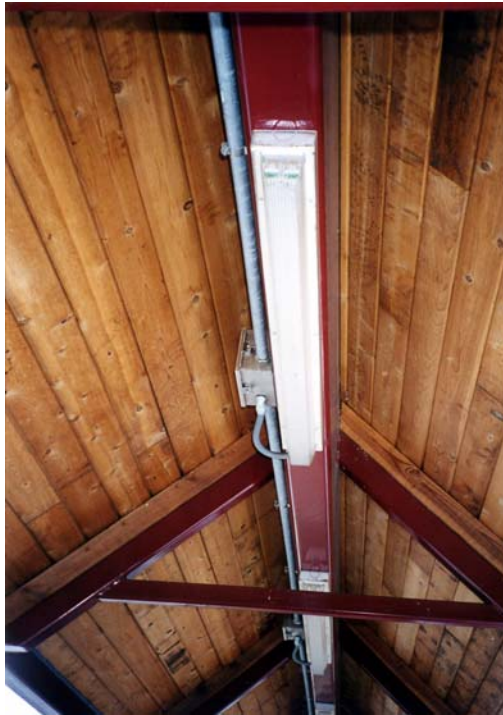
PHOTO NO. 21

Two of the fixtures have broken lenses.

The platform is illuminated with two-lamp fluorescent fixtures that are all completely sealed from the weather except for two. These two fixture lenses should be replaced. The fixtures maintain an average of 9.3 foot-candles on the platform and exceed the IESNA recommended minimum for platform lighting.

Description:
platform lighting

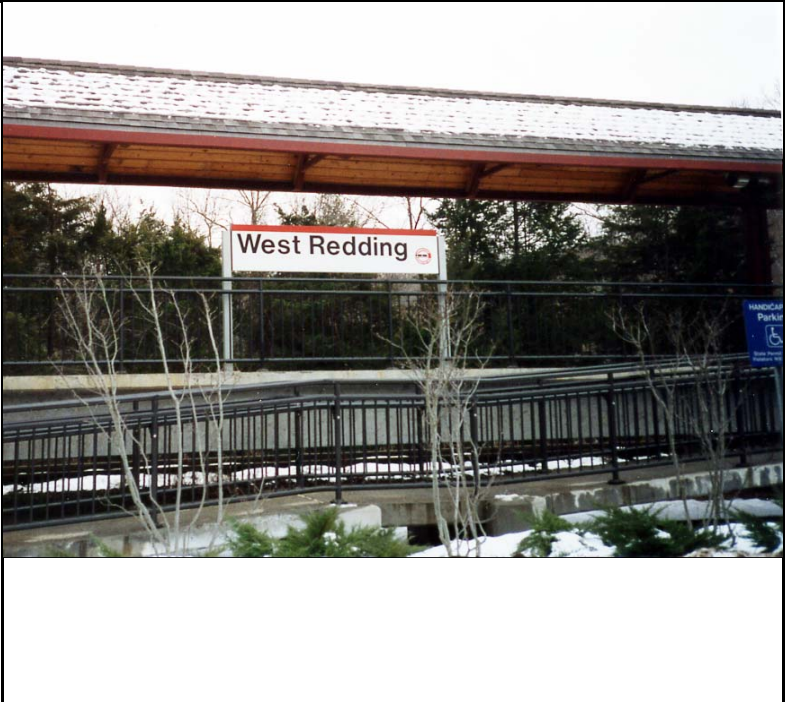
PHOTO NO. 22
Location: WEST REDDING STATION
Description: Station Name and Canopy
Reference: _____

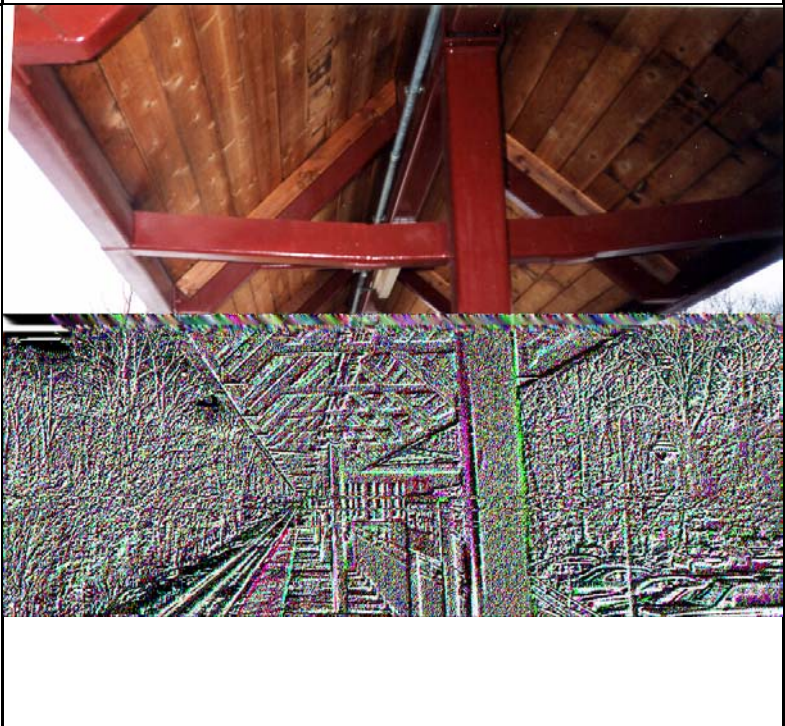
SPAN NO.	GUTTER	DOWNSPOUT/ PIPING	CLEAN-OUTS	SPAN NO.	GUTTER	DOWNSPOUT/ PIPING	CLEAN-OUTS
All	Solid metal (welded) gutters with PVC pipes within formed downspouts are new and in excellent condition.

PHOTO NO. 23
Location: WEST REDDING STATION
Description: Gutters on both sides of the canopy
Reference: _____

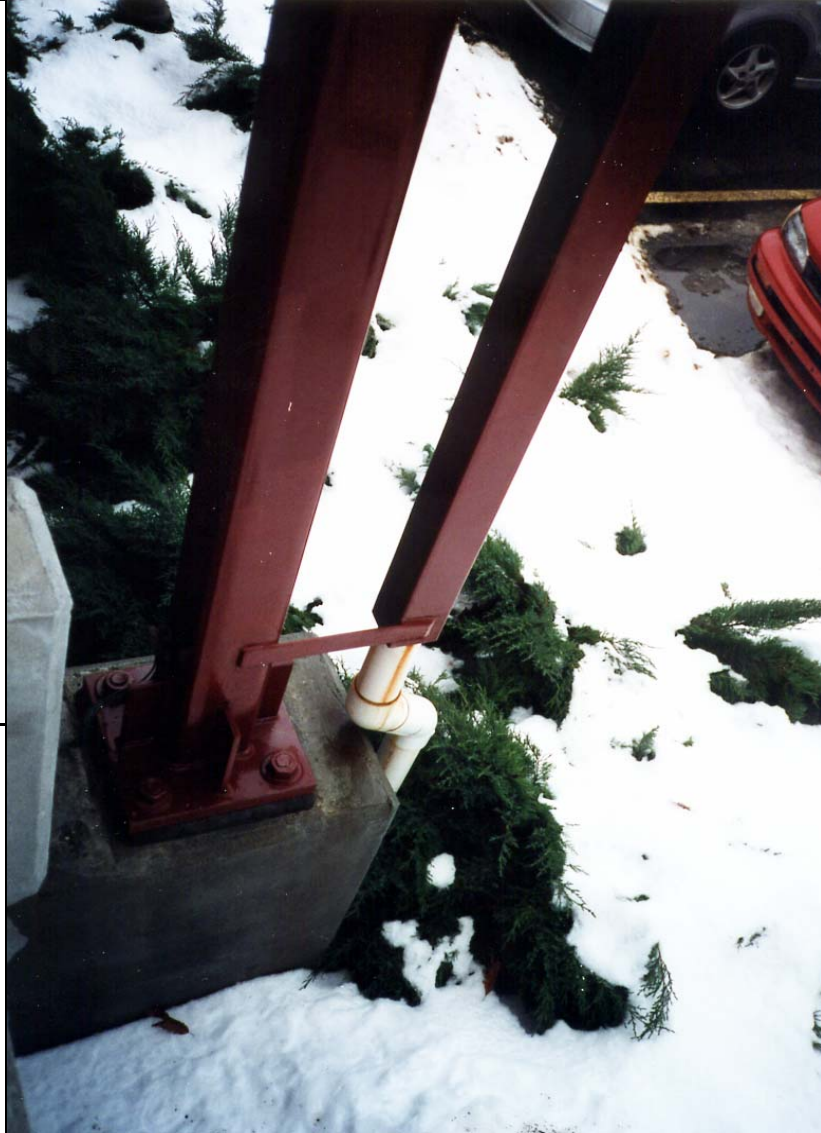
PHOTO NO. 24

Description: Downspout
Heavy Steel
Protector with
inner PVC
Pipe
