Individual Station Report

Noroton Heights

Station Condition Inspection

CONDITION INSPECTION
FOR THE
NOROTON HEIGHTS STATION

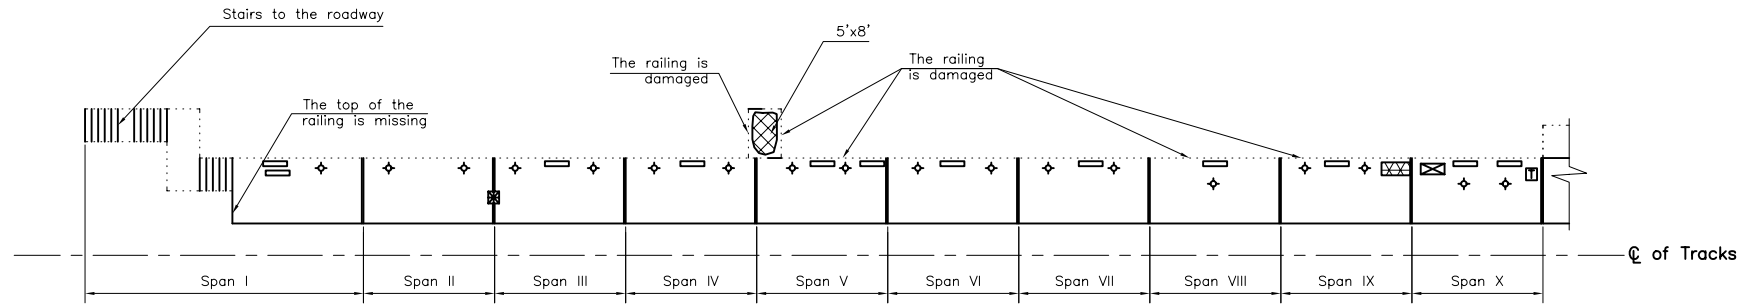
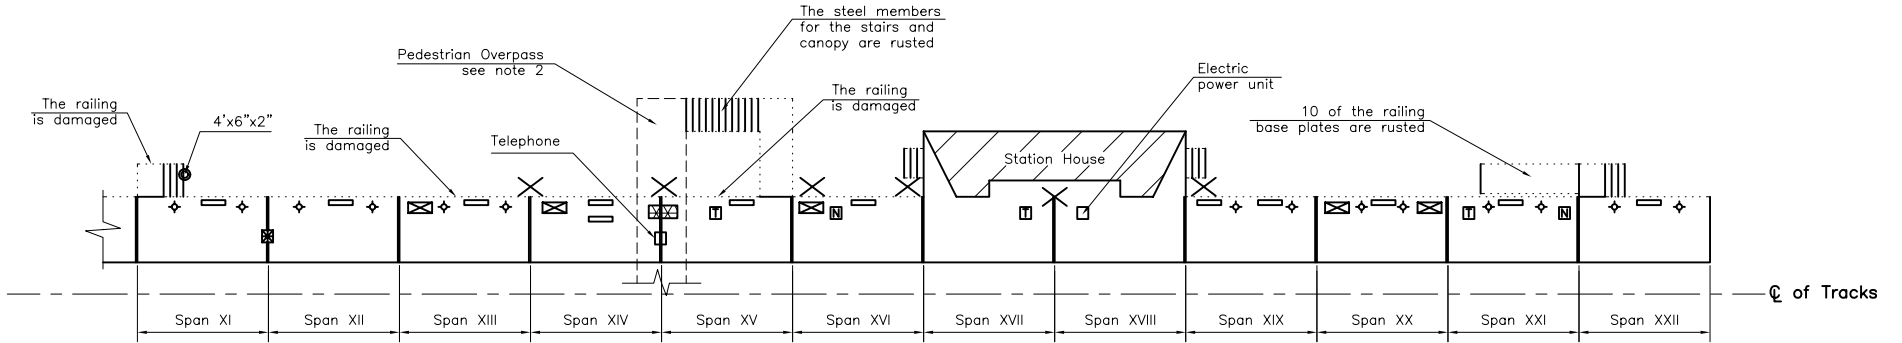
| Noroton Heights Station (Eastbound) North Platform Plan |

1. The warning strip is faded throughout the north platform.
2. The underside of the overpass is rusted (150'x15').

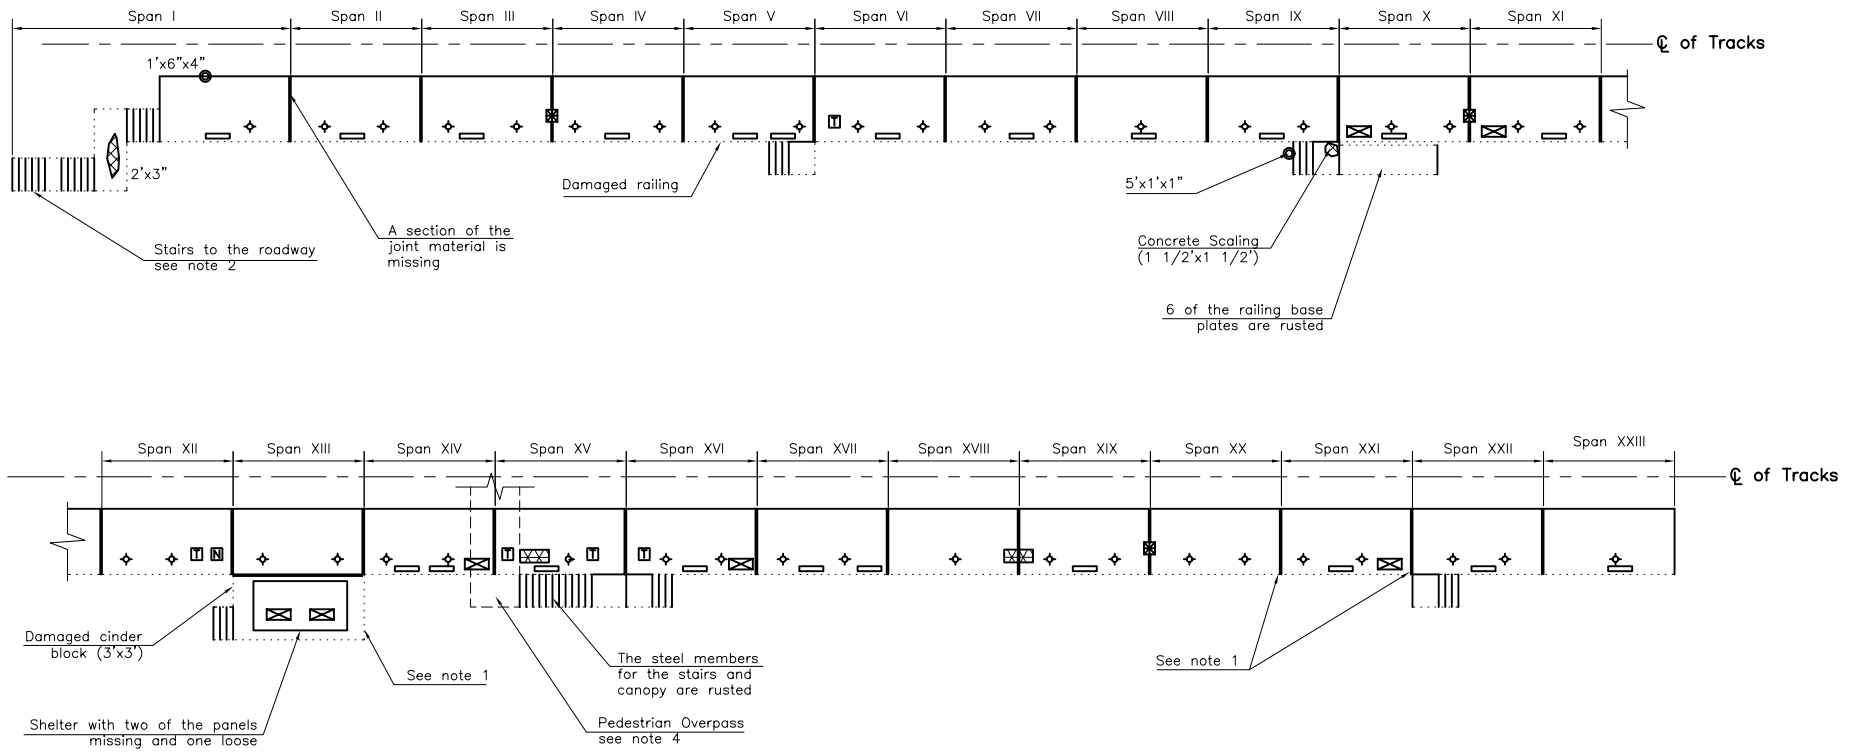
| Noroton Heights Station (Westbound) South Platform Plan |

- NOTES:**
1. The base plate for the double tee is rusted and deteriorated.
 2. The stairs are spalled in various locations. There is an isolated location where the steel is exposed.
 3. The warning strip is faded throughout the south platform.
 4. The underside of the overpass is rusted (150'x15').

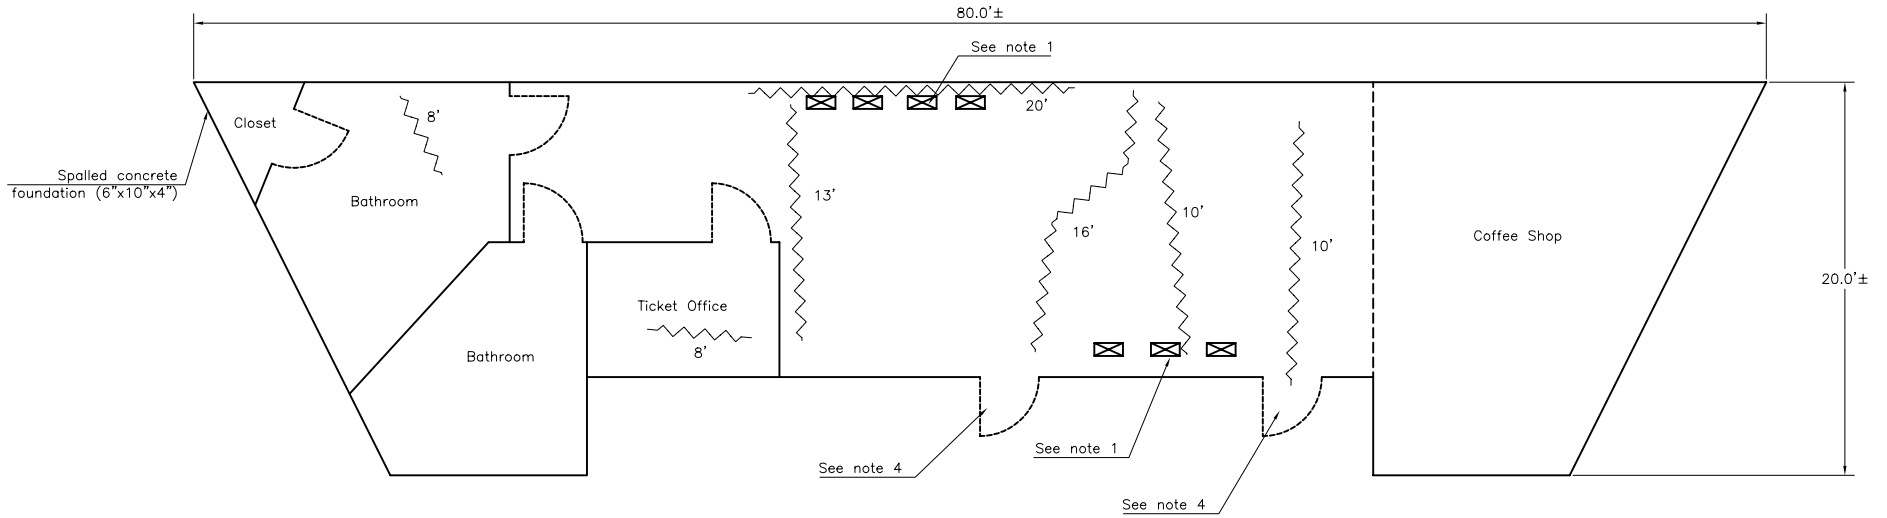
| Norton Heights Station Station House Plan |

1. Typical the base plates for the seats are rusted and deteriorated.
2. There is uneven settlement of the asphalt adjacent to the north elevation of the station house.
3. The station house has a linoleum floor with minor cracks as shown.
4. The doors entering the station house are difficult to open.
5. There are random cracks on the northside foundation.
6. The drop ceiling in the eastend half of the station house is sagging and or cracked.

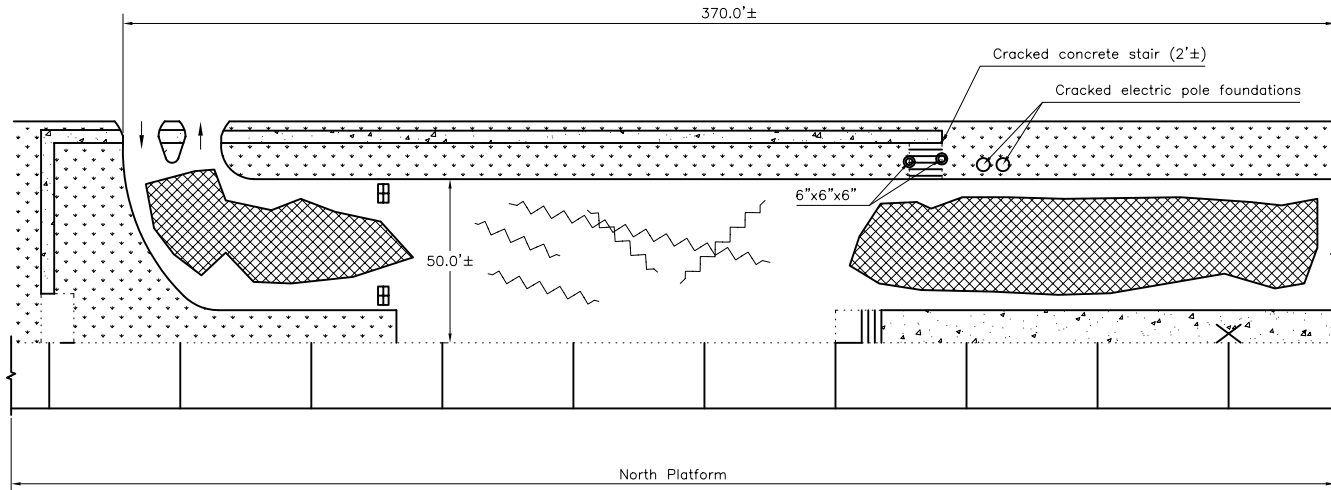
| Noroton Heights Station Quadrant I Plan |

NOTES:
 1. The entire surface is cracked and contains potholes.

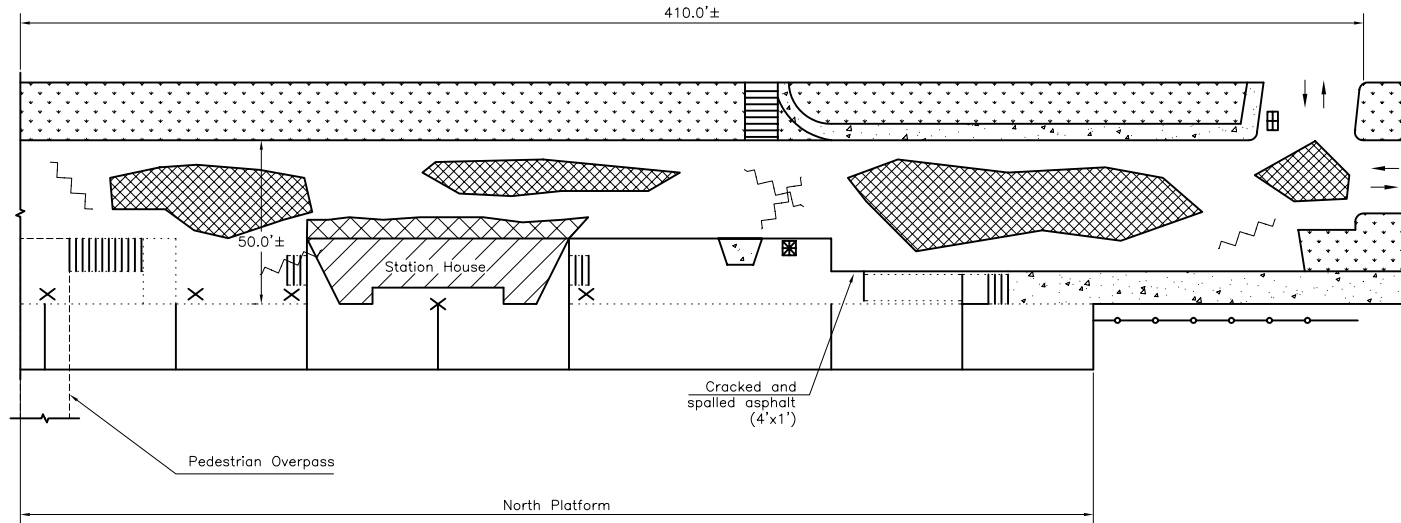
| Noroton Heights Station Quadrant II Plan |

NOTES:
 1. The entire asphalt surface is cracked.
