Individual Station Report

Rowayton

July 2003

CONDITION INSPECTION
FOR THE
ROWAYTON STATION

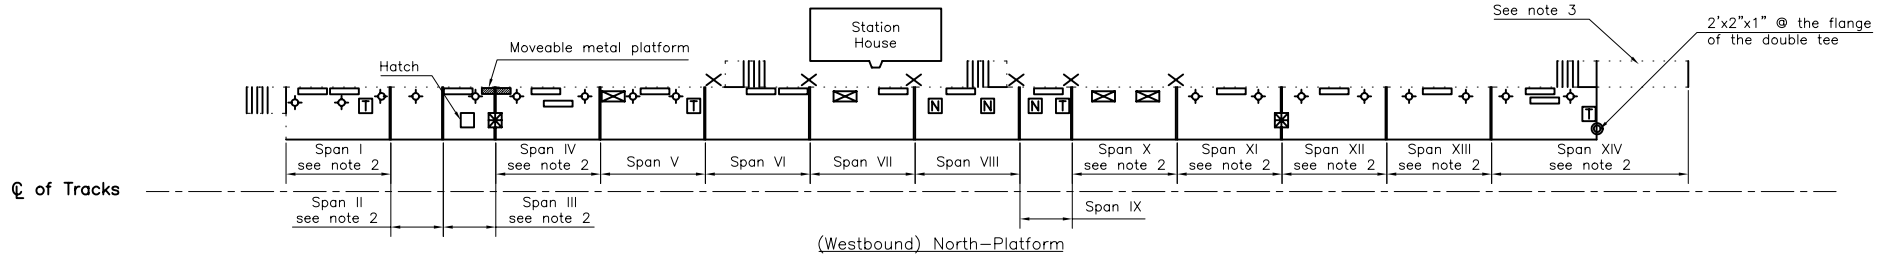
(Westbound) North-Platform

1. The base plates for the double tee are rusted and deteriorated.
2. The railing base plates are rusted.
3. In 11 locations there is spalled concrete adjacent to the rusted railing base plates.
4. The canopy framing materials are rusted in Spans VI-XI.

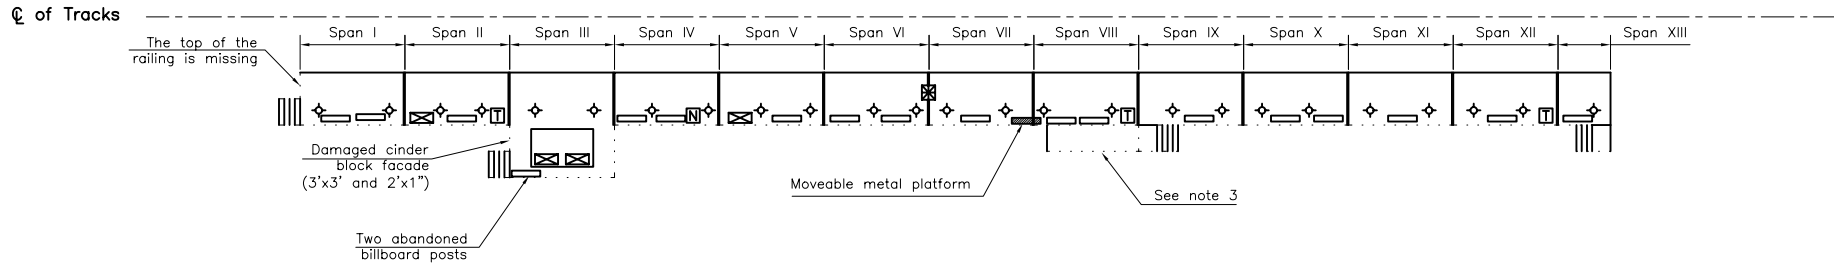
(Eastbound) South-Platform

1. The warning strip is faded throughout this platform.
2. The base plates for the double tees are rusted and deteriorated.
3. In 12 locations there is spalled or cracked concrete adjacent to the rusted railing base plates.
4. In every span the railing base plates are rusted.

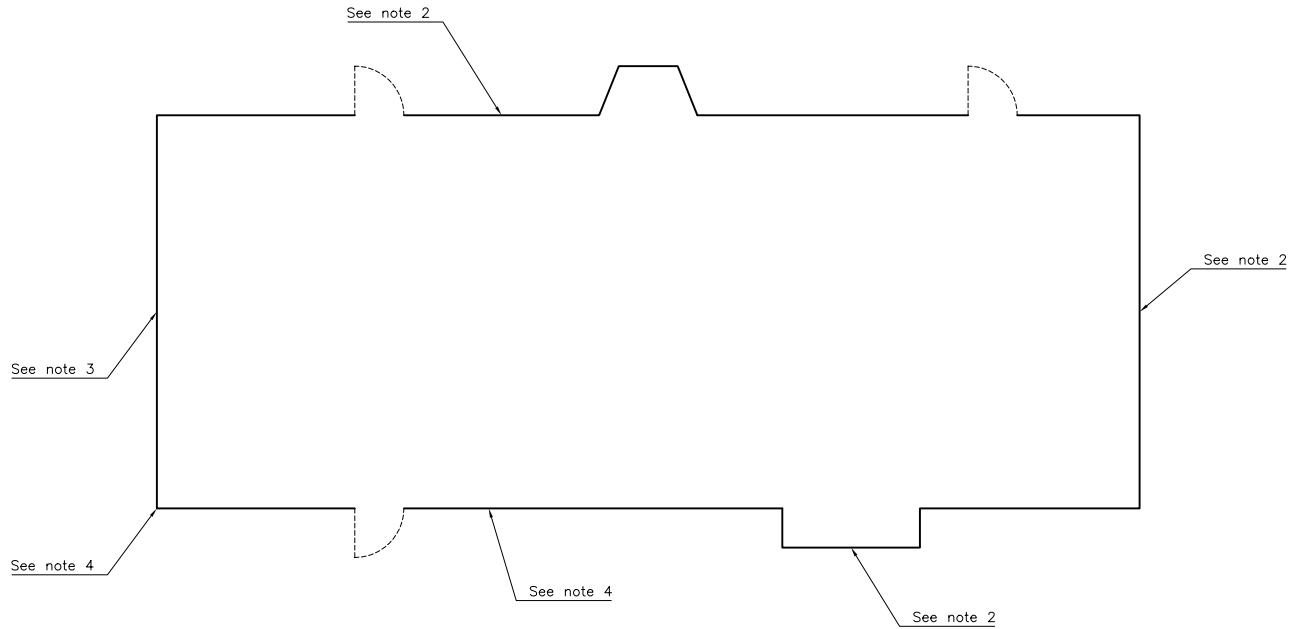
Urbitran Associates, Inc.
Connecticut Dept. of Transportation
Rowayton Station Station House Plan
Date: 12/07/01

1. The roof shingles are starting to uplift.
2. There are isolated areas where the exterior elevation is cracked.
3. There is an isolated area where the gutter is dislocated from the roof.
4. There are isolated areas where the paint is chipped.
5. At the time of inspection we could not get access to the interior of the station house.

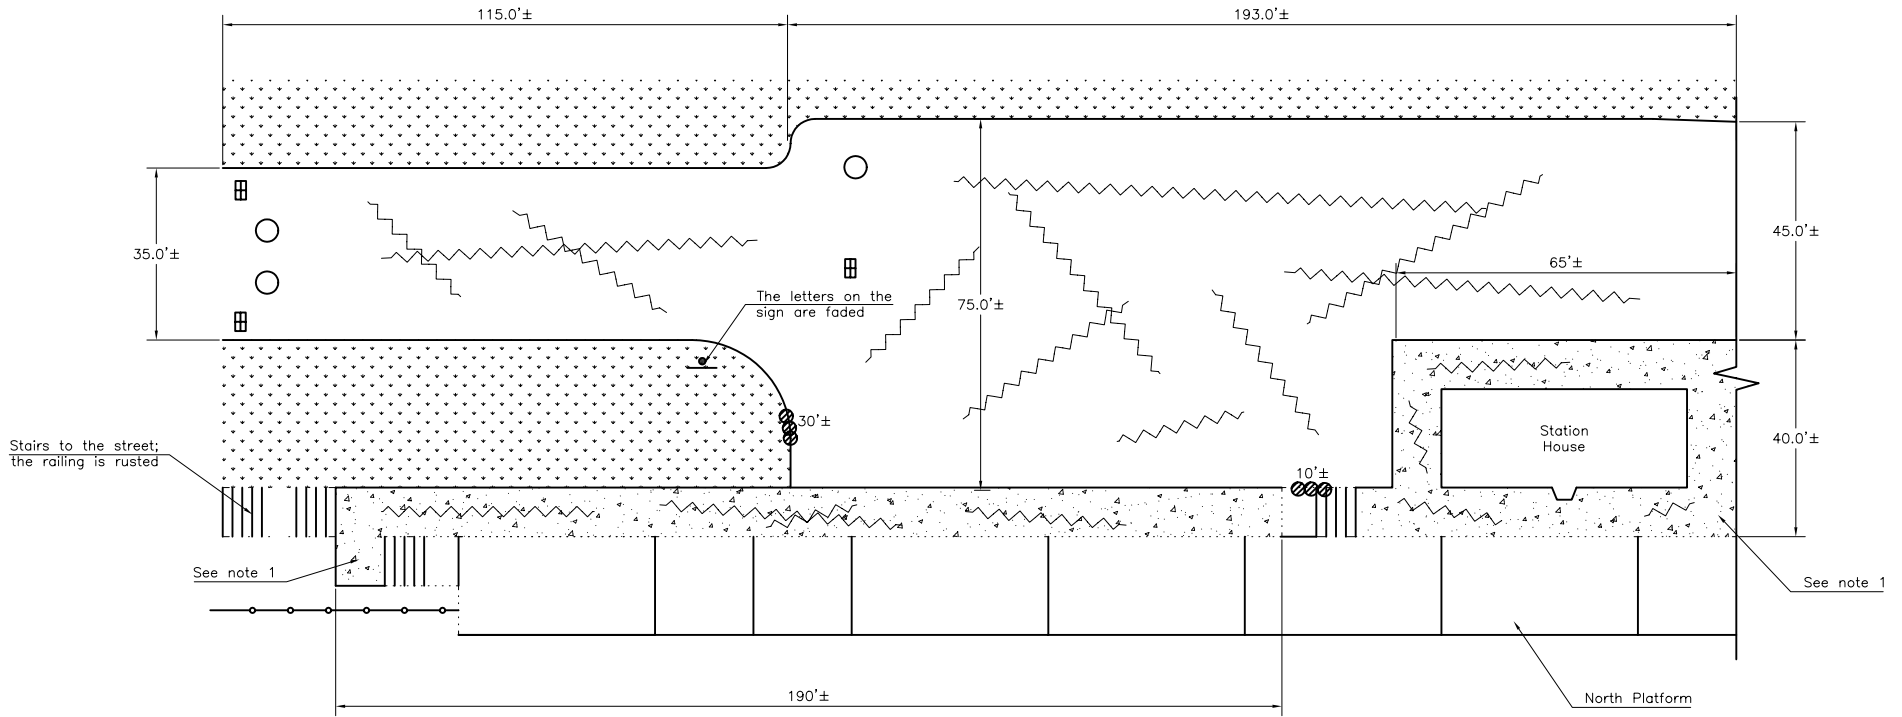
Urbitran Associates, Inc.
Connecticut Dept. of Transportation
Rowayton Station Quadrant I Plan
Date: 8/02/02

1. The curb is spalled and the sidewalk is cracked with vegetation growth and uneven.
2. The asphalt surface contains numerous cracks with vegetation growth.

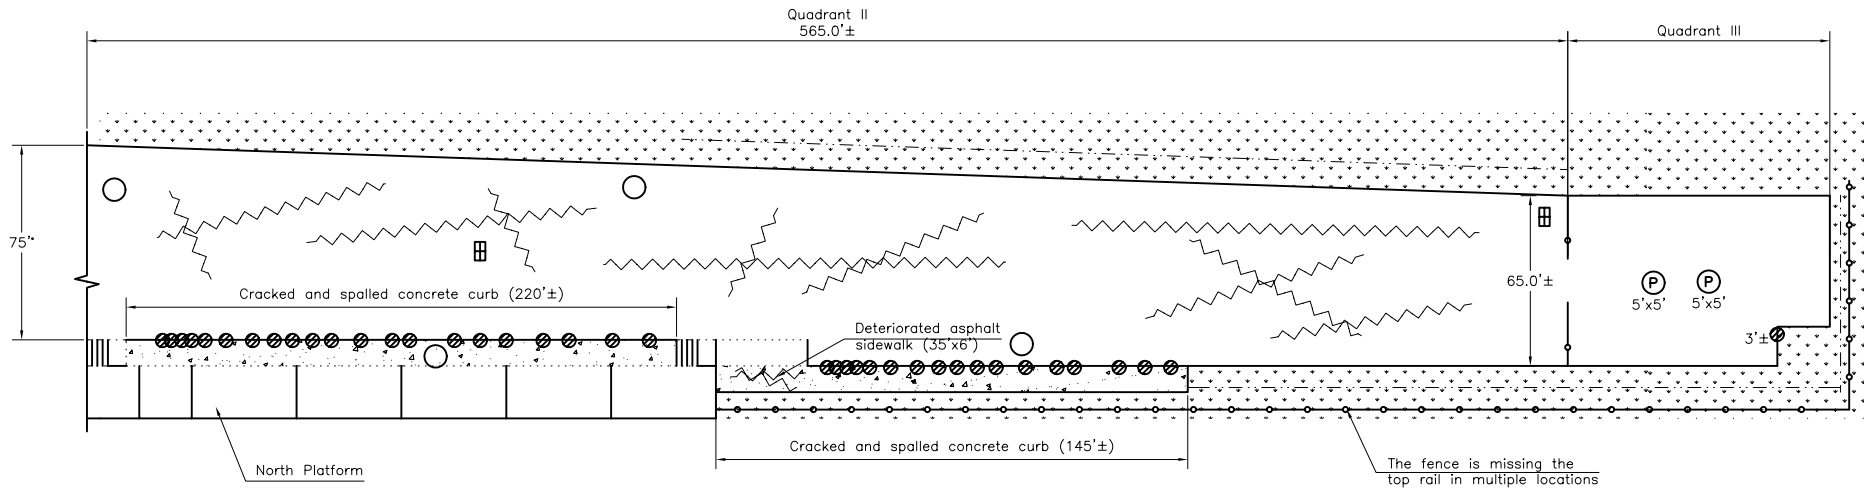
Urbitran Associates, Inc.
Connecticut Dept. of Transportation
Rowayton Station Quadrant II and III Plan
Date: 8/02/02

1. The asphalt surface in Quadrant II contains numerous cracks with vegetation growth.

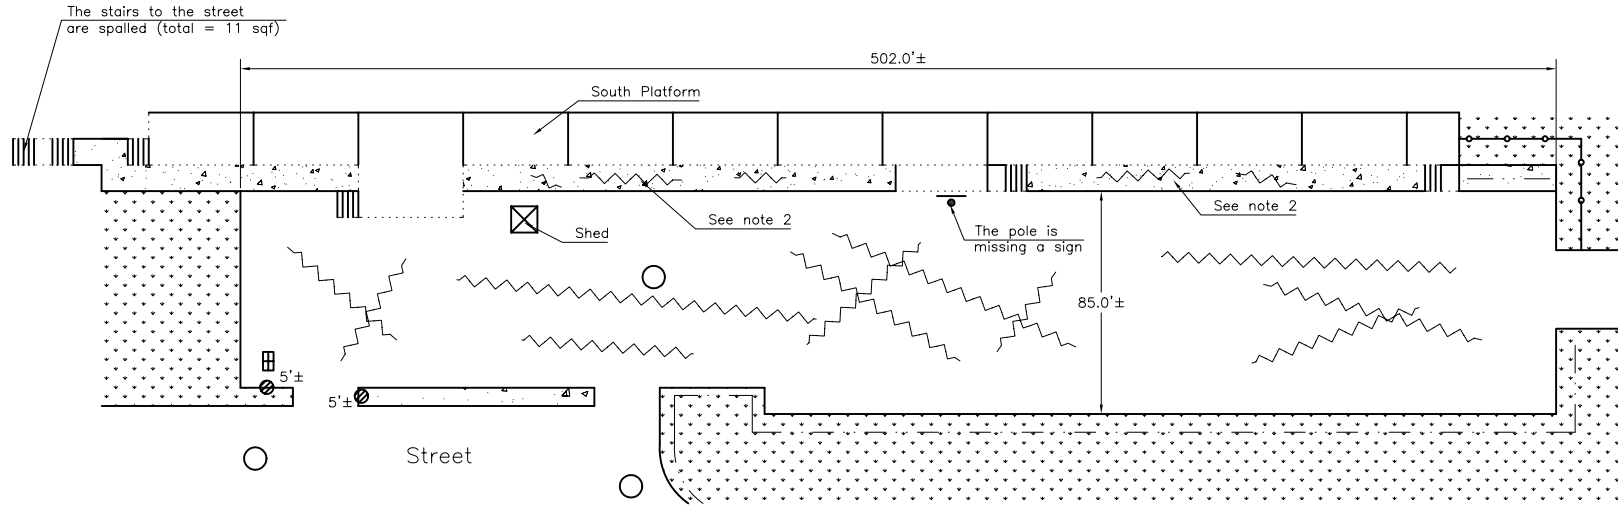
1. The asphalt surface contains numerous cracks with vegetation growth.
2. There are random cracks in the asphalt sidewalk (60'±).
