Individual Station Report

Stratford

Station Condition Inspection

Connecticut Department of Transportation

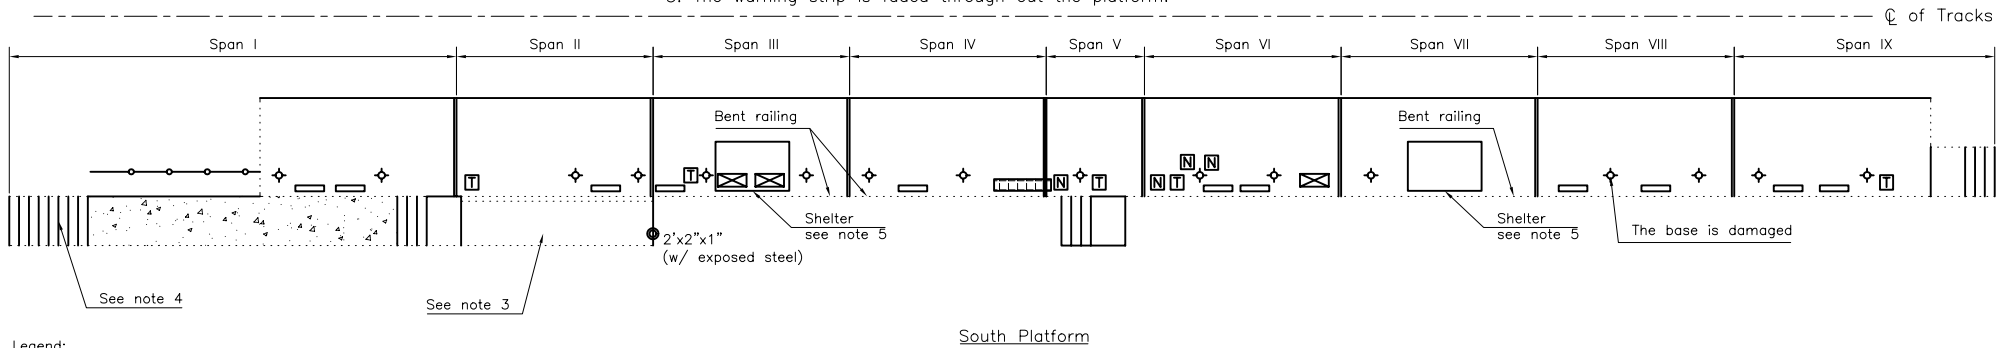
South Platform

1. The base plates for the double tee are rusted and deteriorated throughout the entire platform.
2. The joint material is starting to deteriorate at all locations.
3. There is spalled concrete adjacent to the rusted railing base plates in 12 locations.
4. The stairs contains scaled and cracked concrete with exposed metal treads.
5. The shelter's base plate nuts and bolts are rusted.
6. The warning strip is faded through out the platform.

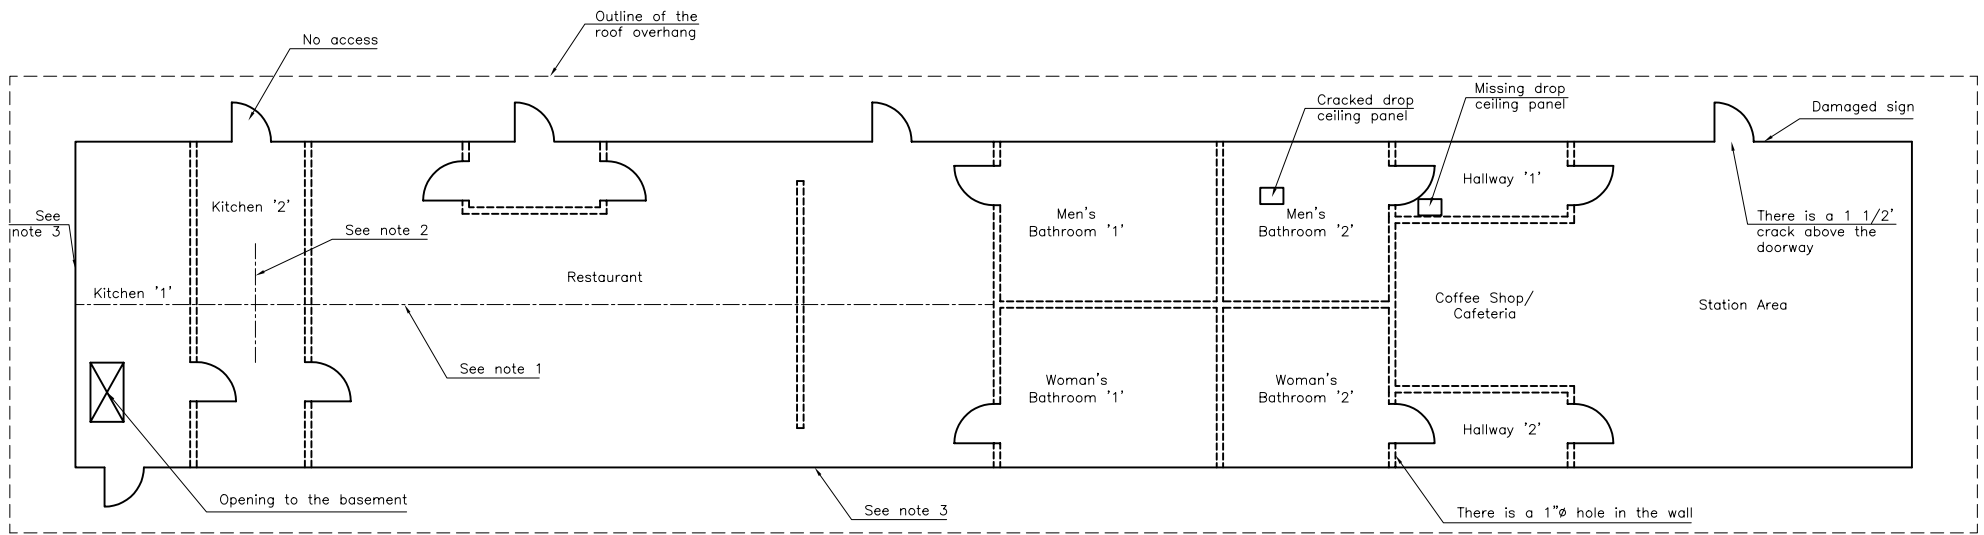
Urbitran Associates, Inc.
Connecticut Dept. of Transportation
Stratford Station North Station House Plan
Date: 12/06/01

1. There is an 1/8" crack at the underside of the beam along the entire length.
2. The underside of the beam is deteriorated.
3. The base timber panel is missing and damaged in various areas.
4. Two windows are cracked on the north exterior face of the building..

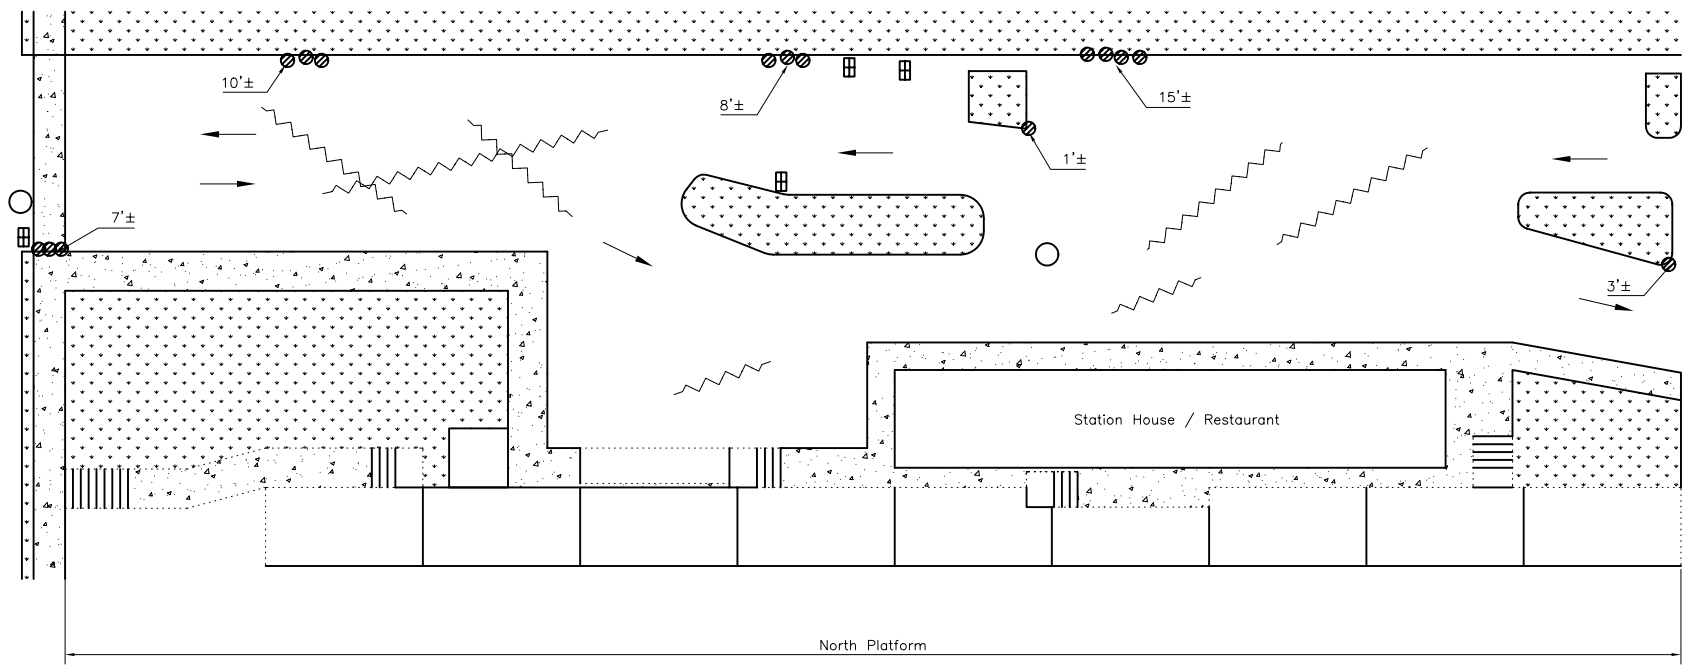
Urbitran Associates, Inc.
Connecticut Dept. of Transportation
Stratford Station Quadrant I Plan
Date: 8/23/02

NOTES:
 1. The asphalt surface is cracked 1000'±.
