CONNECTICUT
DEPARTMENT
OF
TRANSPORTATION

CONDITION INSPECTION
FOR THE
STRATFORD STATION

STATION: Stratford
LINE: New Haven
INSPECTION DATE: 8/23/02
INSPECTION AGENCY / FIRM: UA
INSPECTORS: RGW
WEATHER: Sunny, 80's

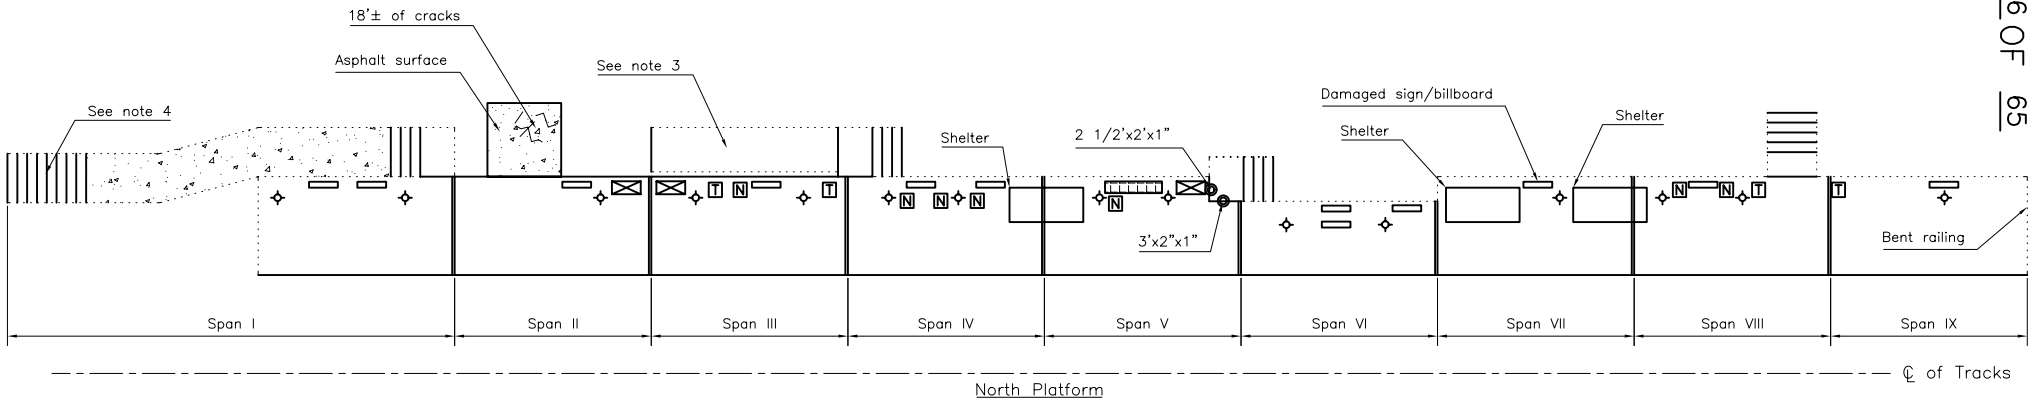
North Platform

1. The base plates for the double tee are rusted and deteriorated throughout the entire platform.
2. The joint material is starting to deteriorate at all locations.
3. There is spalled concrete adjacent to the rusted railing base plates in 12 locations.
4. The concrete stairs are cracked in numerous locations.
5. The warning strip is faded through out the platform.

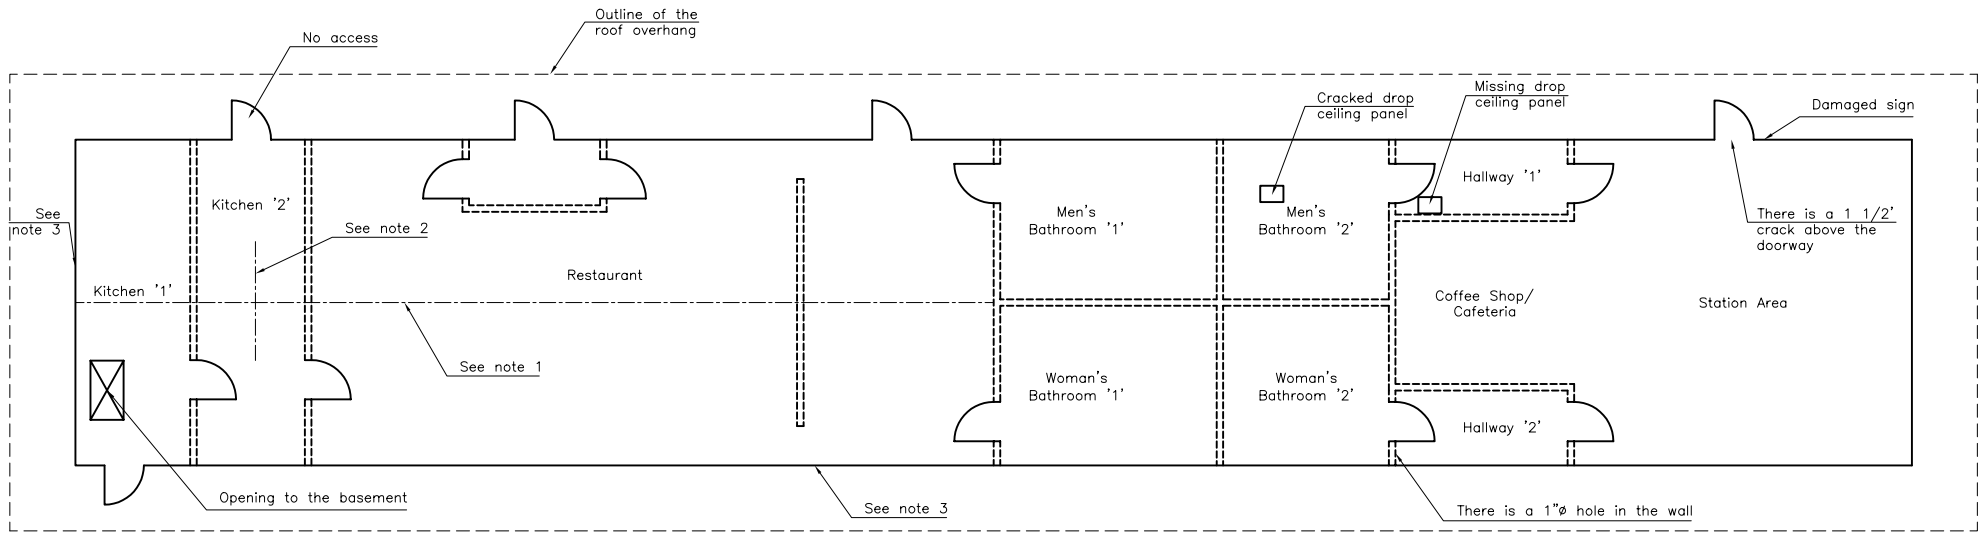
Urbitran Associates, Inc.
Connecticut Dept. of Transportation
Stratford Station North Station House Plan
Date: 12/06/01

1. There is an 1/8" crack at the underside of the beam along the entire length.
2. The underside of the beam is deteriorated.
3. The base timber panel is missing and damaged in various areas.
4. Two windows are cracked on the north exterior face of the building..

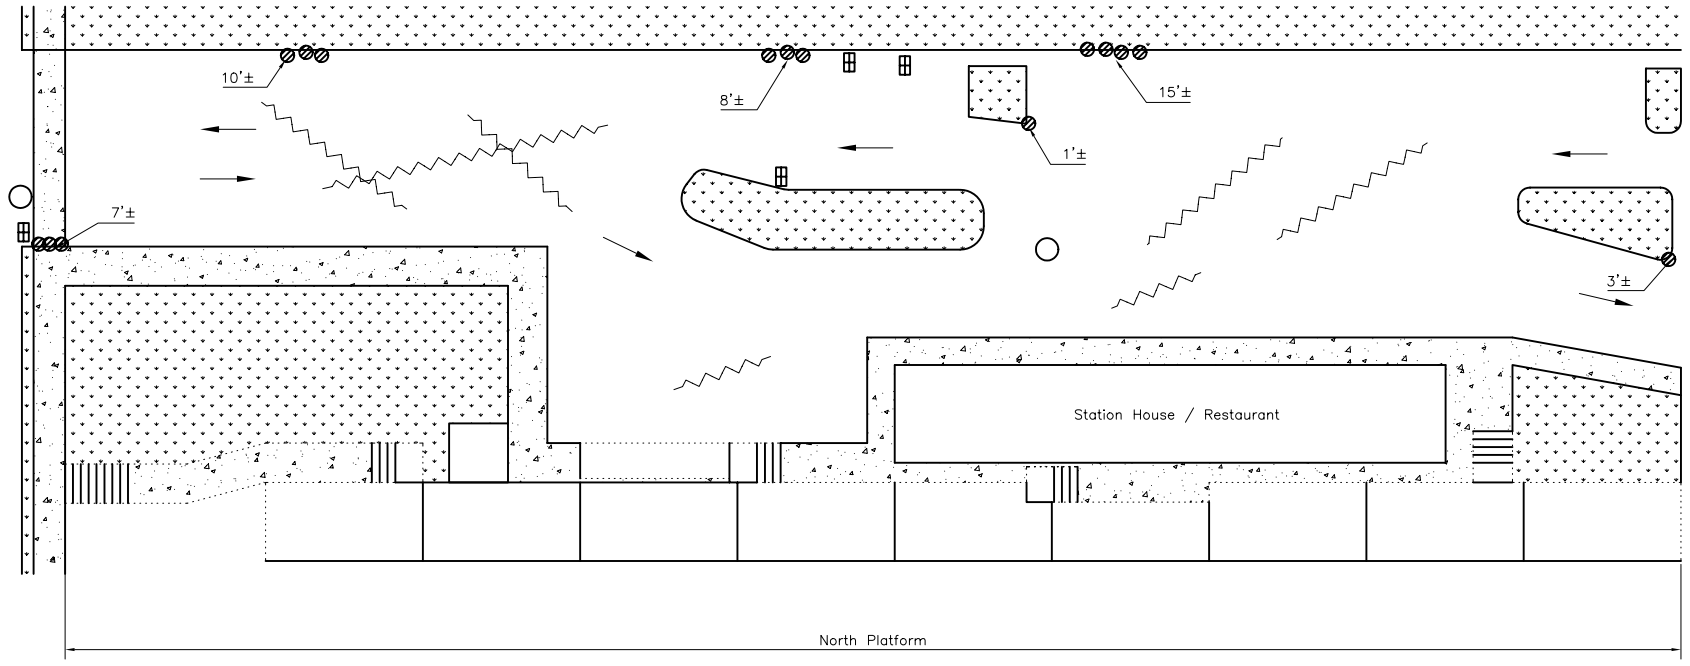
Urbitran Associates, Inc.
Connecticut Dept. of Transportation
Stratford Station Quadrant I Plan
Date: 8/23/02

NOTES:
 1. The asphalt surface is cracked 1000'±.

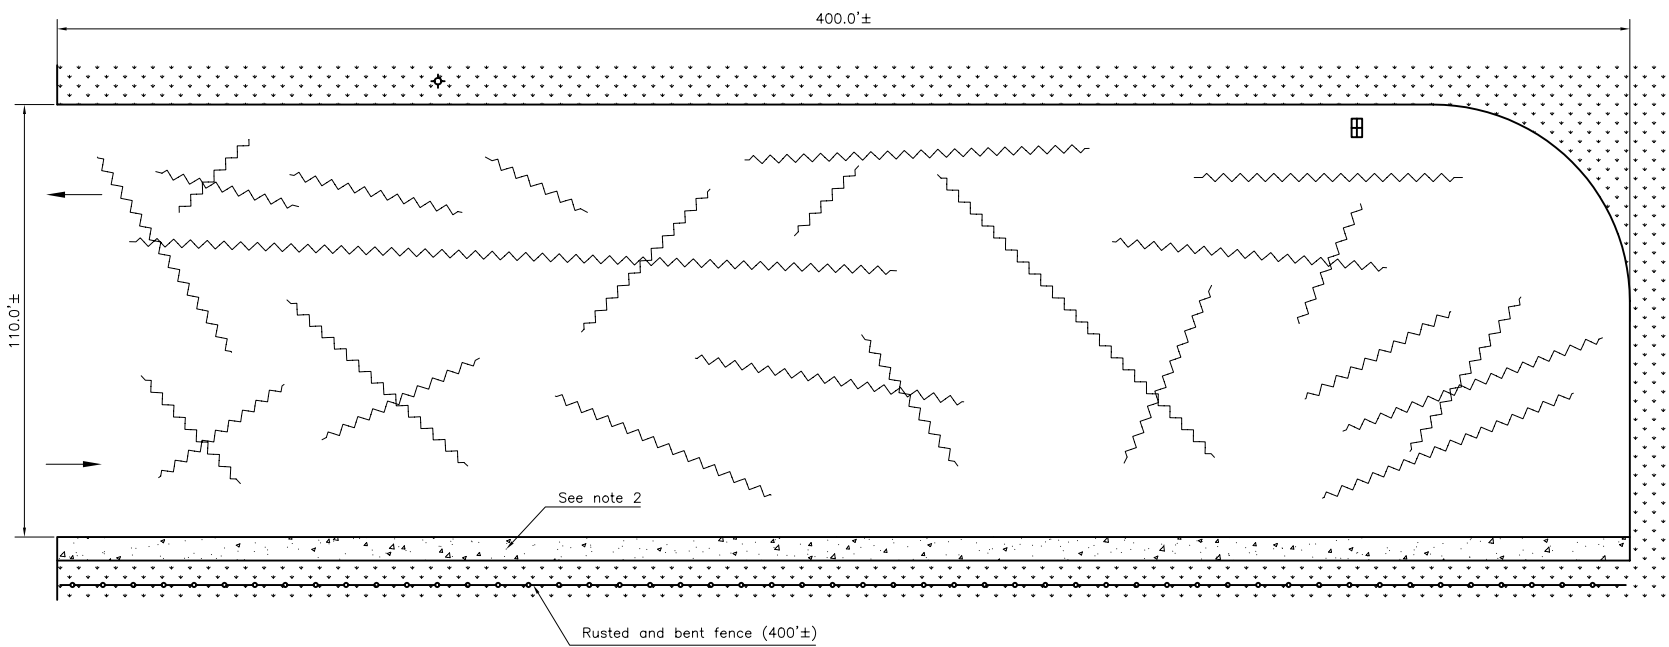
Urbitran Associates, Inc.
Connecticut Dept. of Transportation
Stratford Station Quadrant II Plan
Date: 8/23/02

See note 2

Rusted and bent fence (400'±)

- NOTES:
1. The asphalt surface is cracked 5000'±.
 2. The concrete sidewalk is cracked with vegetation growth and an uneven walking surface (400'x5').

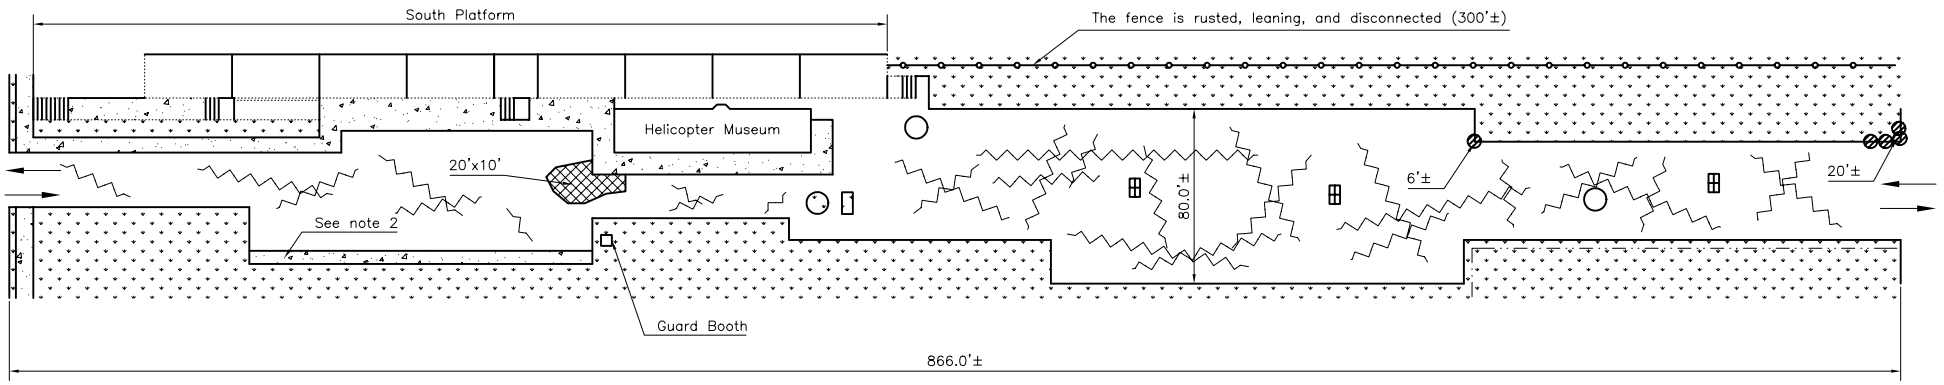
Urbitran Associates, Inc.
Connecticut Dept. of Transportation
Stratford Station Quadrant III Plan
Date: 8/23/02

- NOTES:
1. The asphalt surface is cracked 5000'±.
 2. The concrete sidewalk is cracked with an uneven walking surface (160'x5').

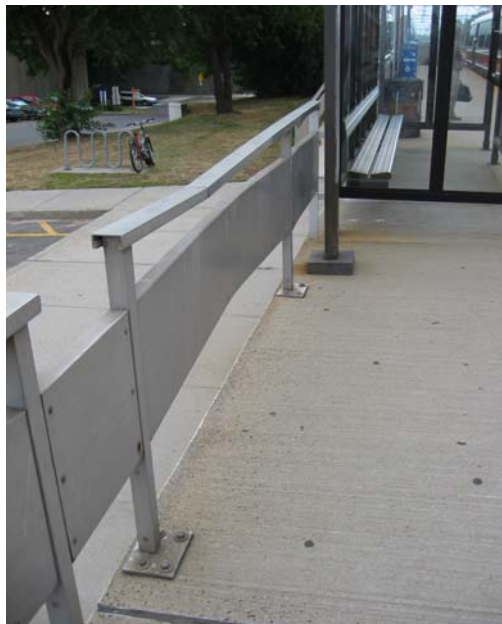
PHOTO NO. 14

Description: Typical bent railing

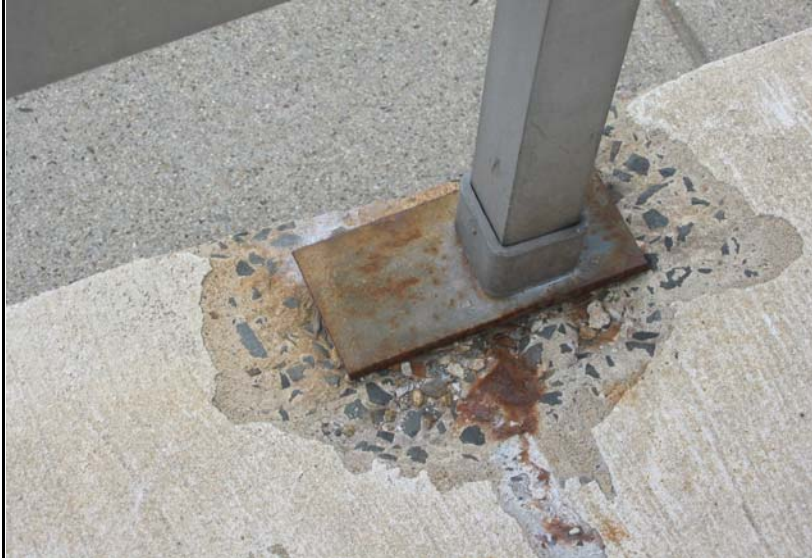
Description: Typical spalled concrete adjacent to the rusted railing base plate

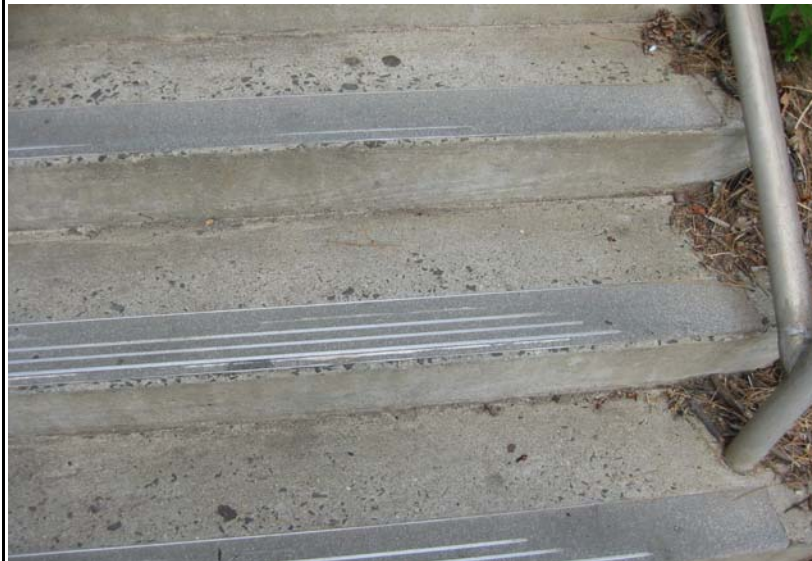
PHOTO NO. 16

Description: Scaled concrete; note the treads were covered with grout but are now exposed

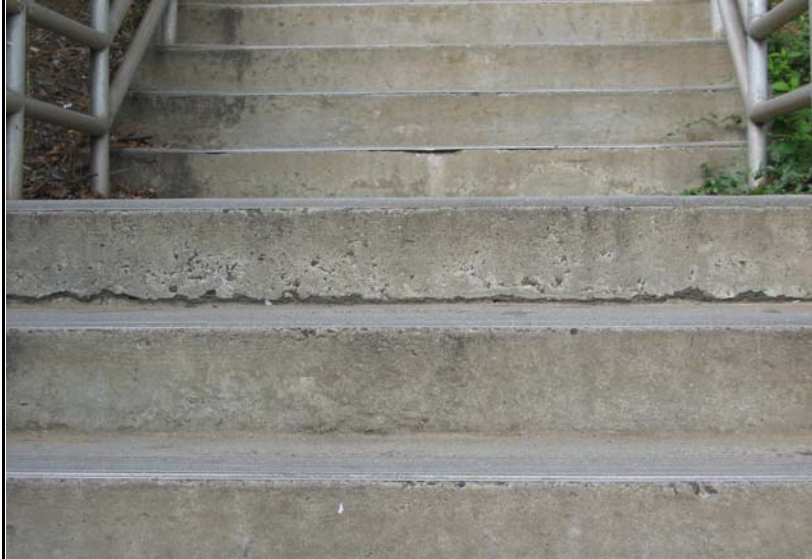
Description: _____
Crack concrete stairs

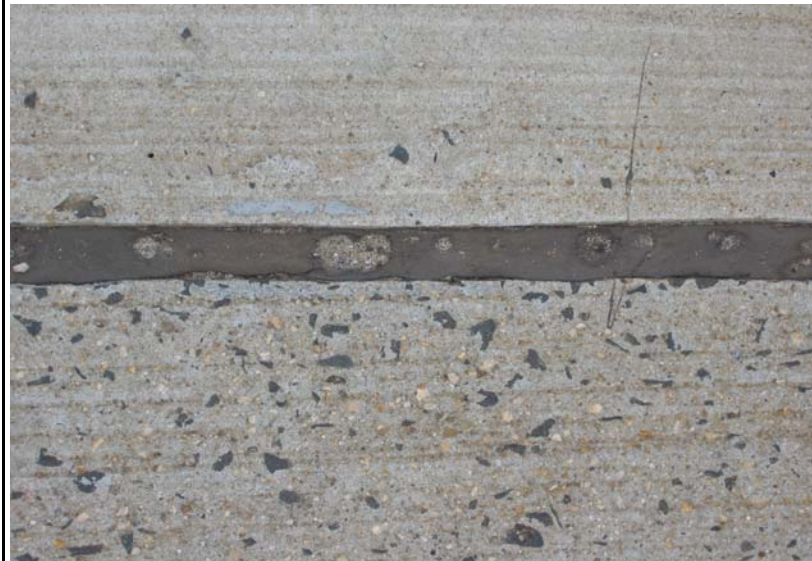
PHOTO NO. 18

Description: _____
Typical deteriorating
joint material

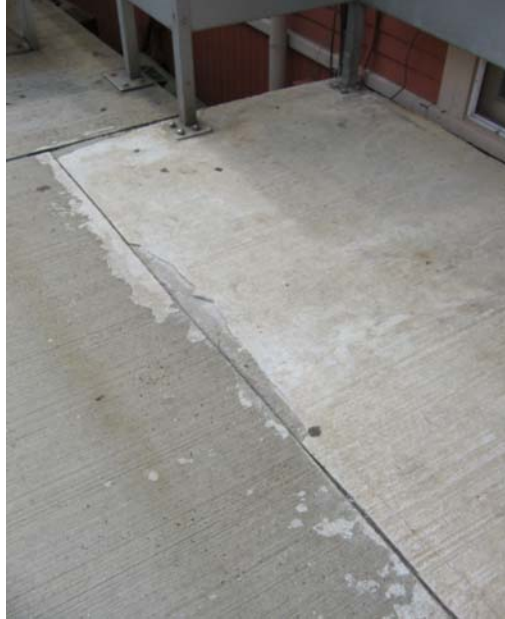
Description: _____
Spalled concrete

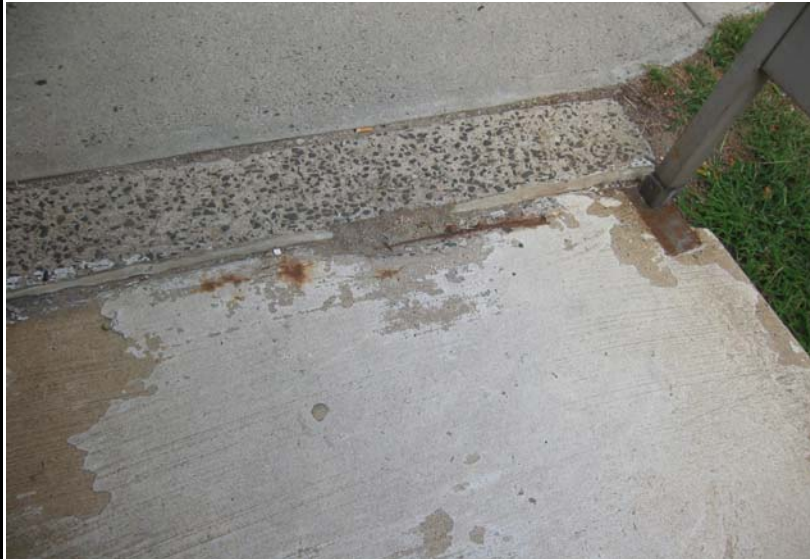
PHOTO NO. 20

Description: _____
Spalled concrete with
exposed rebar

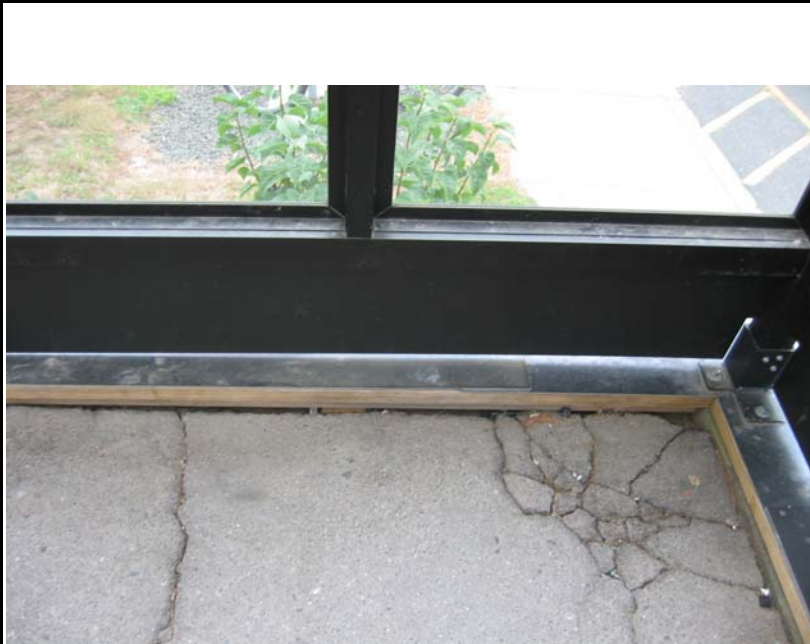
Description: _____
Crack asphalt surface

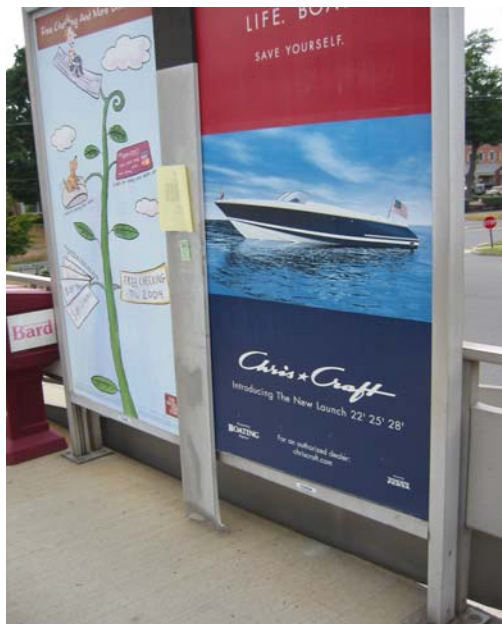
PHOTO NO. 22

Description: _____
The metal cover
in the middle of the
sign / billboard is
coming loose

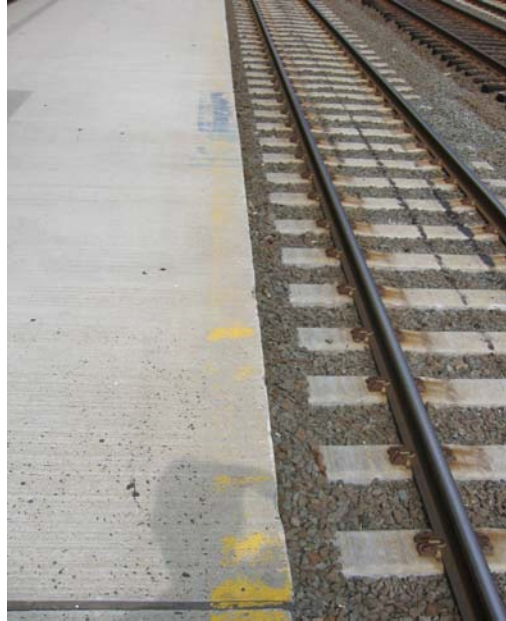
Description: _____
Typical fade warning
strip

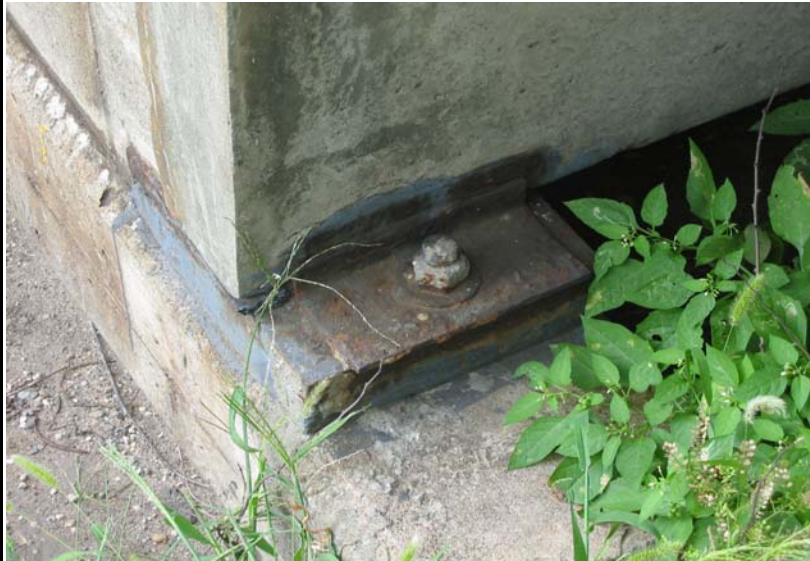
PHOTO NO. 24

Description: _____
Typical rusted and
deteriorated double tee
base plate

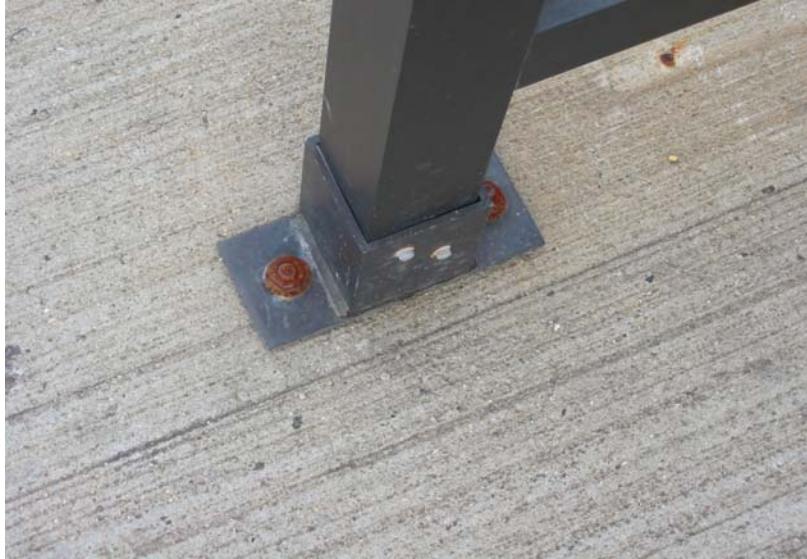
Description: _____
The shelter's nuts and
bolts are rusted

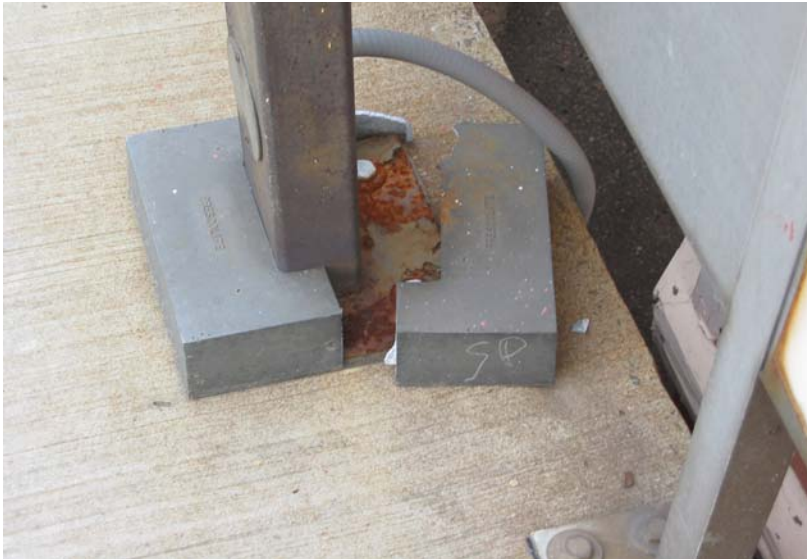
PHOTO NO. 26

Description: _____
The base of the light
is damaged and the
base plate is rusted
and deteriorated

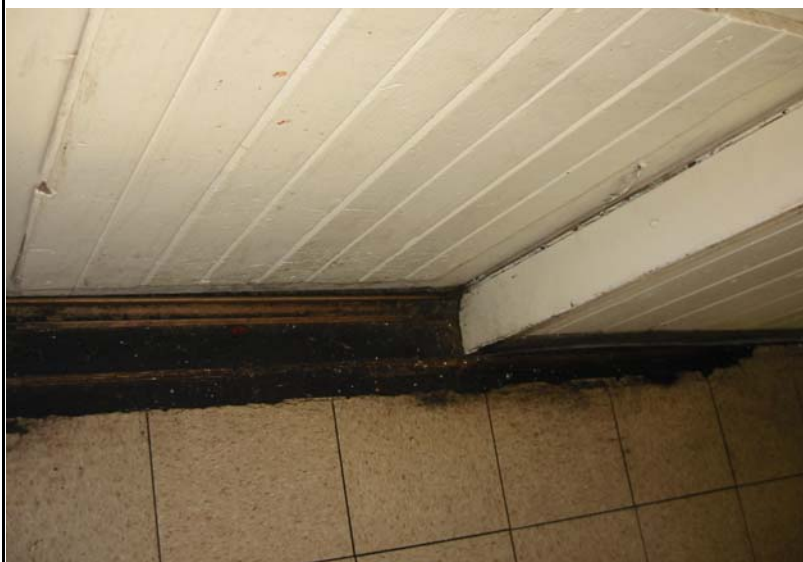
Description: _____
Missing / cracked
floor tile

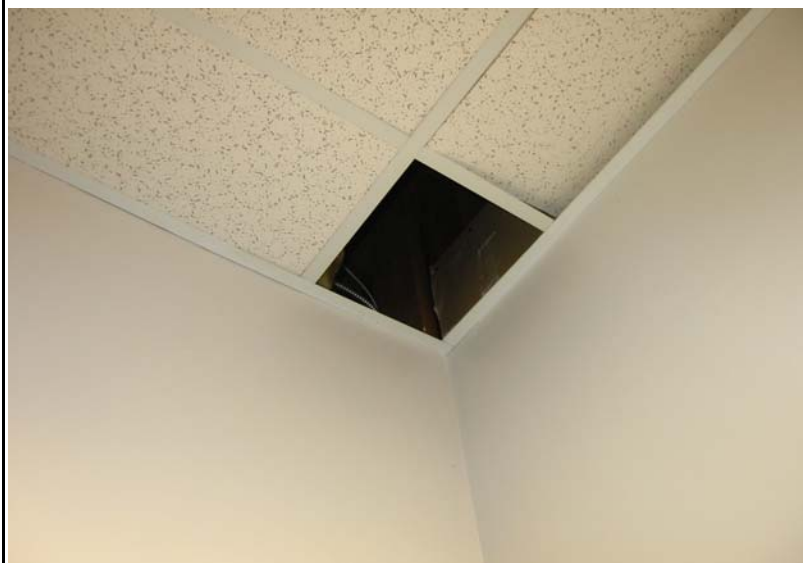
PHOTO NO. 28

Description: _____
Missing drop ceiling
panel

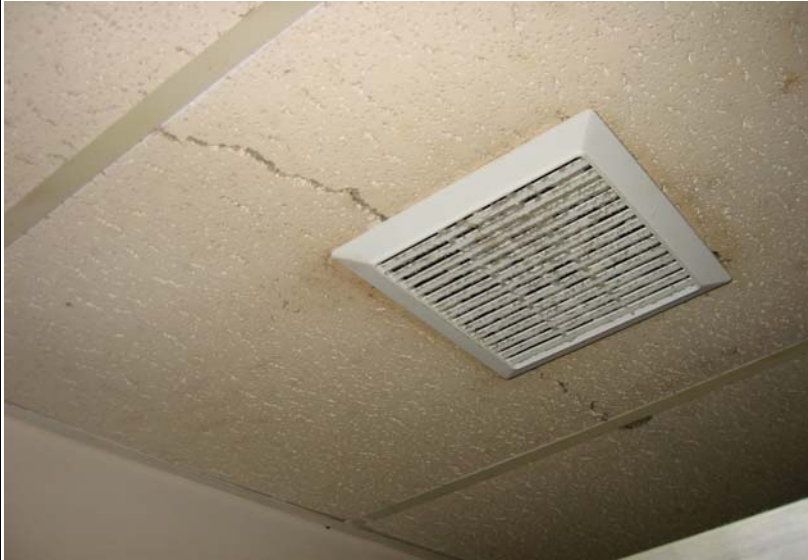
Description: _____
Cracked drop ceiling
panel

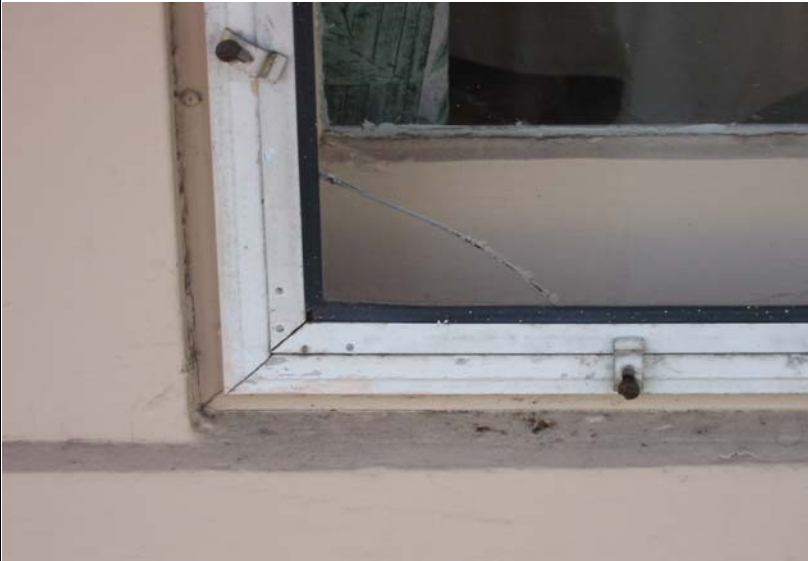
PHOTO NO. 30

Description: _____
Cracked window

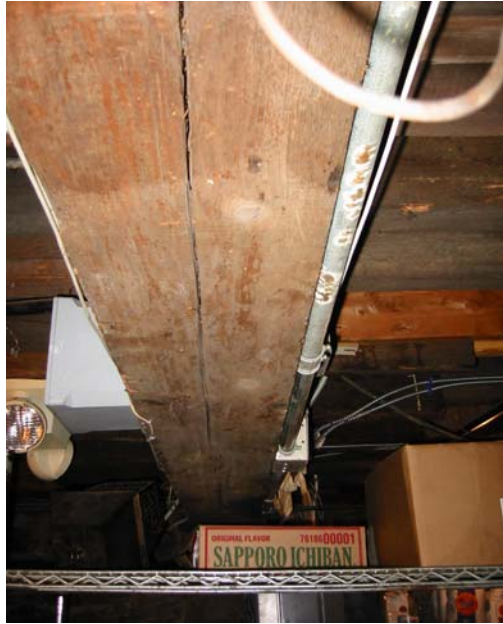
Description: 1/8" wide center crack
running the entire length
of the beam

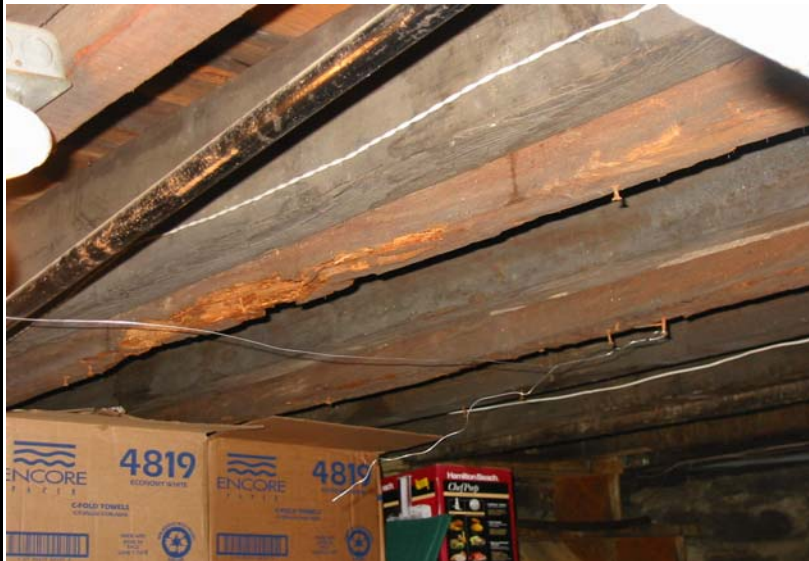
PHOTO NO. 32

Description: The bottom of the
timber beam is
deteriorated

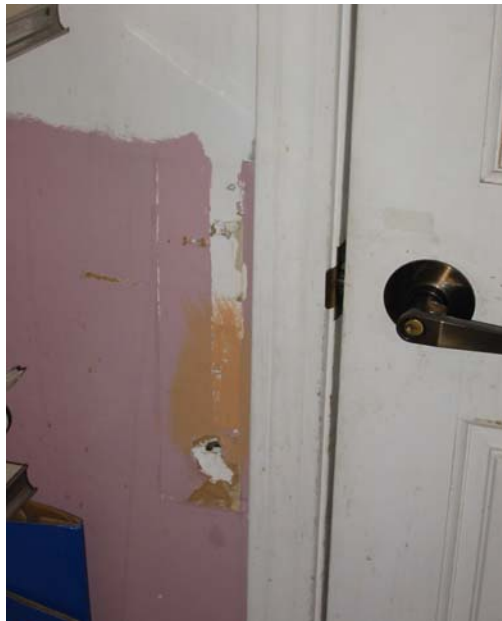
Description: 1" dia. hole in the wall

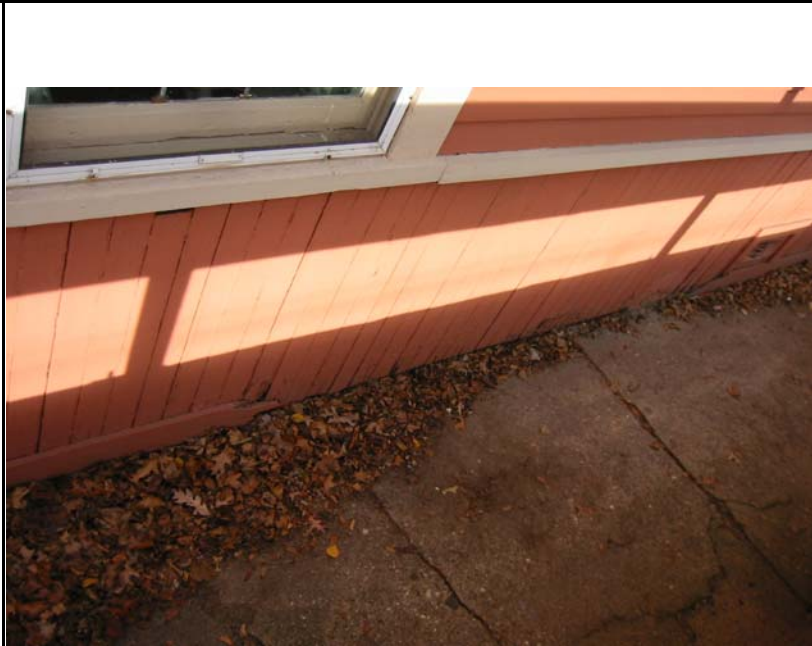
Description: The base timber board is cracked and missing

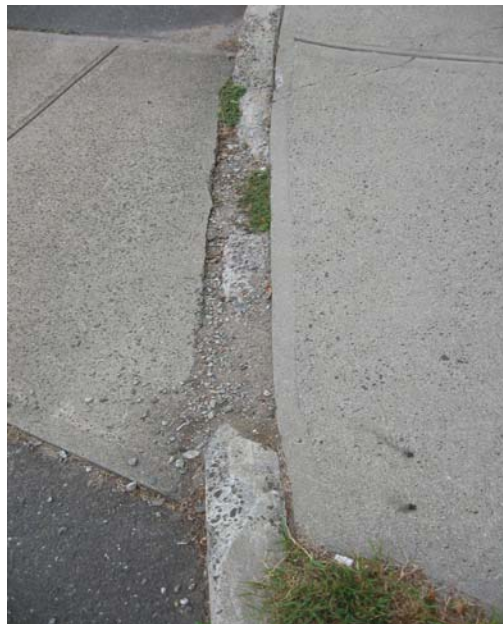
PHOTO NO. 36

Description: Spalled concrete curb

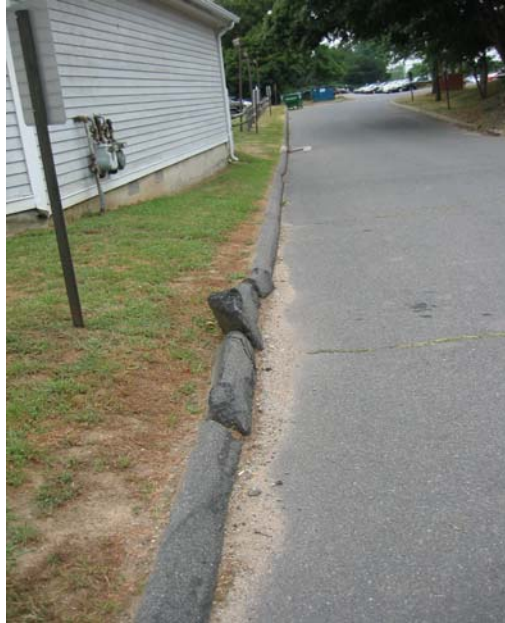
Description: _____
Typical cracked and
dislocated asphalt
curb

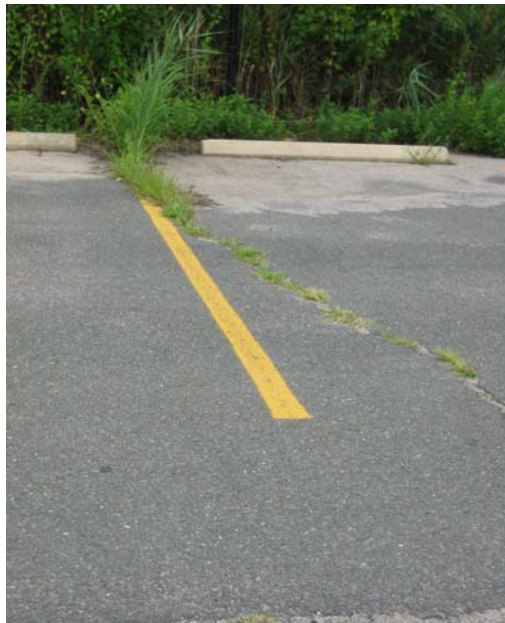
PHOTO NO. 38

Description: _____
Typical crack with
vegetation growth

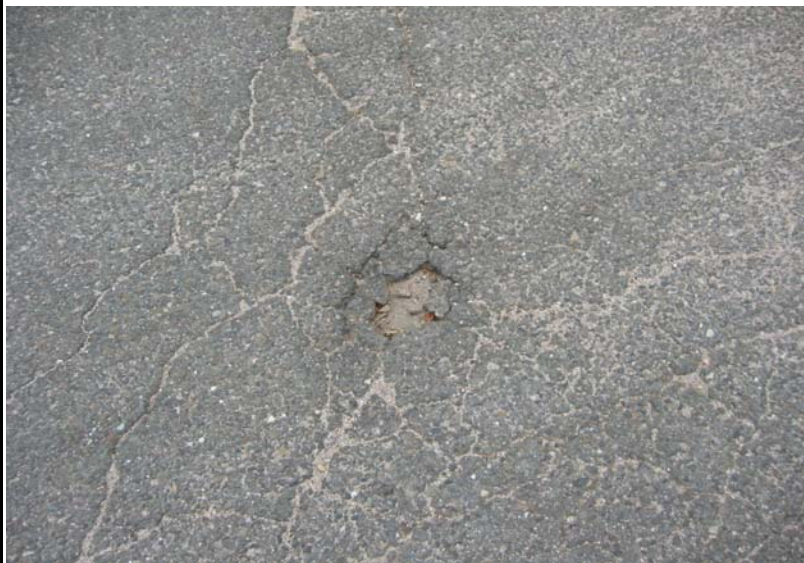
Description: Typical cracked asphalt

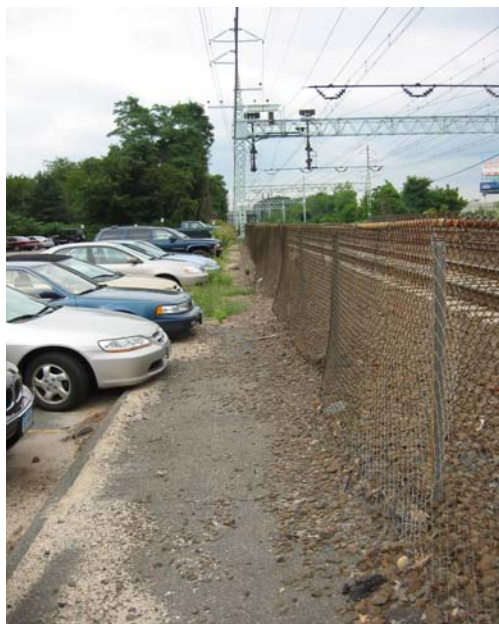
PHOTO NO. 40

Description: Deteriorated asphalt sidewalk with vegetation growth

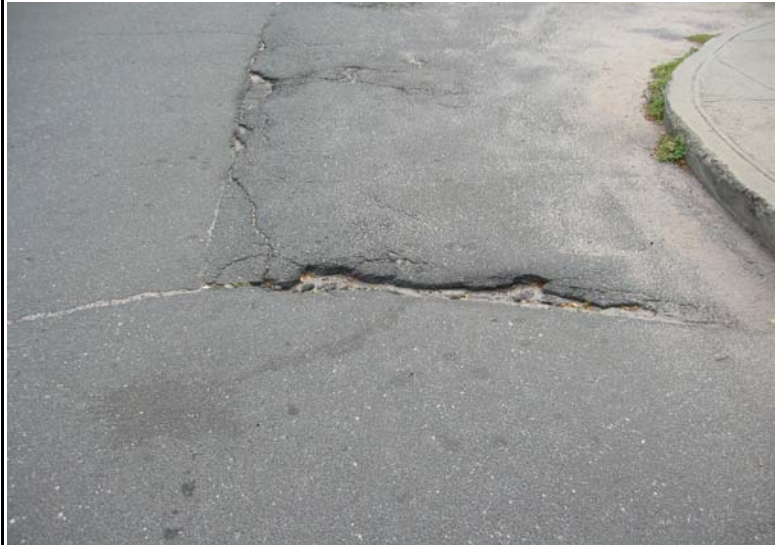
Description: Cracked asphalt surface with potholes

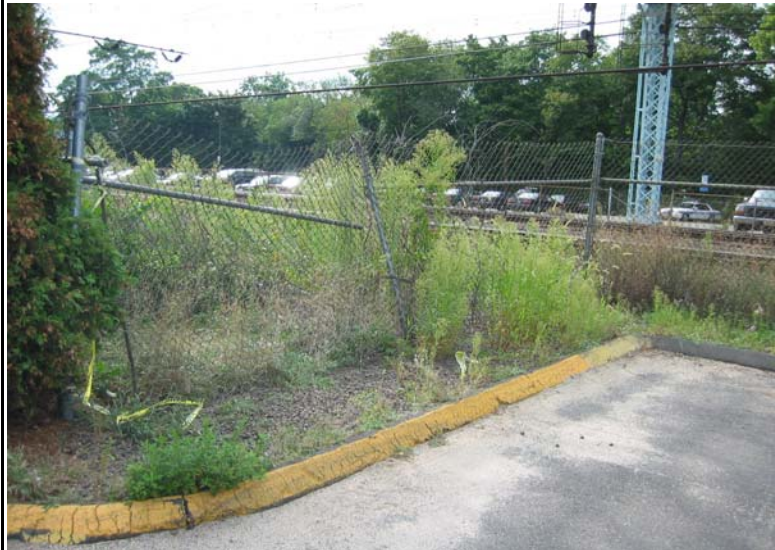
PHOTO NO. 42

Description: Typical damaged fence

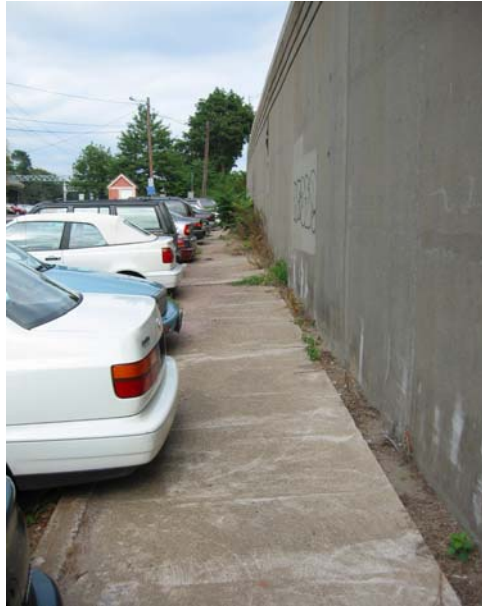
Description: Cracked concrete sidewalk with vegetation growth and an uneven walking surface

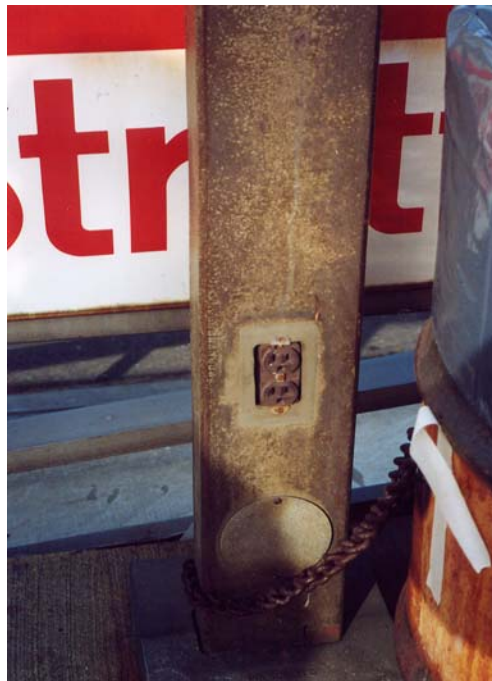
PHOTO NO. 49

Each platform receives electrical service from the station buildings. Both platforms have several non-GFCI receptacles that are either broken or missing covers. We suggest that all the receptacles be replaced with a GFCI type with cover.

Description:
typical receptacle
in light pole

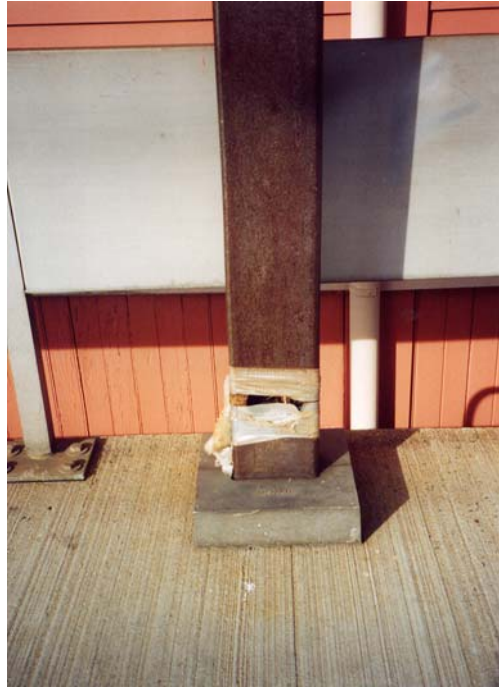
There are pole-mounted luminaires on the platform. Many of the poles have serious deterioration and are missing their handhole covers, allowing the electrical components to be exposed to the environment. We suggest that the covers be replaced as soon as possible and the light poles be replaced in the near future.

Description:
platform light pole
missing handhole
cover (typ)

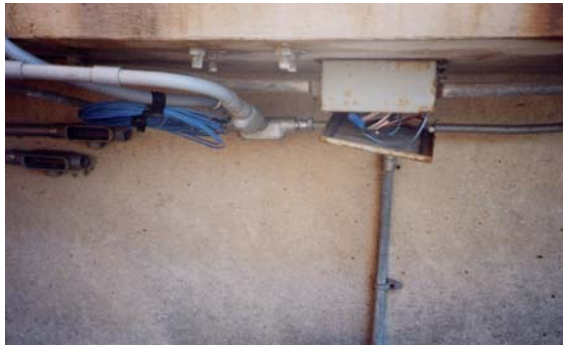
PHOTO NO. 51

Description:
lighting junction
box in need of
repair

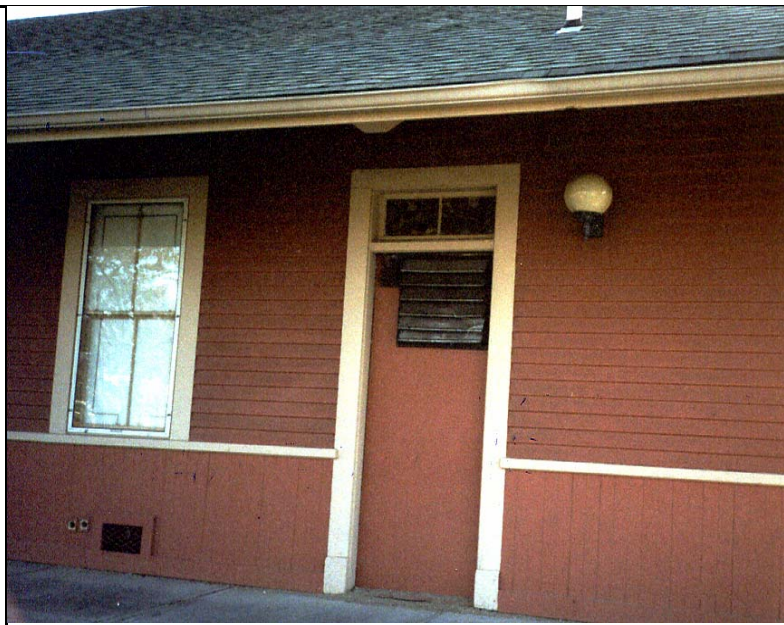
1 wall exhaust fan for heat generated in the kitchen
with a gravity damper for summer operation only.
The assembly works but does not appear to be in good condition
(looks dirty).

Description:
Wall fan at restaurant
in kitchen for summer
heat exhaust

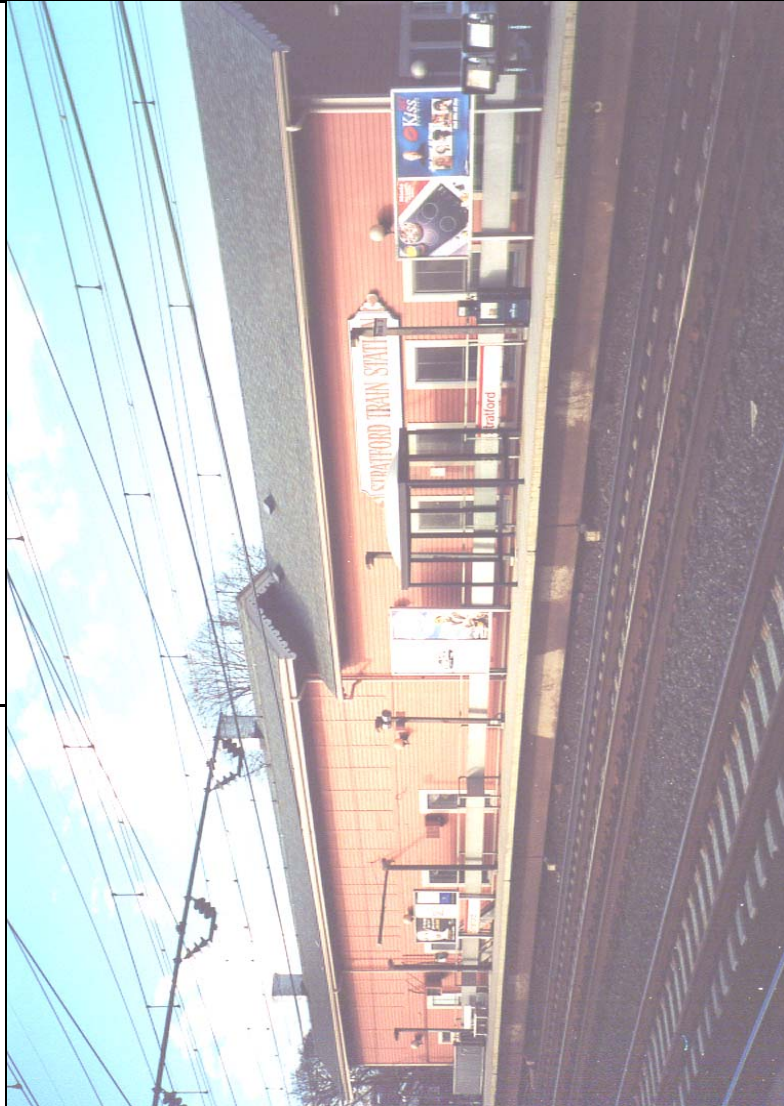
The gutters and downspouts at the station and helicopter museum are in excellent condition. The shelter on the platform has a curbed roof and has no storm drains.

Description:
Rear view of Stratford
Station, gutters and
downspouts in good
repair
