CONNECTICUT  
DEPARTMENT  
OF  
TRANSPORTATION

CONDITION INSPECTION  
FOR THE  
WATERBURY STATION

**CONN. DEPT OF TRANSPORTATION  
STATION INSPECTION**

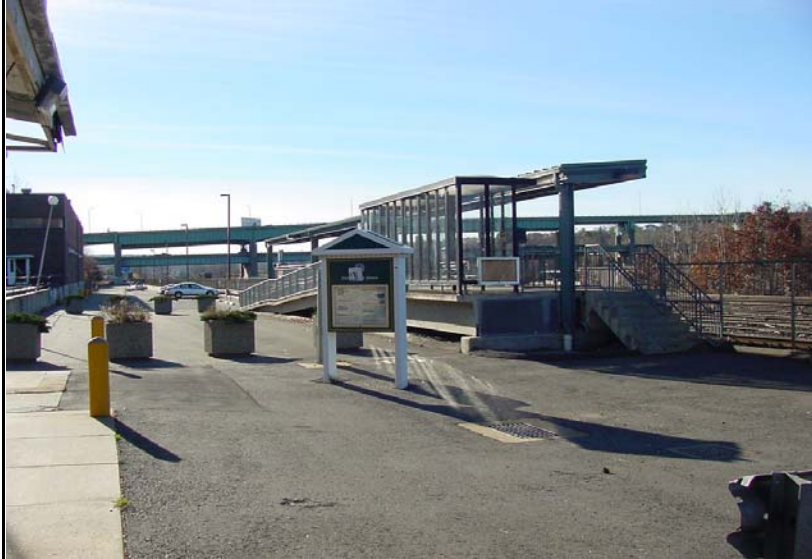
PHOTO NO. 1

Location: \_\_\_\_\_  
North end of the station

Description: \_\_\_\_\_  
General view of the station

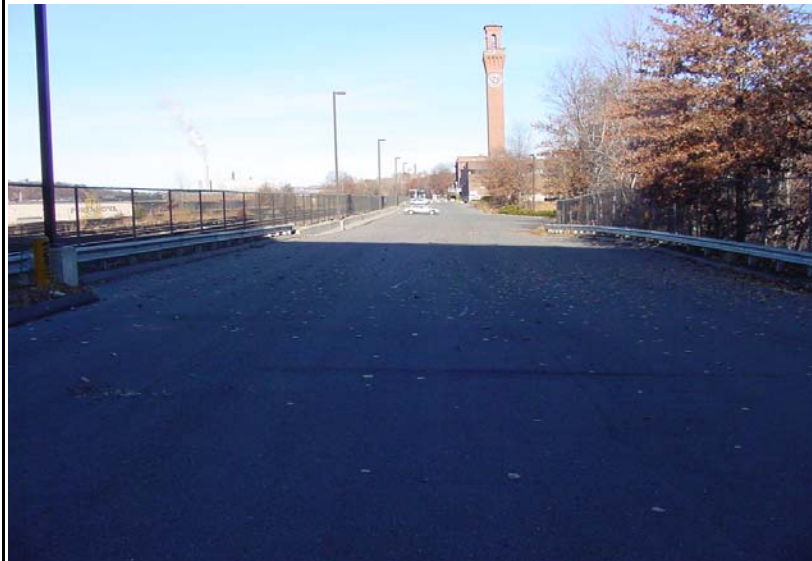
PHOTO NO. 2

Location: \_\_\_\_\_  
South end of Quad III

Description: \_\_\_\_\_  
General view of the station

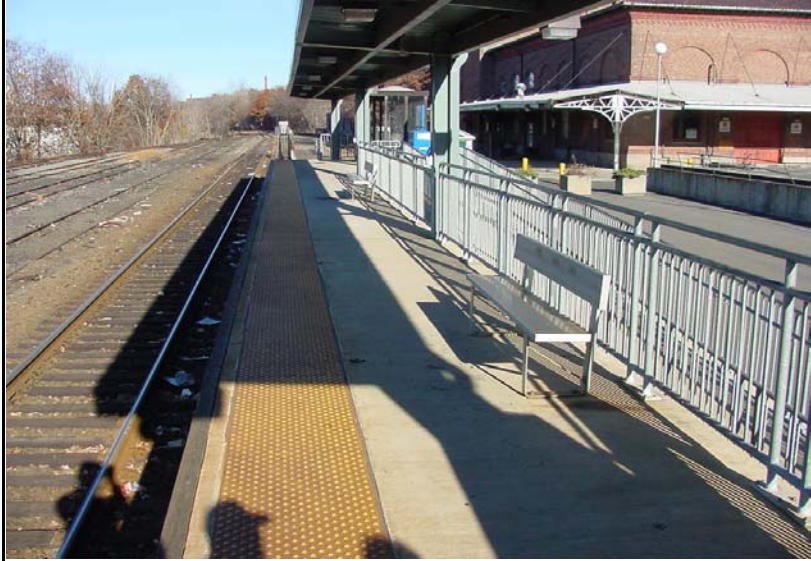
PHOTO NO. 3

Location: \_\_\_\_\_  
South end of Span I

Description: \_\_\_\_\_  
General view of the platform

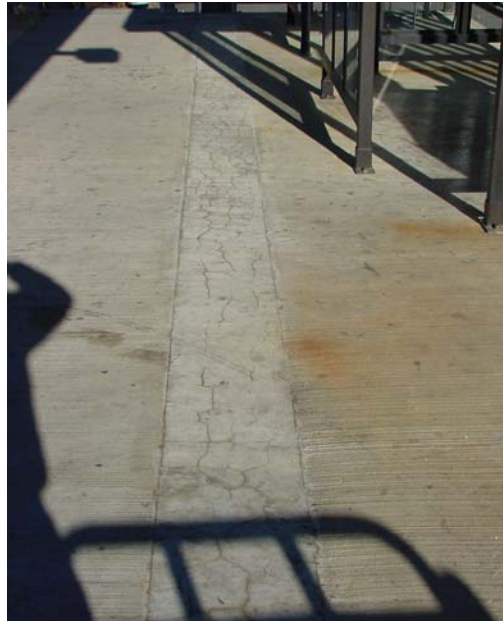
PHOTO NO. 4

Location: \_\_\_\_\_  
South end of Span III

Description: \_\_\_\_\_  
Cracked concrete in span III

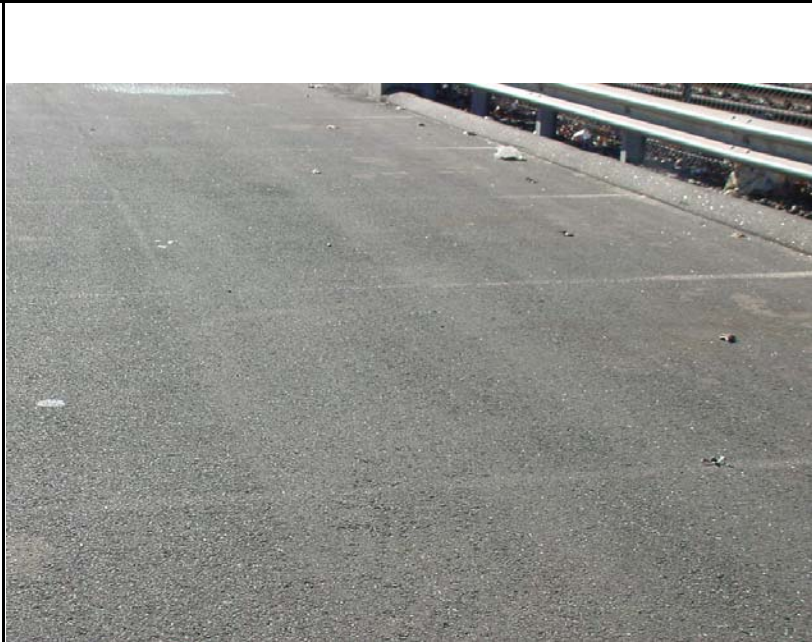
PHOTO NO. 5

CONDITION OF STRIPING: 2

Location: \_\_\_\_\_  
Westside of Quad II

Description: \_\_\_\_\_  
Faded stripping in  
Quad II

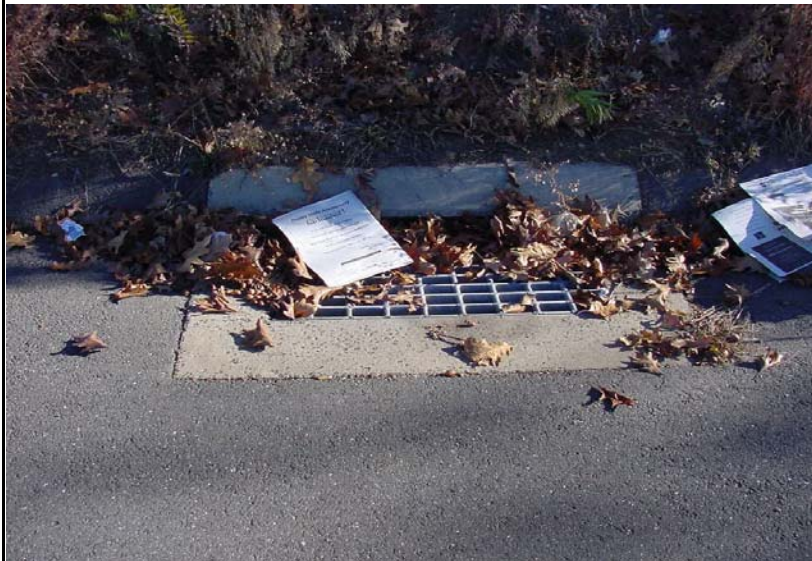
PHOTO NO. 6

CONDITION OF BASIN / DRAINS / ETC: 2  
( FOR LOCATION SEE SHEET: see sketch )

Location: \_\_\_\_\_  
East side of Quad II

Description: \_\_\_\_\_  
Drain covered with  
leaves and garbage  
Note that this is typical  
in Quad II and III

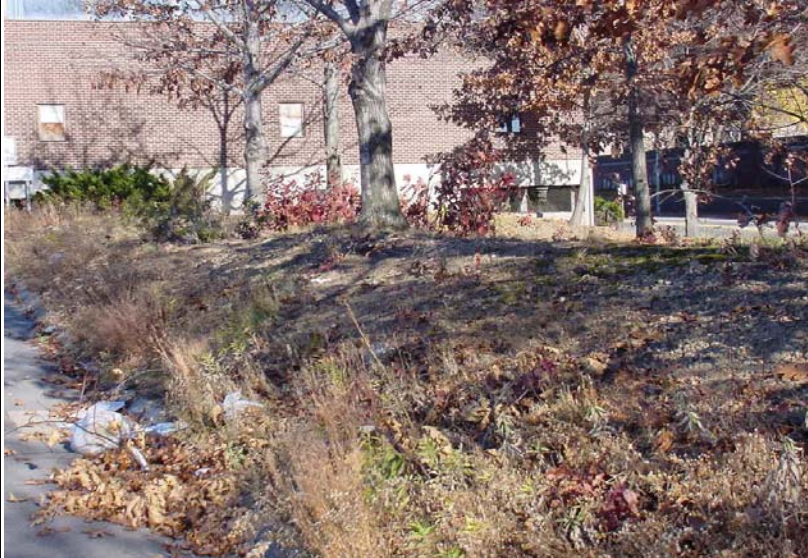
PHOTO NO. 7

Location: \_\_\_\_\_  
East side of Quad II

Description: \_\_\_\_\_  
General view of the  
landscape in Quad II

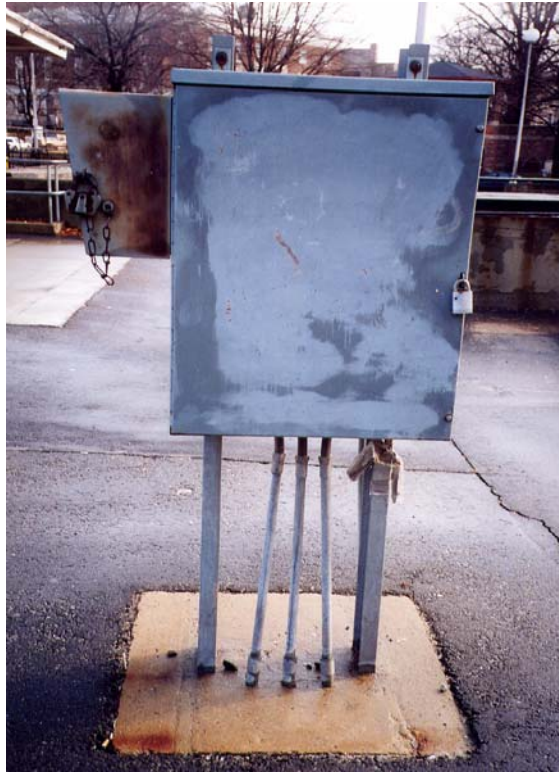
PHOTO NO. 8

Remarks: Electricity to the platform originates from the former station building and terminates in a locked electrical enclosure. We were unable to gain access to the enclosure to verify the exact size and condition of the panelboard.

There is a locked pedestal type electrical cabinet that contains the main electrical panelboard for the platform. We were unable to gain access to this cabinet to verify the exact size and condition of the panelboard. However, the cabinet has only minor deterioration, is well maintained, and appears to be protecting the electrical equipment from harm.

Description:  
electrical  
enclosure

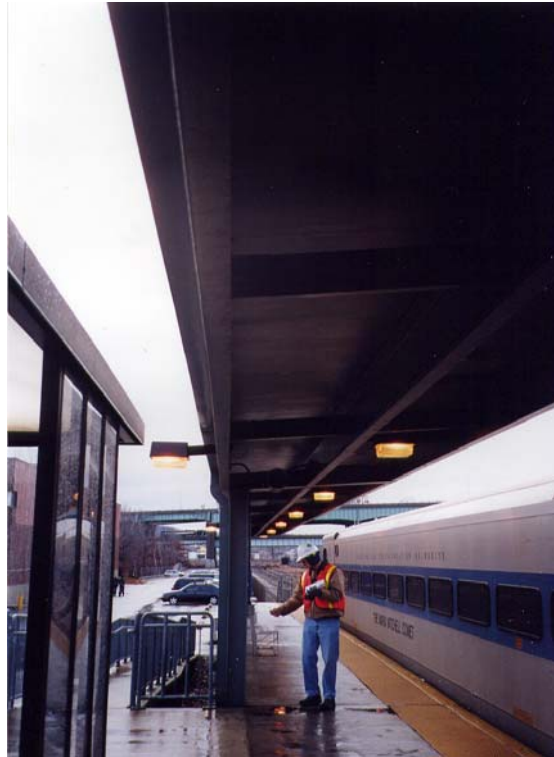
PHOTO NO. 9

Remarks: A typical section of the platform was measured at the location indicated and found to average  
6.49 fc.  
 \_\_\_\_\_  
 \_\_\_\_\_  
 \_\_\_\_\_

A canopy covers the entire length of the platform. The luminaires are installed under the canopy and are high-pressure sodium. The platform luminaires maintain an average of 6.49 foot-candles, which exceed the minimum light level as recommended by the IESNA.

Description:  
platform lighting

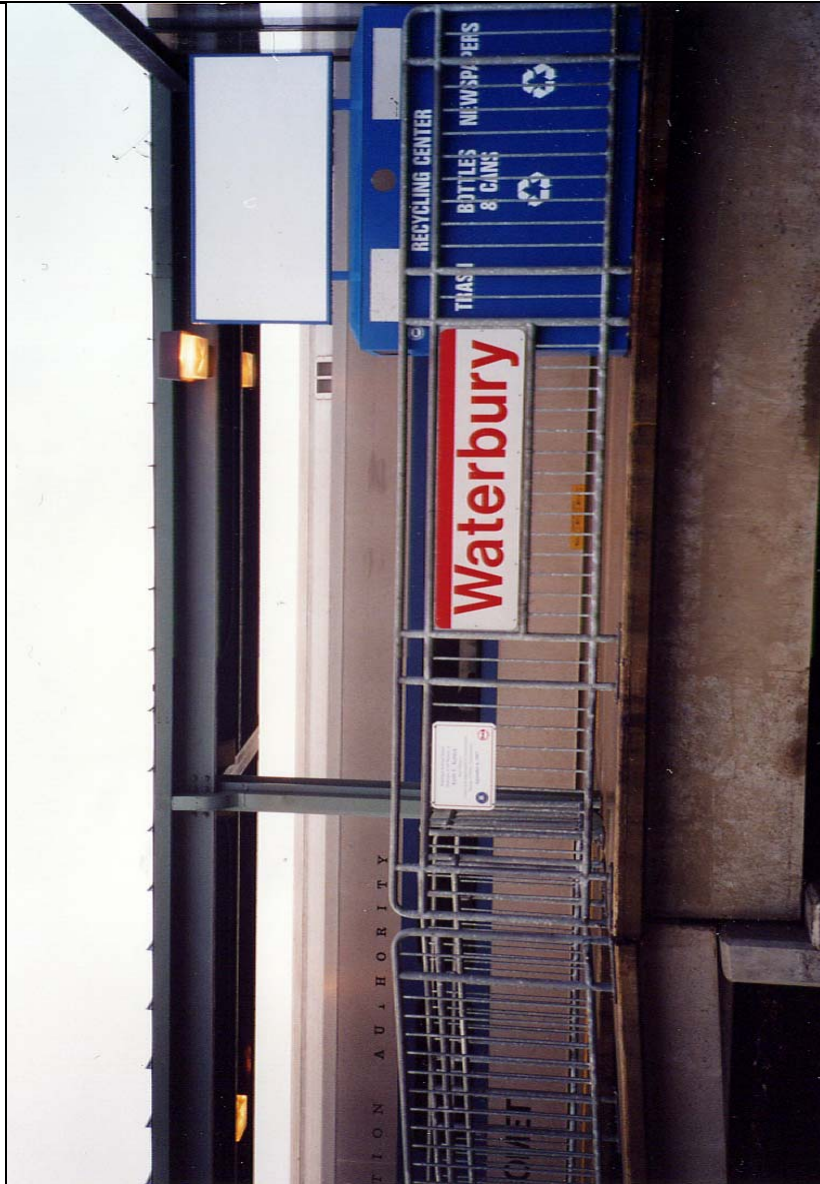
PHOTO NO. 10

Description:  
View of Platform

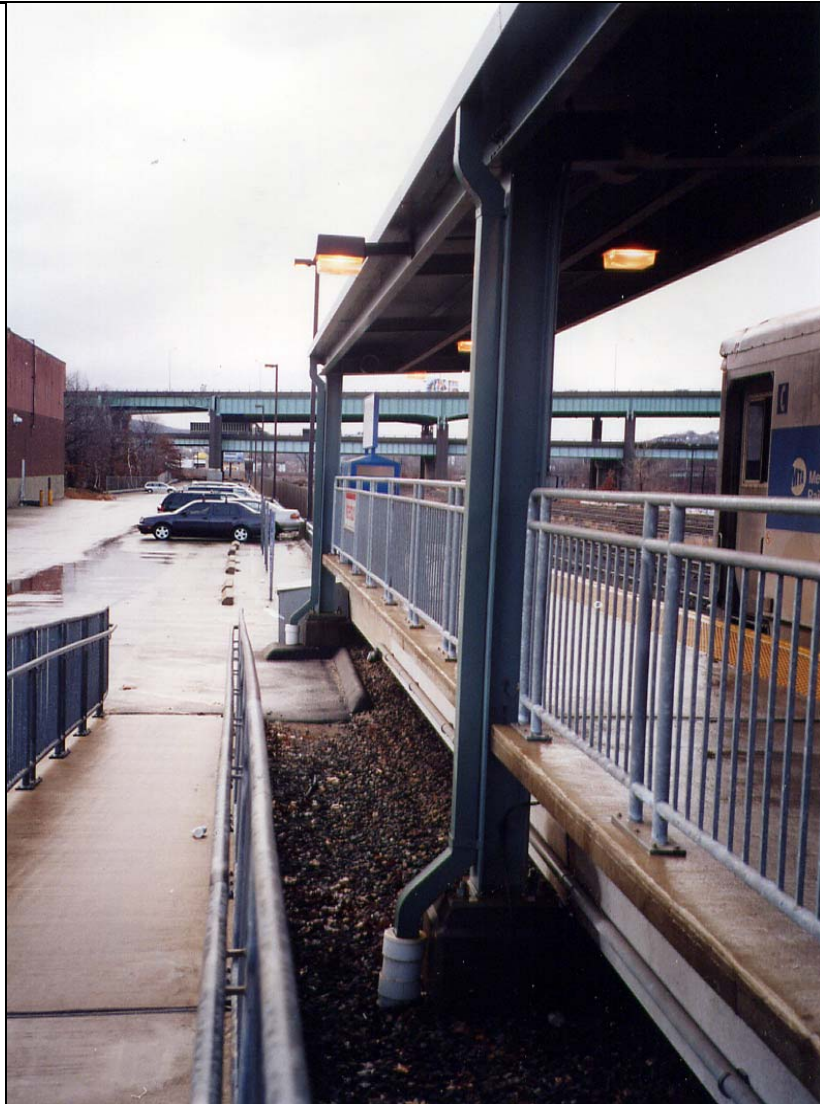
PHOTO NO. 11

All gutters are painted, galvanized sheet metal in good repair. The downspouts are painted, galvanized sheet metal in good repair. The downspouts are occurring at construction joints. There is no need for maintenance.

Description:  
Platform Gutters  
& Downspouts
