CONNECTICUT  
DEPARTMENT  
OF  
TRANSPORTATION

CONDITION INSPECTION  
FOR THE  
WILTON STATION

**CONN. DEPT OF TRANSPORTATION  
STATION INSPECTION**

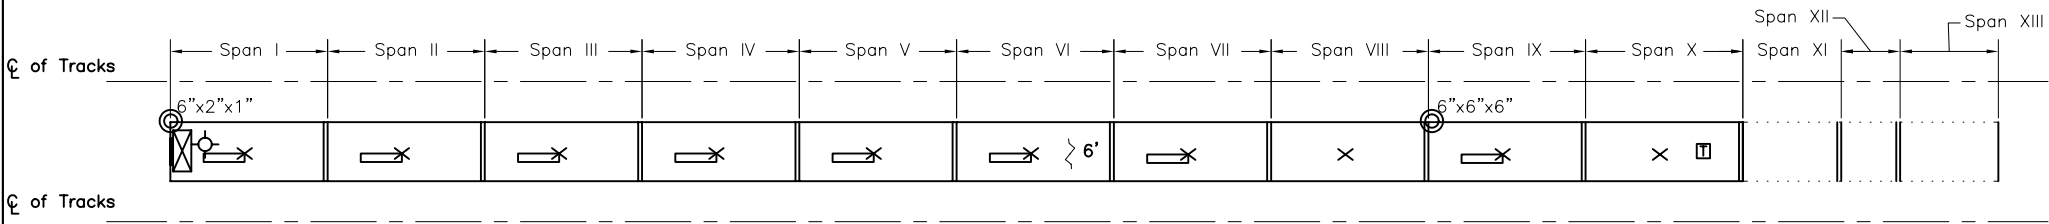
Urbitran Associates, Inc.
Connecticut Dept. of Transportation
Wilton Station Platform Plan
Date: 12-13-01

1. 30% of the concrete base of the columns in Span I, II, III, V, and X is cracked.
2. The top of the footing in Span I is cracked and deteriorated.
3. The base of the light pole is majorly dented.
4. There is rust at the canopy joints; ponding of water was noted below the joints.

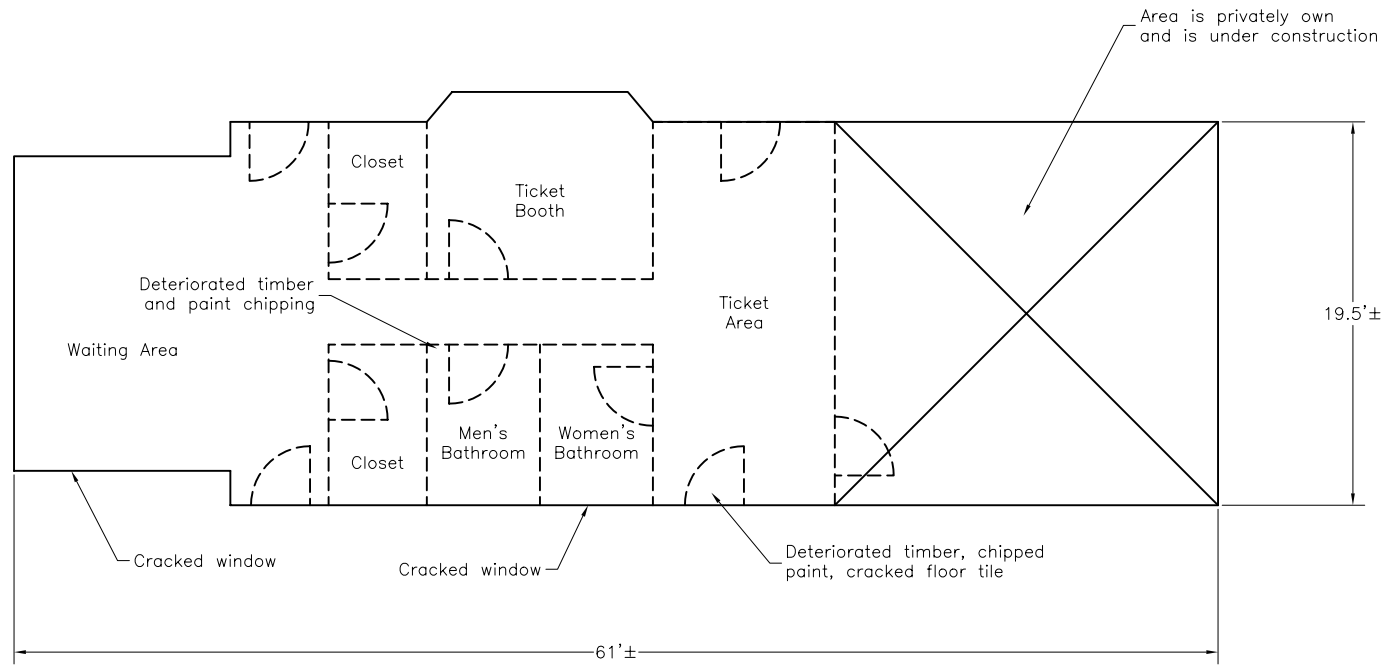
Urbitran Associates, Inc.
Connecticut Dept. of Transportation
Wilton Station Station House Plan
Date: 12-13-01

1. The Northeast coner of the over hang is cracked in two locations.
2. The Northwest corner of the overhang is deteriorated with splintering timber.
3. The roof is damaged in isolated areas.

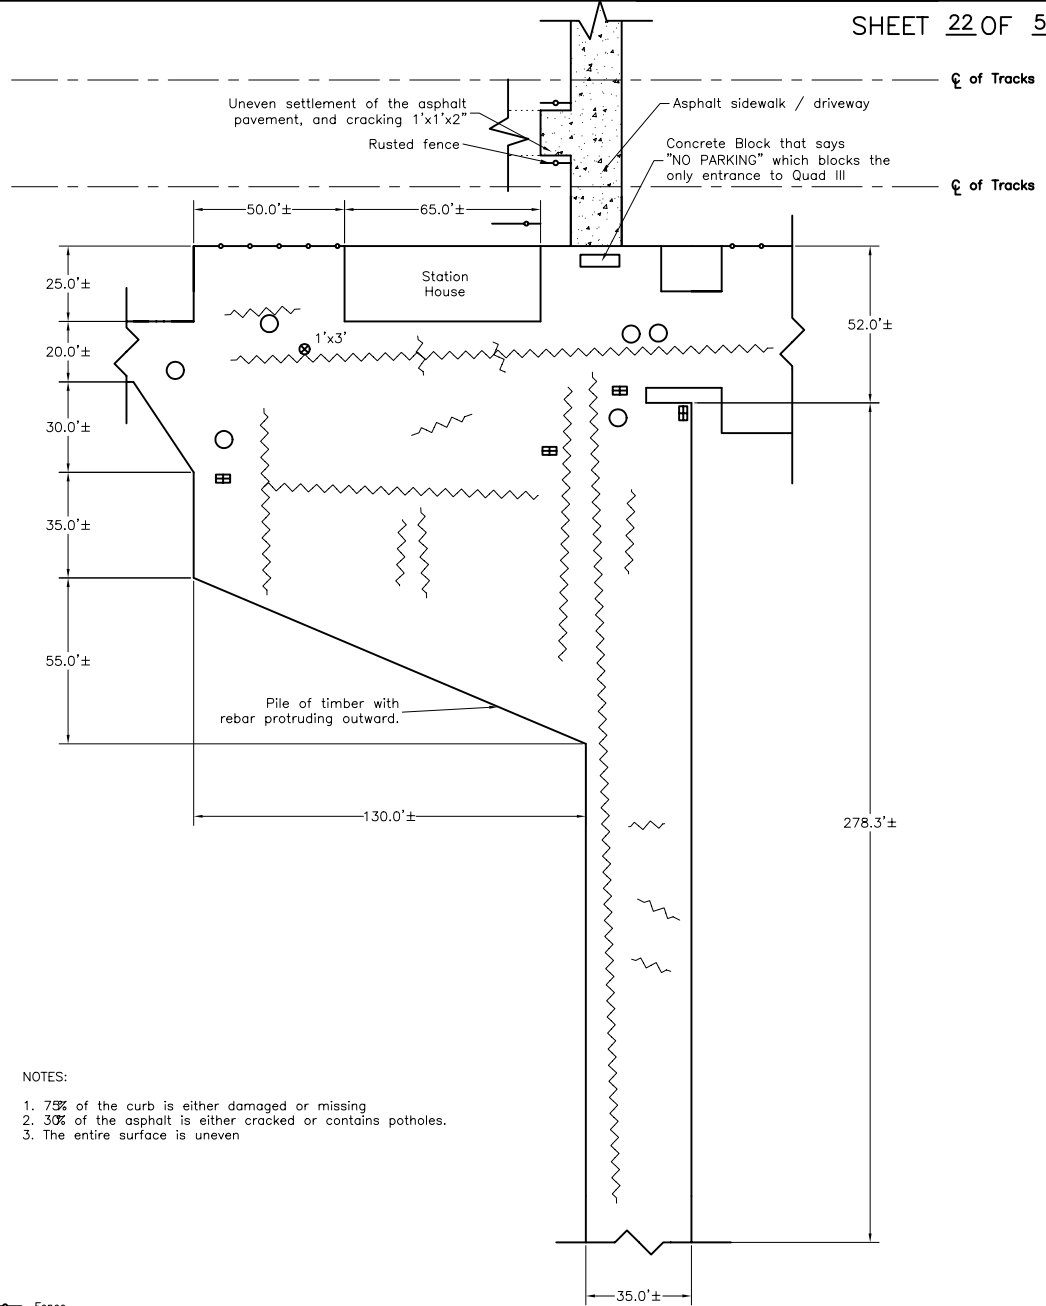
Urbitran Associates, Inc.
Connecticut Dept. of Transportation
Wilton Station Quadrant I Plan
Date: 12-13-01

- NOTES:
1. 73% of the curb is either damaged or missing
  2. 30% of the asphalt is either cracked or contains potholes.
  3. The entire surface is uneven

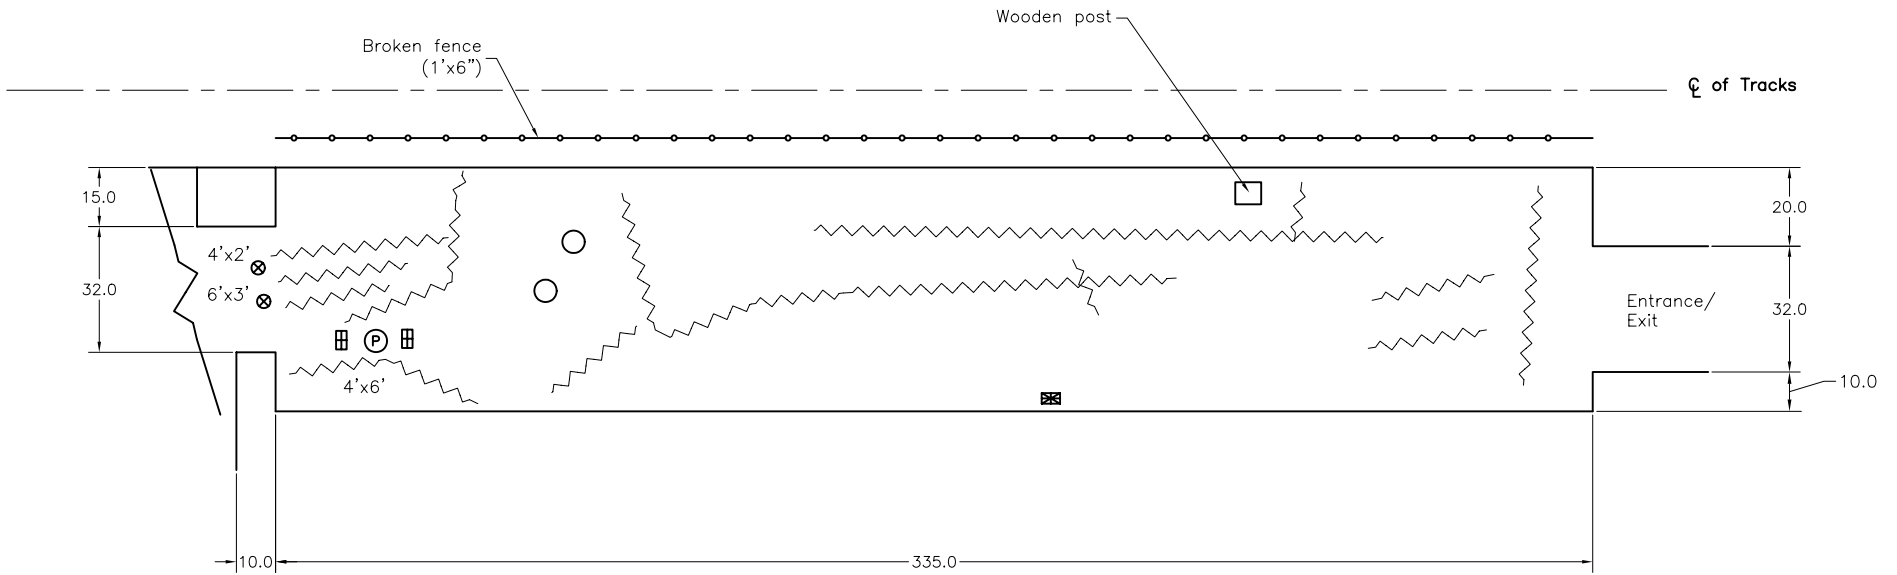
Urbitran Associates, Inc.
Connecticut Dept. of Transportation
Wilton Station Quadrant II Plan
Date: 12-13-01

1. 20% of the asphalt curb is cracked.
2. 8% of the asphalt curb is broken or missing.
3. 10% of the asphalt surface is cracked.

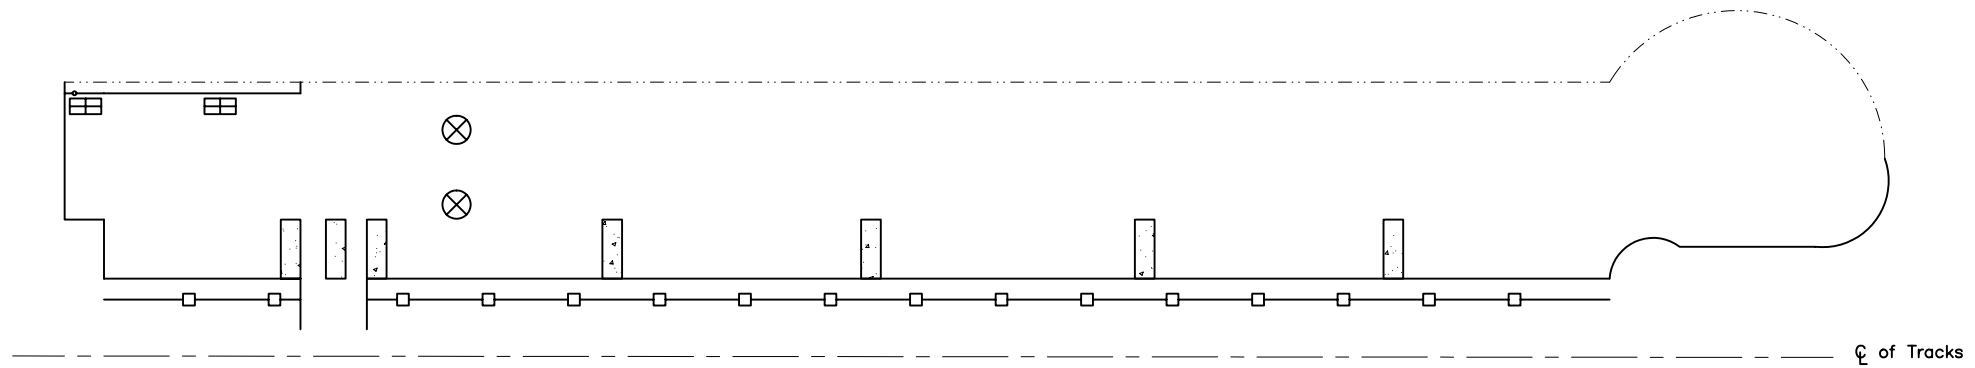
Urbitran Associates, Inc.
Connecticut Dept. of Transportation
Wilton Station Quadrant III Plan
Date: 12-13-01

1. The parking lot appears to be a new lot and the only entrance is blocked by a concrete barrier

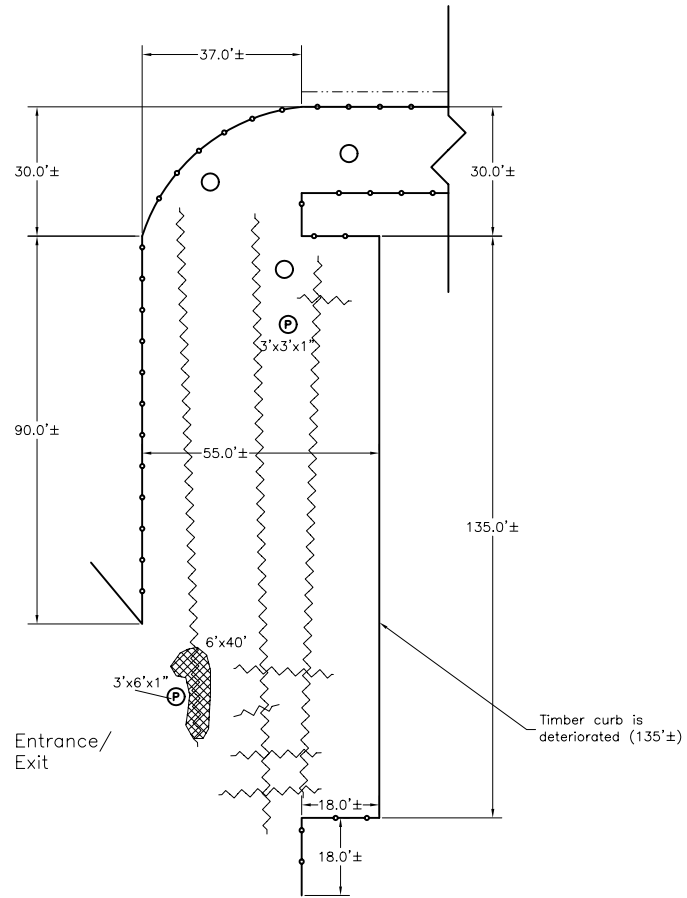
Urbitran Associates, Inc.
Connecticut Dept. of Transportation
Wilton Station Quadrant V Plan
Date: 12-13-01

- NOTES:
1. 50% of the asphalt curb is missing
  2. 30% of the asphalt pavement is cracked.

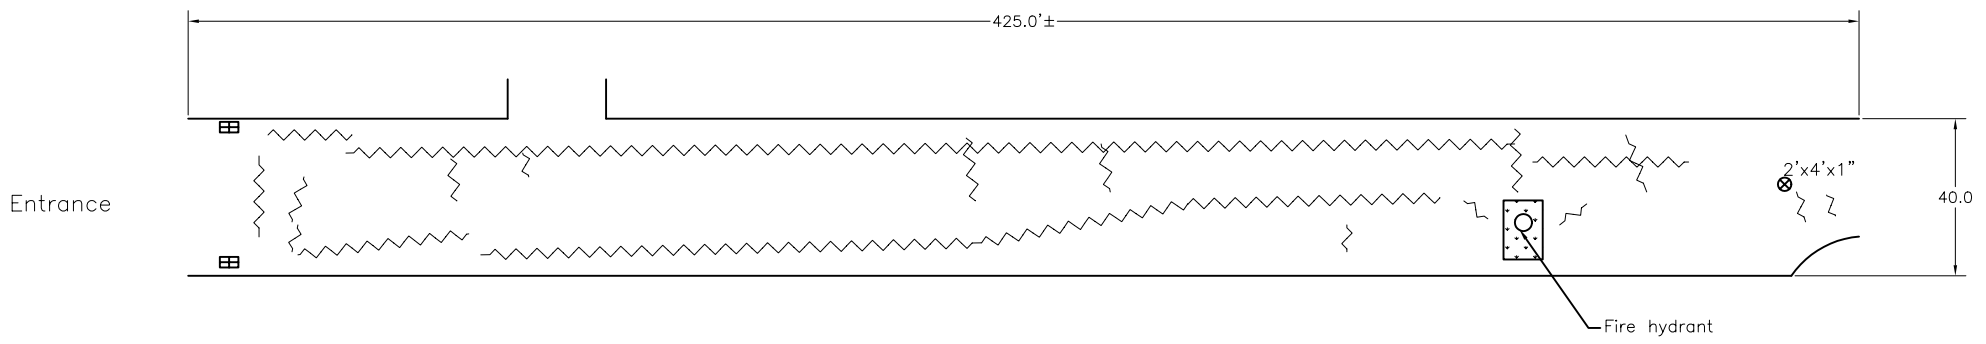
- NOTES:
1. 30% of the east side curb is damaged or missing.
  2. 15% of the west side curb is damaged or missing.
  3. 10% of the asphalt surface is cracked.

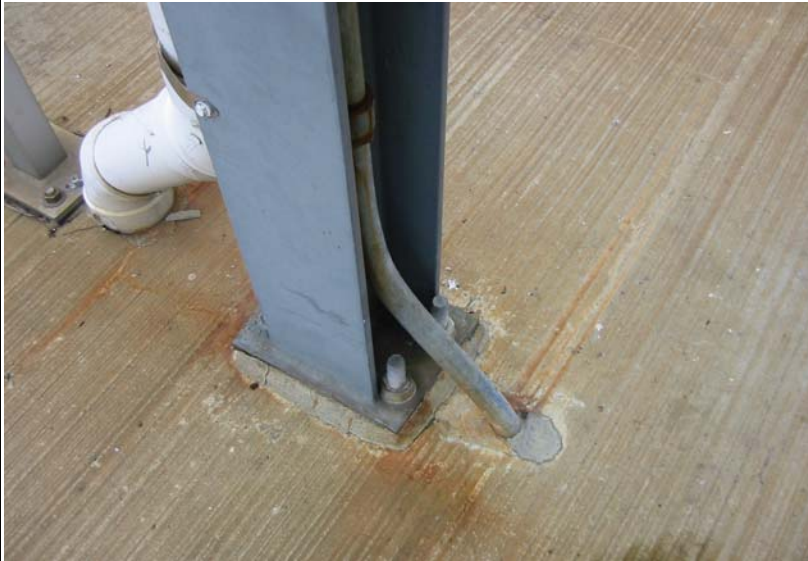
PHOTO NO. 16

Location: Span XI

Description: Typical cracks along concrete base of the column

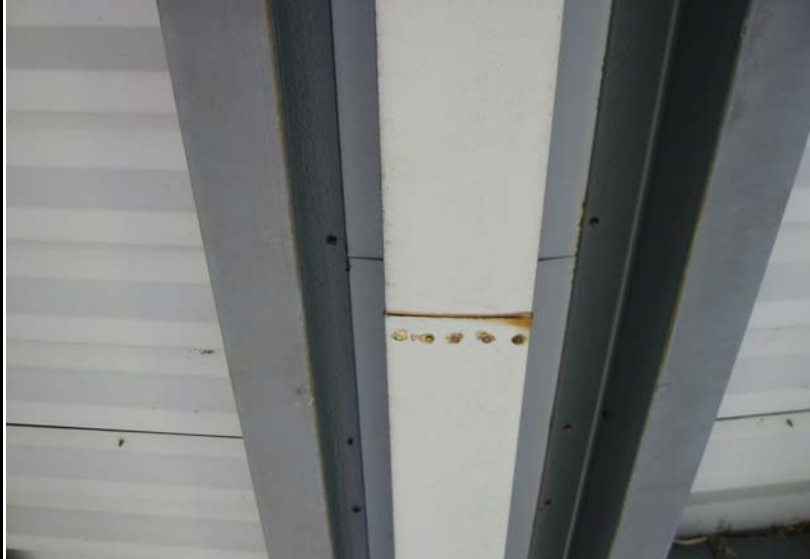
Description: \_\_\_\_\_  
There is rusting at the  
the joint

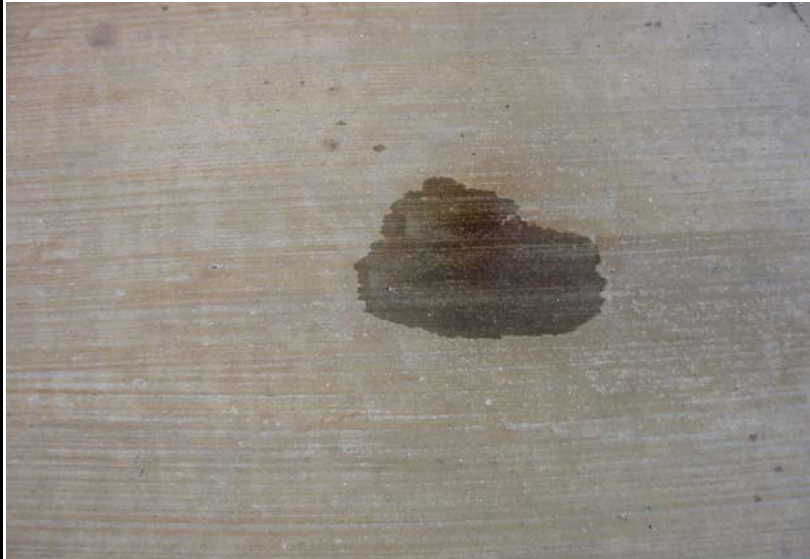
PHOTO NO. 18

Location: \_\_\_\_\_  
Middle of Span VII

Description: \_\_\_\_\_  
Below the canopy  
joint there are  
puddles of water

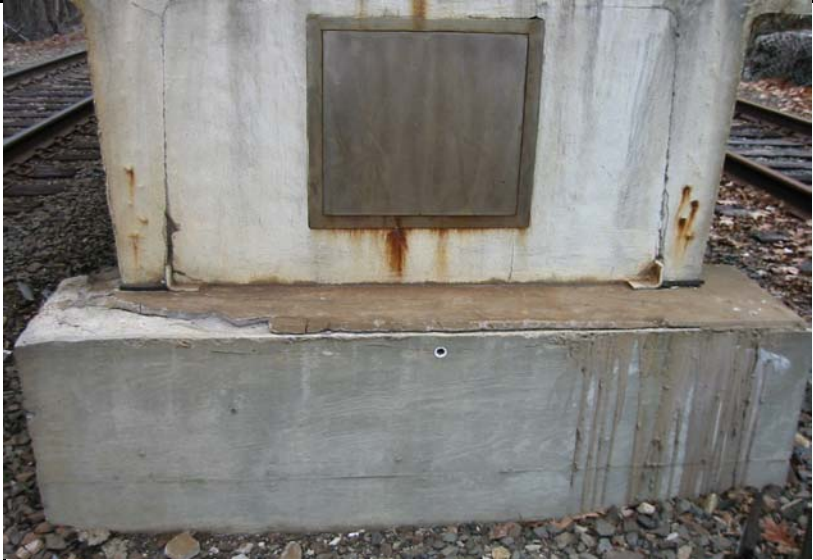
Description: \_\_\_\_\_  
Spall concrete on the  
top of the footing  
(2' x1 1/2' x 2")

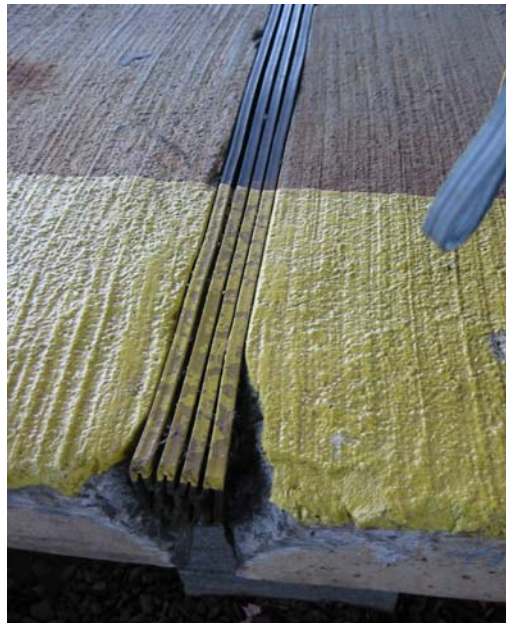
PHOTO NO. 20

Location: \_\_\_\_\_  
Between Spans IX and  
VIII

Description: \_\_\_\_\_  
Spalled concrete  
adjacent to the joint  
(6"x6"x4")

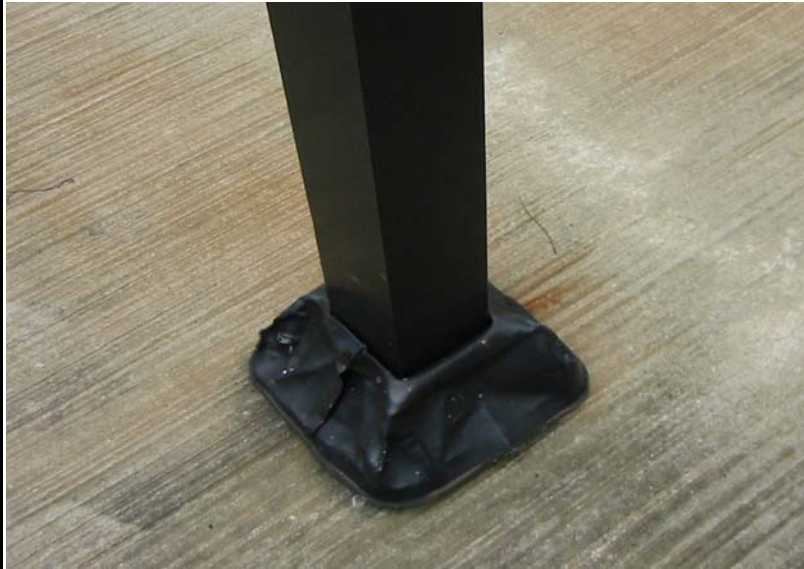
Description: \_\_\_\_\_  
The base of the light  
pole is dented  
\_\_\_\_\_  
\_\_\_\_\_

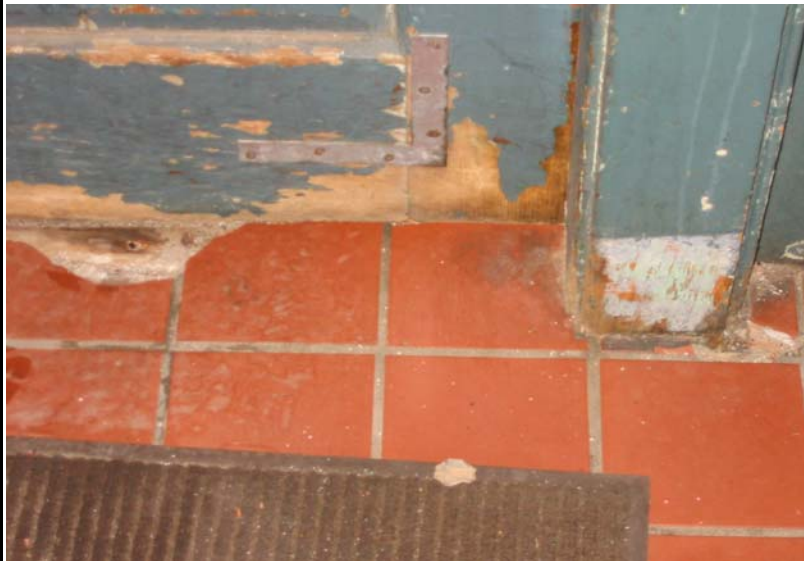
PHOTO NO. 22

Location: \_\_\_\_\_  
East side of the  
ticket area  
\_\_\_\_\_

Description: \_\_\_\_\_  
Cracked tile along the  
East door of the ticket  
area  
\_\_\_\_\_  
\_\_\_\_\_

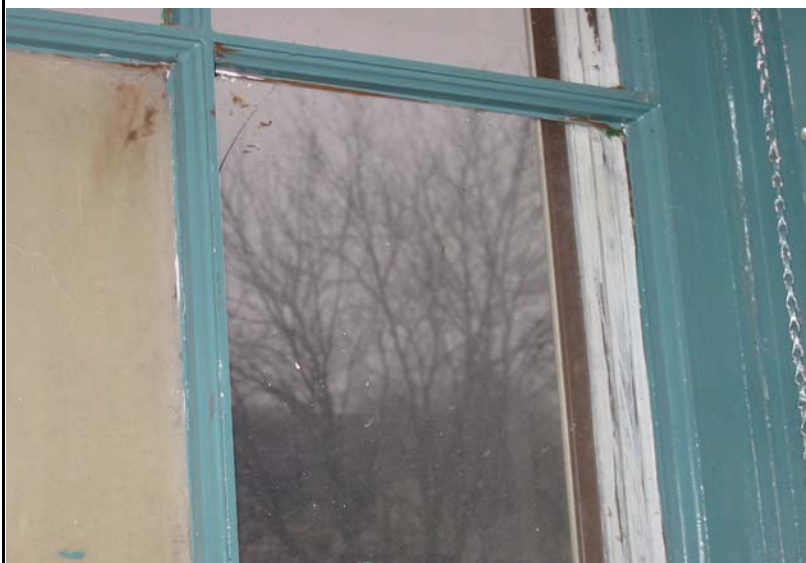
Description: \_\_\_\_\_  
Cracked East window in  
the ladies room

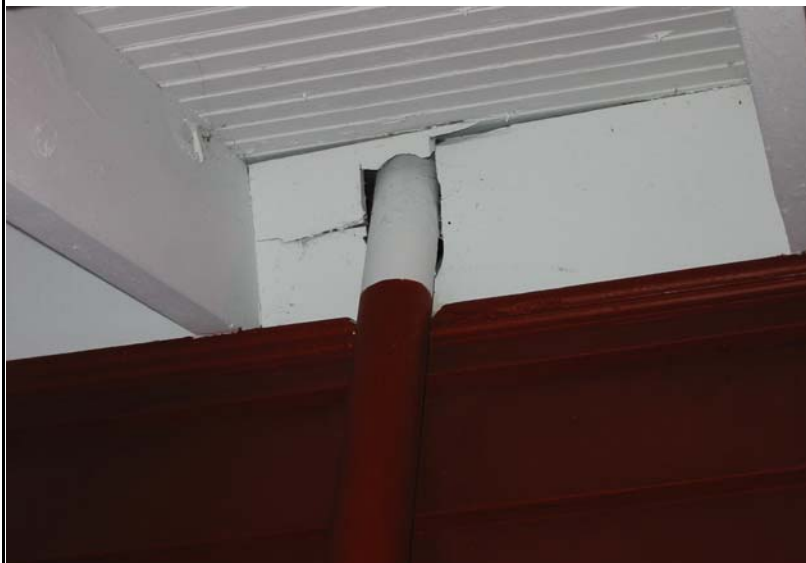
PHOTO NO. 24

Location: \_\_\_\_\_  
Near the North east  
corner the station house

Description: \_\_\_\_\_  
Cracked and damaged  
wood on the overhang  
near the northeast  
corner

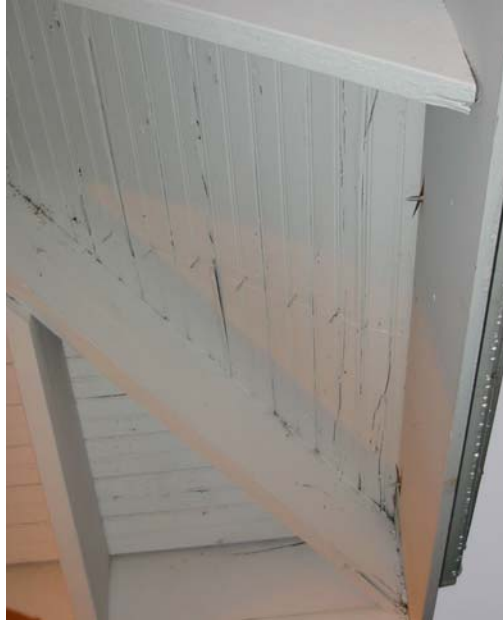
Description: Deteriorated timber with splintering in the northwest corner of the overhang

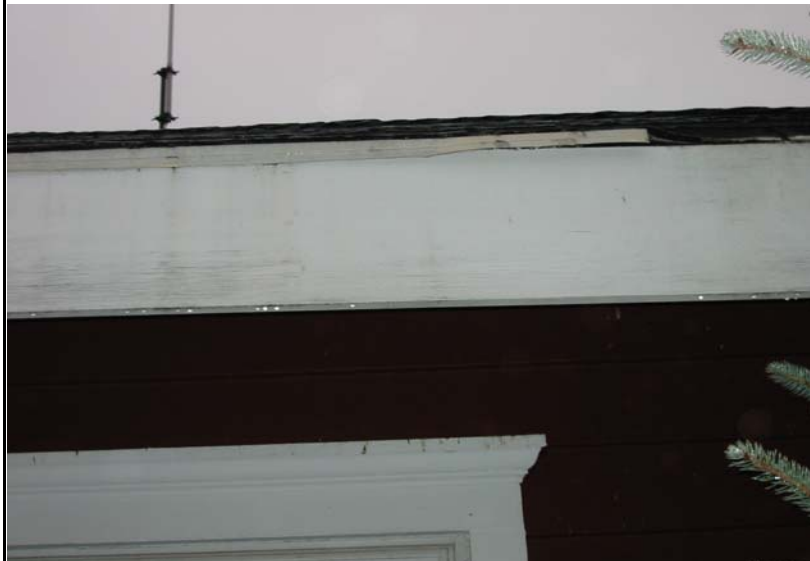
PHOTO NO. 26

Location: South of the Southwest corner of the station house

Description: Damaged area between the roof and the overhang

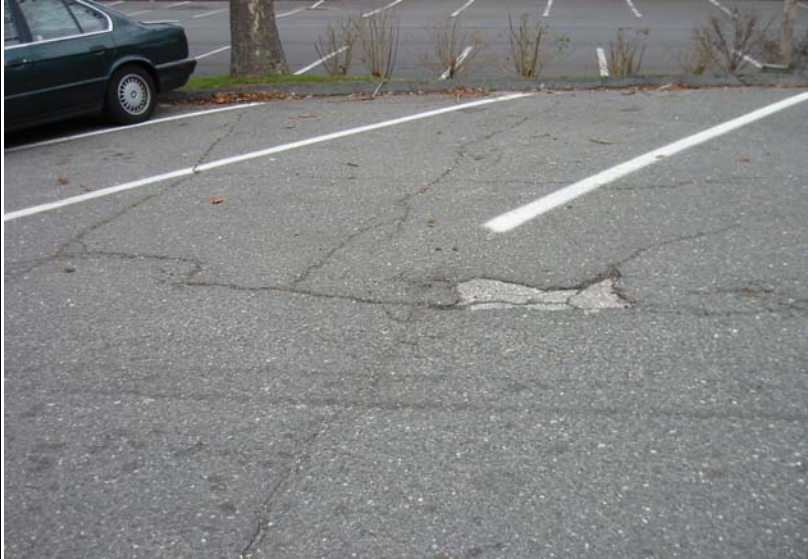
Description: \_\_\_\_\_  
Typical cracks and  
potholes

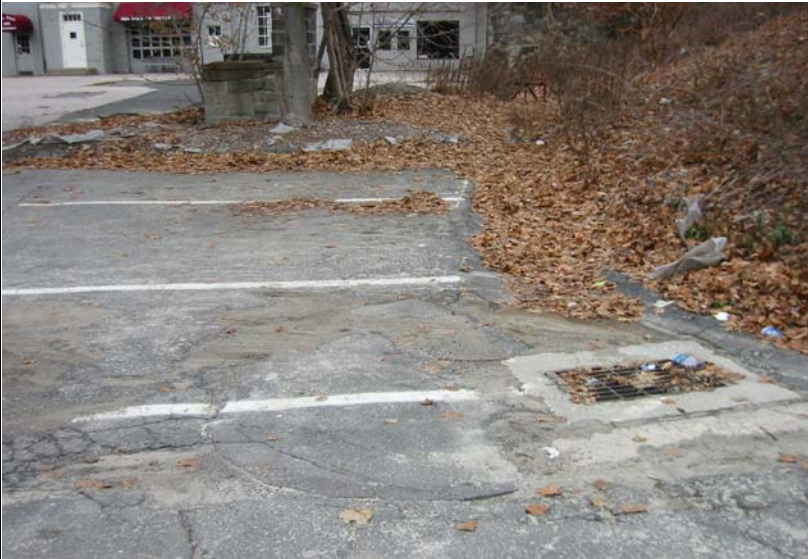
PHOTO NO. 28

Location: \_\_\_\_\_  
Southeast corner of  
Quad I

Description: \_\_\_\_\_  
Typical uneven driving  
surface, map cracking  
and accumulation of  
leaves into the parking  
area

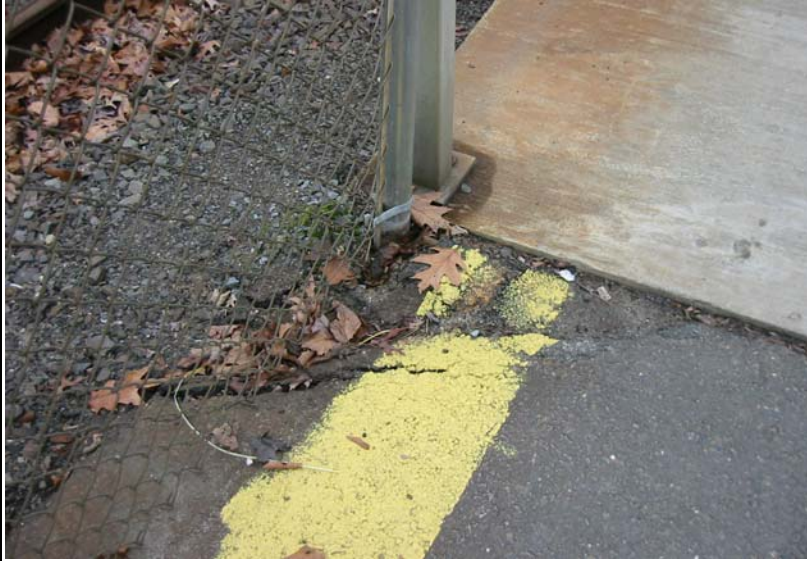
Description: \_\_\_\_\_  
Settlement and cracking  
of the asphalt pavement  
in Quad I

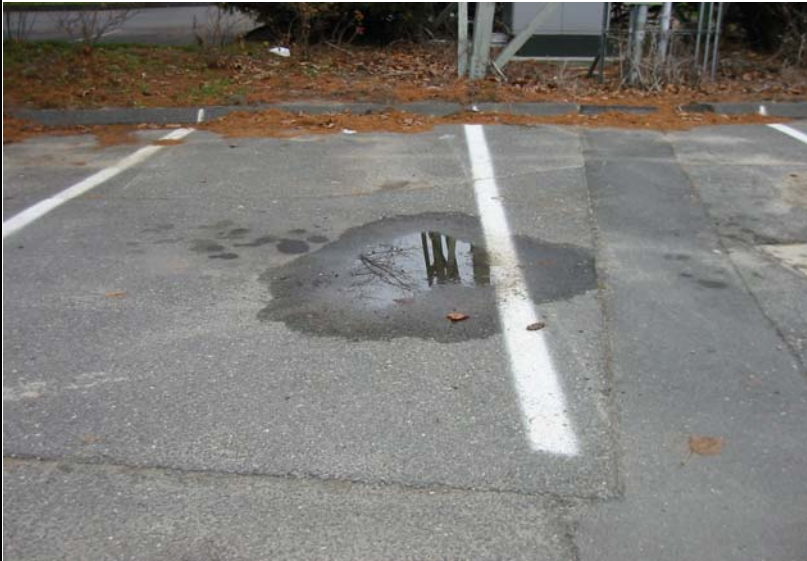
PHOTO NO. 30

Location: \_\_\_\_\_  
Northwest corner of  
Quad II

Description: \_\_\_\_\_  
Ponding (4'x6')

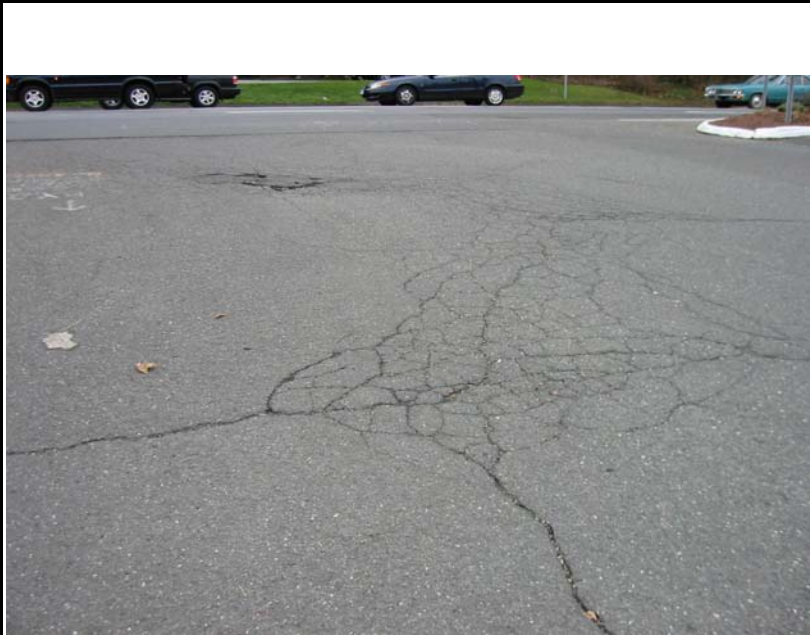
Description: \_\_\_\_\_  
Typical map cracking

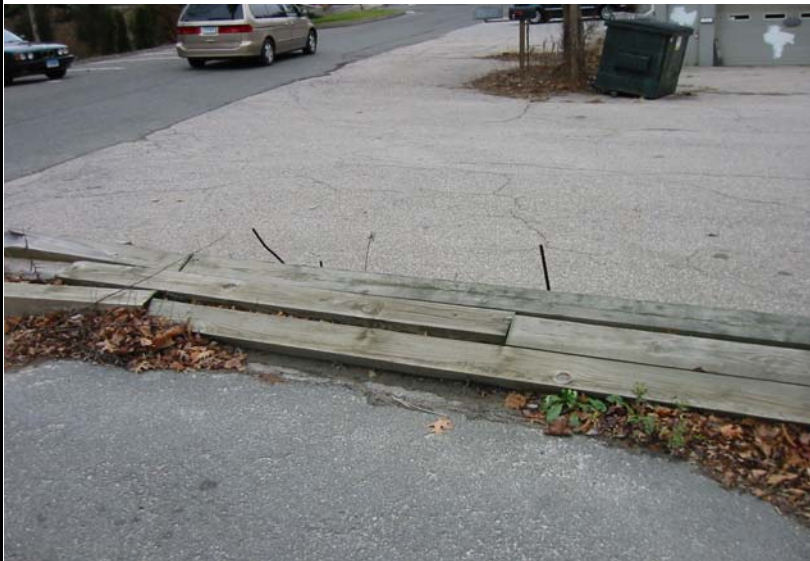
PHOTO NO. 32

3		33	Quad I <b>Fence</b> -The northwest fence in Quad I is rusted
2		28	Quad I,II,IV <b>Landscape</b> - Leaves are accumulating in the parking area
1		32	Quad I <b>Curb</b> -There is timber with protruding rebar which is dangerous for the pedestrians

Location: \_\_\_\_\_  
East side of Quad I

Description: \_\_\_\_\_  
Timber with rebar protruding which is dangerous for pedestrians

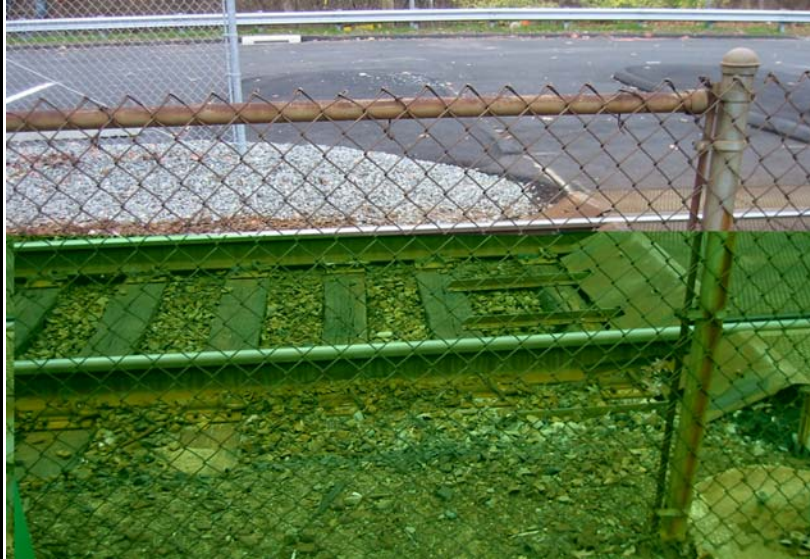
Description: Typical rusting along the fence North of the platform

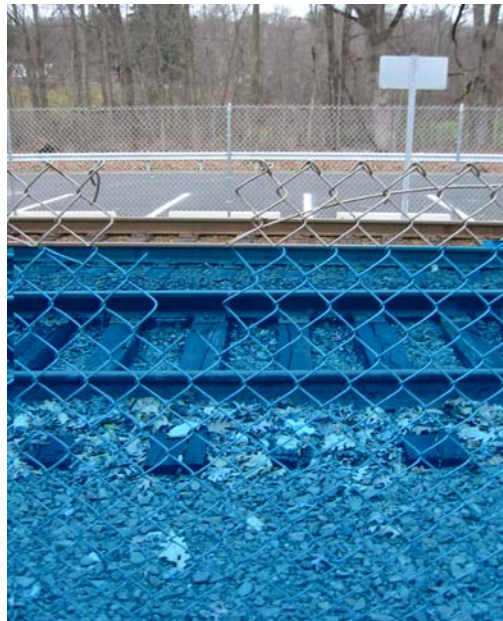
PHOTO NO. 34

Location: West side of Quad II

Description: Damaged fence on the west side of Quad II

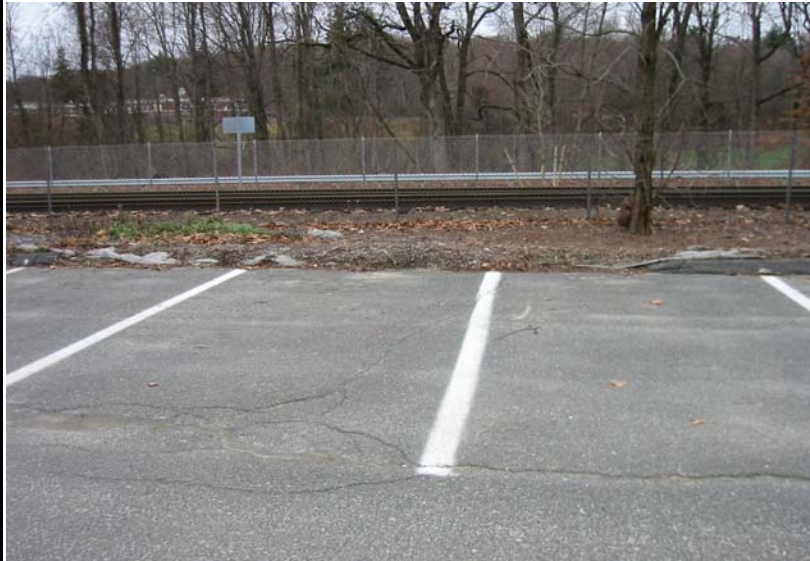
Description: \_\_\_\_\_  
Missing asphalt  
curb along the east  
side of Quad II (20')

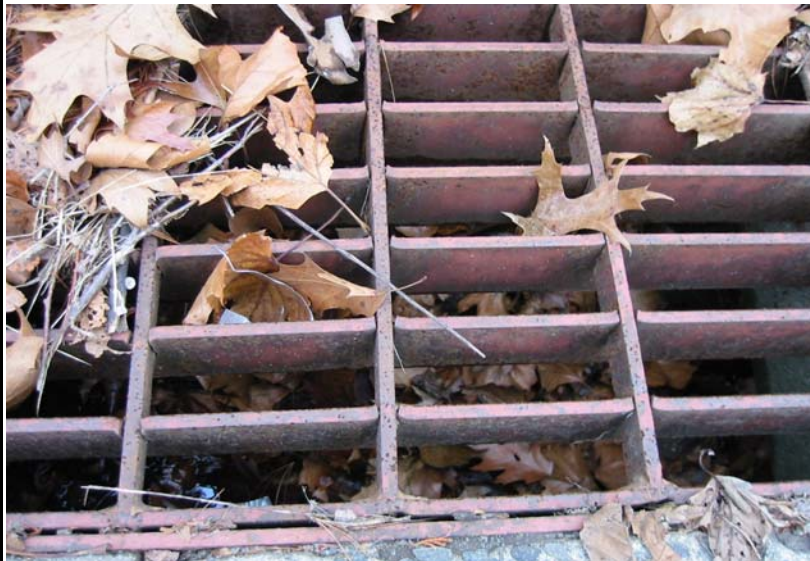
PHOTO NO. 36

Location: \_\_\_\_\_  
Middle of the West side  
of Quad II

Description: \_\_\_\_\_  
The drain is clogged by  
leaves which block the  
drain pipe

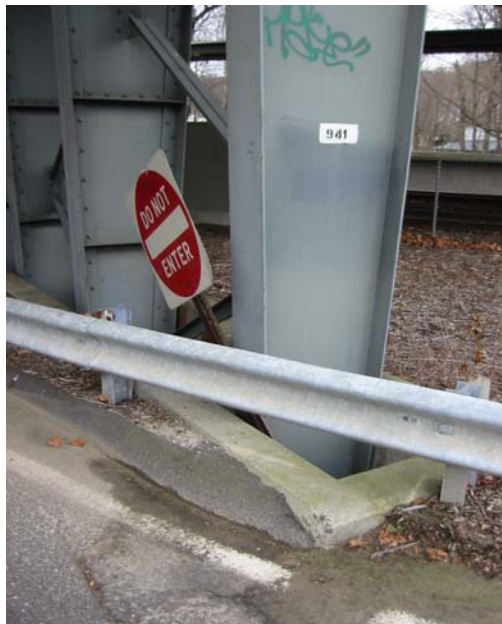
Description: \_\_\_\_\_  
Abandoned sign

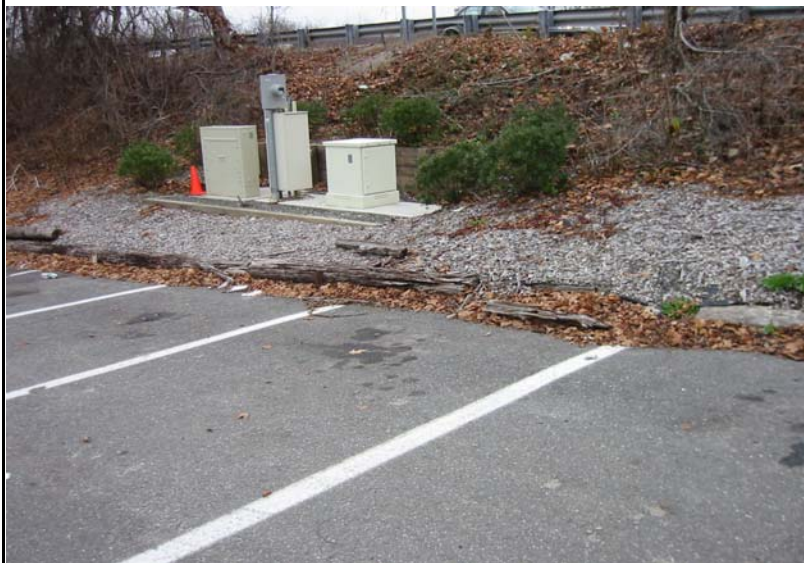
PHOTO NO. 38

Location: \_\_\_\_\_  
North side of Quad V

Description: \_\_\_\_\_  
Deteriorated  
timber curb through out  
North side of Quad V

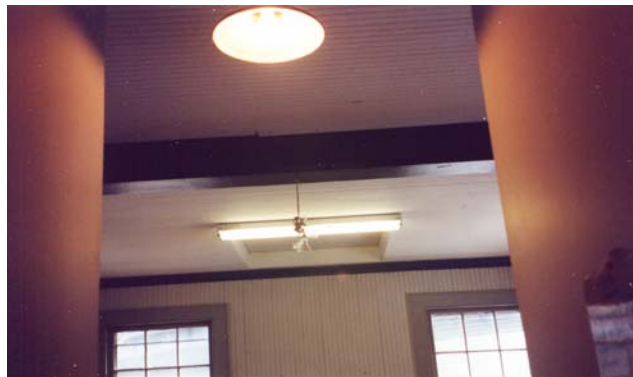
PHOTO NO. 40

Remarks: A typical section of the waiting room and lobby area were measured and found to average 3.45 and 18 fc respectively.  
 Two egresses are missing exit/emergency lighting. Lighting should be provided at these points of egress.

Location:  
waiting room

Description:  
waiting room  
lighting

We recommend that additional luminaires be installed in the waiting area to increase the average light levels to 5.0 foot-candles from the measured average of 3.2 foot-candles. Additionally, exit signs should be installed at all egress points to meet the current requirements of NFPA 101.

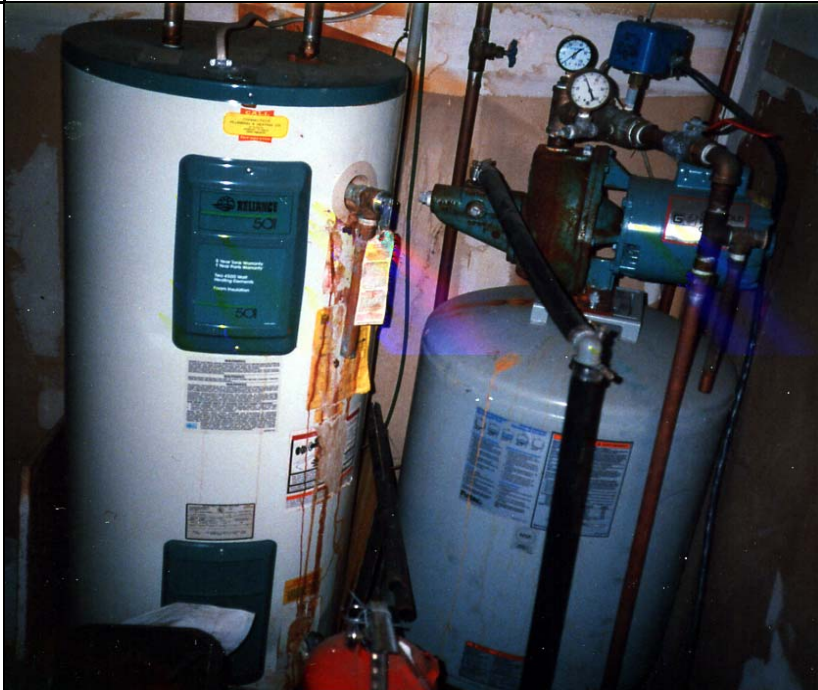
PHOTO NO. 46

There is a water pressure tank (the diaphragm type with cushion of air). The air pump make is Griswald Pump. It is badly in need of maintenance (deficient).

Description:  
Water heater  
and water  
pressure tank  
with diaphragm

Comment: This equipment is not in accordance with the code, which requires 18" open space around equipment; this area is too small, equipment is too tightly spaced.

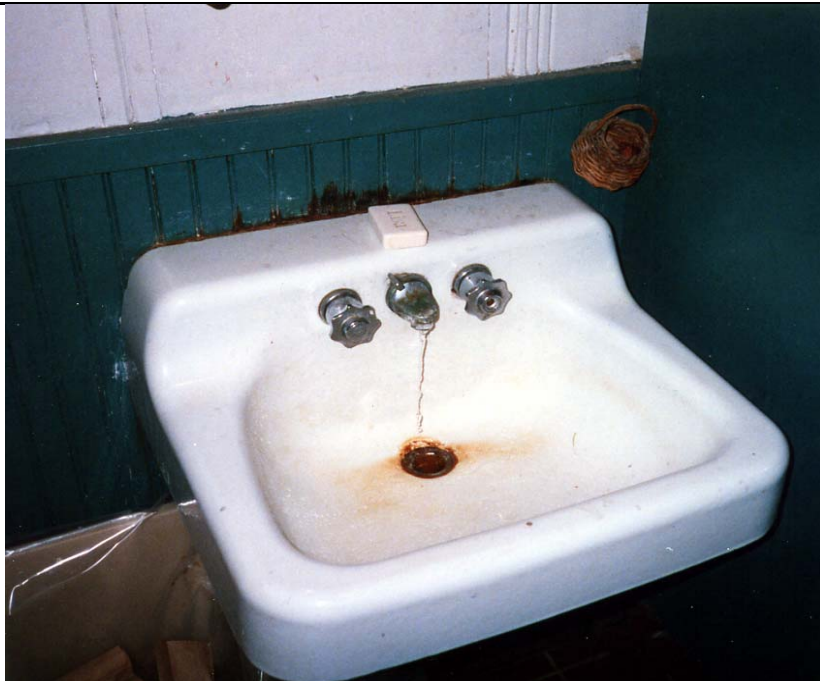
In the Men's restroom the cold water pressure is low. The fixtures are old and in very poor condition. Fixtures are not handicapped type or water conservation type. The faucet leaks continuously. There is not handicapped access. The women's restroom is in the same condition. In the inspectors opinion there is no room within the existing building for two handicapped accessible restrooms. This building will require extensive modification to make fixtures and areas meet ADA requirements. It might be possible to install one unisex restroom. An exhaust fan must be installed. The door must be louvered or undercut. At this time there are windows in the restrooms but they cannot be opened. The estimated cost for renovations to conform to ADA recommendation for one unisex bathroom (the plumbing cost estimated) is \$6,000-\$7,000. Otherwise to replace the severely deficient fixtures with handicapped ones is estimated at \$3,000-\$4,000 (not recommended by the inspectors because there will not be any handicapped access).

Description: \_\_\_\_\_  
Sink  
deteriorated  
condition  
typical

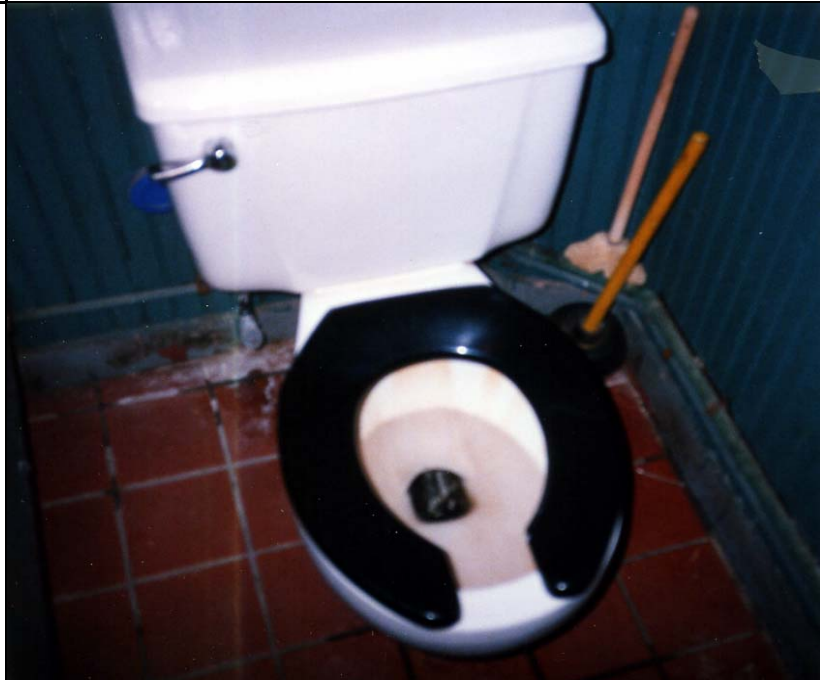
PHOTO NO. 48

Description: \_\_\_\_\_  
Toilet  
deteriorated  
condition  
typical
