REHABILITATION STUDY REPORT

State Project No. 63-703
Bridge No. 02555 in Hartford
Interstate 91 over Clark Dike Service Road

Prepared For:
State of Connecticut
Department of Transportation
Newington, Connecticut

Submitted: February 2016

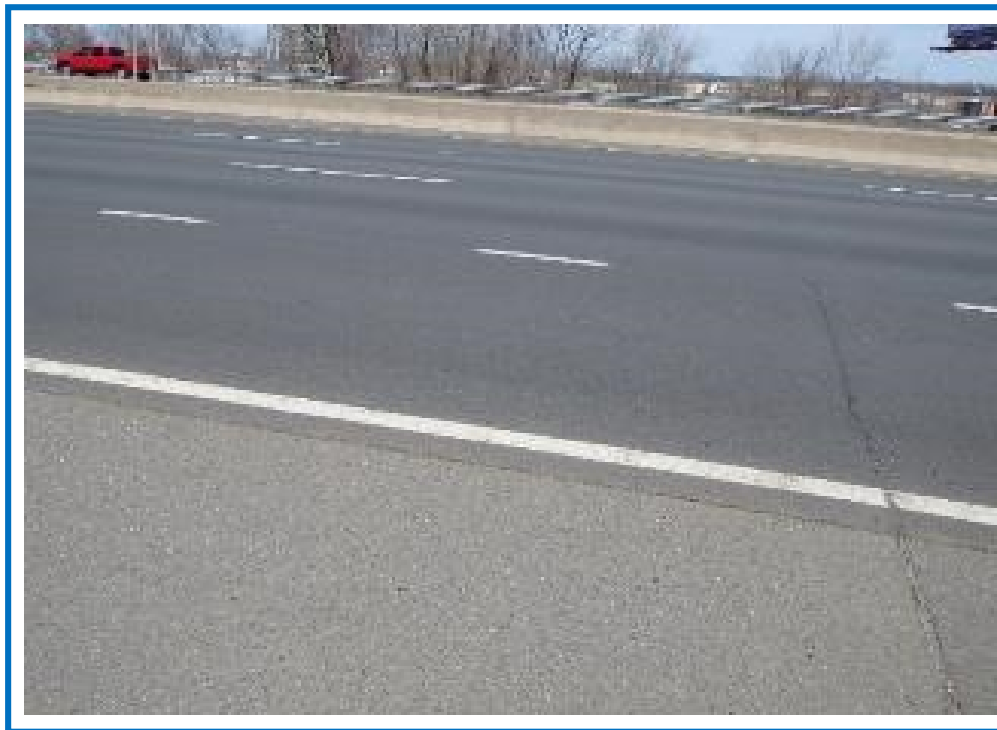
Typical Overlay Condition (Note: New pavement in lanes)

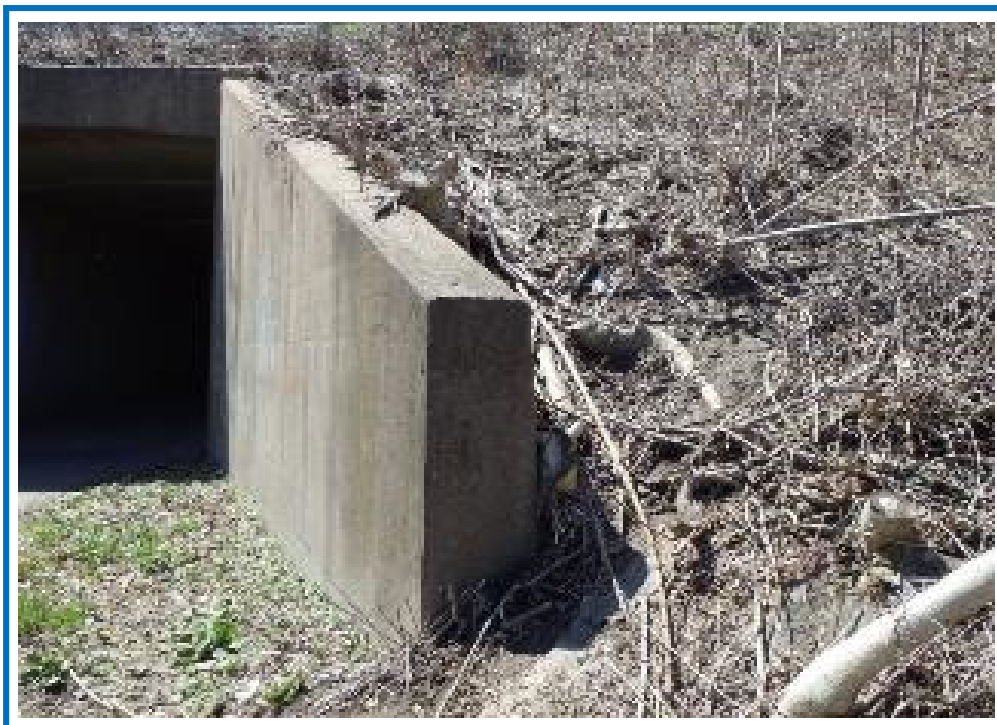
Northeast Wingwall (Note: Area of erosion behind)

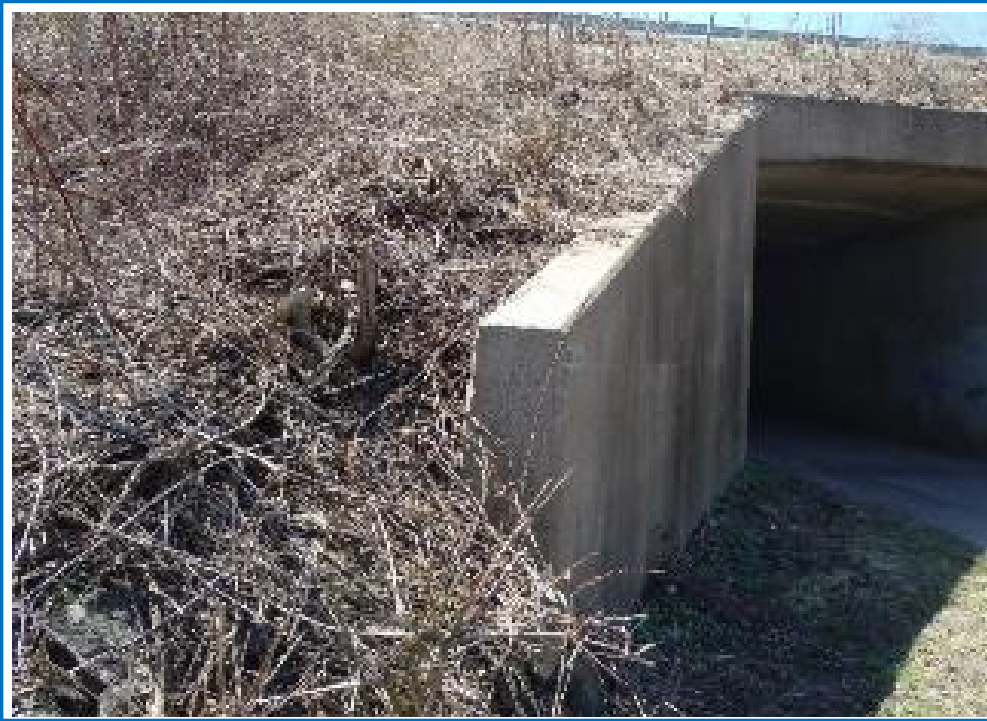
Southeast Wingwall (Note: Area of erosion behind)

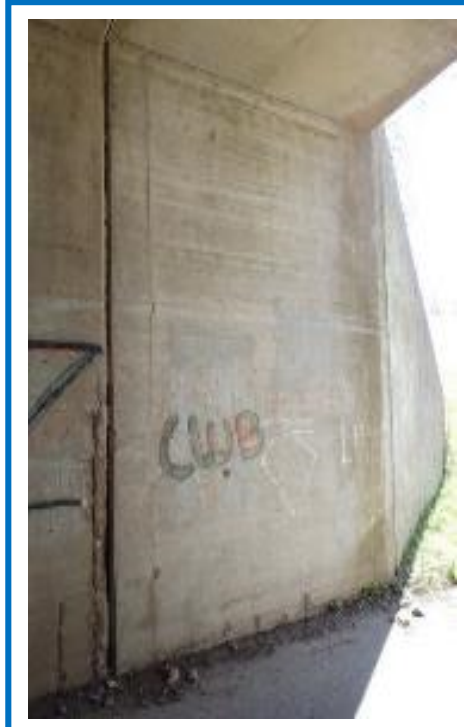
Panel 1 Southwall (Note: Spall with exposed reinforcement)

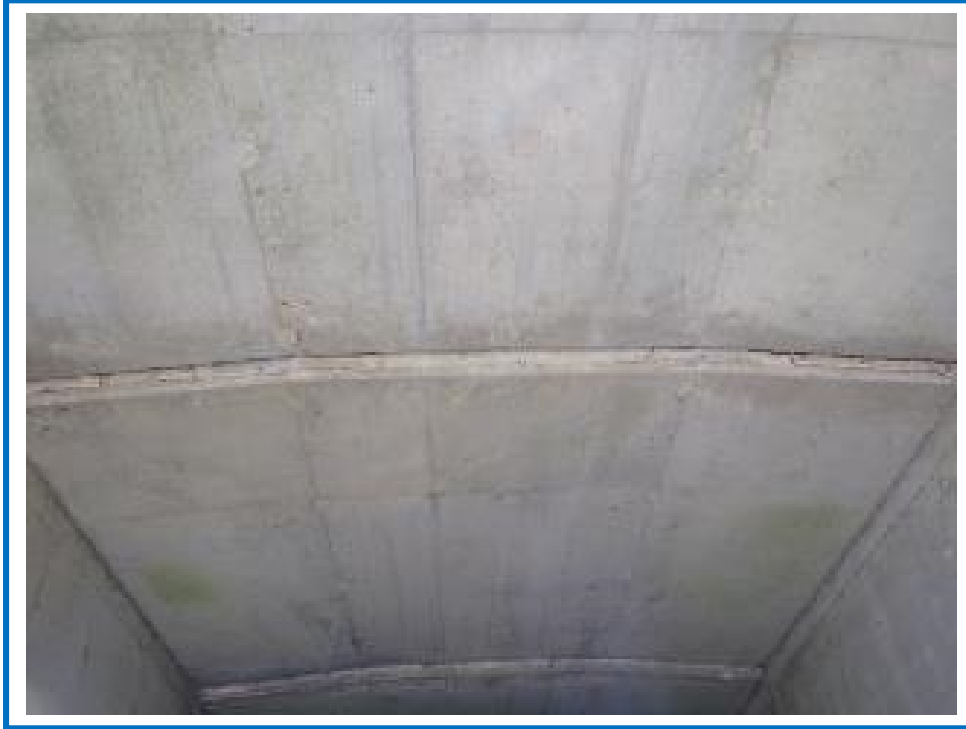
Joint at Roof Panels 1 & 2 (Note: Misalignment typical in first and last four spans)

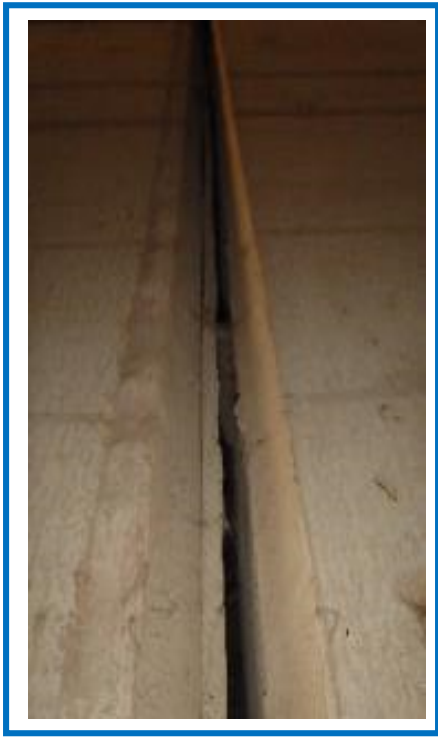
Typical Vertical Joint with Gap
(Note: Joint between panels 6 and 7 south wall shown)

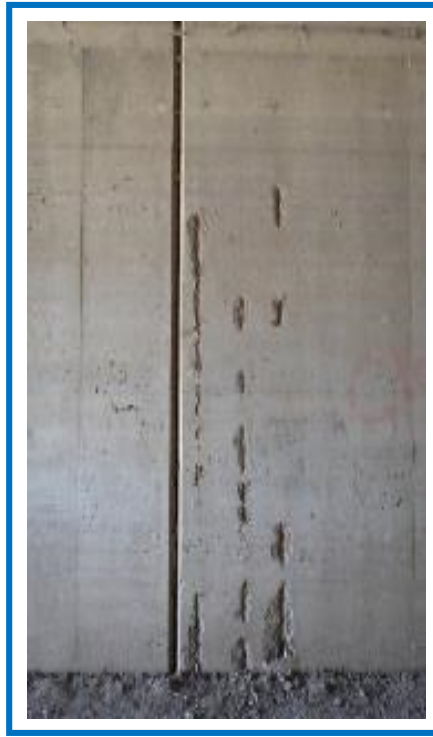
Panel 8 at Joint 8 South Wall
(Note: Spalls and gap in joint)

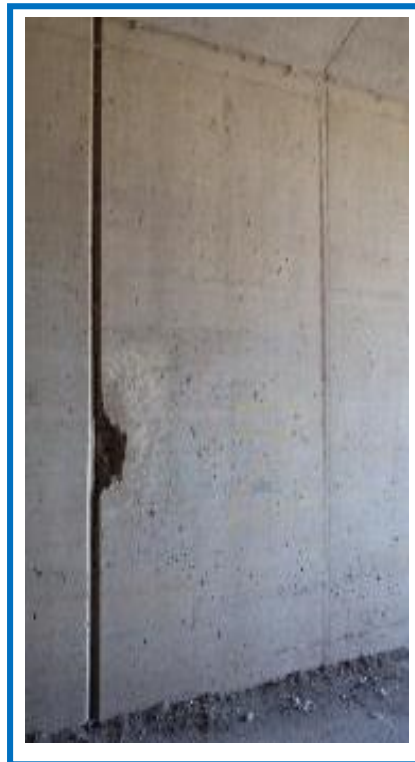
Panel 9 North Wall at Joint 8 with Spall and Exposed Reinforcement

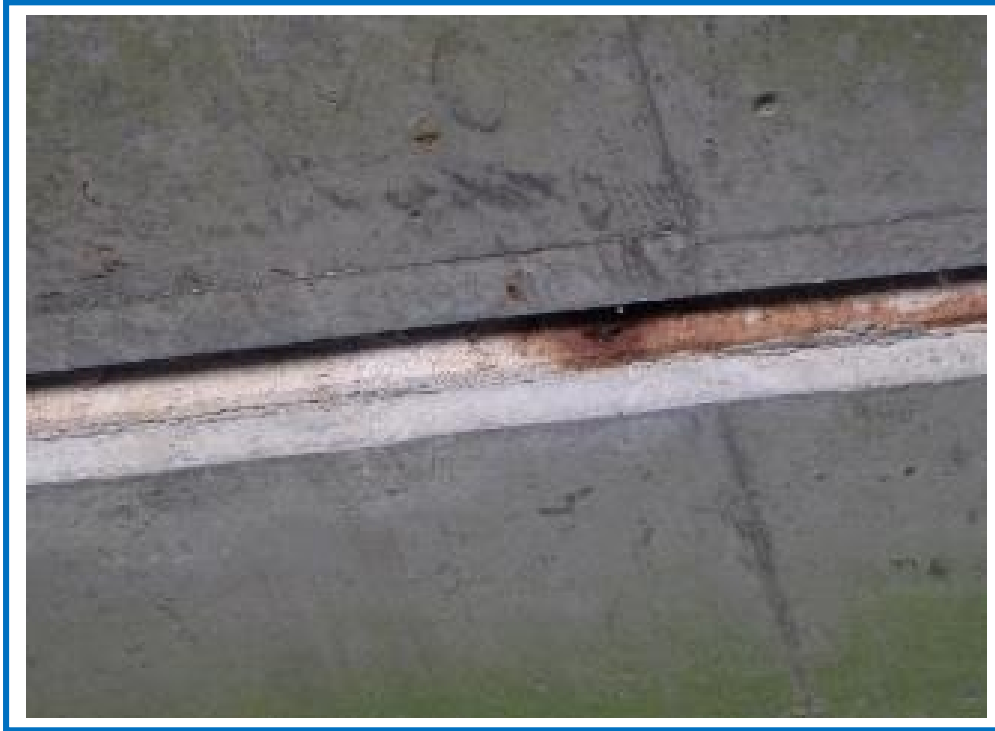
Vertical Misalignment between Panels 10 & 11 up to 3”

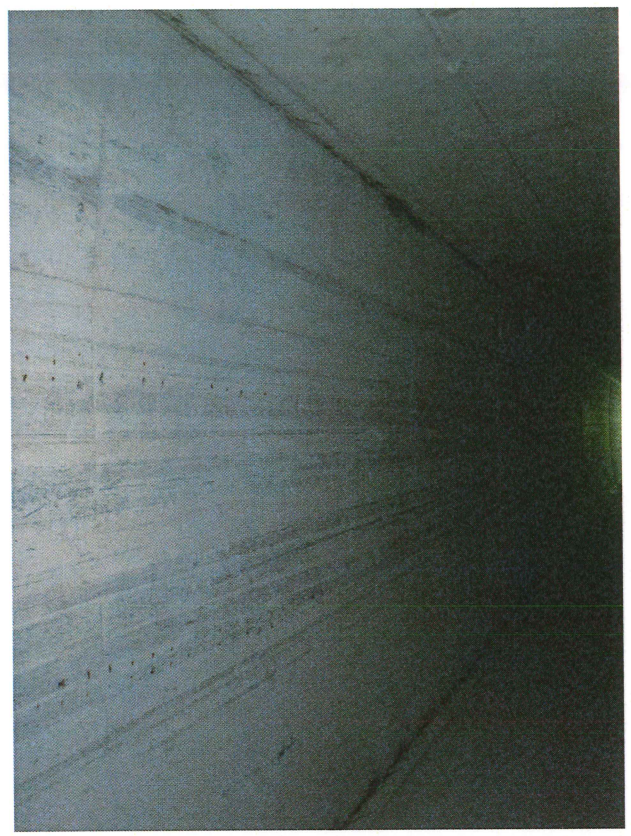
Photo # 8 TYPICAL SOFFIT CONDITIONS.

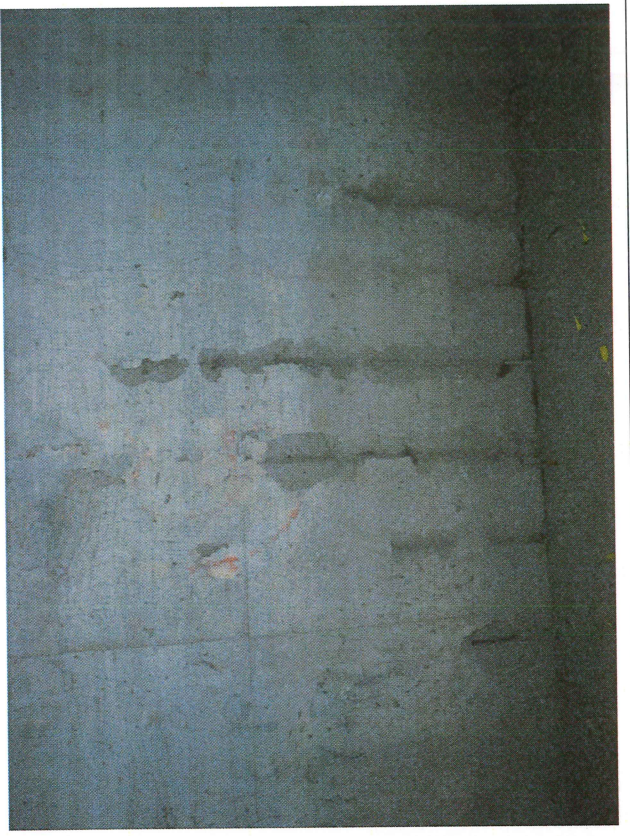
| Photo # 9 SOUTHERLY STEM. | Photo # 10 SHALLOW RE-BARS OF THE SOUTHERLY STEM. |
