REHABILITATION STUDY REPORT

State Project No. 63-703
Bridge No. 03244 in Hartford
I-91 over Drainage

State of Connecticut
Department of Transportation
Newington, Connecticut

Submitted: February 2016

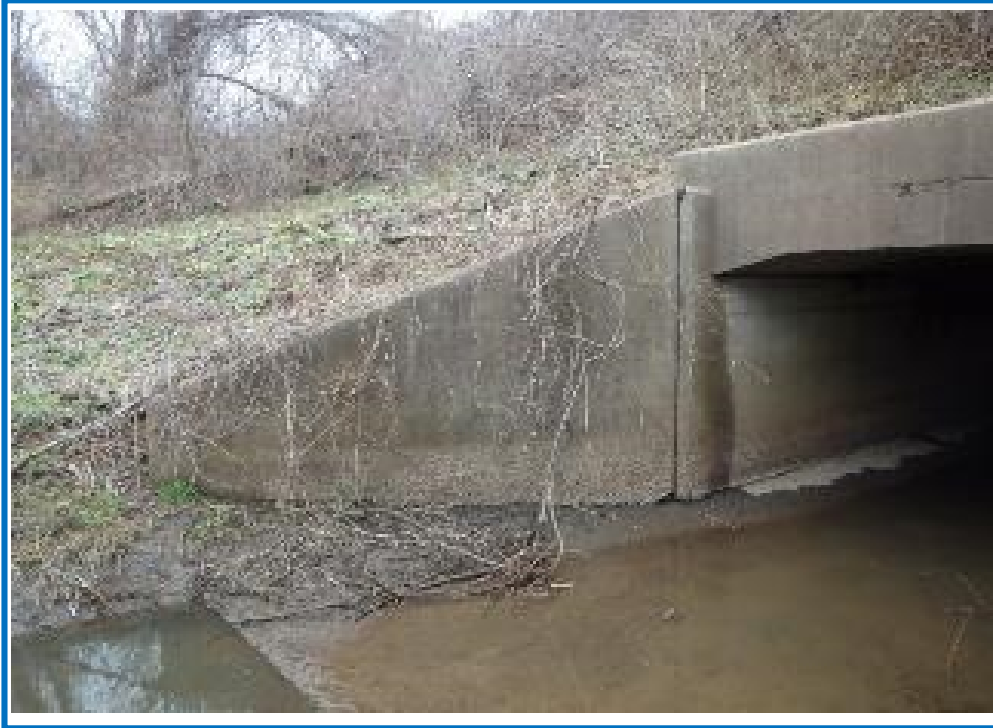
Northwest Wingwall

The retaining wall stem is in good condition (rating = 7) and exhibits heavy scale at the waterline of the northwest wingwall and others showing light scale.

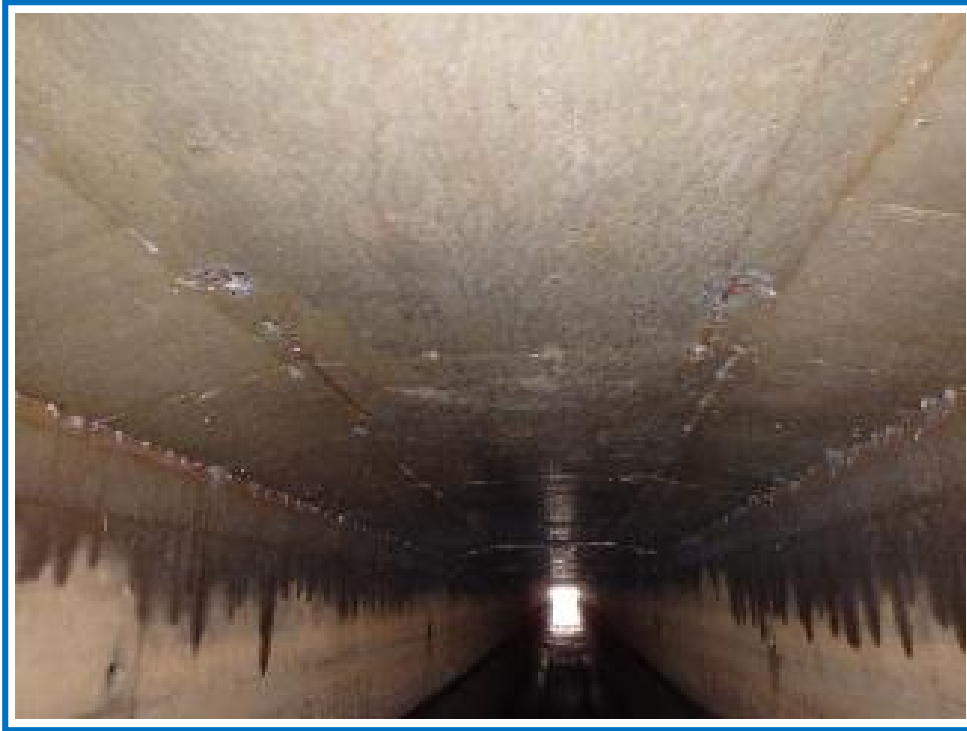
Top Panel 10 (Note: Spalls with exposed rusted reinforcement)

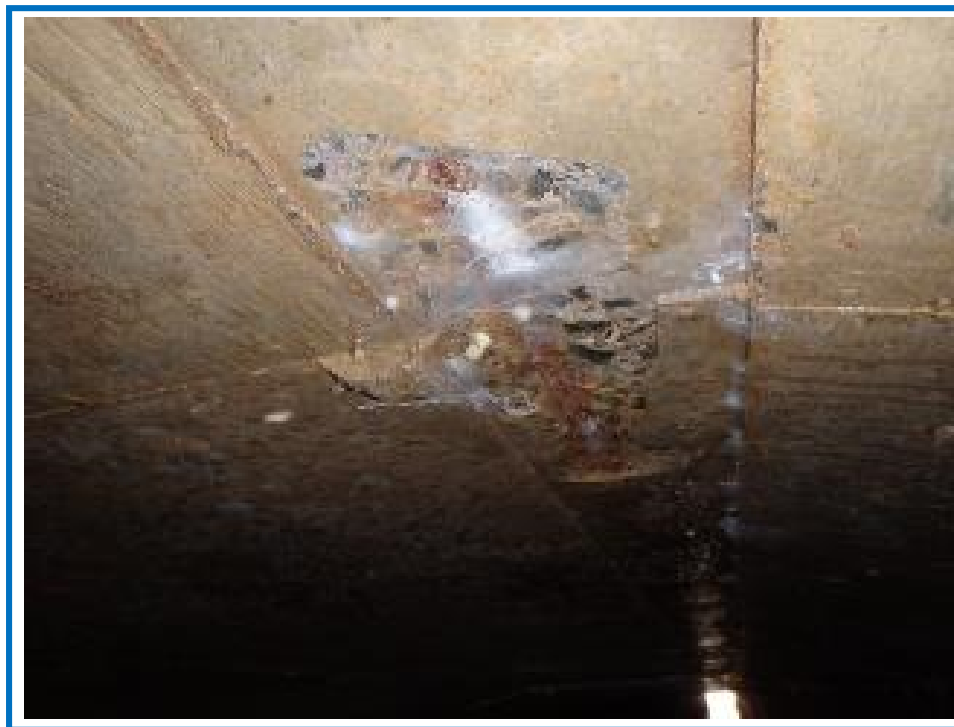
Spall at Top Panel 10 (Note: Exposed rusted reinforcement)

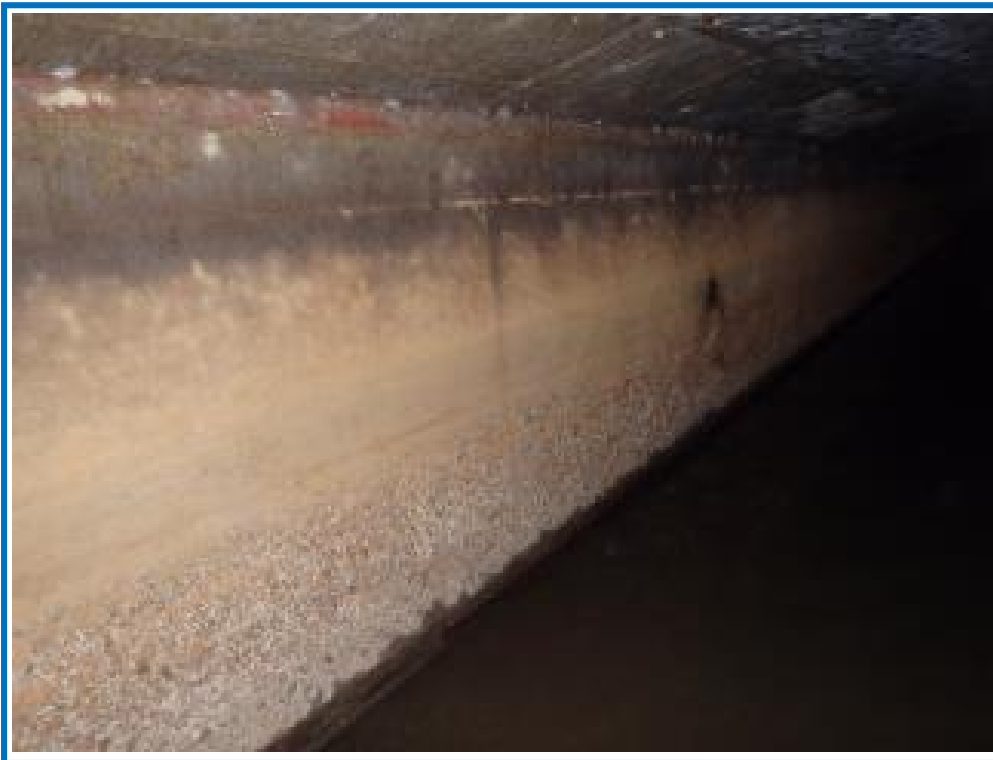
North Wall Panel 9 (Note: Scale at waterline)

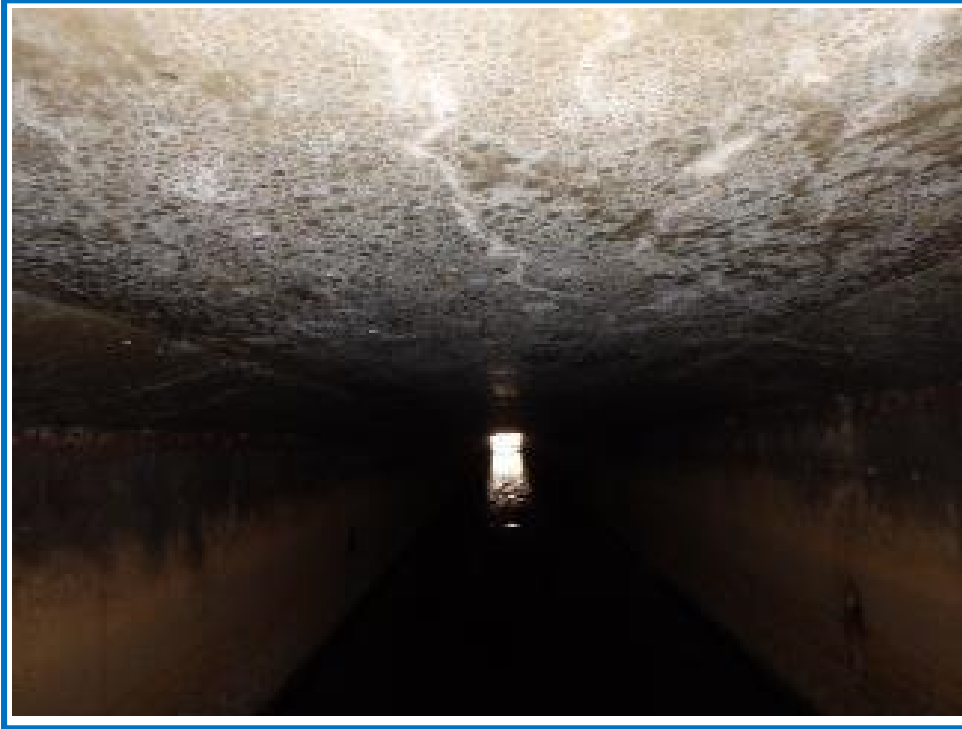
Top Panel 8 (Note: Scaling and heavy efflorescence)

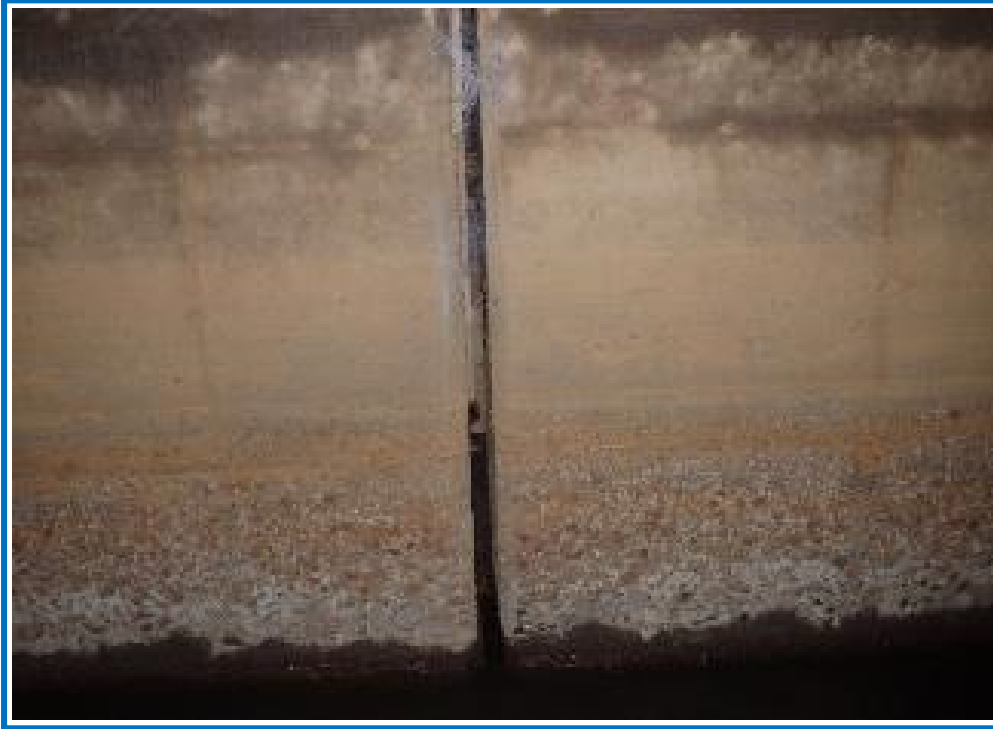
Joint 5 at South Panel (Note: Up to 2.5" wide gap between panels)

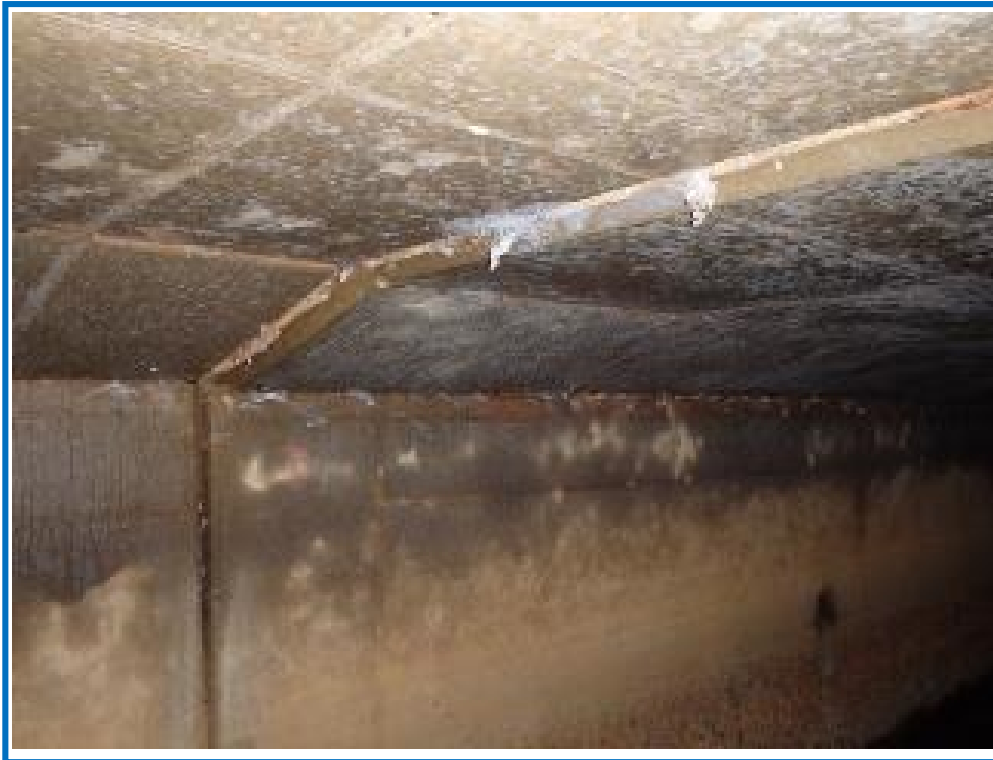
Joint 2 Top Panel (Note: Typical misalignment up to ½")

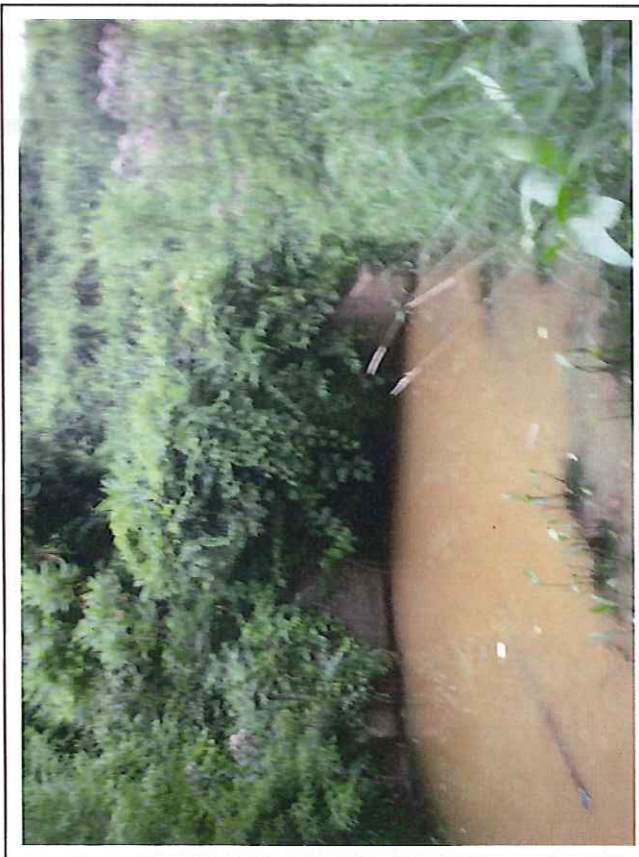
Photo # 4 : General View, Inlet elevation. (West) Note Heavy vegetation.

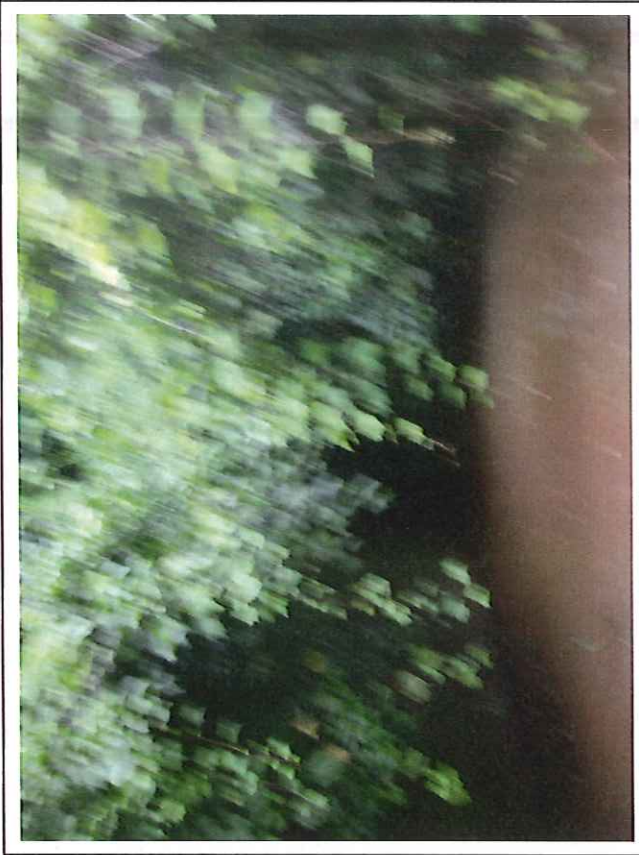
Photo # 6 : General View, Outlet elevation. (East) Note Heavy vegetation.
