# REHABILITATION STUDY REPORT

State Project No. 063-703  
Bridge No. 03614 in Hartford, CT  
I-91 TR 828, 15-161 over Drainage

State of Connecticut  
Department of Transportation  
Newington, Connecticut

*Submitted:* February, 2016

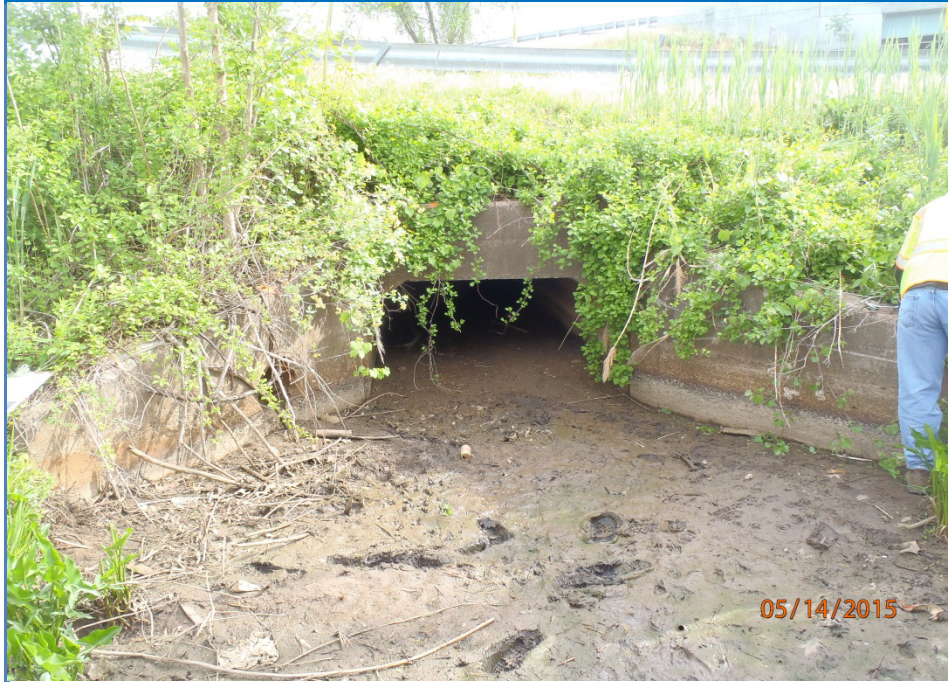
The existing 12" CMP which outlets at the Southwest Wingwall is severely deteriorated with up to 50% section loss.

**1: South Endwall, Outlet.**  
**Note CMP outlet at SW Wingwall**

Existing CMP that outlets at the Southwest Wingwall will be replaced as part of the drainage revisions for the project.

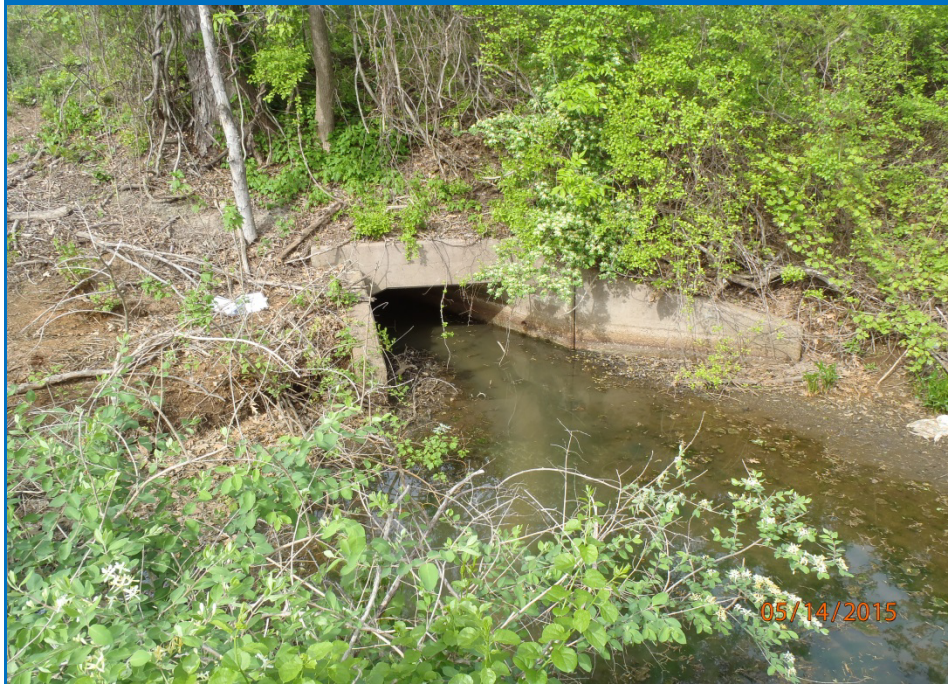
Erosion is in good condition (Rating = 7) and exhibits erosion at both northerly wingwalls; approximately 1.5' long x 1.5' wide x 0.8' behind the Northwest Wingwall, 2.5' long x 4' wide x 1.8' deep behind the Northeast Wingwall.

**2: North Headwall, Inlet**  
**Note erosion at both wingwalls**

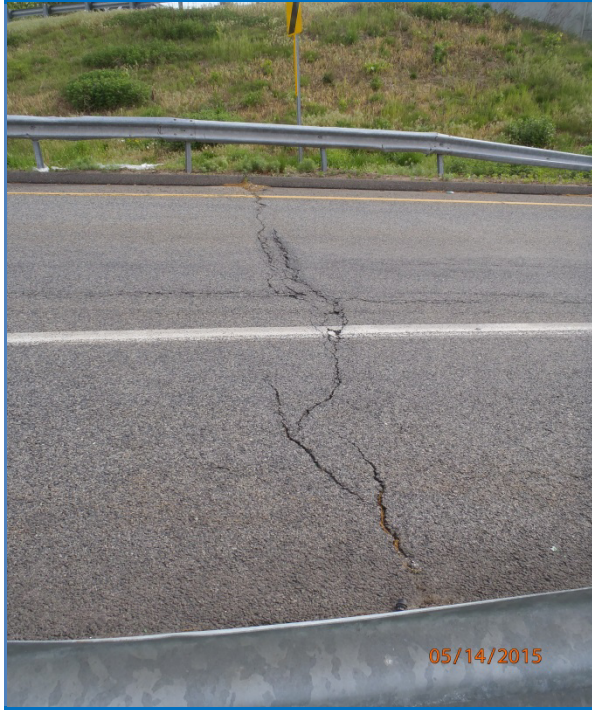
Approach pavement in satisfactory condition (Rating=6) and exhibits minor transverse cracking up to 1/2" width at I-91 TR 828. No notable deterioration at Route 5/15 TR 15-161.

**5: TR-828, Transverse cracks in bituminous**

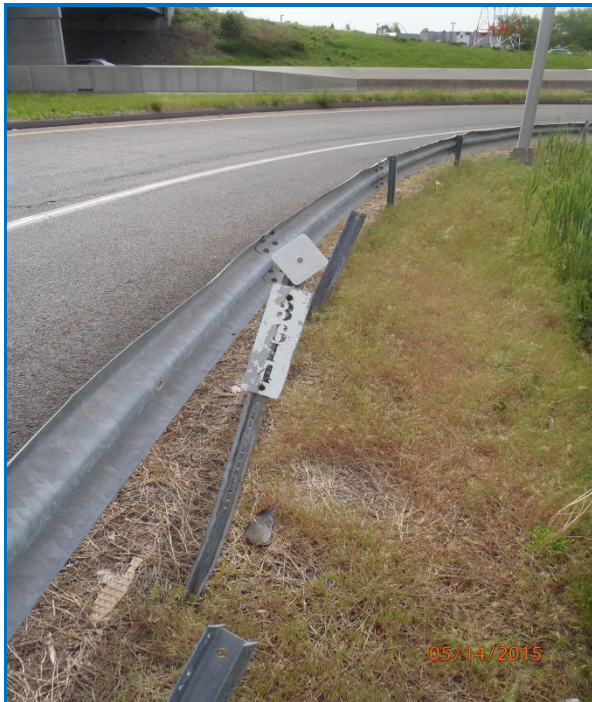
The approach guide rail is in satisfactory condition (Rating = 5) and the I-91 TR 828 metal beam rail has collision damage with minor scrapes and a few bent posts.

**6: TR-828, Damaged MBR at right EOR**

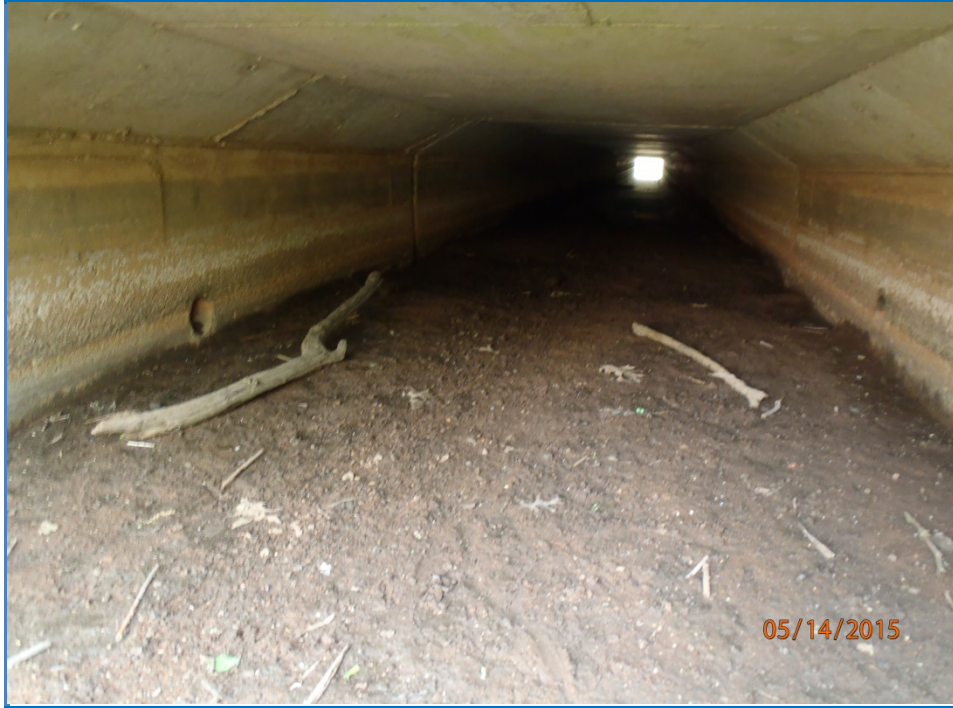
Debris is in fair condition (Rating = 5). There is up to 1.5' of silt covering the culver floor.

**7: Inside culvert**  
**Note sediment and debris**

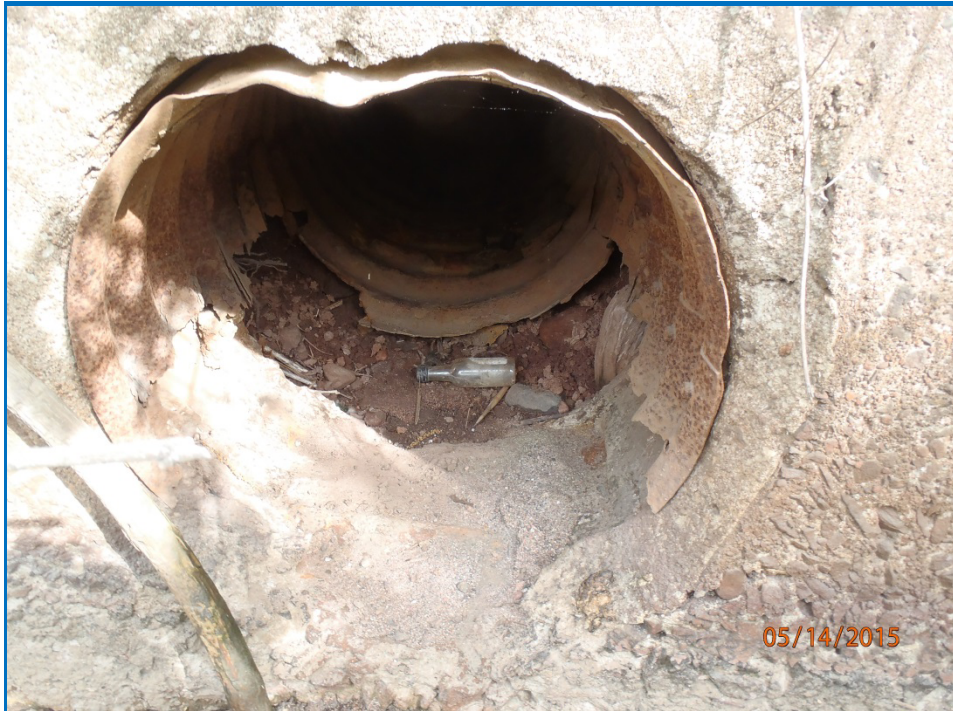
**8: CMP at Southwest Wingwall**  
**Note section loss of pipe**

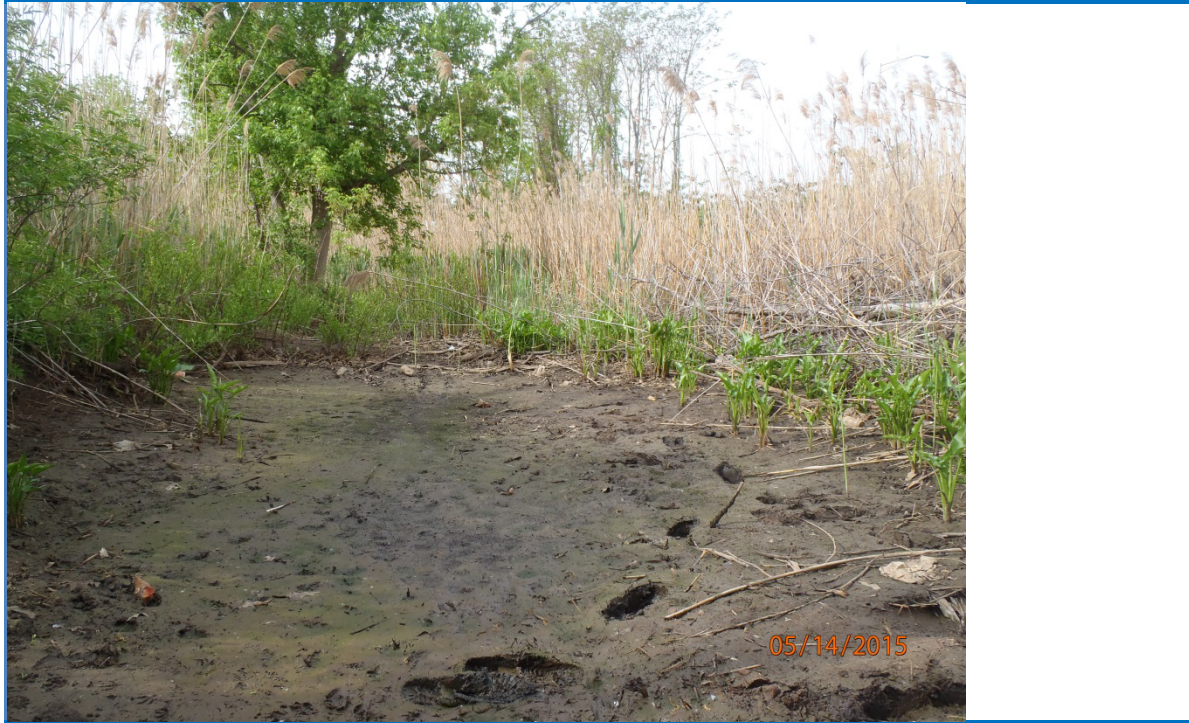
The channel is in fair condition (Rating=5) and has heavy vegetation growth which is restricting flow.

**9-: Outlet looking downstream**  
**Note vegetation blocking channel**

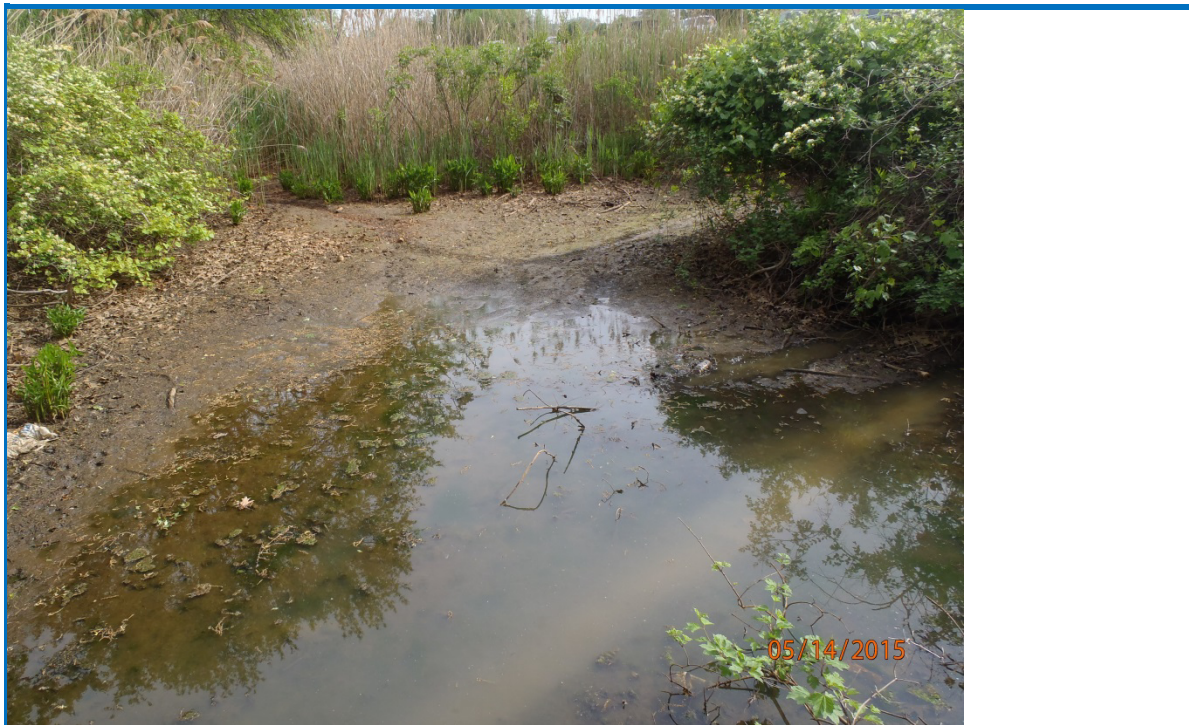
**10: Headwall looking upstream**  
**Note vegetation blocking channel**

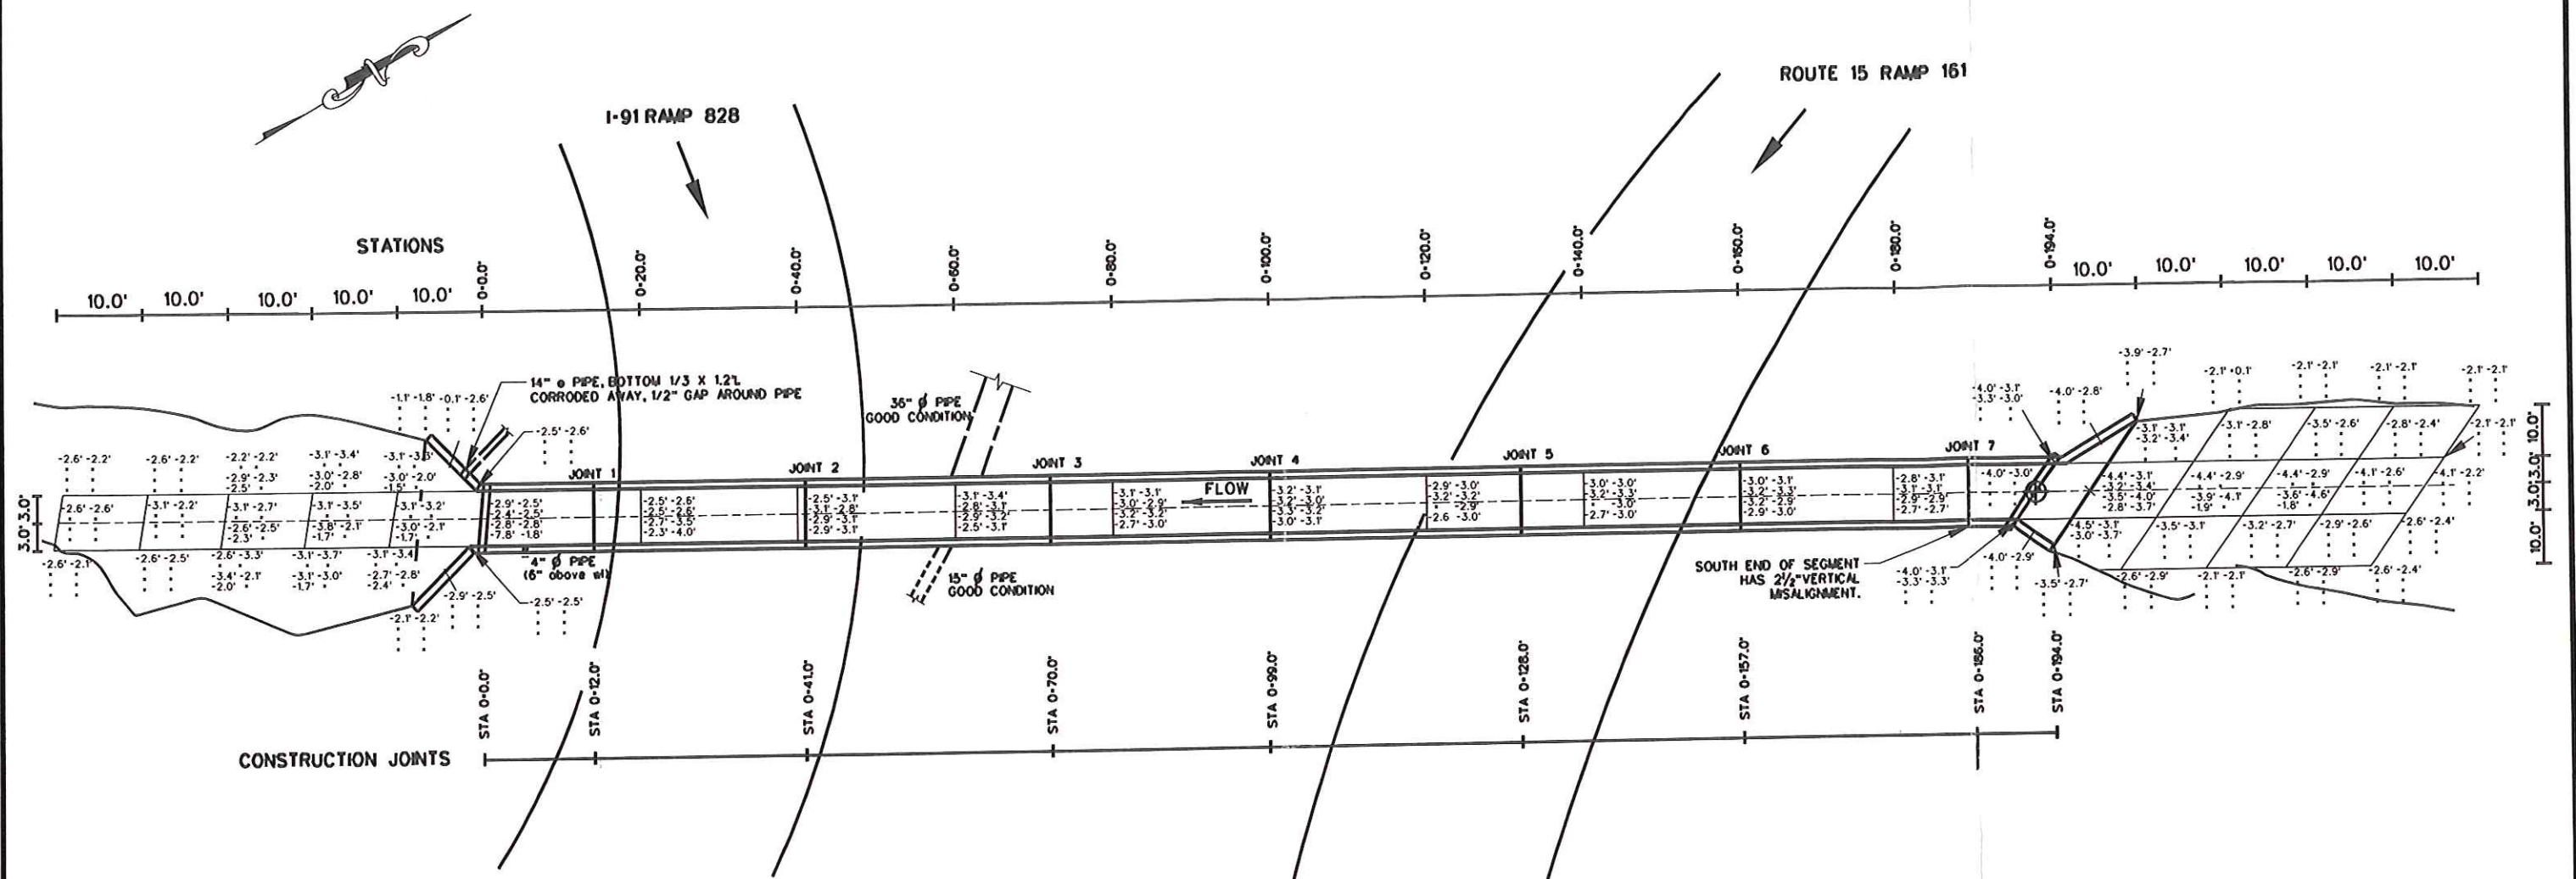
**SOUNDING PLAN**

- NOTES (DOWNSTREAM)**
- JOINT MATERIAL AT HEADWALL & WINGWALL MISSING, FROM MUDLINE TO TOP OF WINGWALLS, 0.9' PEN.
  - 1.5' OF SILT BUILD-UP AT SOUTH END.

- NOTES (UPSTREAM)**
- MINOR EROSION AT END OF NW WINGWALL, UP TO 1.5'L x 1.5'W x 0.8'D.
  - AREAS OF EROSION BEHIND NE WINGWALL, UP TO 2.5'L x 4.0'W x 1.8'D.
  - NE EMBANKMENT HAS MINOR EROSION UP TO 1.0'D.
  - NW EMBANKMENT IS WELL VEGETATED AND OVERLAYING THE CHANNEL.
  - MINOR TIMBER DEBRIS GROWING AND LAYING ON HEADWALL, WINGWALL AND INLET.

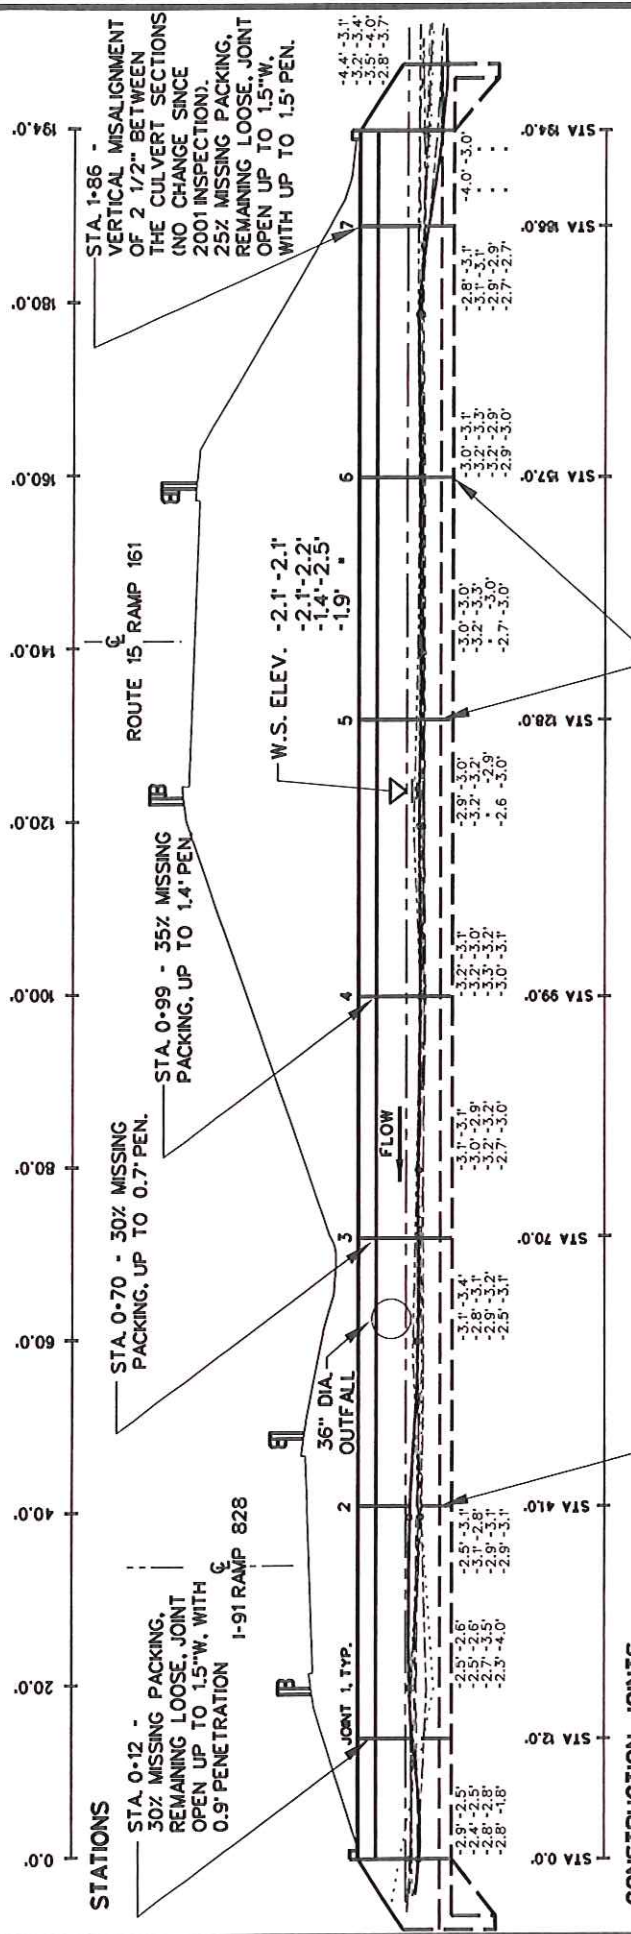
**CULVERT (WEST WALL)**

- NOTES:**
1. THE TOE OF THE CULVERT AT THE UPSTREAM END IS EXPOSED UP TO 0.5' HIGH.
  2. THE SOUNDINGS WERE TAKEN ALONG THE CENTERLINE OF THE CULVERT.
  3. THE EAST WALL HAS A 15" DIAMETER OUTFALL AT STA 0+90. THE OUTFALL HAS MINOR CHAMFER SPALLS.
  4. SCALING UP TO 1/8" DEEP FROM MUDLINE TO 4" ABOVE WATERLINE.
  5. INTERMITTENT HONEYCOMBING THROUGHOUT THE CULVERT UP TO 1/2" DEEP.

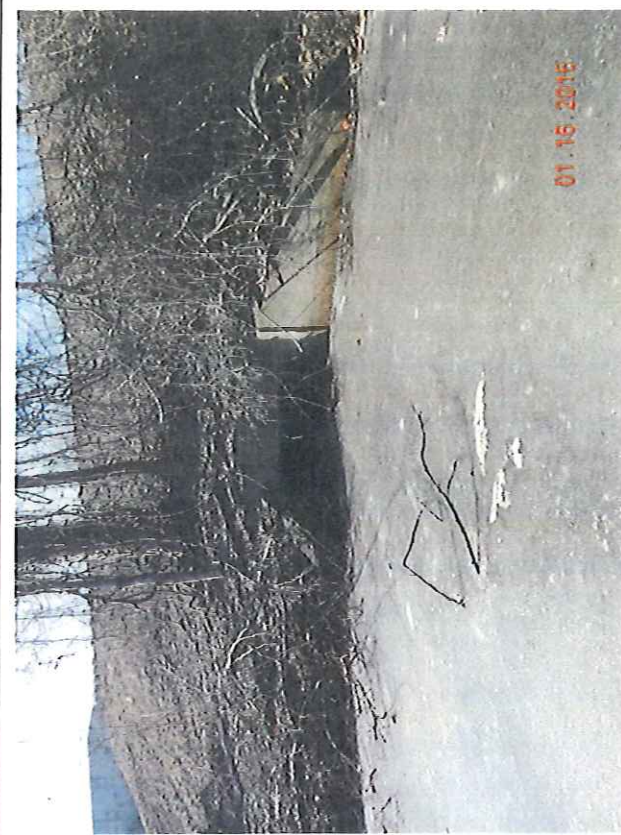
CHANNEL SCOUR:	7	<p>The channel bottom consists of silt and sand with up to 6' of penetration into the stream bed outside of the culvert.</p> <p>The upstream channel has areas of degradation up to 2.2'. The downstream channel has an isolated area of 2.5' aggradation along the southwest wingwall. Otherwise, the downstream channel bottom is relatively unchanged since the 2013 Inspection.</p> <p>The toe of the cutoff wall is exposed up to 0.5' high at the inlet.</p> <p>See Sheets 13 - 15.</p>
EMBANKMENT EROSION:	7	<p>There is 1.5' long x 1.5' wide x 0.8' deep erosion behind the end of the northwest wingwall and 2.5' long x 4' wide x 1.8' deep erosion behind the northeast wingwall. The northeast embankment has erosion up to 1' deep.</p> <p>See Sheet 13.</p>
DEBRIS:	5	<p>There is sediment buildup within the entire structure up to 1.5' high (38% of culvert height). Infilling is relatively unchanged since the 2013 Inspection. Minor timber debris is overhanging the southwest wingwall and north headwall and wingwalls.</p> <p>See Sheets 13 - 15 and Photos 6 &amp; 7.</p>

VEGETATION:	6	<p>Upstream and downstream embankments exhibit moderate to heavy vegetation growth that is overhanging the channel, southwest wingwall, and north headwall and wingwalls.</p> <p>See Sheet 13 and Photos 6 - 9.</p>
CHANNEL CHANGE:	5	<p>The upstream channel has areas of degradation up to 2.2'. The downstream channel has an isolated area of 2.5' aggradation along the southwest wingwall. Otherwise, the downstream channel bottom is relatively unchanged since the 2013 Inspection. Long term aggradation of the channel bottom has infilled the culvert up to 1.5' high.</p> <p>See Sheets 13 - 15.</p>

Photo # 6: North (Upstream) Elevation

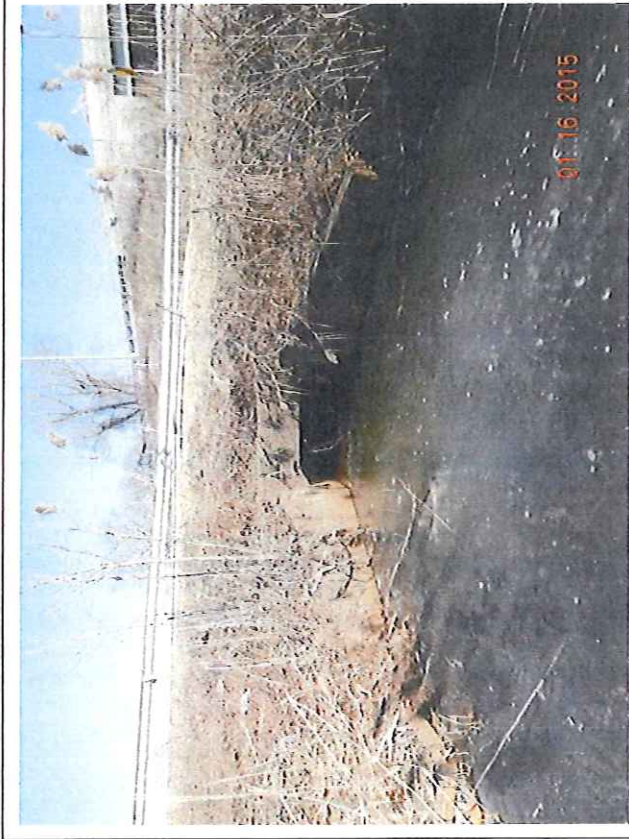
DEBRIS:	5	There is sediment build-up within the entire structure up to 1.5' high (38% of culvert height). Minor timber debris is overhanging the southwest wingwall and north headwall and wingwalls. See Sheets 13 - 15 and Photos 6 & 7.
RETAINING WALL STEM:	7	Concrete wingwalls have scale up to 1/8" deep from the mudline to 4" above the waterline. There is missing joint material from the mudline to the top of the wingwalls with up to 0.9' penetration. The southeast wingwall has minor damage from backhoe teeth consisting of scrapes and two mechanical spalls 1' long x 0.5' high x up to 1/2" deep.
FOOTING:	N	-

Photo # 7: South (Downstream) Elevation

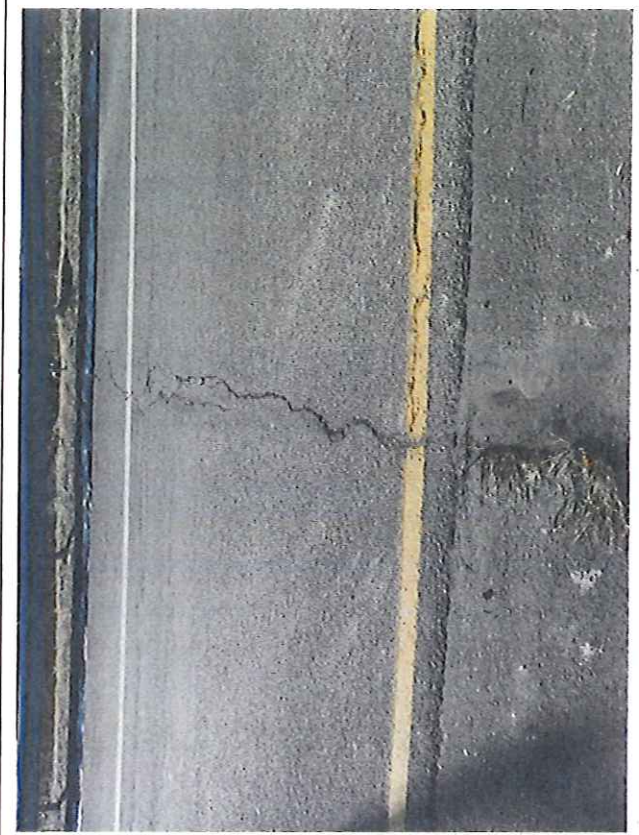
<b>OVERLAY:</b>	6	I-91 Ramp 828 has full width transverse cracking up to 1" wide and two longitudinal cracks up to 1/4" wide.  Route 15 Ramp 161 has no notable deficiencies.  See Sheet 12 and Photo 10.
<b>DECK-STR. CONDITION:</b>	N	-
<b>CURBS:</b>	6	Bituminous concrete curbs have isolated vertical cracks up to 1" wide and scrape marks.
<b>MEDIAN:</b>	N	There is a grass swale between ramps.
<b>SIDEWALKS:</b>	N	-
<b>PARAPET:</b>	N	-
<b>RAILING:</b>	5	Metal beam rail is continuous across culvert.

Photo # 10: I-91 TR 828, Bituminous Concrete Pavement Over the Culvert, Looking South

Note: The pavement has transverse cracking.

Repair Recommendations:  
1) Seal the culvert joints and wingwall joints (130 LF).  
2) Seal the cracks in the I-91 Ramp 828 pavement (150± LF).

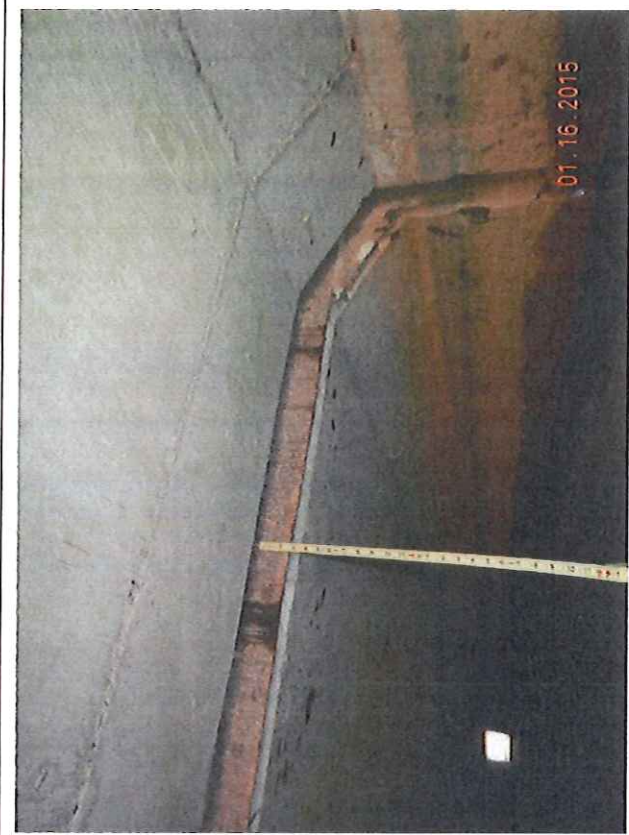
Photo # 12: Culvert Near the North End, Looking Southwest

Note: The culvert sections are misaligned.

BARREL:	6 ✓	The construction joints exhibit up to 70% missing packing with up to 1.5' penetration at chamfer sections. The remaining joint material is typically loose and ineffective. Joint packing was previously reported as up to 100% missing with up to 6" penetration. The construction joints are open up to 1.5" W. Construction joint 7 at Sta 1+86 is vertically misaligned 2.5" (no change since the 2001 inspection), and is open up to 1.5" W. Active water and or soil infiltration was not observed. There were no sink holes or evidence of soil infiltration into the pipe. ✓ See Sheet 14 and Photos 10 & 11.
CONCRETE:	7 ✓	The first 20' +/- of the barrel upstream and downstream exhibits up to 1/8" D scaling from the mudline to 4" above the waterline. The remaining areas of the barrel exhibit light scaling and intermittent honeycombing up to 1/2" deep. ✓ See Sheet 14 and Photos 10 & 12.
STEEL:	N	-
TIMBER:	N	-

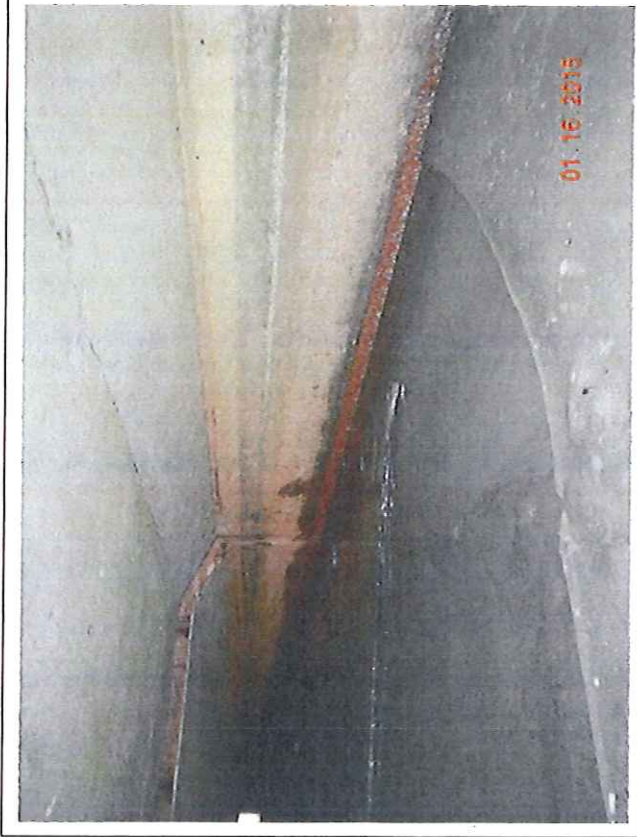
**Photo # 13: Typical Condition of Culvert Wall, Looking Southwest**

**Note:** There is a band of light scale along the waterline.

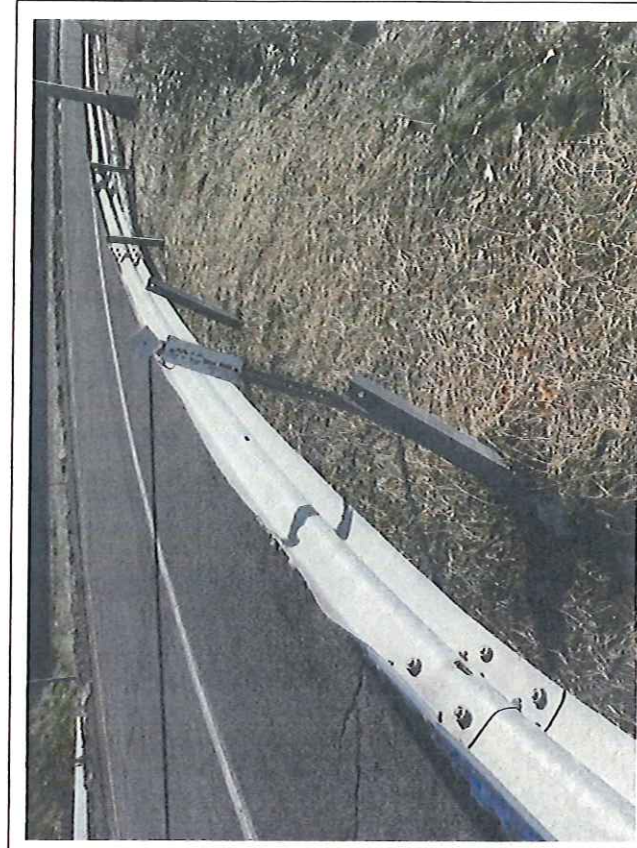
**Photo # 14: I-91 TR 828, South Metal Beam Rail, Looking East**

**Note:** There are three disconnected posts and the rail is loose.

RAIL:	5	Metal beam rails at both sides of both ramps. I-91 Ramp 828 metal beam rails have minor impact damage on both sides with a total of six disconnected posts. South mbr has 3 consecutive disconnected posts. The rail is unsupported for ± 45' and is loose. North mbr has 2 disconnected posts. See Sheet 12 and Photos 3, 14 & 15. The rail is not loose, Rte 15 Ramp 161 has random minor scrapes
APPROACH PAVEMENT:	6 I-91 Ramp 828	Bituminous pavement has random transverse cracks up to full length and longitudinal. Rte 15 Ramp 161 bit. conc. pavement has no notable deficiencies. See Sheet 12 and Photos 2 - 5, & 13. Roadway width up to 1/2' wide
APPROACH EMBANKMENT:	7	Minor erosion of the banks due to run-off.

Repair Recommendations:  
 1) Repair the damaged I-91 Ramp 828 Guide Rail (LS).  
 2) Remove timber debris and overhanging vegetation from the north and south headwalls and wingwalls (LS).  
 3) Seal the culvert joints and wingwall joints (130 LF).  
 4) Seal the cracks in the overlay (150± LF).
