Eastern Connecticut Corridor Rail and Transit Feasibility Study (ECRTS)

Appendix D: Thames River Corridor Assessment

November 2023

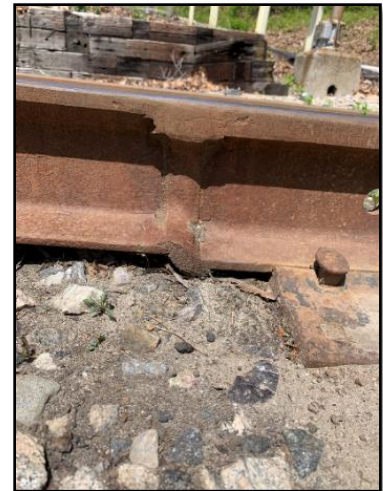
Although the steel rail conditions appeared to be in good shape, the freight railroads currently utilize 100 or 115 RE steel rail which is insufficient for passenger rail service and would need to be upgraded. It appears that Continuous Welded Rail (CWR) was used in many locations.

Figure 2: Weld between 100 and 115 lb. Steel Rail

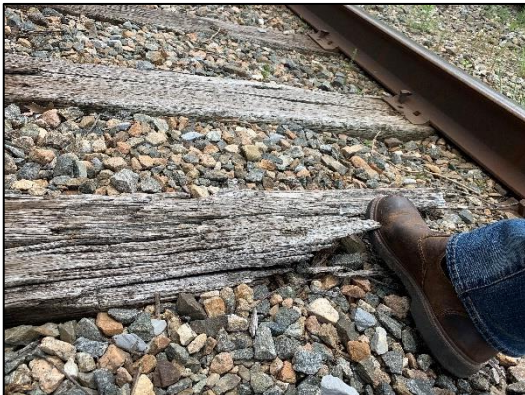
Figure 3: Severe Rotting of Wooden Ties - Lower Bartlett Road (MP 5.05)

Most ties are wooden ties that showed signs of longitudinal cracking and rotting, and it would be recommended they be replaced with concrete ties.

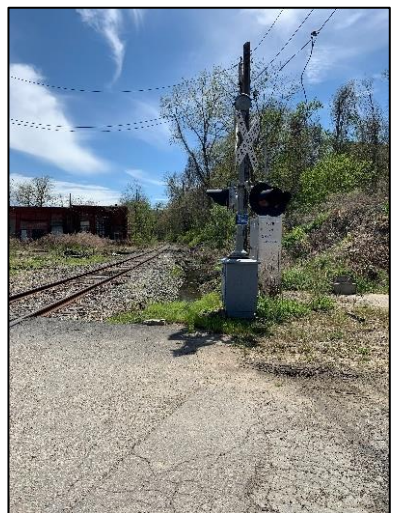
Figure 4: Ponding of Water Alongside Track Bed (MP 11.90)

Ballast / Sub-Ballast was generally in good / fair condition in most observed areas however some spot checks found areas of poor drainage, that would require further investigation of widespread drainage concerns.

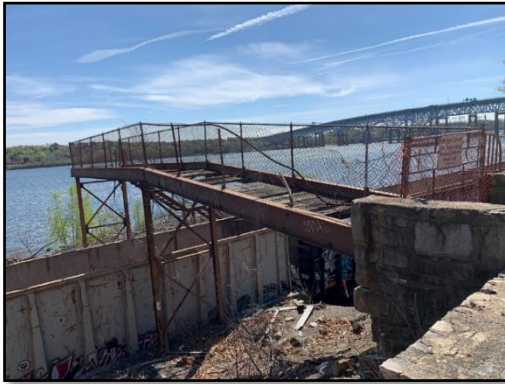
Figure 6: Abandoned Bridge - Riverside Park (MP 1.07)

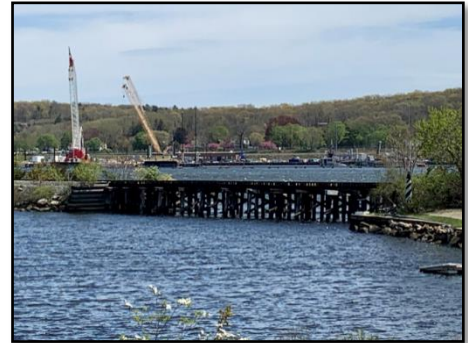
timber trestle, which is not recommended for passenger rail service, given its flammable properties and its tendency to rot from moisture or have potential termite damage.

Figure 5: Timber Trestle Bridge

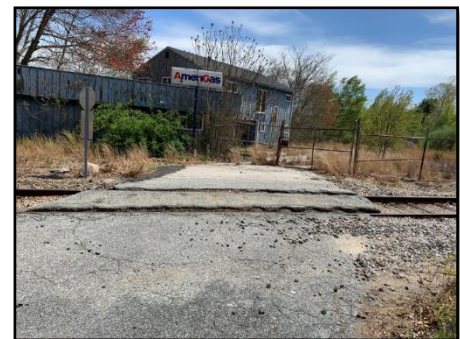
Grade crossings were mostly in poor condition, with numerous crossing surfaces having severe issues. Asphalt crossing surfaces had severe heaving and cracks and should be replaced with either concrete or railway rubber. Other grade crossings either had wood that was severely cracked or unstable earth material as the crossing surface. Many grade crossings were passive crossings that did not have flashers, and most active grade crossings did not have crossing gates. Almost all grade crossings would likely have to be upgraded to include flashers and gate crossings. There were also several grade crossings that appeared to be private and/or unidentifiable that would require further inspection.

Figure 7: Grade Crossing with Severe Heaving (MP 5.05)

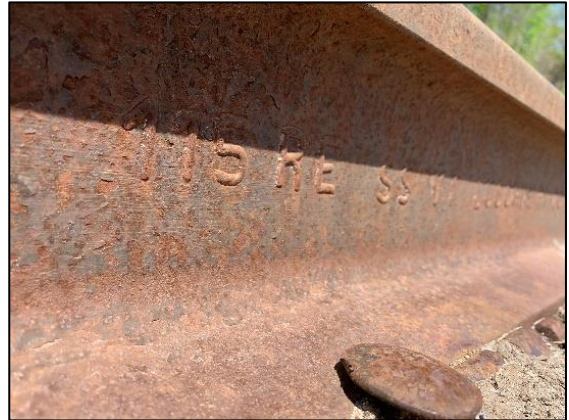
The inspection team performed spot checks of the steel. In areas where the inspection team was able to assess the track, the team observed the steel rails to be in reasonable condition, with weights of 100 or 115RE steel. In the United States, it is recommended that main line steel rail for passenger services uses greater than 130 weight steel, most commonly manufactured 132/133 weight.

Figure 11: 115 RE Steel Rail

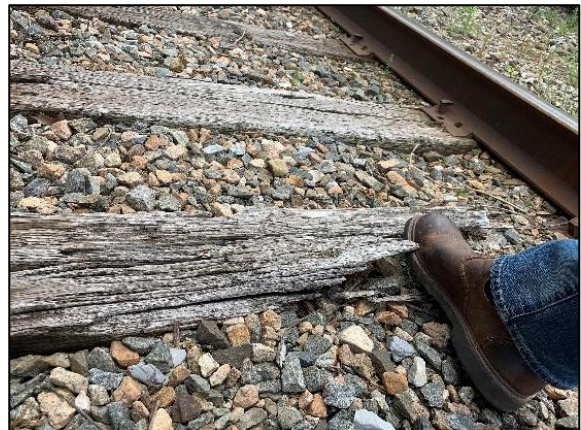
The inspection team performed spot checks of the ties. In areas where the inspection team was able to assess the track, the team observed only the existence of wood ties. Ties were in various conditions, but the team took photos of ties that were in poor condition. Signs of poor ties were either showing longitudinal cracking, severe rotting, or buried, which shows signs of poor drainage.

Figure 12: Wooden Ties with Severe Rotting

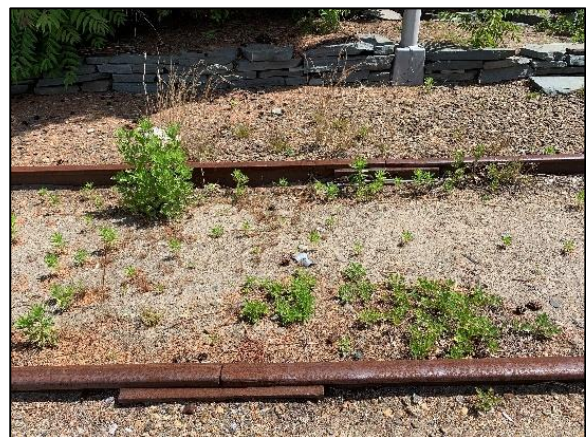
The inspection team performed spot checks of the ballast. In areas where the inspection team was able to assess the track, the team observed the general condition of the ballast to be overall in good/fair condition, but in some spots, it was evident that the ballast condition was poor due to ponding water and excessive vegetation growth. This could signify unstable soil beneath that would require a thicker layer of ballast (>6 inches) or a need to replace the sub-ballast. The inspection team recommends that a follow up in-depth inspection occur along the entire corridor to provide a complete assessment of the ballast profile.

Figure 13: Lack of Visible Ballast/Ties and Vegetation Growth

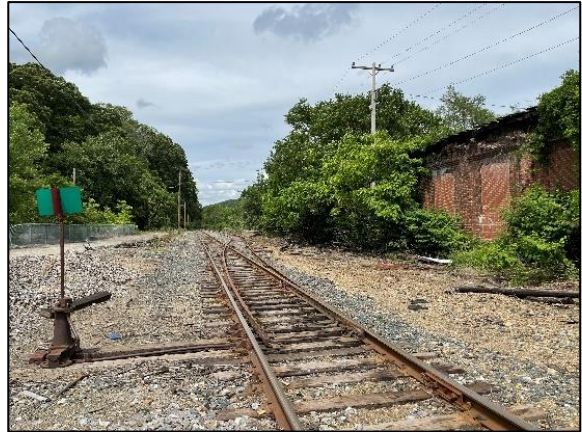
The inspection team was able to identify a few sidings, mainly on the west corridor, with manual switches. These switches were not able to be inspected for functionality and if necessary, it is recommended that further inspection be scheduled to test working condition. Additionally, the prospect of passenger rail service may recommend these sidings have automated switches for safety purposes.

Figure 14: Manual Track Switches and Interlockings

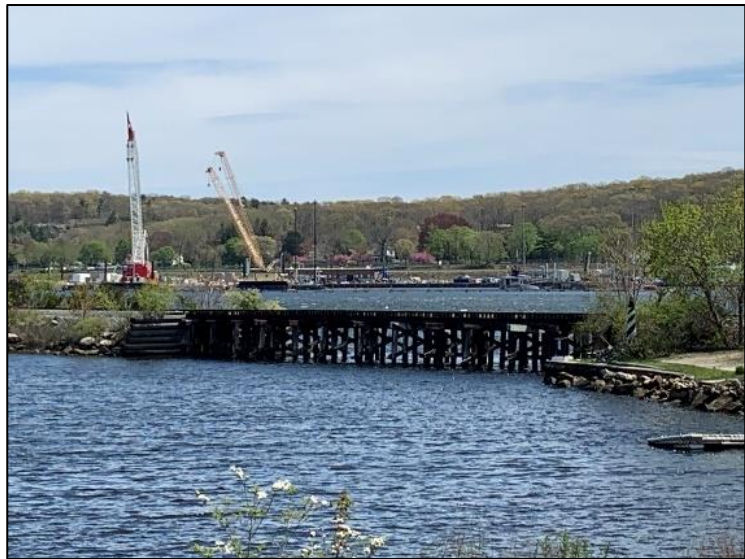
Along the west corridor, seven (7) UG structures were identified as Timber Trestles. Of these seven, only two (2) were able to obtain visual inspection and it was limited for both (MP 3.18 and 11.72). The other five (5) were inaccessible due to the inability to obtain visual inspection safely. Further inspection would require authorized access to these locations to obtain an in-depth review of condition of these bridges.

Figure 22: Timber Trestle (MP 3.18)

Further in-depth inspection and load rating analysis would be required to determine to what extent repairs, rehabilitation, or replacement would be needed for undergrade structures. It is assumed, however, that any timber trestle identified would need to be replaced, as this study team recommends that passenger service does not run on any timber trestle bridges. There were seven (7) timber trestles identified along the west corridor.

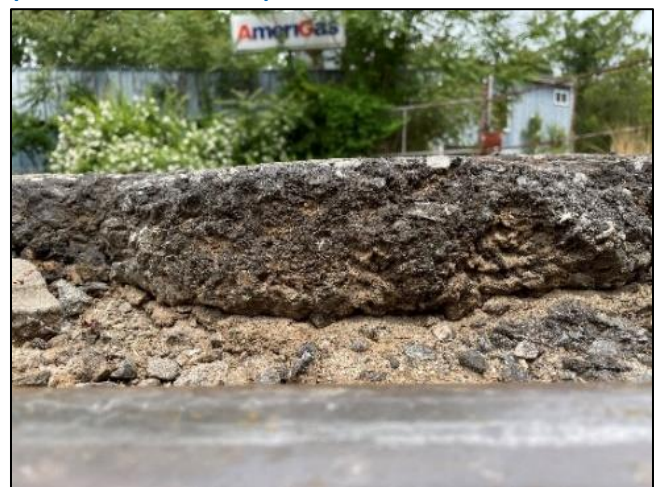
Asphalt crossing surfaces had mixed condition assessments. While some surfaces appeared to show minimal cracking, others were in poor condition and showed signs of heaving, to some degree showing evidence of rubbing against the undercarriage of passing trains.

Figure 30: Elevation of Heaving from Rail Surface (Lower Bartlett Road)

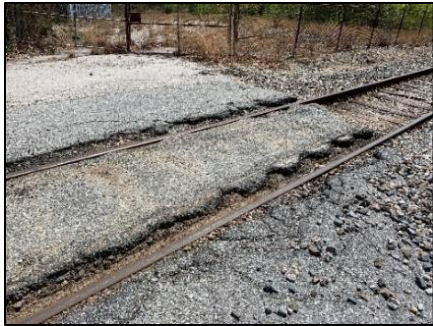
Figure 34: Poor Condition - Lower Bartlett Road (MP 5.05)

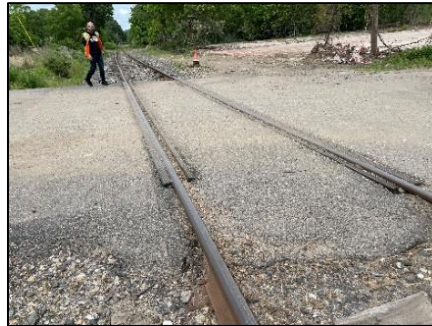
Figure 33: Good Condition - Terminal Way (MP 12.08)

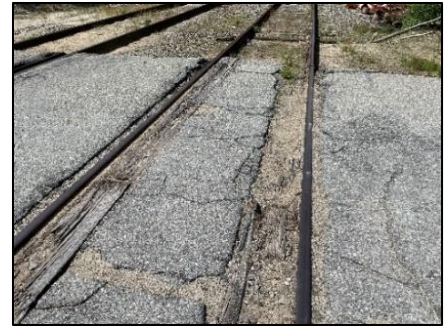
Figure 32: Fair Condition - DOW Chemical (MP 6.08)

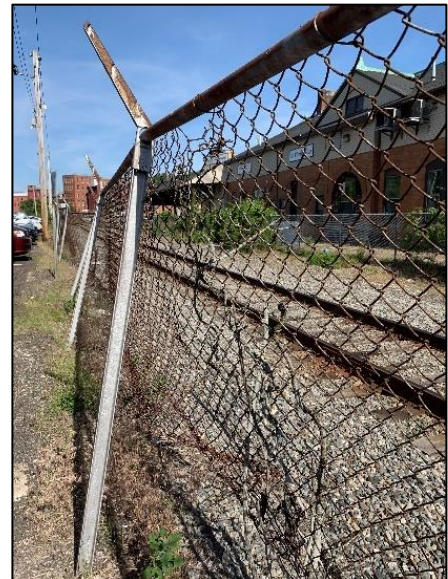
On various observed segments, there were existing chain link fencing that offered ROW protection. In many cases, the fencing was deficient and should be upgraded. A further inspection should identify other segments of the corridor that have either deficient fencing and/or require upgraded fencing for ROW protection.

Figure 45: Damaged Fencing at Old Norwich Train Station (MP 12.3)

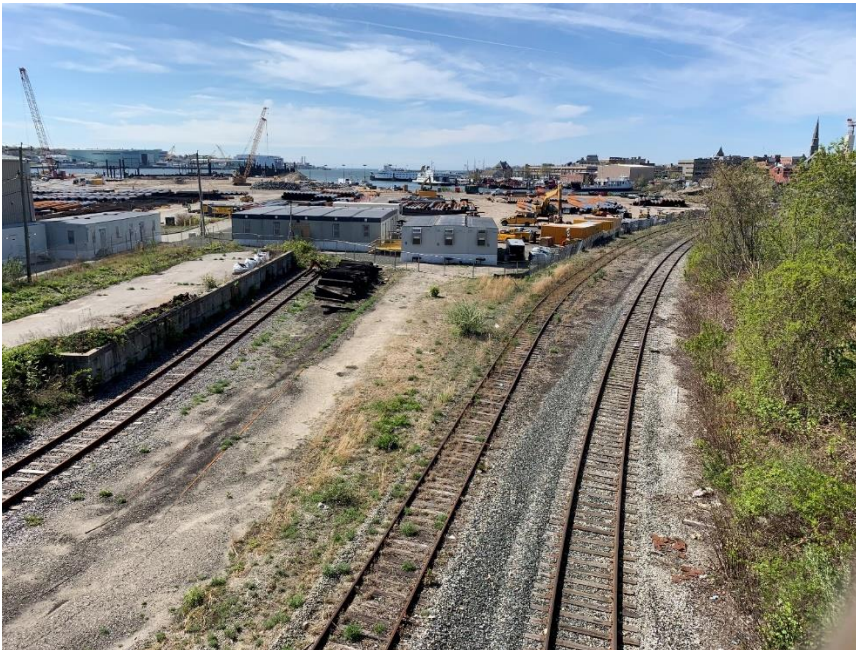
Figure 13: MP 0.62 – OH Bridge - State Pier Road (Looking South)

Two tracks approaching an overhead bridge. It is assumed that only the western track (viewer's right side of the photo) is in active use because the eastern track has a lot of vegetation present. It is a sign of poor drainage, and possibly rotten railroad ties which makes the track unsafe. Walking the right of way with flagmen would be necessary to perform a closer inspection.

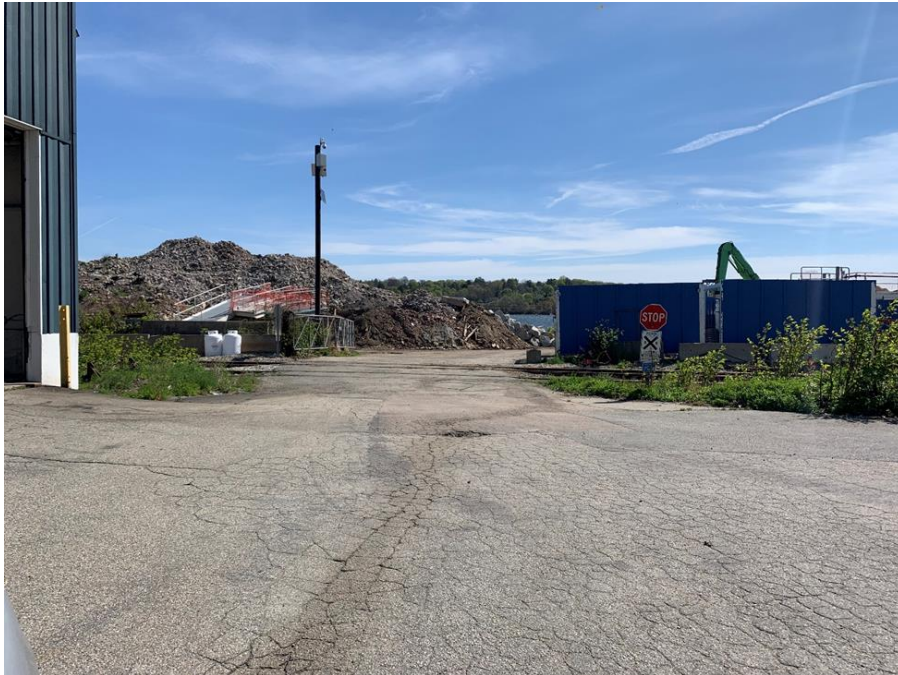
Figure 16: MP 0.91 – Grade Crossing - Approach near Eastern Ave - Looking East

Crossing is in poor condition and is not signaled. Vegetation growing in the gauge – sign of very poor drainage. Most likely, only one track is in active use.

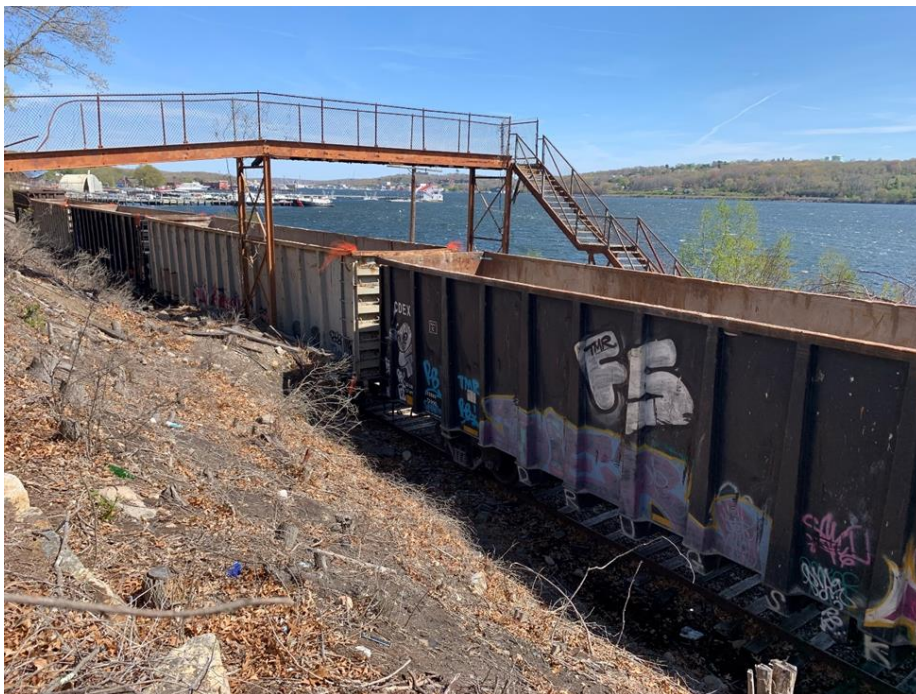
Figure 25: MP 1.07 - OH Bridge – Ped Bridge Riverside Park (Looking Northeast)

The bridge is closed due to its unsafe and unusable condition. Corrosion and missing timber boards. Some steel members have cross-sectional losses. The bridge would have to be removed to make the line safe for passenger service.

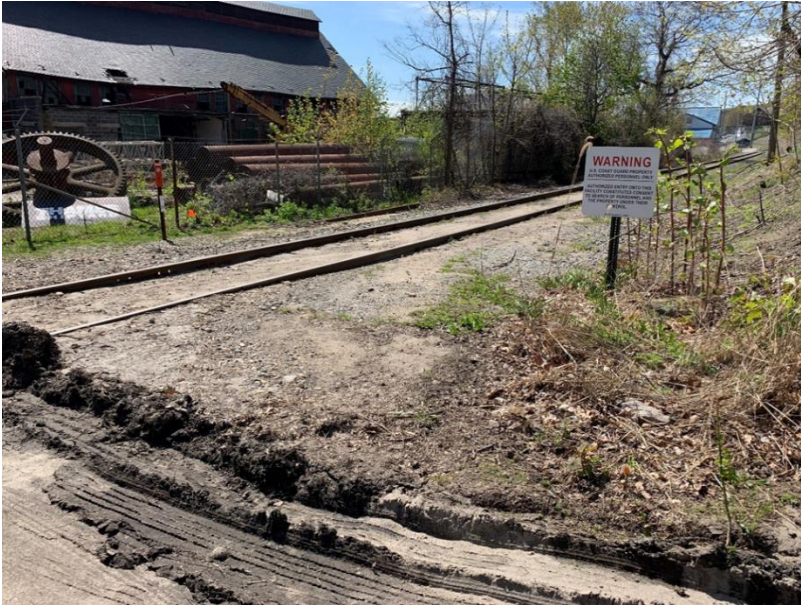
Figure 33: MP 1.79 - Grade Crossing - Farnsworth Street - Old Thames Shipyard (Looking South)

The vehicles crossing the tracks in and out of the shipyard carry a lot of fine material on their tires that gets spread over Farnsworth Street (marks are visible on the asphalt). The material gets washed back towards the tracks after every rainfall. The voids in the ballast get clogged, thus preventing the water from draining away from the tracks. Retaining moisture around the tracks, specifically around the railroad ties causes them to rot and breakdown thus compromising the required structural properties of the track.

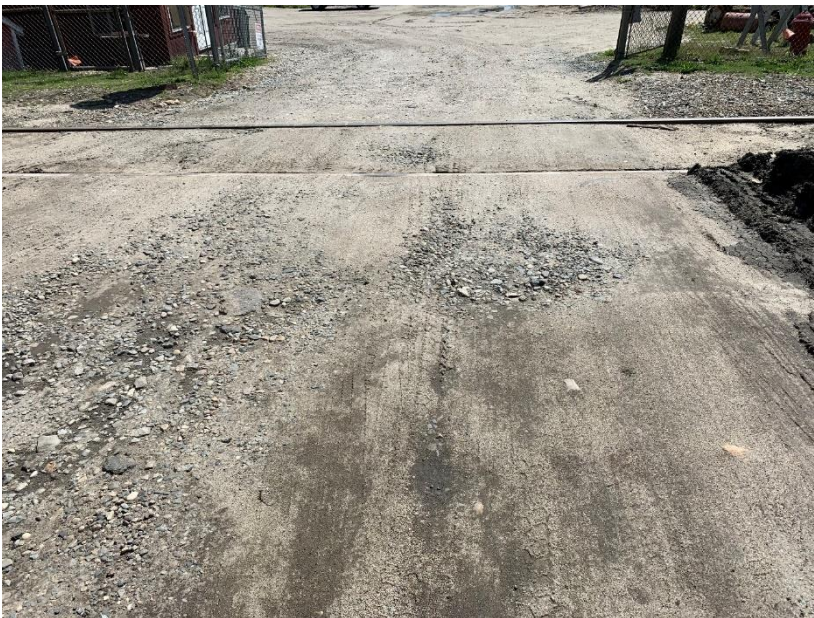
Figure 34: MP 1.79 - Grade Crossing - Farnsworth Street - Old Thames Shipyard (Looking East)

The crossing is covered with a lot of fine material from passing vehicles in and out of the shipyard – will need to be rebuilt with drains to the west of the crossing.

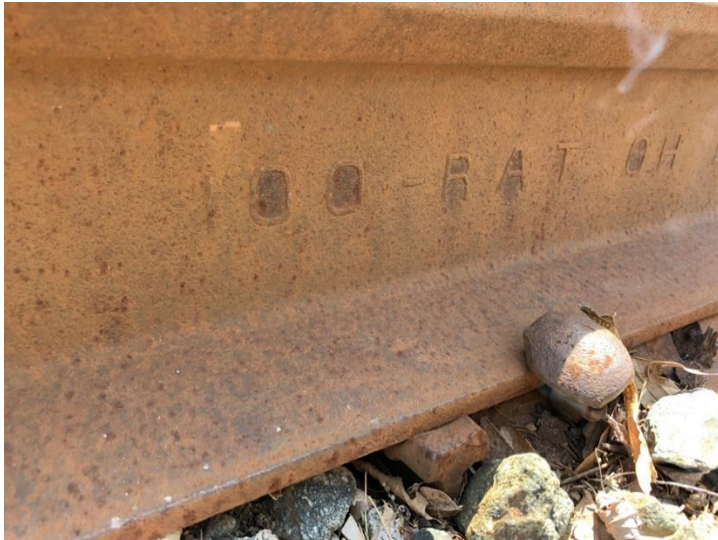
Figure 37: MP 2.37 – Track - Bentham Avenue

Typical 100 lb/yd rail. However, some sections of this line have 115 lb/yd rail.

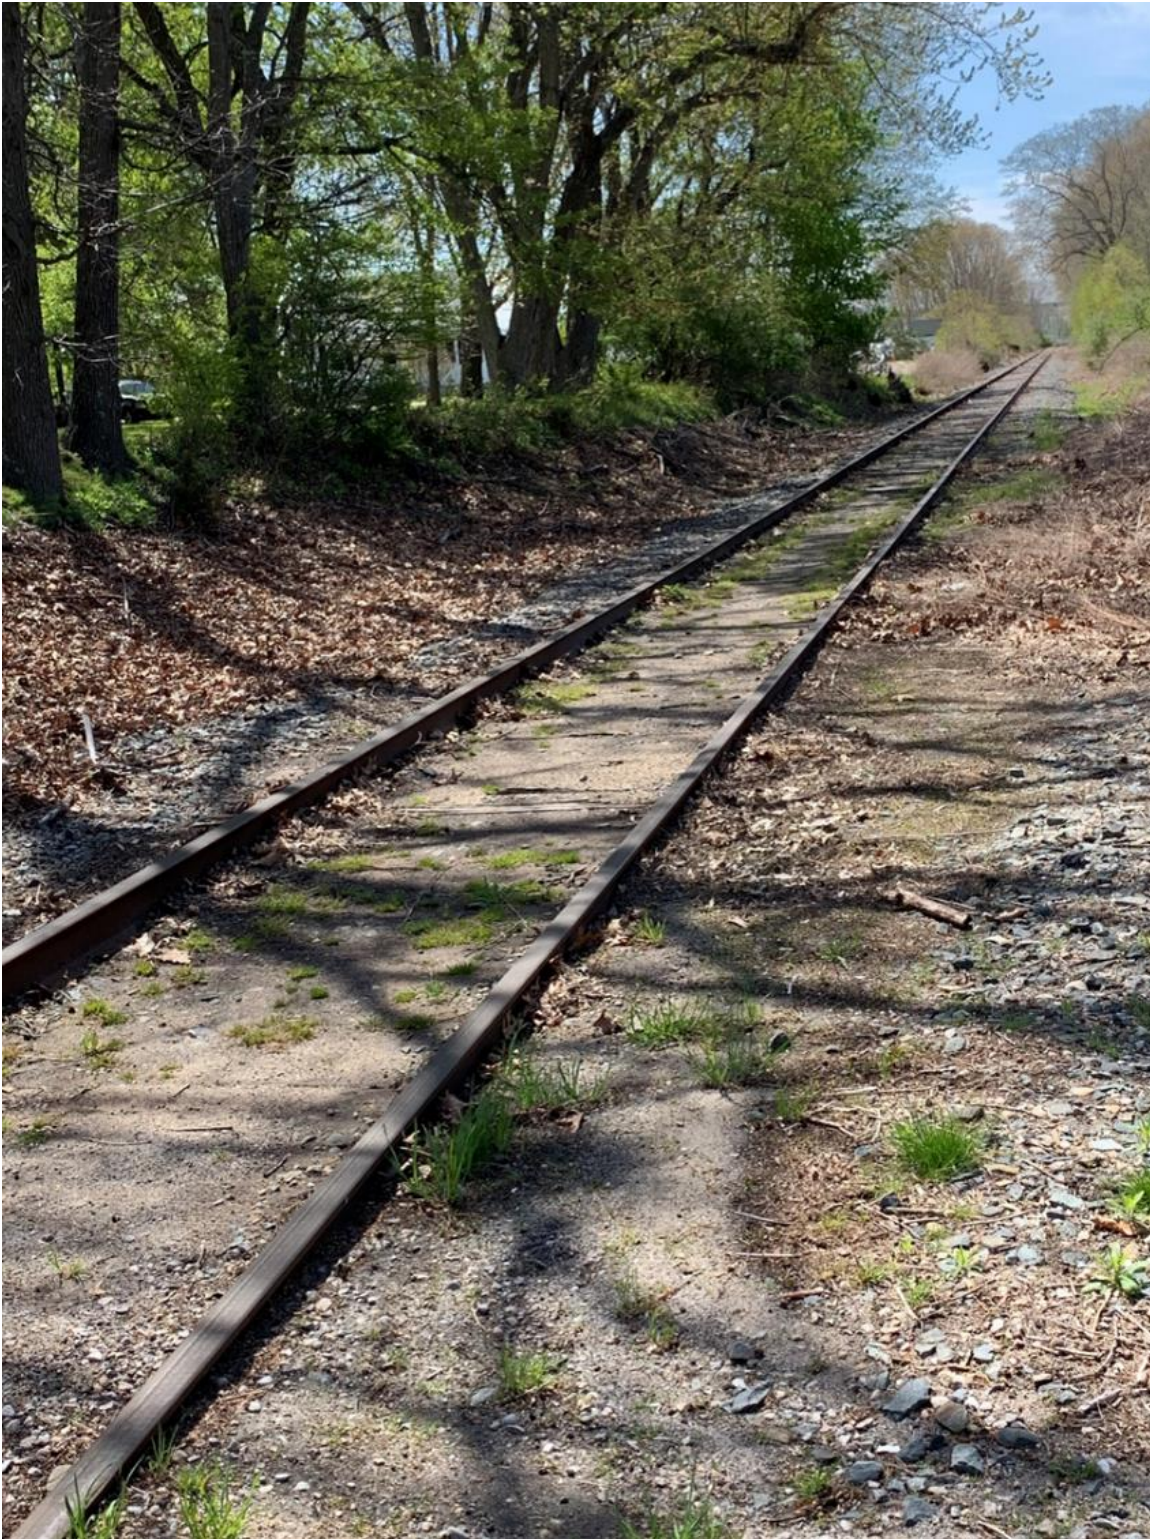
Figure 41: MP 2.37 - Grade Crossing - Bentham Avenue (Looking South)

Some vegetation in the gage and near the crossing. Proper drainage is needed.

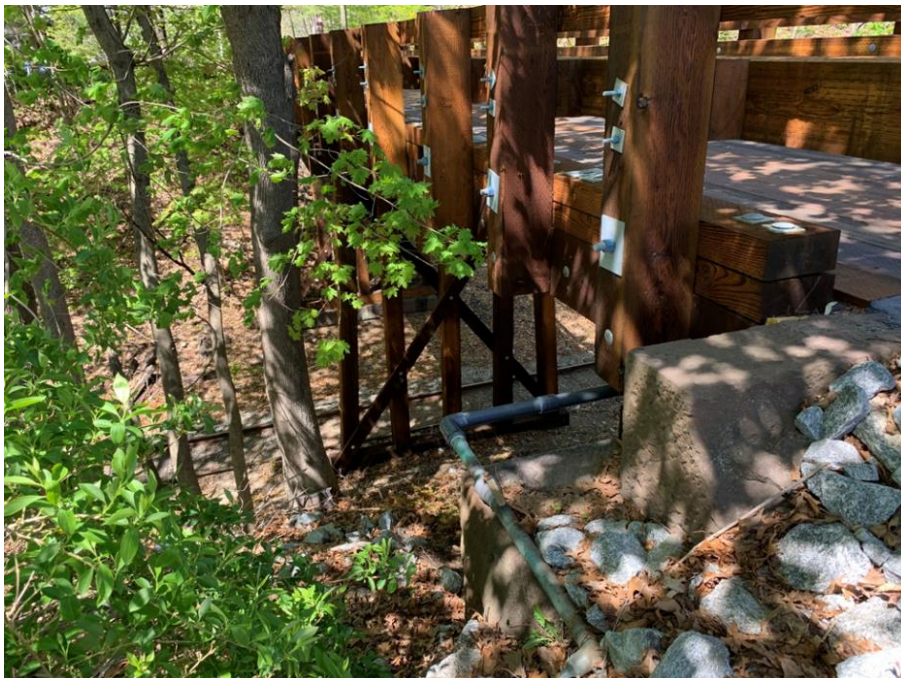
Figure 101: MP 4.45 - OH Bridge - Browns Crossing Road - Timber Trestle (Looking West)

Private timber bridge on Browns Crossing Road. The bridge is in good condition.
