ANSONIA TRAIN STATION

VISUAL INSPECTION REPORT

January 2007

Prepared by the Bureau of Public Transportation
Connecticut Department of Transportation

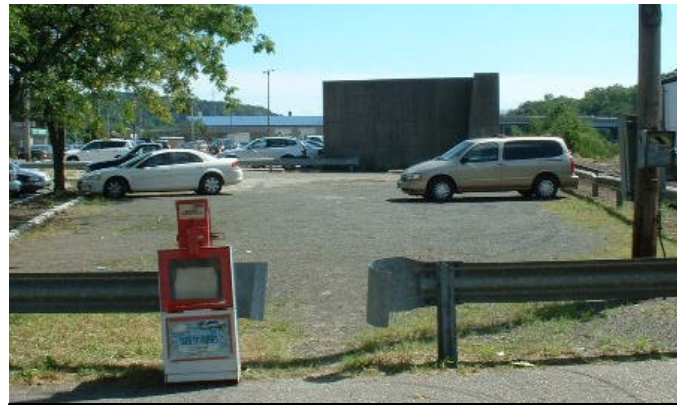
Ansonia Station Parking Area

South of the canopy is a small, poorly defined parking area (above). Due to its odd shape, only nine cars can squeeze into the lot. This area should be reconfigured or eliminated. The reconfigured lot might accommodate several van accessible handicap spaces. If eliminated, the Department should consider landscaping the area. The unsightly highway guide rail should be removed. Consider a raised walk and black steel fencing along the tracks.

Fences – The small parking lot just south of the canopy has weathered, dented and unsightly highway guide rail. It should be removed. Black steel railing and a raised concrete sidewalk are recommended along the track.

- Reconfigure or eliminate the parking area just south of the canopy.
- Remove parking lot guide rail and replace with station railing, if warranted.
- Add raised sidewalk and railing along the track.
- Repair or replace the low-level boarding platform.
- Replace bituminous pavement in platform area with concrete or paver blocks.
- Add post mounted lights along the path from Main Street and around the station area.
- Place the aerial wires to the canopy underground.
- Add a vending shelter if vendors plan to place additional equipment at this facility.
- Place low maintenance trees and shrubs on the other side of the tracks. Coordinate with the Army Corps of Engineers

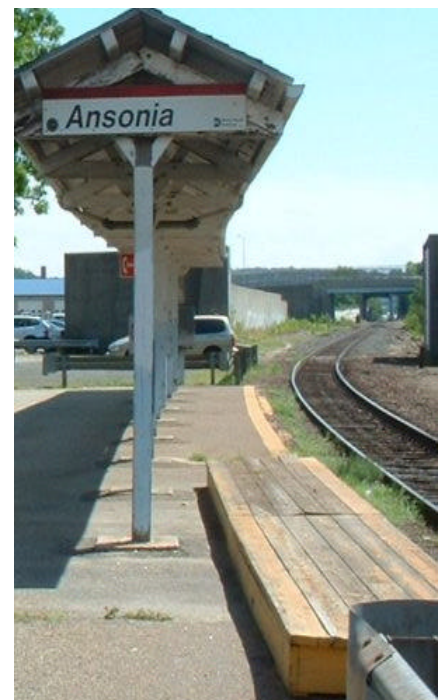
Wooden Low-Level Platform

Platforms – There are no high-level platforms at this station. Commuters board trains using a wooden box (right) with an uneven surface. The surface under the box and adjacent canopy is bituminous pavement. Unsightly cracks and uneven surfaces make this a poor choice for a boarding area. It is recommended that the blacktop be replaced with concrete or paver blocks.

Canopy – The Ansonia Train Station has a classic wooden canopy (right), which is the focal point of the station. The structure's wood surfaces need to be scraped and repainted. Rain gutters should be regularly

maintained. Illumination levels under the canopy need to be evaluated and fixtures replace, if necessary. It is recommended that canopy electrical wires be placed underground, possibly when the bituminous pavement is replaced.

- Redeck or seal/repaint the wooden platform.
- Repair uneven joint between the platform sections.
- Paint the canopy, check gutters.
- Provide signage to any nearby bus stops.

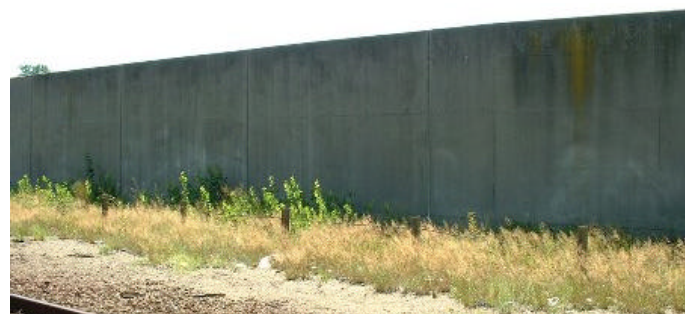
Ansonia Station Floodwall

Litter – This is a very clean station. On the day of the site visit, trash was limited to that found in the brush on the floodwall side of the tracks. As noted in the picture to the right, the floodwall was free of graffiti. A standard blue recycling bin is located next to the shelter. Although not specifically observed, it is likely that trash cans have been placed along West Main Street. The floodwall across the tracks remains relatively free of graffiti. The Department and municipality should consider planting trees and shrubs in front of the wall, provided there is adequate width to perform normal wall maintenance activities.
