BEACON FALLS TRAIN STATION

VISUAL INSPECTION REPORT

January 2007

Prepared by the Bureau of Public Transportation
Connecticut Department of Transportation

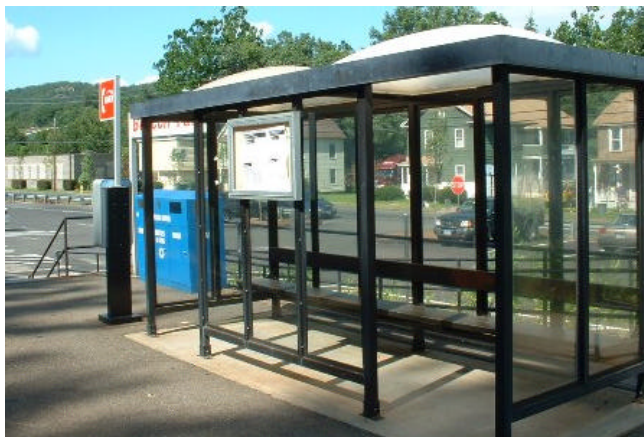
Shelter – The platform shelter (right) is functional with some scratched glazing from graffiti and numerous attempts to remove it. It sits on a concrete pad, which is in good condition.

- Add trailblazing signage from Route 8 to the train station.
- Add a station entrance sign.
- Paint the steps to the platform.
- Paint the handrail.
- Replace scratched shelter glazing

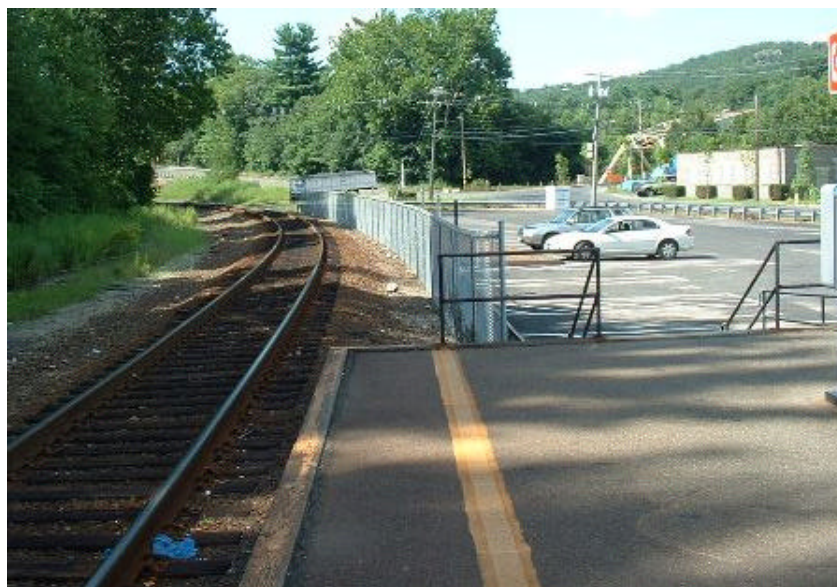
Beacon Falls Station Platform – Looking North

Platforms – This location has a small mid-level platform accessible by a ramp and stairs consisting of six risers. The raised platform has a paved bituminous surface on fill retained by landscaping timber. All railings and their base plates are rusted to some level. A floodlight illuminates the platform. A freshly painted yellow line highlights the platform edge. The wooden stairs have been painted yellow with only some minor fading noted. The concrete ramp is in good condition. Some plantings have been placed along the ramp.
