BRANCHVILLE TRAIN STATION

VISUAL INSPECTION REPORT

January 2007

Prepared by the Bureau of Public Transportation
Connecticut Department of Transportation

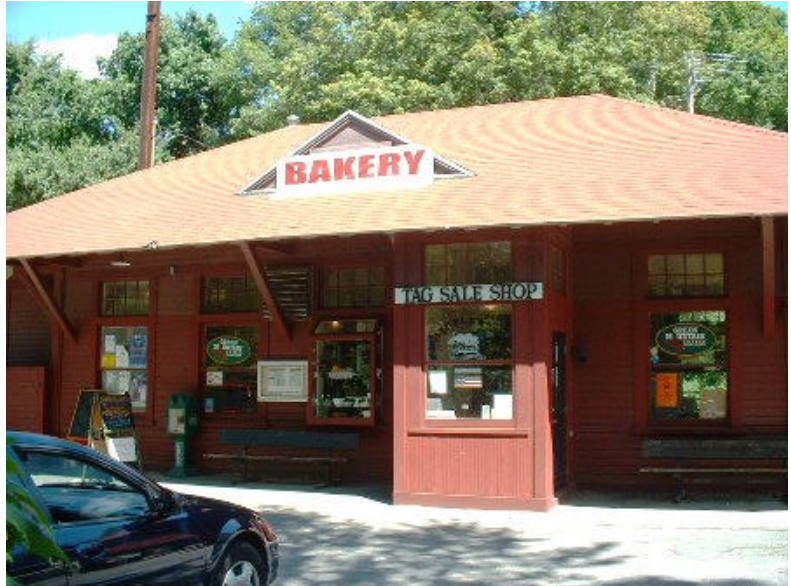
An awning provides some shelter for patrons of the bakery or waiting commuters. The area is neat, likely from the housekeeping efforts of bakery personnel.

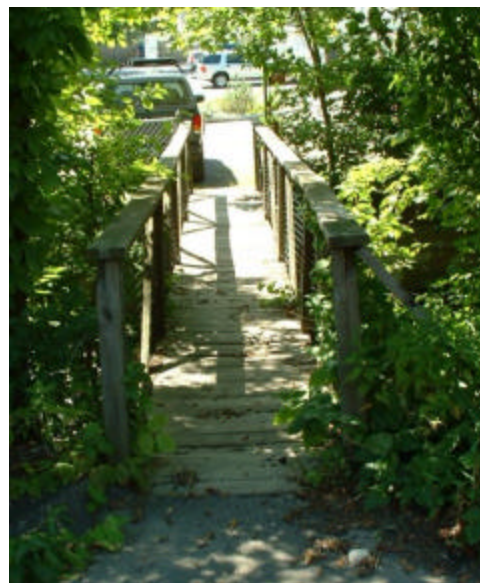
Walks/Paths – The station building is located in the middle of the parking lot. Access to the platform has been improved by the recent addition of raised sidewalks and black railing along the track side of the lot. This feature provides an attractive buffer between vehicles and trains, while keeping pedestrians away from the parking aisles. In front of the bakery is a narrow pedestrian bridge (right) that spans the Norwalk River. The bridge connects the parking lot to an auto body shop. The bridge deck appears to be structural sound, but the railing is substandard. There are no signs indicating the ownership or availability of this bridge to the public. If the bridge is private, then it should be signed as such. If it is part of the station, the structure should be brought up to current structural standards.

- Replace aluminum platform, stair and ramp railing with black steel railing.
- Evaluate illumination levels throughout the station.
- Install a tactile warning strip.
- Repave the parking lot.
- Allow the public to use rest rooms in future leases.
- If the general public cannot use the station building as a waiting room, then add a shelter for waiting commuters. The shelter can be placed in the awning area or extended out from behind the platform. This latter choice may eliminate parking spaces.
- Resolve the status of the footbridge across from the station building. If private, provide appropriate signage and disclaimers. If public, then remove or upgrade to standards.
- Inspect Depot Road bridge over river
- Inspect Portland Avenue bridge over river

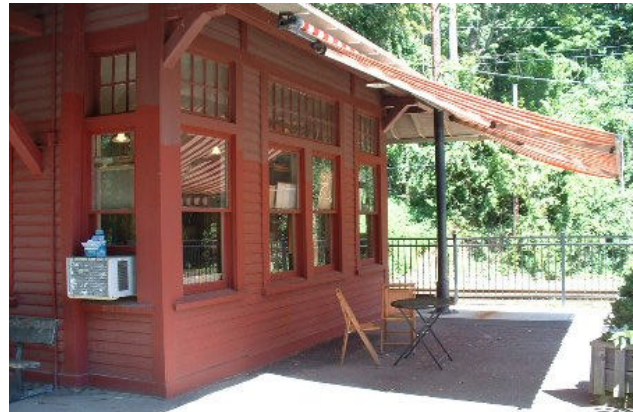
Seating Under Awning on Side of Station

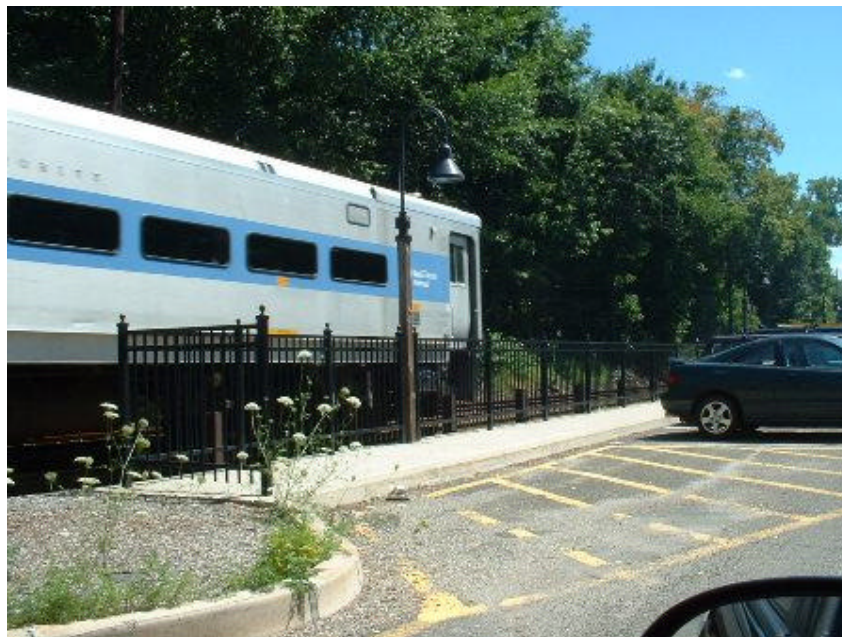
Fences – The railing along the sidewalk is new and in good shape.

New Walk, Railing and Lights at Branchville Station
