BRIDGEPORT TRANSPORTATION CENTER VISUAL INSPECTION REPORT

January 2007

Prepared by the Bureau of Public Transportation Connecticut Department of Transportation

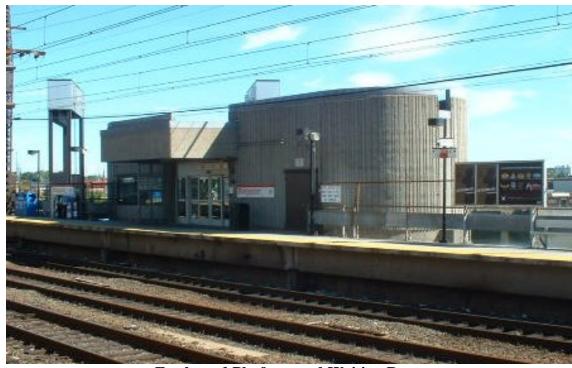
Eastbound Platform and Waiting Room

Platforms – The platforms are beginning to show their age. The concrete is deteriorating and the expansion joints are failing. Several stairs are cracked and spalled, while the aluminum railings are eroding with some requiring repair. The eastbound platform has a small gap (right) between concrete sections, which poses a safety concern for commuters near the waiting room entrance.

- Remove track level debris from under the platforms and behind the westbound platform.
- Clean and paint the canopy structures.
- Upgrade roadway directional signing to the station parking areas.
- Post information in the concourse concerning construction progress, closures, detours and other disruptions.
- Remedy the hazard posed by the eastbound platform gap.
