DANBURY TRAIN STATION  
VISUAL INSPECTION REPORT

January 2007

Prepared by the Bureau of Public Transportation  
Connecticut Department of Transportation

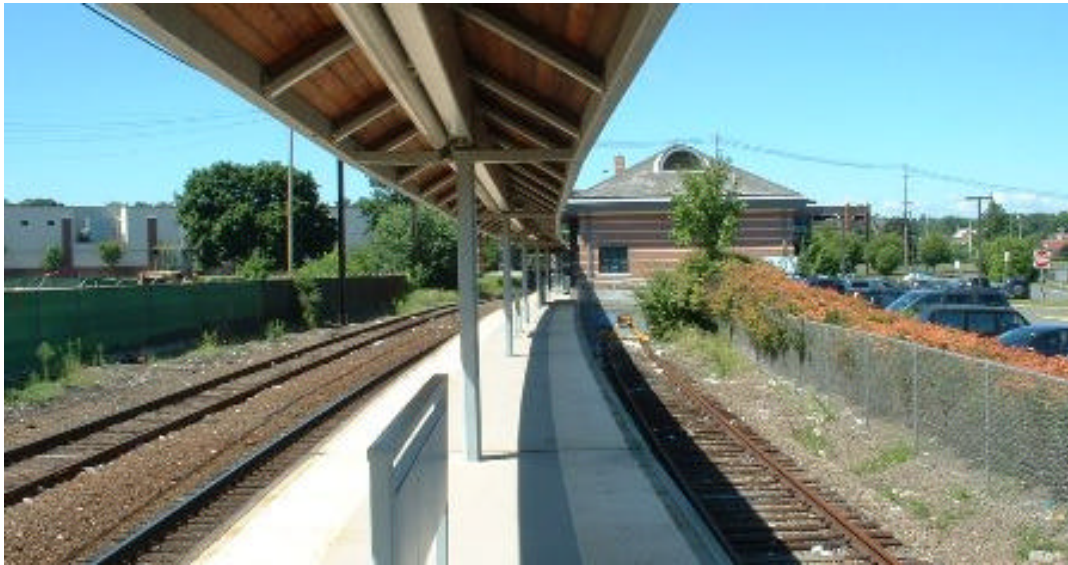
**Litter** – The end of the pocket or stub track is very messy at track level. The remainder of the station is clean and neat.

**Center Island Platform at Danbury Station – Note Litter on Right Track**

- Touch up canopy columns and handrails.
- Clean track level trash.
- Trim vegetation along all paths.
- Trim weeds from concrete cracks.
- Seal and paint wood platform rub rail.
- Repair the chain link fence at the southbound end of parking lot.

- Review trailblazing sign locations. Supplement, if necessary.
- Add station entrance sign at Patriot Drive.
- Newspaper boxes are properly located on the side of the station building. If vending machines are added, keep these off platforms and primary paths.
- Add benches to the platform, where width allows.
- Add a trash can near the pocket or stub track.
