DARIEN TRAIN STATION

VISUAL INSPECTION REPORT

January 2007

Prepared by the Bureau of Public Transportation
Connecticut Department of Transportation

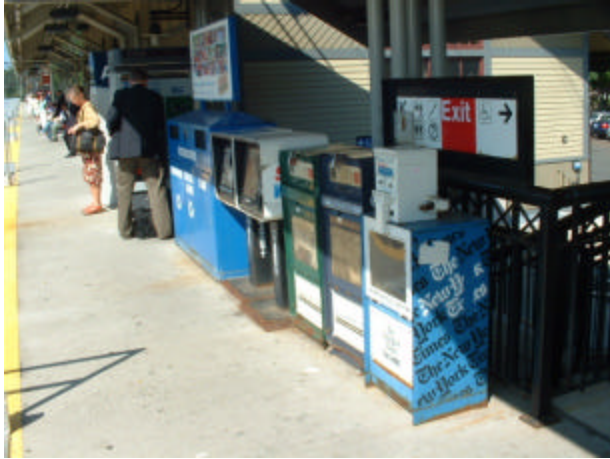
**Recycle Bin to close to TVM.
Vending encroaching on platform space**

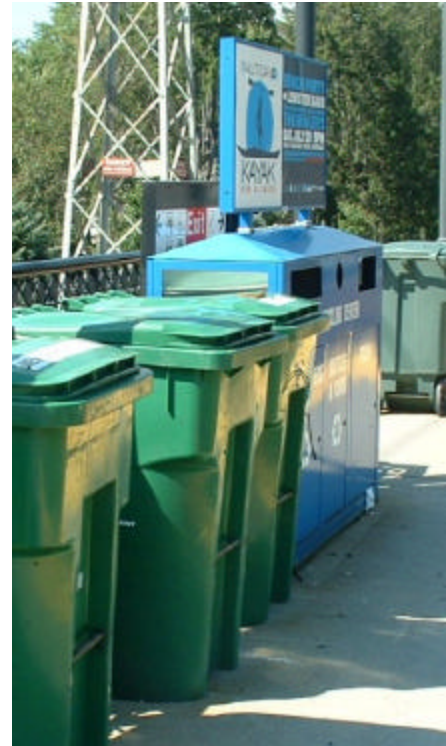
Recycle Bin Blocks Exit Sign

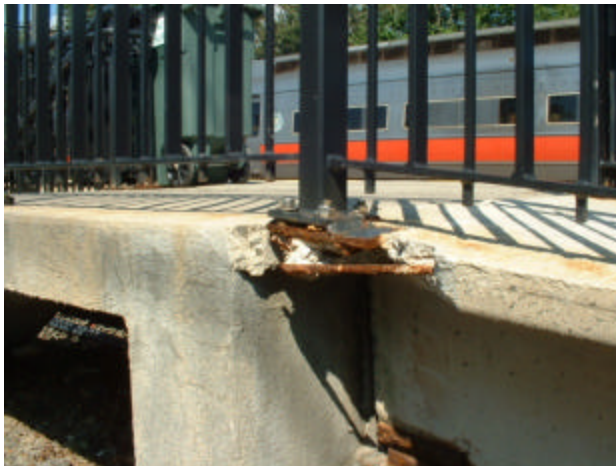
Concrete Spall and Poor Connection

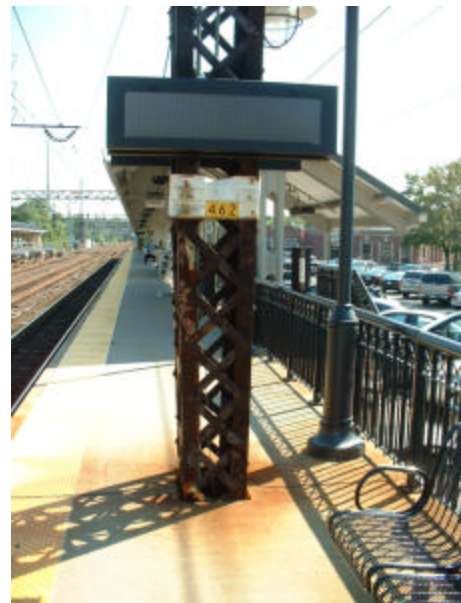
In stark contrast to the freshness of the station platforms, rusted catenary supports rise prominently from the eastbound platform. Portions of the westbound platform have been cut away to accommodate catenary and high voltage towers on that side. Black railing protects these structures. As expected, the rust looks awful. It has discolored everything directly under the structures, including the platform, canopies and tactile warning strips.

Catenary Support in Platform

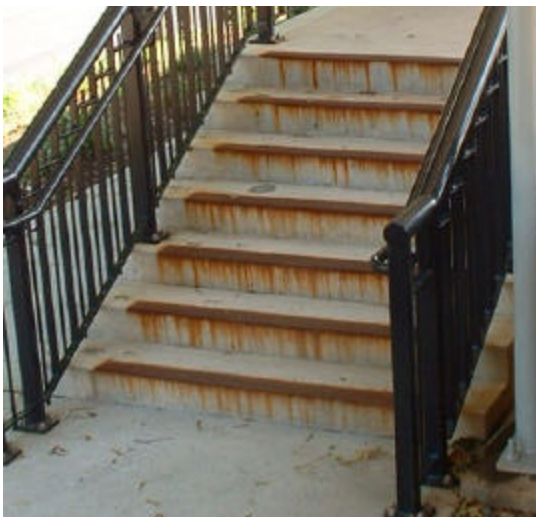
Stairs and ramps are new. However, much of the metal stair nosing is prematurely rusting, leaving brown stains on the new concrete. Premature rusting was also noticed in the welds at the top of one of the westbound stairs.

Stains from Rusted Stair Nosing

- Keep bathrooms clean.
- Properly ground all metal fixtures on and adjacent to the platforms. Coordinate the grounding with Metro-North.
- Monitor corrosion of galvanized fittings under light poles, conduit and light pole bases.
- Address premature rusting of platform stair nosings, and clean the rust stains.
- Repair concrete spall and railing connections at eastbound stair/ramp.
- Repair the lower end of the eastbound ramp to the platform
- Replace the taxi phone on eastbound platform or remove the "booth" and pictogram sign.
- Place emergency telephones on both platforms.
- Move the blue recycling bin, which blocks the exit sign on the eastbound platform.
- Blue recycling bin is too close to TVM on westbound platform, restricting ADA access.
- Repair storm damage to landscaping behind the east end of the westbound platform.
