GLENBROOK TRAIN STATION  
VISUAL INSPECTION REPORT

January 2007

Prepared by the Bureau of Public Transportation  
Connecticut Department of Transportation

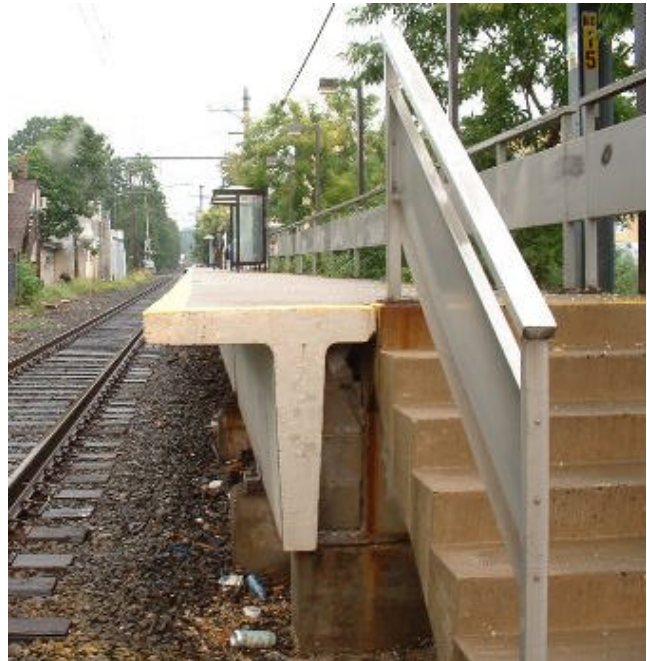
**Platforms** – The platform is in satisfactory condition, although the Governance Study notes some issues with the footings. The edge is painted with a narrow yellow stripe. The railing base plates are rusted. The stairs at either end of the platform are set back from the outside edge of the platform. The gap between the platform edge and handrail appears to be excessive. One could easily exit the ramp on the wrong side of the handrail.

**Glenbrook - Gap between Platform Edge and Stair Handrail**

- Replace aluminum platform railing with a black railing.
- Protect the opening on the track side of the stairs at the ends of the platform.
- Evaluate lighting levels around station area.
- Evaluate station signage and supplement, as necessary.
- Replace bituminous walks with concrete sidewalk.
- Place black railing between the new concrete sidewalk and the tracks at the south end of the station. Replace the chain link fence with a black railing at the north end of the station.
- Install post mounted lights along the new walkways.
- Install a tactile warning strip along the edge of the platform.

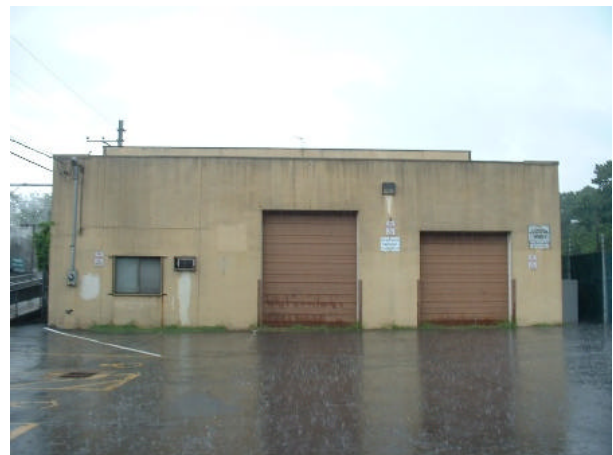
**Stamford Traffic Division Building**

**Parking** – The parking lot is accessible from both ends of the station. The City's Traffic Department occupies an area in the middle of the lot behind the platform. Entering and exiting the station lot can be difficult at either end of the station due to high traffic volumes, the proximity of the railroad crossing and nearby signalized intersections.

- Add a canopy to the platform
- Replace platform shelters. Consider the West Redding template.
- Consider acquiring the City Traffic Department building to provide additional parking or investigate a land trade.
