# MERRITT 7 TRAIN STATION

## VISUAL INSPECTION REPORT

January 2007

Prepared by the Bureau of Public Transportation  
Connecticut Department of Transportation

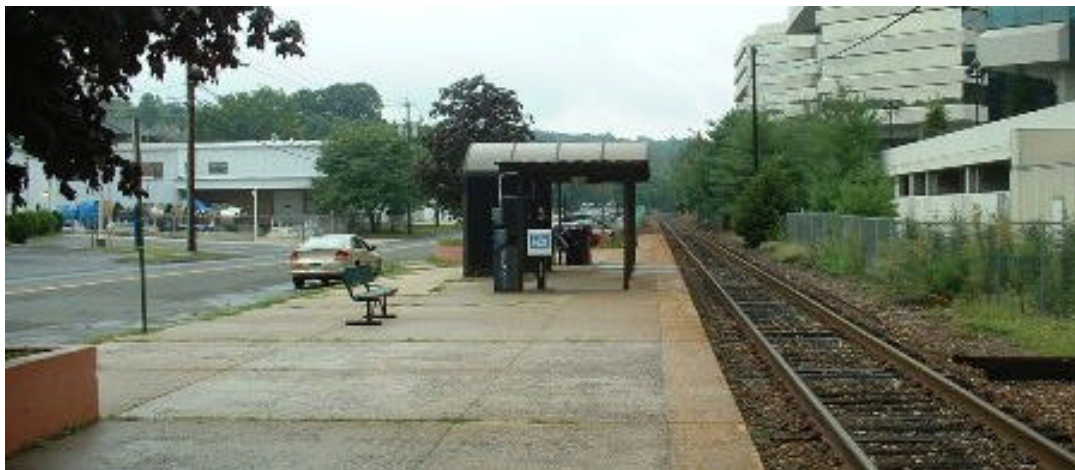
**Merritt 7 Station Platform**

**Platforms** – There is a low-level concrete platform in front of the shelter. The surface is cracked and worn and has a faded yellow warning stripe along its edge.

- Repaint yellow stripe along platform edge.
- Paint the rusty top rail of the chain link fence.
- Remove weeds from sidewalk cracks.
- Trim weeds along the tracks.
