NEW HAVEN UNION STATION

VISUAL INSPECTION REPORT

January 2007

Prepared by the Bureau of Public Transportation
Connecticut Department of Transportation

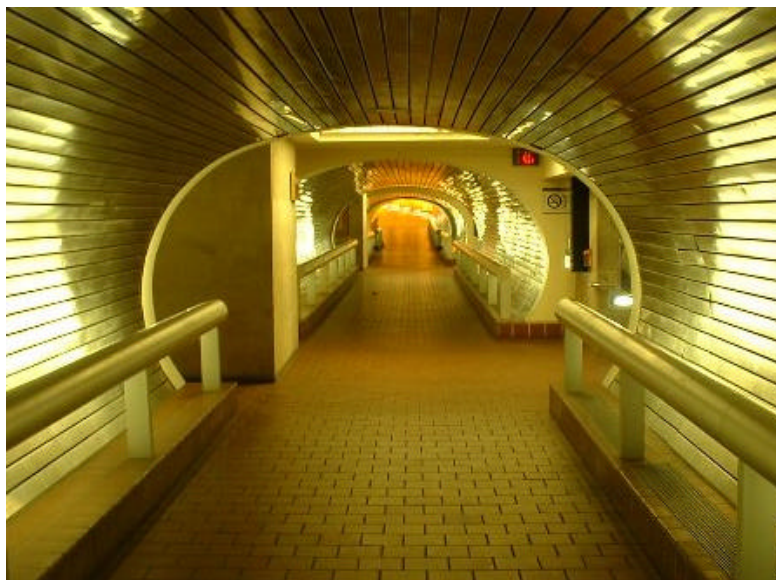
Union Station - South Tunnel Tube

The tunnel is well light. It has a modern, contoured metal siding. Although the condition of the concrete behind the metal sheathing was not accessible, previous inspections have noted drainage issues, which are to be addressed by a project currently in design. There is evidence of water leakage at the base of a few stairways. The railing along one of the stairways has pulled apart from its connection. Several kick panels are pulling away from the stair risers.

- Improve main garage entrance/exit sight distance.
- Upgrade station building to code.
- Rehabilitate tunnel.
- Upgrade PA system and install variable message signs.
- Refurbish station building elevators.

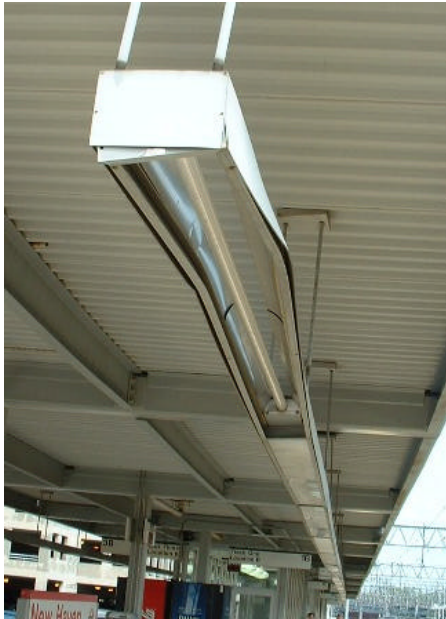
Canopy – Canopies are in good shape, although a coat of paint is needed here and there. Many canopy lights are damaged and/or rusted requiring repair or replacement. Many drainage fixtures suffer from rust and peeling paint. A few pipes are rotted through.

Broken Canopy Lights

- Repair and/or replace broken and rusted light fixtures.
- Repair, replace and/or cover rusted light post bases.
- Eliminate platform tripping hazards.
- Repair loose stairway kick panels.
- Fix loose handrail along platform stairs.
- Determine source of platform stairway water leaks and repair if necessary.
- Eliminate non-code conforming conduit connections to platform vending machines.
- Review practice of leaving gates open at the ends of the platforms.
- Paint canopies
- Repair and paint drainage pipes/fixtures.
- Repair and repaint platform edge wooden rub rail (Metro-North).
- Replace undersized gate at south end of easternmost platform (Metro-North).

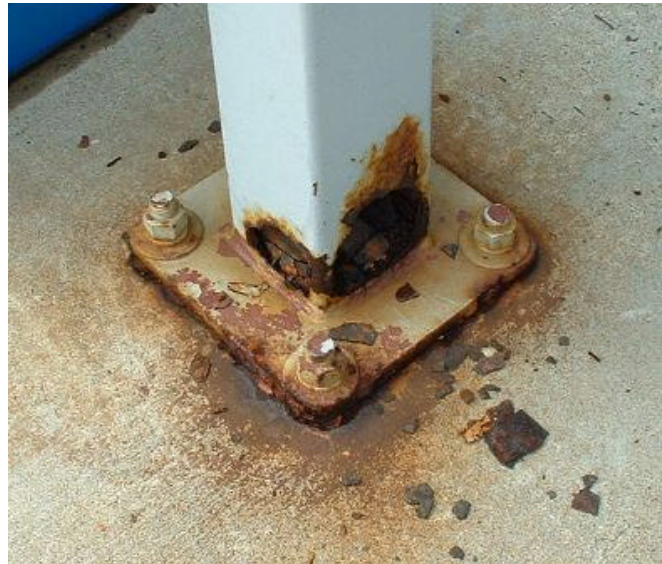
Platforms & Tunnel – The four center platforms are accessed by tunnel from the waiting room. Elevators, escalators and stairs provide access from the waiting room to the tunnel. Each platform is accessed by elevators and stairs. Lighting levels appeared to be sufficient. However, rust is prevalent on many light bases with some rotting through. The rub rails are rotted in several places and need a coat of paint. There are several tripping hazards (old light bases, light base bolts, conduit, etc.) that need to be eliminated. Power feeds to several platform vending machines does not meet electrical code. The gates at the ends of the platforms are left open. The gate at the south end of the easternmost platform is too small for the opening, which should be corrected. Ramps at the ends of the platforms should have tactile warning sections placed at the bottom edges.

Rust Light Pole Base

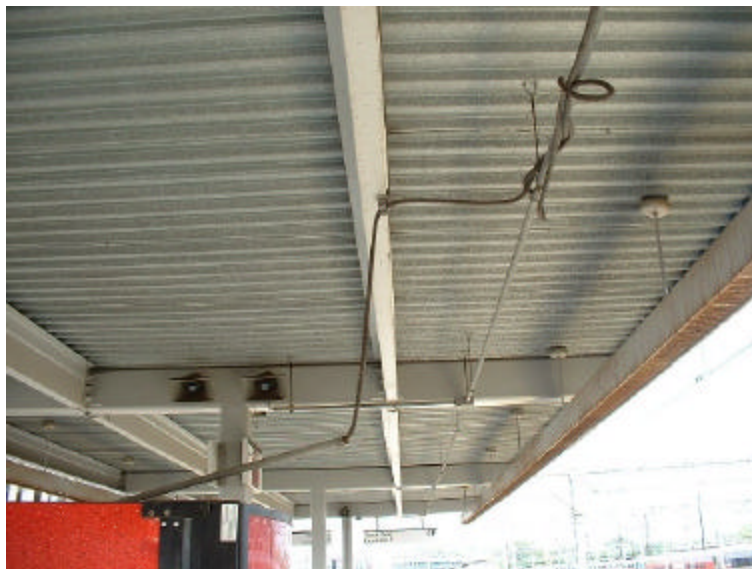
Power Feed Hanging from Canopy

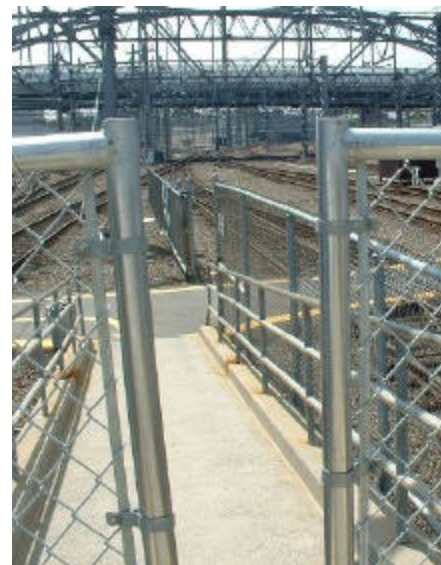
Fences – The black chain link fencing between the back employee lot and the tracks was recently replaced. Gates and fencing at the ends of the platforms are in good condition. However, as noted above, one of the gates is too small for the opening.

Gap in Platform Gate
