NOROTON HEIGHTS TRAIN STATION

VISUAL INSPECTION REPORT

January 2007

Prepared by the Bureau of Public Transportation
Connecticut Department of Transportation

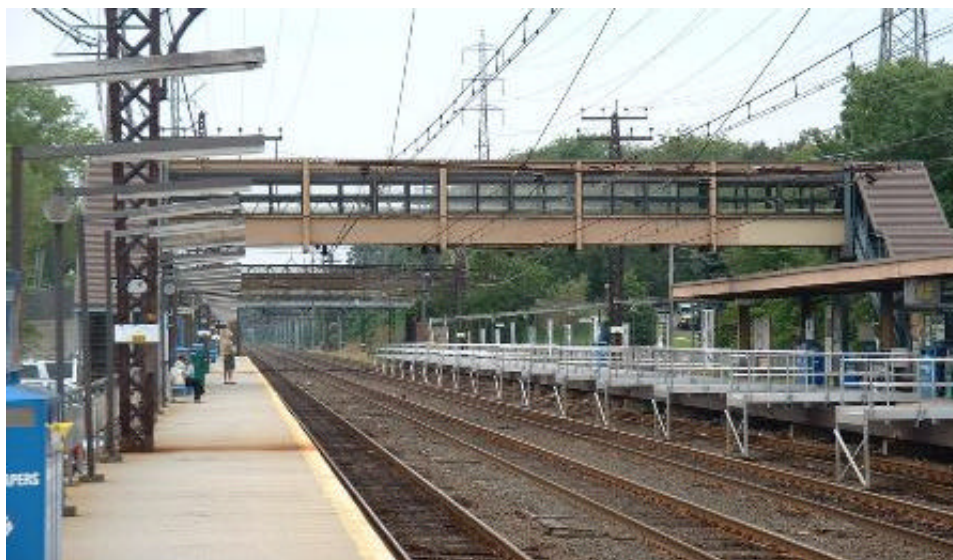
Pedestrian Bridge at Noroton Heights

Walks/Paths – The pedestrian bridge appears to be in fair to satisfactory condition. Paint is peeling, many surfaces are pitted and all the stairs treads are rusted. Glazing is in good shape. There are several paths from the parking lots and platforms to Heights Road. Weeds and vegetation encroach on some of the paths. The west end of the station uses Hollow Tree Ridge Road as a pedestrian crossover. Badly patched concrete stairs lead up to the highway bridge where a sidewalk carries commuters over the tracks. A pile of stone impedes movement along the path leading away from the east end of the westbound platform. The sidewalk along Heights Road has sections of steep cross slopes.

- Repair the two stairways at the west end of the platforms.
- Clean and paint the pedestrian bridge and replace stair nosings.
- Remove newspaper boxes from platforms and primary paths.

- Rehabilitate or replace the pedestrian bridge with an ADA compliant structure.
- Extend and/or replace westbound platform canopy.
- Add a canopy and/or replace the shelter on the eastbound platform. Consider a smaller version of the westbound station building.
