OLD GREENWICH TRAIN STATION

VISUAL INSPECTION REPORT

January 2007

Prepared by the Bureau of Public Transportation
Connecticut Department of Transportation

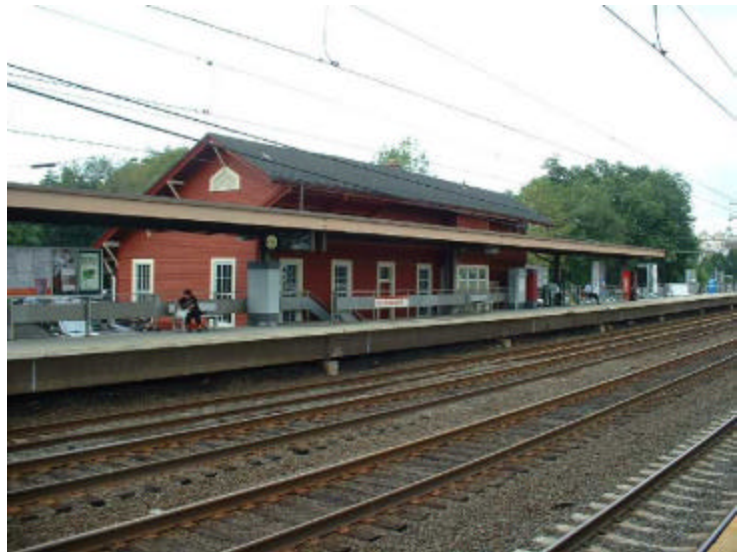
The bridge over Sound Beach Avenue is in poor condition as are the stairs and paths adjacent to the structure. The remainder of the station looks worn but functional.

- Replace Sound Beach Avenue railroad bridge.
- Lengthen 6-car platforms to 10 cars.
- Extend and/or replace westbound platform canopy.
- Add a canopy and/or replace the shelter on the eastbound platform. Consider the West Redding Station shelter as a template.
