SEYMOUR TRAIN STATION
VISUAL INSPECTION REPORT

January 2007

Prepared by the Bureau of Public Transportation
Connecticut Department of Transportation

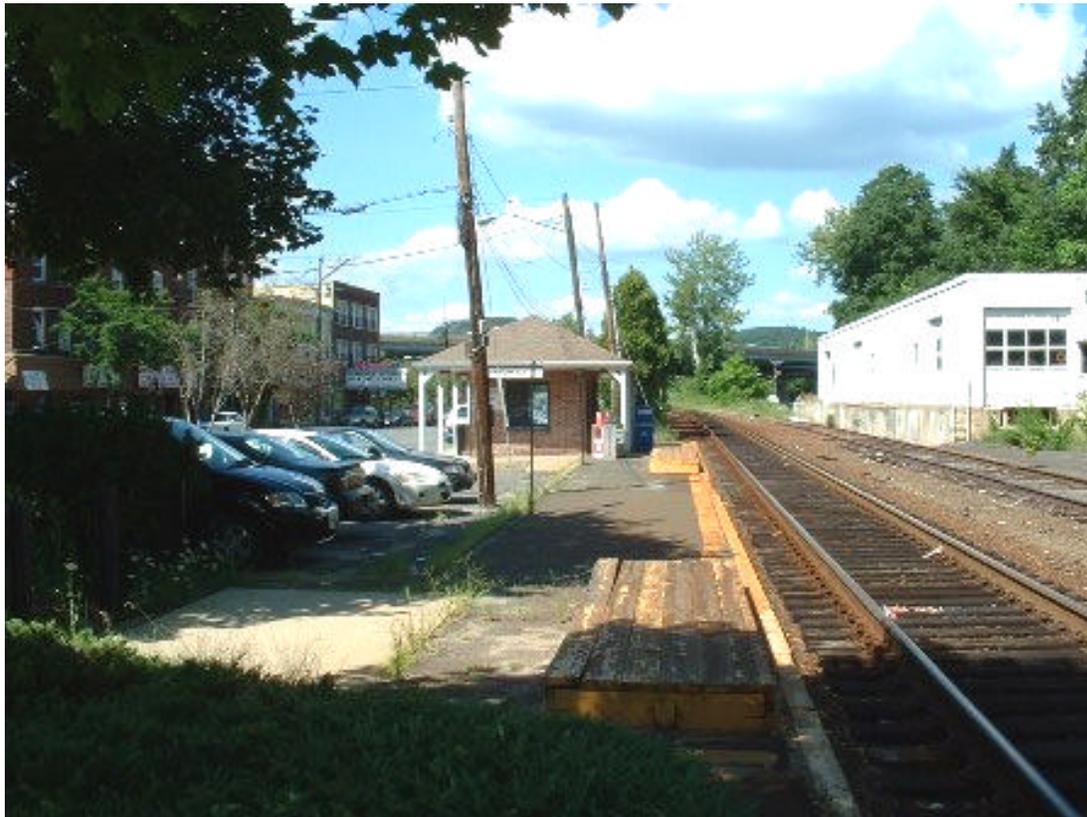
View of Platform Area Looking North

Platforms – Platforms consist of two separate wooden boxes in varying stages of disrepair. Illumination is provided by streetlights and lights mounted in the eaves of the shelter. The bituminous pavement under the platform is uneven and cracked with weeds growing through. The painted yellow warning stripe is bright.

- Supplement and/or relocate trailblazing signage to and from Routes 8 and 67.
- Clean and deodorize the inside of the brick shelter.
- Repaint, repair, replace or remove the north boarding platform.
- Remove the south boarding platform if it is not needed. Coordinate with Metro-North.
- Keep up with housekeeping duties.
- Seal cracks in bituminous pavement in the platform area.
- Replace dead trees in front of shelter.
- Ask the owner of the old freight house on the other side of the tracks to paint the structure.
- Repair the shelter's roof gutters
