SPRINGDALE TRAIN STATION VISUAL INSPECTION REPORT

January 2007

Prepared by the Bureau of Public Transportation
Connecticut Department of Transportation

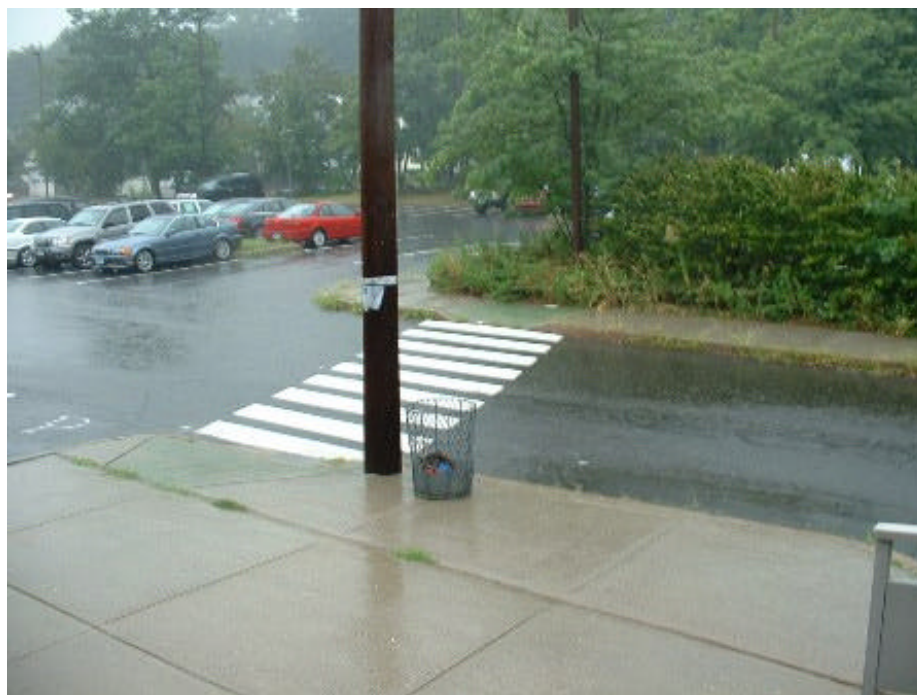
Walks/Paths – Several paths transverse the parking lot out to the Hope Street sidewalk. One path includes marked crosswalks. There is some landscaping but it is but poorly maintained.

Path to Street at Springdale Station
