WEST REDDING TRAIN STATION

VISUAL INSPECTION REPORT

January 2007

Prepared by the Bureau of Public Transportation
Connecticut Department of Transportation

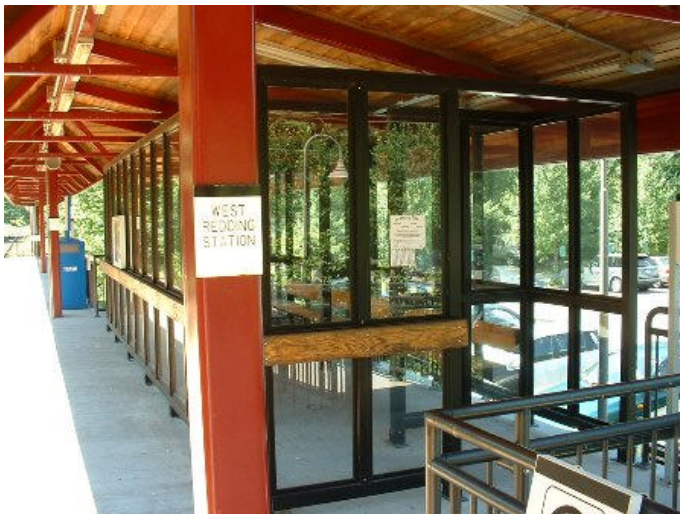
Shelter – The 8' by 25' Plexiglas shelter has been installed on the platform under the canopy. The glazing shows only minor wear, as does the framing. Although in good condition, the wood bench and handrails should be cleaned and refinished, if necessary.

New Platform Shelter at West Redding Station

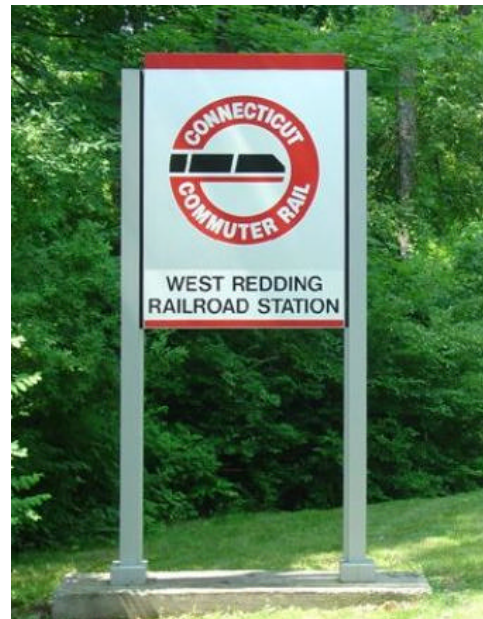
Parking – A station entrance sign is located just into the opening of the station. The only recommendation would be to place the sign closer to Long Ridge Road to avoid being obscured by the foliage. There is adequate signage indicating the location of daily and permit parking as well as daily rates.

West Redding Entrance Sign
