WILTON TRAIN STATION

VISUAL INSPECTION REPORT

January 2007

Prepared by the Bureau of Public Transportation
Connecticut Department of Transportation

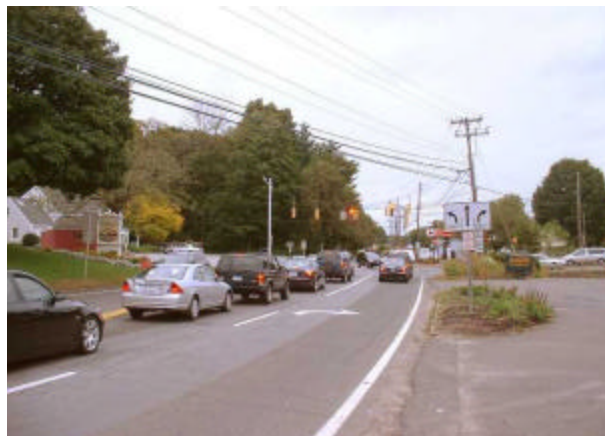
Highway Access – Located at the busy Routes 7/33 intersection, Wilton Station is difficult to find, hard to enter and even more challenging to exit. A station entrance sign is needed to announce the existence of the depot, as it is located in a depression well below Route 33. Current and future construction projects will eventually improve access to the station. Until then, maneuvers in and out of the parking lot will be formidable at times. As this is a busy intersection with its own clutter of signage, it is recommended that the Department provide additional trailblazing signage about a half mile in advance of the station on Route 7 from both directions and on Route 33.

Route 7 Traffic at Wilton Station Entrance

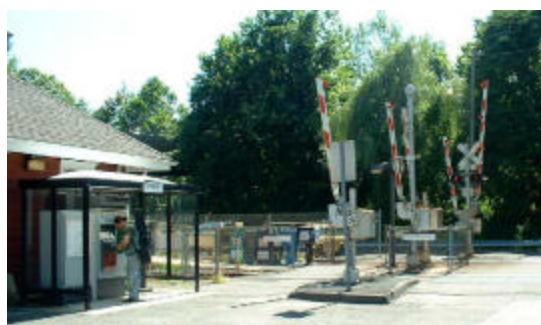
Walks/Paths – With parking available on either side of the tracks, access to this platform requires crossing one track to the center island platform ramp. Both the pedestrian and adjacent vehicular crossings (right) are protected by crossing gates. The crossing has a bituminous surface that is cracked and uneven, especially at the bottom of the platform ramp. The ramp has no tactile warning at its base. The bollard mounted light fixtures on the edges of the platform ramp need to be sealed with new gaskets. The bituminous walk on the trackside of the station building is also cracked and uneven. Pedestrians move about the remainder of the station through parking lot aisles.

Wilton Station At Grade Rail Crossing

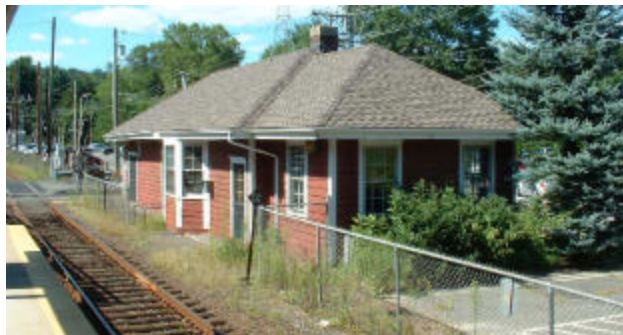
Station Building – The station building was closed during the site visit. There are no hours posted on either the waiting room or concession doors. Overgrown vegetation at both front doors give the appearance of an abandoned building. However, a glimpse through the door window reveals a well-stocked coffee shop. The Rail Governance Study notes that building ownership is shared between CDOT and another party. The study also notes deficiencies in waiting room lighting levels, electrical systems and ADA requirements. It is assumed that the rear door to the waiting room is always lock since it leads directly to the tracks. However, the rear door of the concession area has a fenced walkway to the pedestrian crossing (right). The building appears to be in good shape apart from the overgrown vegetation.

- Repaint warning strip on edge of platform.
- Address bird drop and nesting problem.
- Reseal bollard mounted light fixtures along platform ramp.
- Re-Post station/concession hours signs to the front door.
- Maintain aluminum ramp rail to eliminate rust stains on the concrete beneath.
- Move the newspaper boxes off the platform ramp and from between the tracks. Place the boxes (and any vending machines) sufficiently away from primary walkways to avoid impeding pedestrian movement along the paths.
- Clean up the track level litter along the platforms.
- Trim the vegetation around the building and parking lots.
