Flexural Capacity of Fire-Damaged Prestressed Concrete Box Beams

PUBLICATION NO. FHWA-HRT-07-024

FEBRUARY 2007

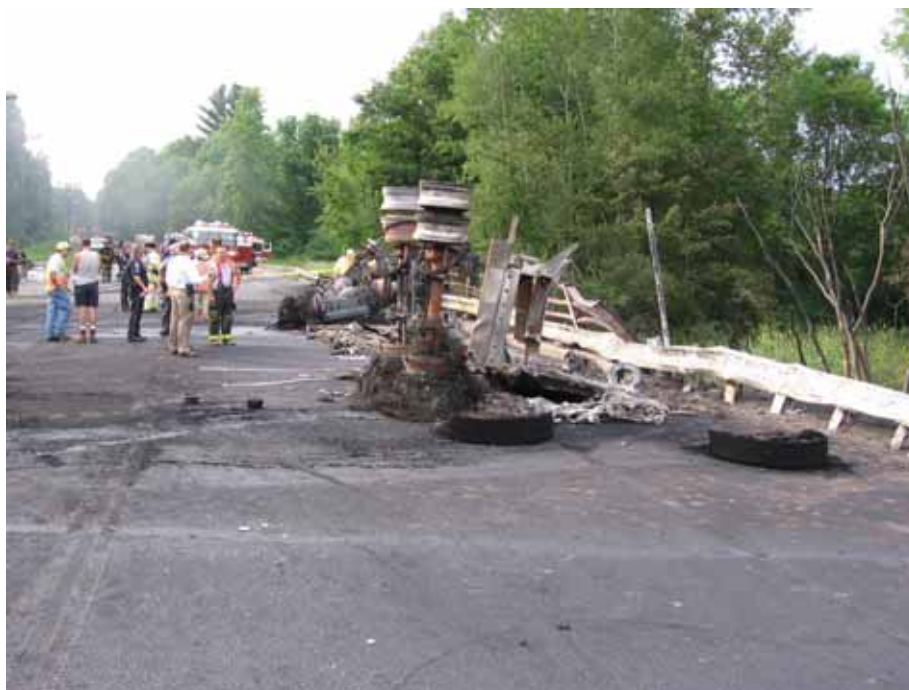
On the afternoon of July 12, 2005, a gasoline tanker truck traveling north on U.S. Route 7 near Ridgefield, CT overturned and exploded. The truck came to rest on the east side of the northbound shoulder of the Route 7 bridge over the Norwalk River. The 30,300 liters (8,000 gallons) of burning fuel flowed over the bridge and into the river below. As evidenced by the melting and possible vaporization of the aluminum that was originally part of the tanker truck, the temperature in the immediate vicinity of the truck could have been over 2,467 °C (4,472 °F). Figure 1 shows the remains of the tanker truck on the bridge after the fire.

Figure 1. Photo. Remains of tanker truck after fire.

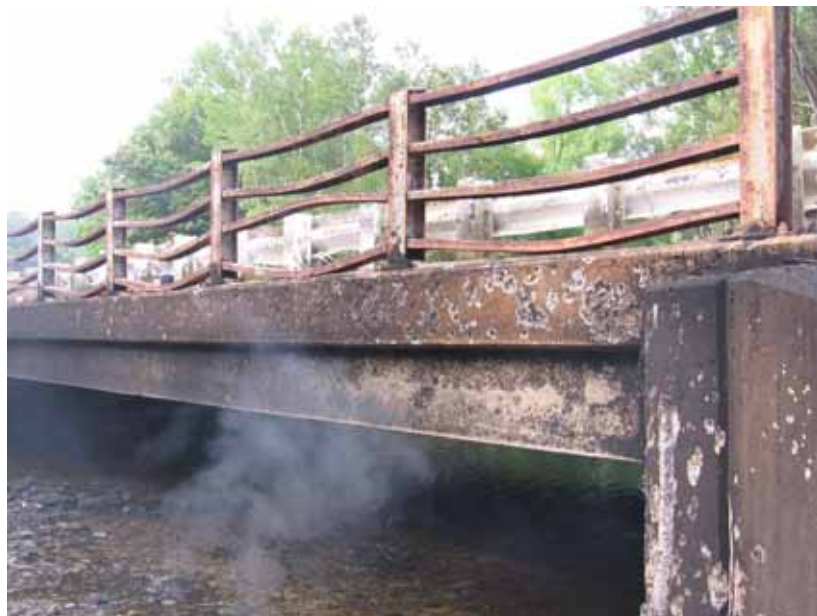
Visual examination of the bridge structure immediately after the fire found that scaling of the concrete surface had occurred on the bottom flanges of all 15 beams as well as on the exterior faces of the fascia beams. The bridge fascia is shown in Figure 2. The bituminous concrete overlay in the immediate vicinity of the tanker truck was in poor condition, but the membrane was intact. As nondestructive means were not available to quantify the integrity of the prestressing strands, ConnDOT decided to replace all of the beams in the superstructure.

Figure 2. Photo. Bridge fascia immediately after fire.

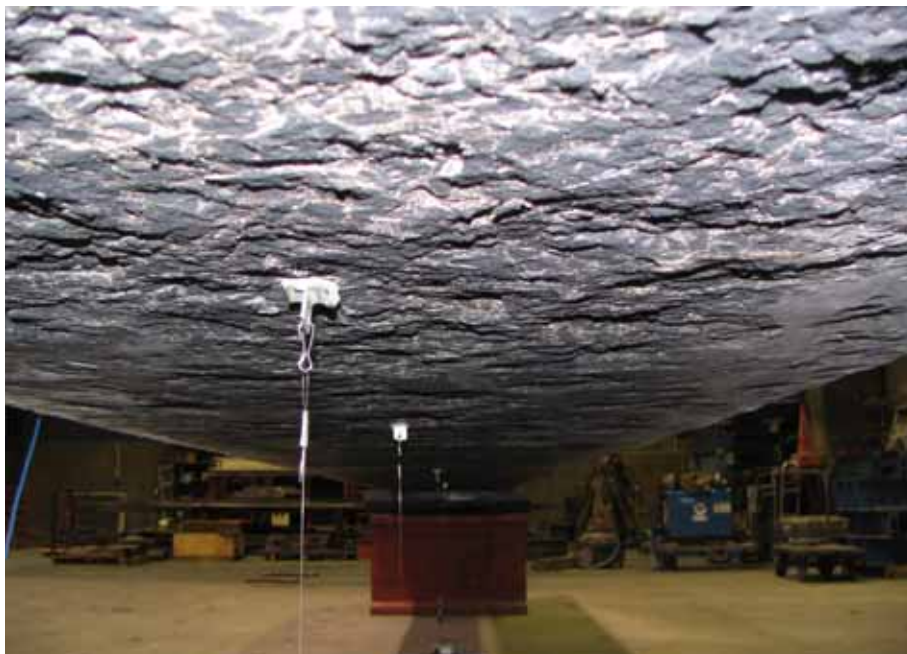
box-beam bridge that was covered by a thick asphalt overlay. As such, these beams only exhibited fire related damage on their bottom surfaces. Figure 6 shows the damage on the bottom surface of Beam 4. As a whole, the bottom surfaces of Beams 3, 4, and 7 exhibited similar damage with large patches of scaled concrete. Beam 14 exhibited more widespread surface scaling with most of the bottom flange being uniformly scaled. In all cases, the scaling was focused more toward the middle of the bottom flange, with the bottom flange edges along the length of the beams remaining primarily intact. In general throughout the four beams, the average scaling depth was approximately 10 mm (0.4 inch) with some local scaling of up to 15 mm (0.6 inch) deep. Based on a limited number of scaled but still intact scaled areas, the scaling seems to have occurred in small, thin sheets passing through the aggregate. Fractured aggregate is also visible on a significant portion of the scaled areas, also indicating that the scaling occurred through the aggregate.

Figure 6. Photo. Bottom face of Beam 4.

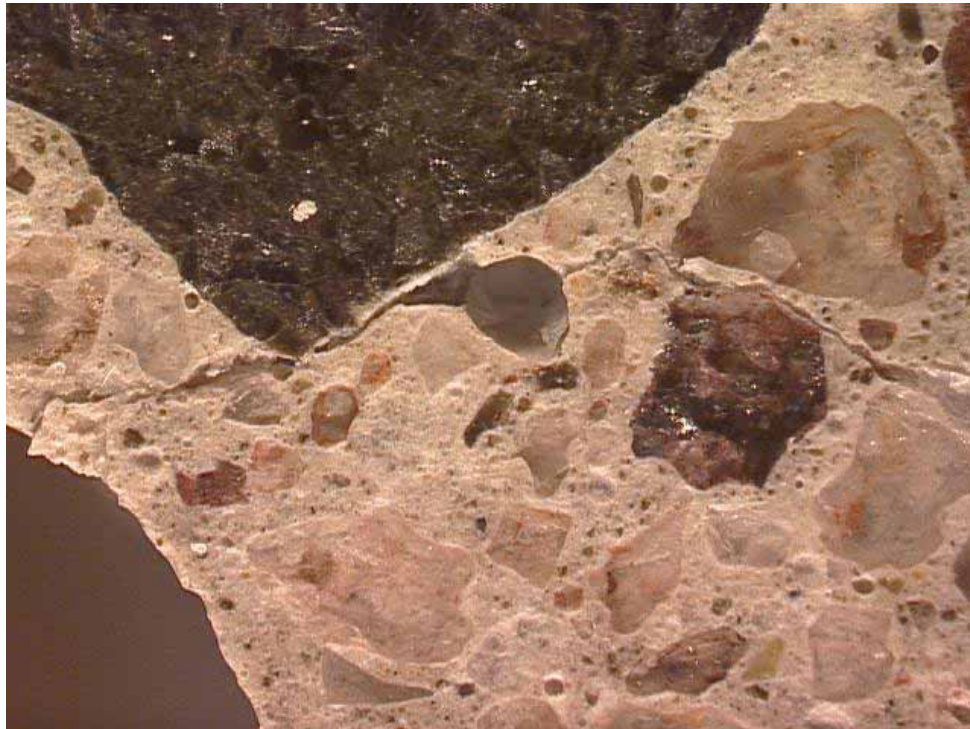
The petrographic examination determined that the concrete in the cores suffered damage to a depth of approximately 25 mm (1 inch) from the exposed surface. In this zone the concrete exhibits both small and large size cracks extending through the paste, through the aggregate, and along the paste aggregate interface. These cracks tend to be perpendicular to the exposed surface of the core. It is likely that these cracks occurred due to desiccation-related shrinkage of the concrete caused by the fire. Concrete beyond the 25 mm (1 inch) zone exhibits much less severe damage with fewer cracks and smaller crack sizes. Figure 7 presents a photomicrograph with a 4.0-mm- (0.157-inch-) width of field and with the center of the photograph located 10 mm (0.4 inch) from the exposed surface of the core to the right of the photo. This figure shows a large crack extending through the 25-mm-(1-inch-) deep zone of damage.

Figure 7. Photo. Photomicrograph of a crack near the exposed surface of the concrete.

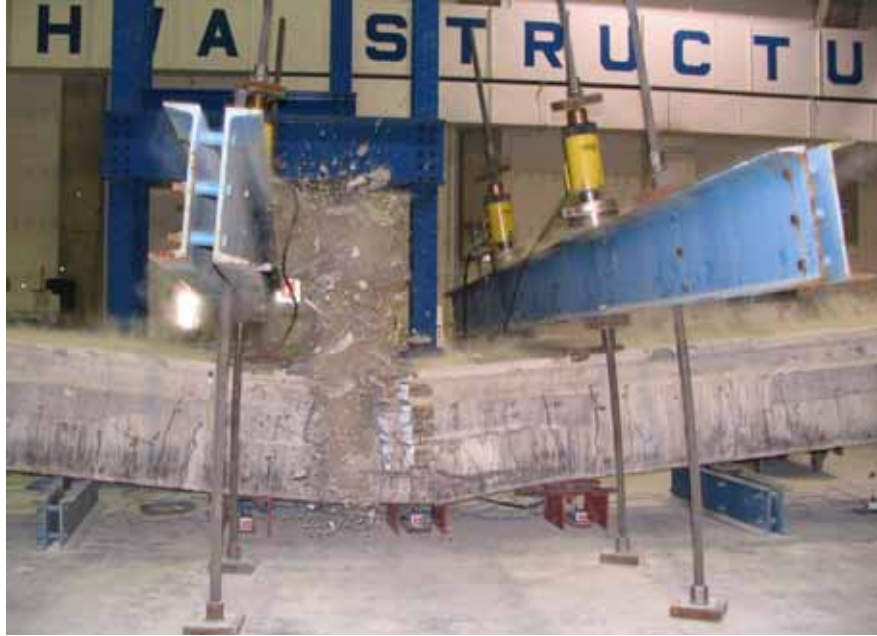
The failure of this beam, although preceded by significant tensile cracking of the bottom flange and a significant rise in the neutral axis, was caused by a compression failure of the concrete in the top flange. Figure 11 provides a photograph showing the sudden nature of the final failure. No spalling of concrete or rupturing of strands occurred prior to the compression failure of the top flange.

Figure 11. Photo. Failure of Beam 3.

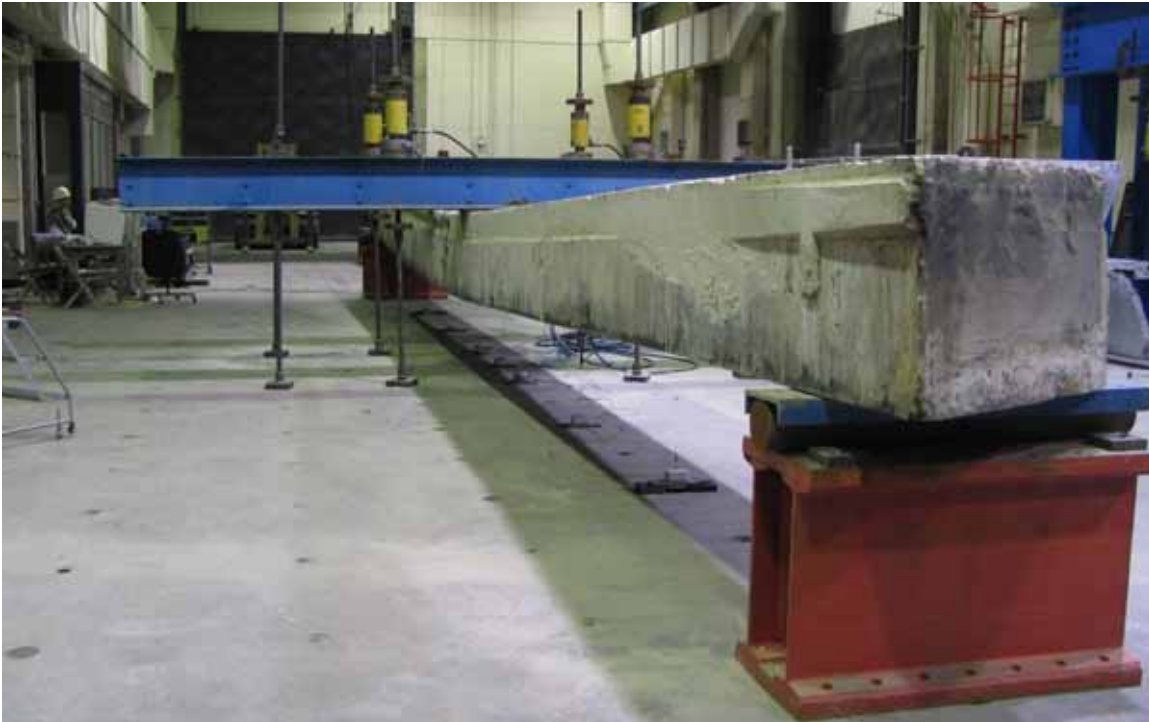
Figure 15 provides a photo of the deflected shape of the beam at the maximum applied load. Clearly, this beam exhibited significant deflection capacity prior to failure. The failure of this beam, although preceded by significant tensile cracking of the bottom flange and a significant rise in the neutral axis, occurred in a brittle manner, likely as a result of the compression failure of the concrete. Figure 16 provides a photograph of the beam just after failure. No spalling of concrete or rupturing of strands occurred prior to failure of the beam.

Figure 15. Photo. Deflection of Beam 4 at maximum applied load.

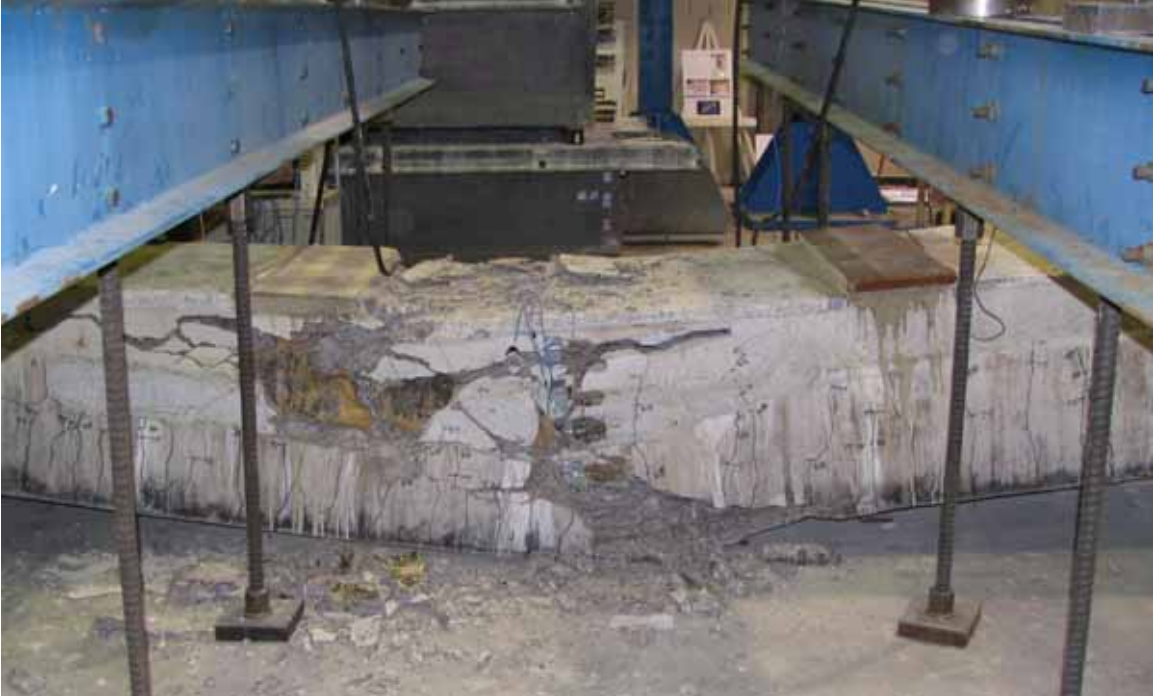
Figure 16. Photo. Failed Beam 4.

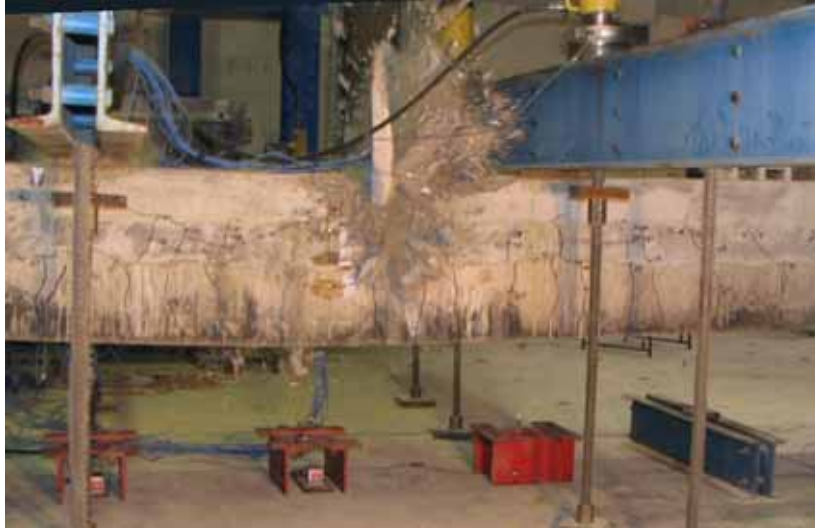
The failure of this beam, although preceded by significant tensile cracking of the bottom flange and a significant rise in the neutral axis, occurred in a brittle manner as a result of the compression failure of the concrete. Figure 20 provides a photograph captured during failure of the beam. No spalling of concrete or rupturing of strands occurred prior to failure of the beam.

Figure 20. Photo. Failure of Beam 7.

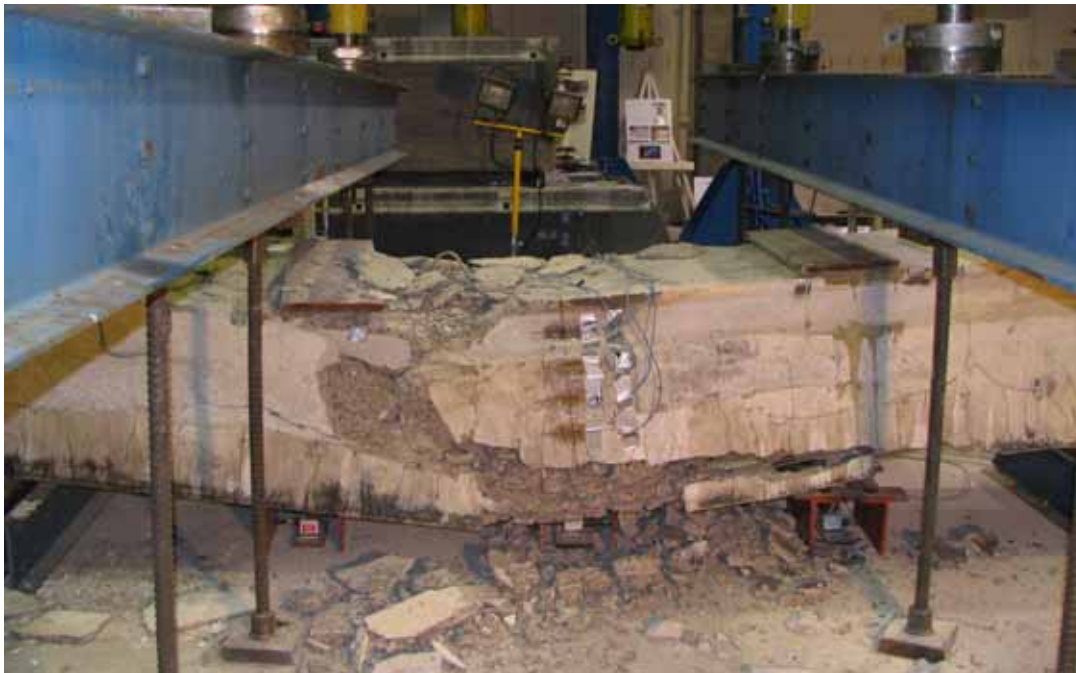
The failure of this beam, although preceded by significant tensile cracking of the bottom flange and a significant rise in the neutral axis, occurred in a brittle manner likely as a result of compression failure of the concrete in the top flange. Figure 24 provides a photograph captured just after failure of the beam. No spalling of concrete or rupturing of strands occurred prior to failure of the beam.

Figure 24. Photo. Failed Beam 14.
