# Baseline Watershed Assessment Tankerhoosen River Watershed

Friends of the Hockanum River  
Linear Park of Vernon, Inc.

May 28, 2008

Fuss & O'Neill, Inc.  
78 Interstate Drive  
West Springfield, MA 01089

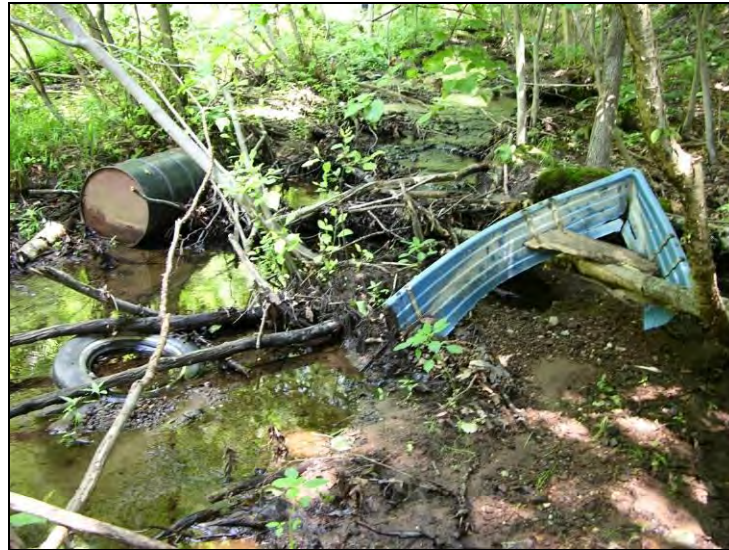
- TR – Significant quantities of trash and debris (an estimated 1 pickup truck load) were observed including tires, automotive waste, appliances and a closed 55-gallon drum of unknown contents. The debris and waste materials should be removed and disposed in accordance with applicable local, state, and federal regulations.

*Trash and debris along reach CB-02*

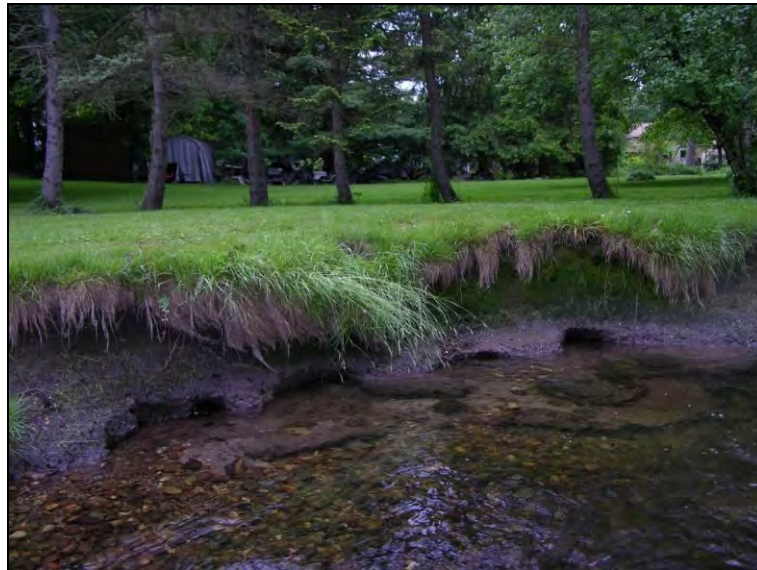
vegetation and habitat and moderate floodplain encroachment. The dominant in-stream substrate is gravel and cobble, and 50 percent of the stream surface is shaded.

*Stream segment MRT-01 has areas with little or no vegetative buffer.*

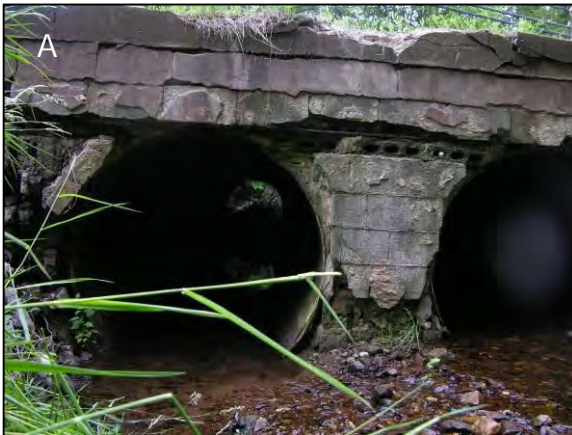
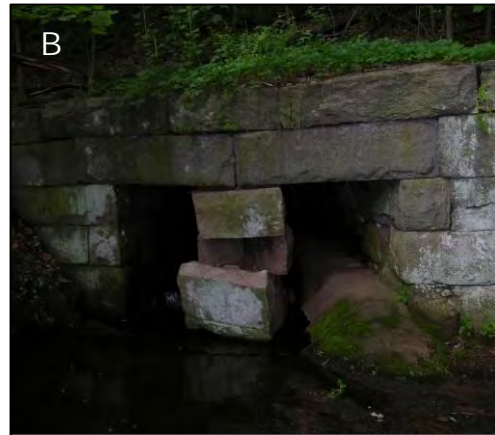
- SC –There are two road crossings and a rail crossing along this reach. The stone blocks on the outside of the Rails to Trails culvert crossing are partially dislodged and in need of repair. The Tunnel Road stream crossing has debris partially blocking the outlet of the culvert. The outlet of a concrete box culvert located north of Warren Avenue is perched approximately 14 inches above the elevation of the stream bed and is a potential barrier to fish passage. This culvert is a potential candidate for fish barrier removal to address the perched outlet.

*The Tunnel Road stream crossing (A) and the Rails to Trails crossing (B).*

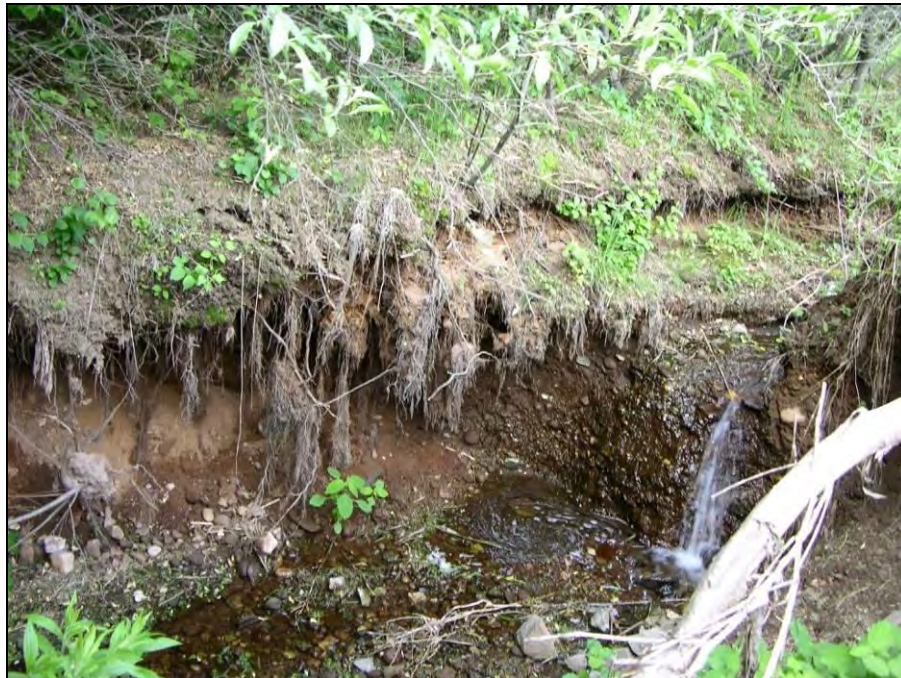
- OT – Stormwater outfall OT-01 is an earthen channel located on the left bank upstream of the Route 31 crossing. The channel originates from an adjacent residential property and was observed to have significant (3 to 4 feet deep) headcutting (erosion of the channel progressing upstream). A moderate flow of clear water was discharging from the channel at the time of the inspection. The property owner indicated that the source of the flow is groundwater seepage and surface runoff from upgradient areas. A discharge investigation is recommended, and this channel is a potential candidate for stream bank stabilization. The second outfall, OT-02, is a paved asphalt channel on the right bank, 8-inches deep and approximately 3 feet wide. The channel conveys road runoff.

*Eroded channel and discharge from a residential property.*

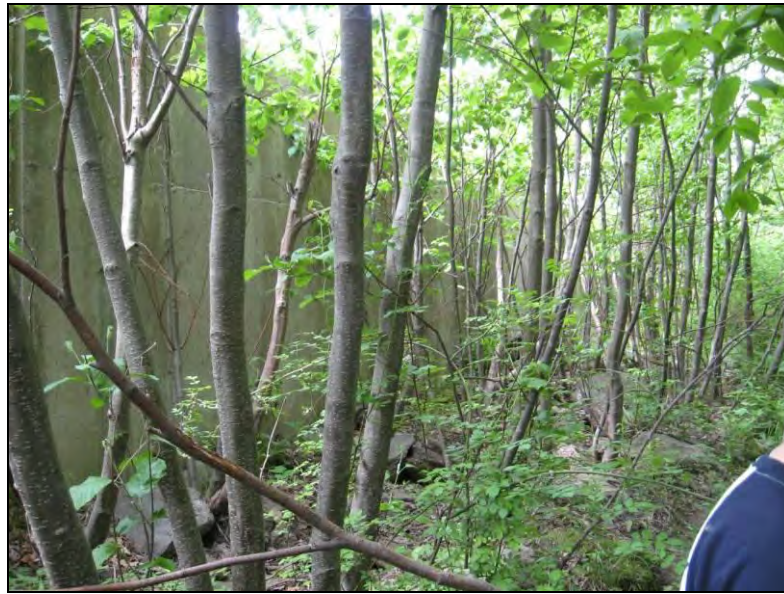
- IB – The majority of the stream reach has limited and highly impacted stream buffers. At the downstream end of the reach, a retaining wall is located along the top of the right bank, and industrial parking lots are located close to the left bank. Due to the limited area on both sides of the stream, there is low potential for stream restoration along this reach.

*Concrete retaining wall adjacent to Gerber Drive along segment GB-03B*

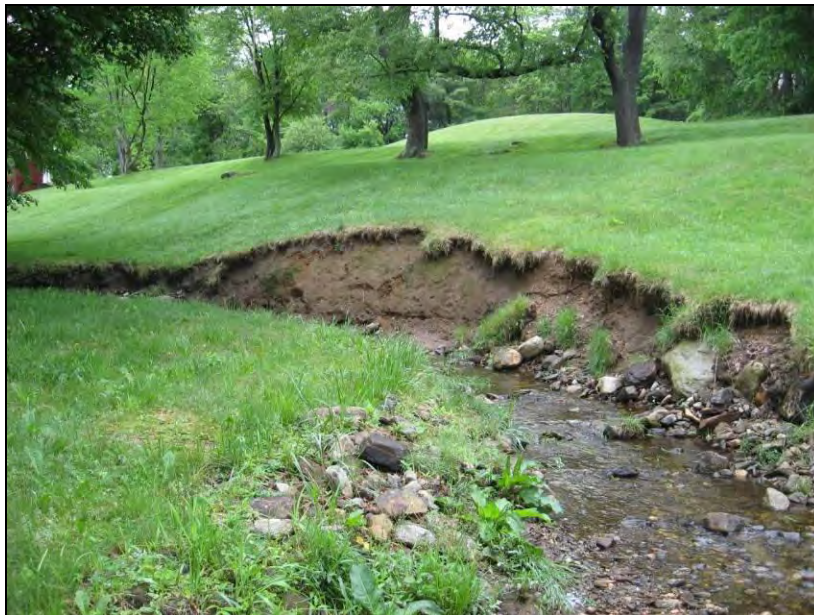
- ER - A significant area of bank erosion was observed in a bend in the stream. The erosive cut was approximately 5.5 feet in height and greater than 100 feet in length. This area is a potential candidate for stream bank stabilization.

*Stream segment GB-05B showing area of stream bank erosion.*

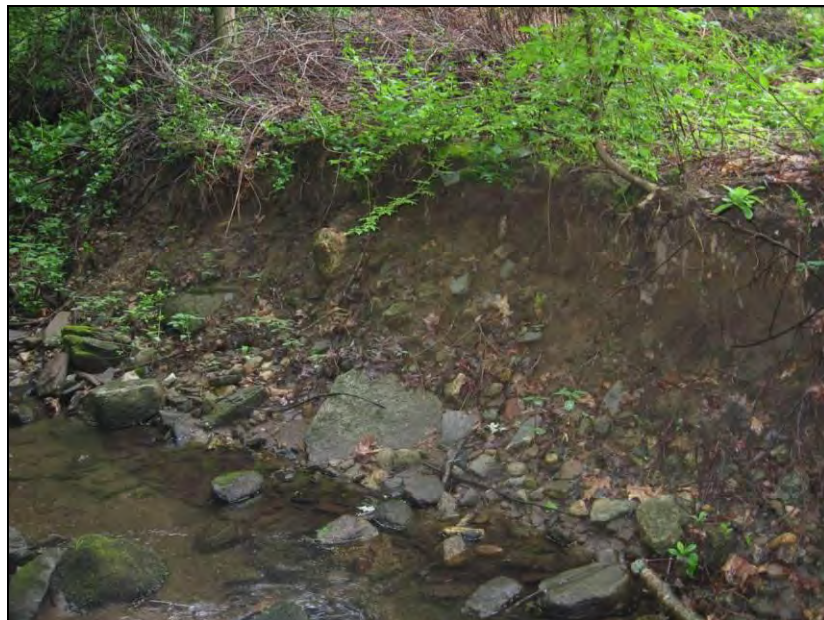
- ER - Numerous areas of significant erosion were identified along this stream segment. Three areas of bank scour on the outside banks of bends were observed. One area included a low-head concrete dam where the stream eroded the abutment, creating a bypass channel around the structure. The last area included active downcutting ending at a nick point behind several residences at the terminus of the reach. These areas are potential candidates for stream bank stabilization.

*Stream segment GB-06 showing area of stream bank erosion.*

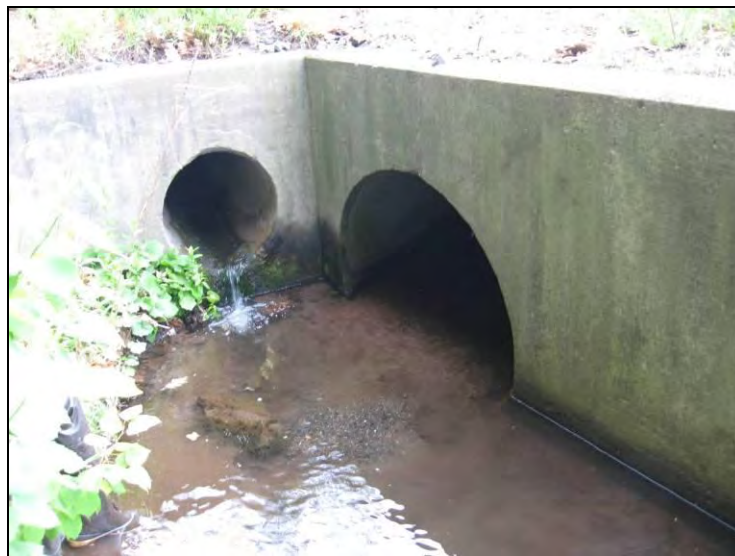
- SC - This stream crossing conveys the tributary below Interstate 84. The crossing is a concrete culvert several hundred feet long. The crossing is partially blocked by accumulated sediment.

*Stream crossing (SC-01) below I-84 and outfall (OT-03) along reach GBST-02.*

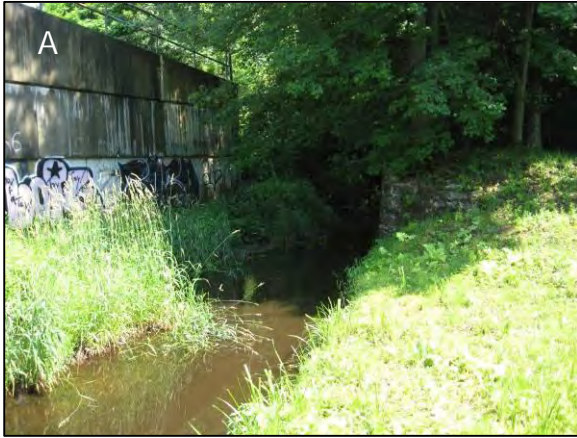
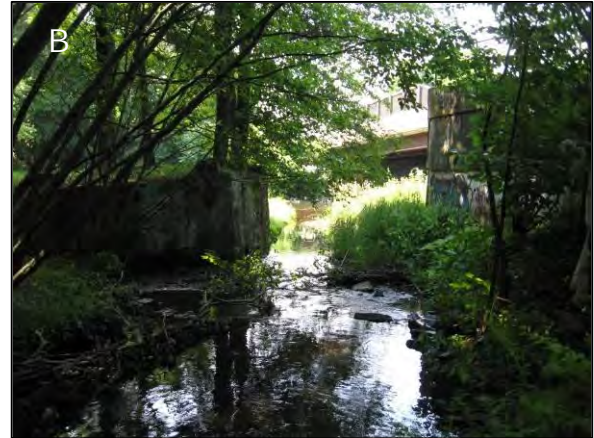
This lower reach extends from the confluence with the Tankerhoosen River upstream to Brookview Drive. Partially demolished cement building foundations and stream crossings from demolished industrial-era infrastructure remain along the downstream portion of the stream. The upper portion of the reach has significant stream buffers, native vegetation, stream shading and flood plains.

*Examples of impacted buffers along reach TB-01. A cement retaining wall (A) for the street and bridge on the right bank near the confluence with the Tankerhoosen River and partially demolished cement infrastructure along the banks (B).*

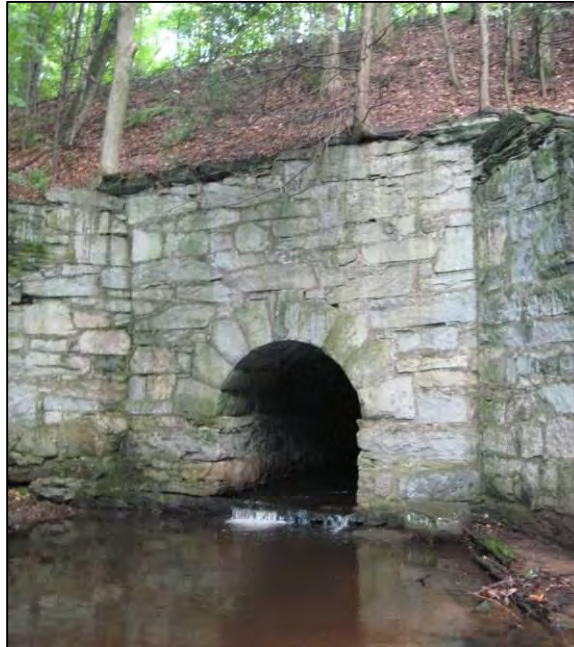
*Arch-type railroad crossing (SC-02) constructed of stone and extending approximately 125 feet. The crossing may prevent fish passage and is suffering from downstream scour evidenced by the large pool shown in the photograph.*

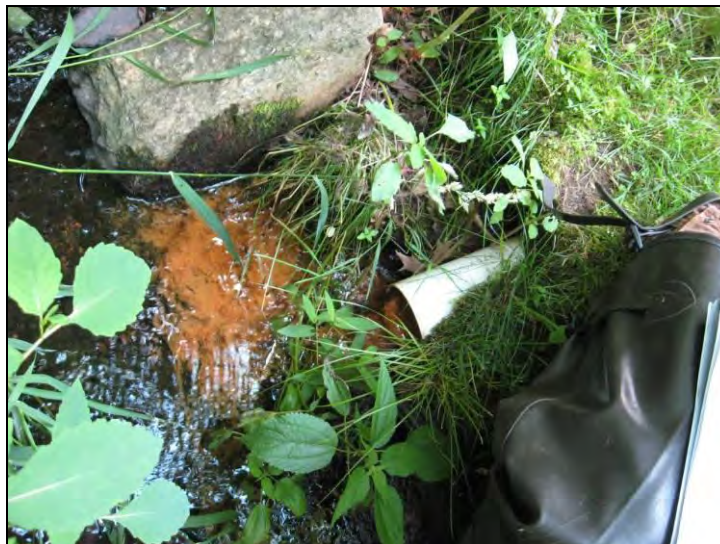
*Outfall pipe originating from a residential property on the left bank of segment TB-04C.*

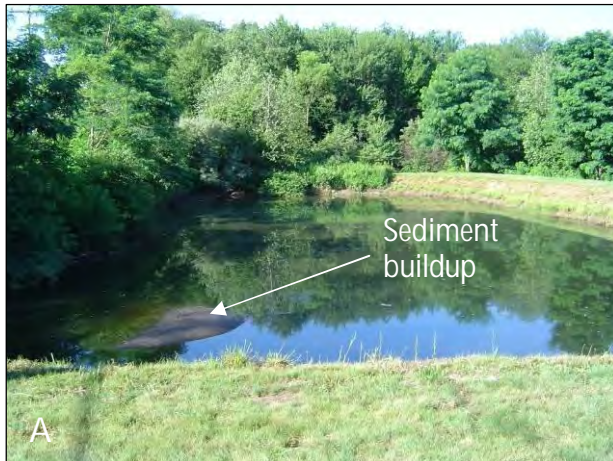
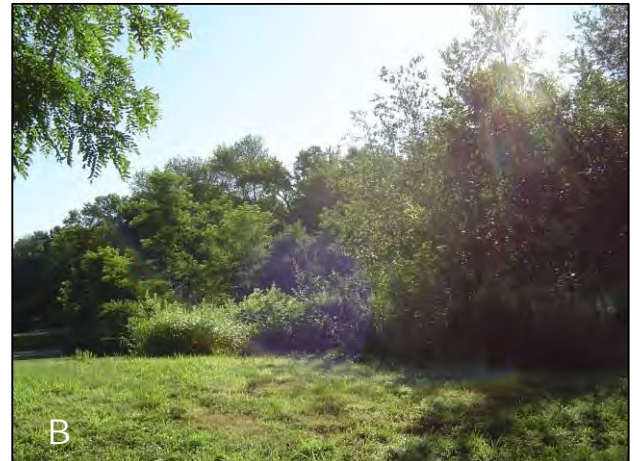
*Stormwater basin at the Gerber Technologies facility on Industrial Park Road West. Sediment has built up near the center of the basin (A) and the basin overflow spillway is overgrown with vegetation (B).*

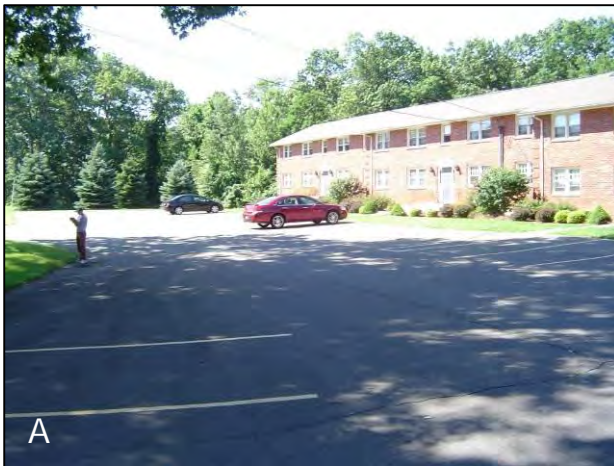
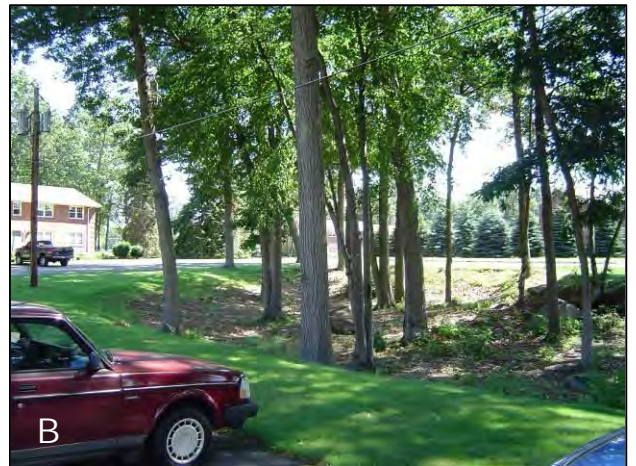
*The Mount Vernon apartment complex buildings showing clean and well-maintained parking areas and landscaping (A) and a landscaped area that has the potential to be used as a rain garden (B).*
